HomeTeam[®]
INSPECTION SERVICE

**123 Main St
Anywhere, NC**

HOME INSPECTION REPORT

File Number: **655439**

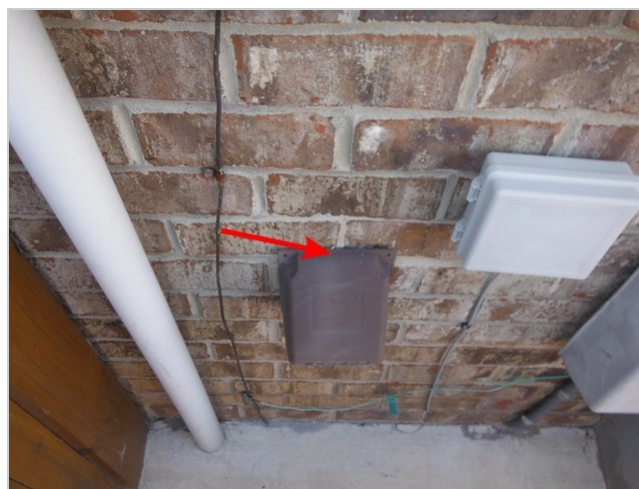
Unsealed-Right

Unsealed penetrations through brickwork in areas at but not limited to right side around dryer vent, and left side around HVAC piping and water spigot. This is a water penetration concern. Recommend repairs as necessary.

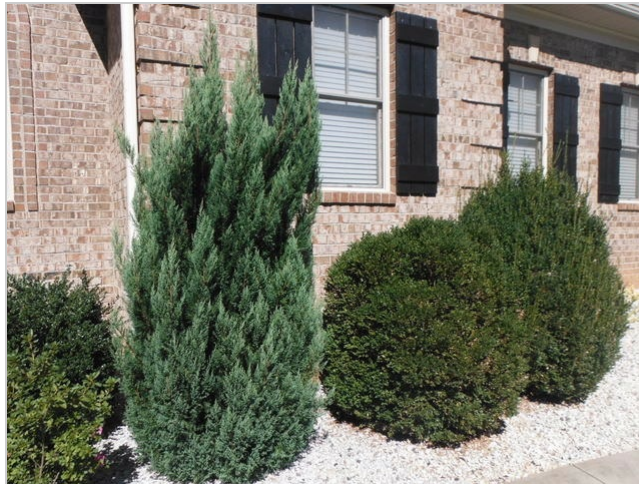
Vegetation at house-Front

Vegetation touching front side of the house. It is recommended to have an 18-24 inch clearance between vegetation and siding to minimize moisture/pest concerns. Recommend repairs by qualified person.

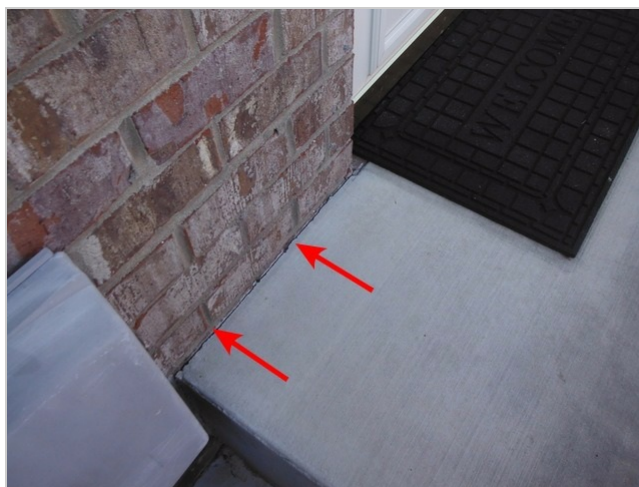
Open joints-Right

Open mortar joints observed at right side porch/patio. This is a water penetration/settlement concern. Recommend repairs by a qualified person.

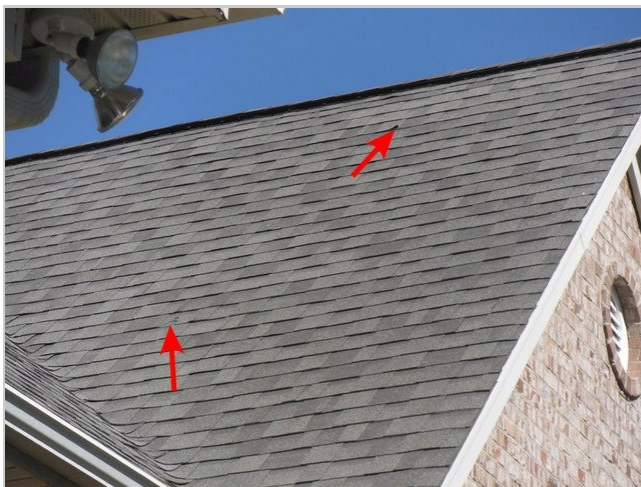
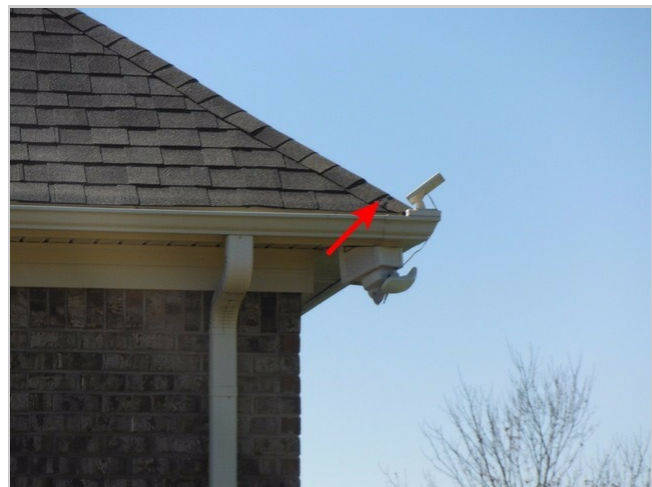
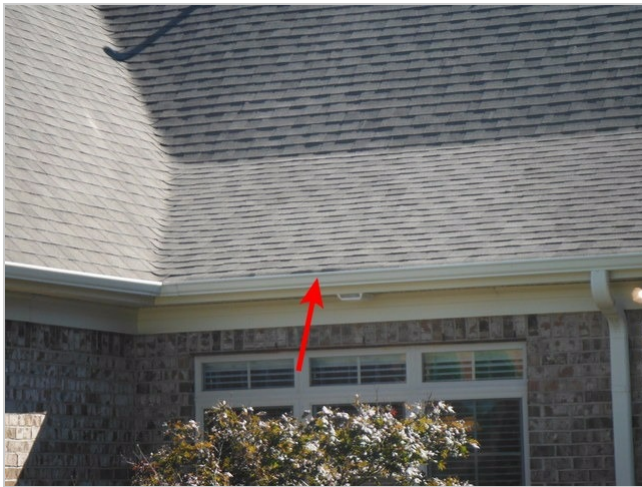
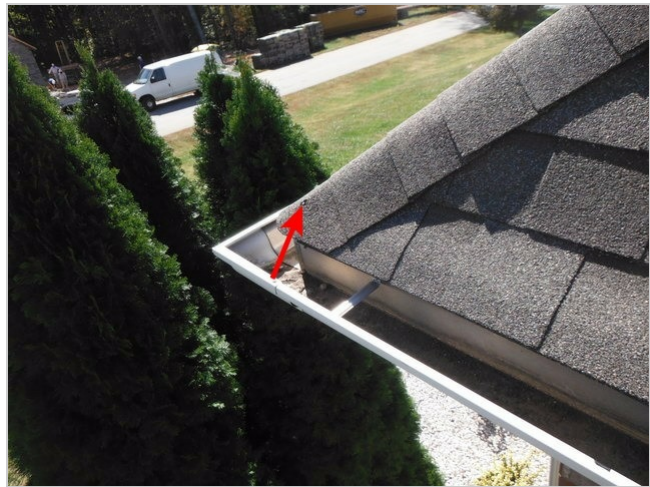
1. ***Raised shingles at but not limited to the front and rear roof of the house. This is a water penetration/wind lift/nail wear through concern.***
2. ***Damaged shingles observed on areas at but not limited to the front, rear right, and rear roof. This is a water penetration/substrate damage concern.***

Damage-Front

Damage-Rear

Damage-Front right

Recommend review and repairs as directed by qualified contractor.

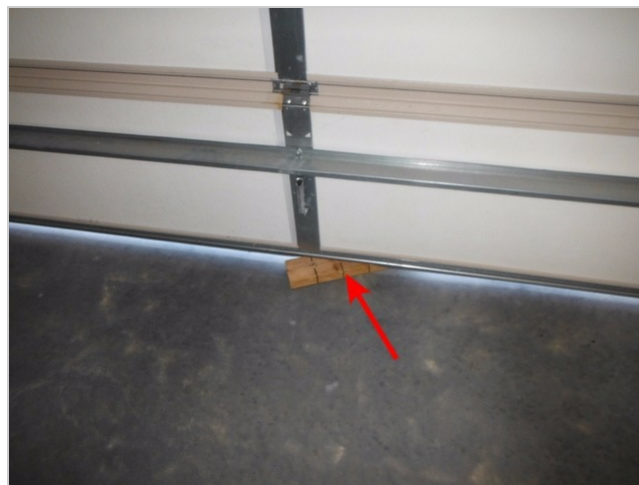
Did not reverse

The rear most garage door did not reverse when met with reasonable resistance (as tested with a 2x4 block). This is a safety concern. Recommend repairs/adjustments by qualified person and verifying proper operation prior to closing.

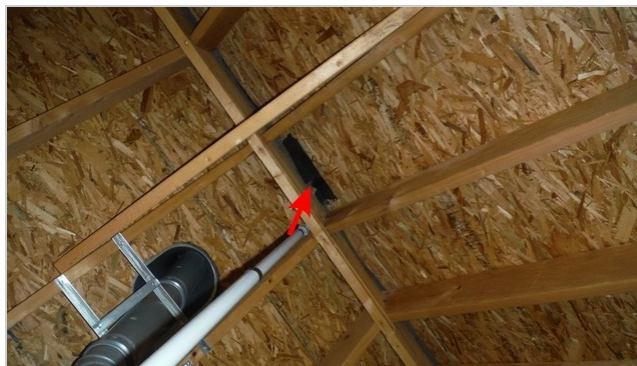
Damaged

Observed damaged roof decking at the right rear of the attic. This is a support concern. Recommend repairs by a qualified contractor.

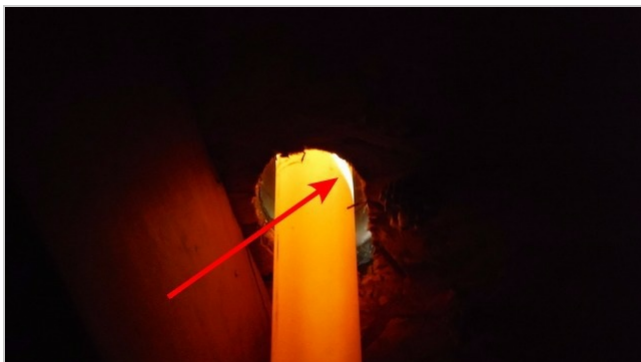
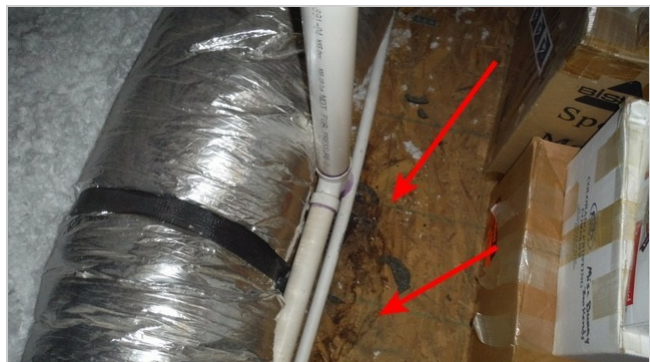
Exhaust vent stack in the right rear attic space had light visible around boot area and stained OSB decking below indicating possible leak. This is a possible leakage/damage concern. Recommend review and repairs as directed by qualified contractor.

Penetrating daylight-attic

Deck staining below exhaust vent-attic

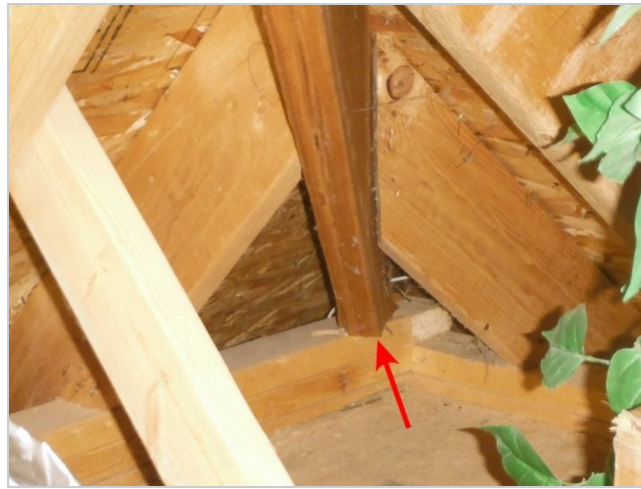
Not fully bearing

LVL framing at the front right of house is not fully bearing at the heel cut. This is a

support/installation/damage concern. Recommend repairs as directed by qualified contractor.

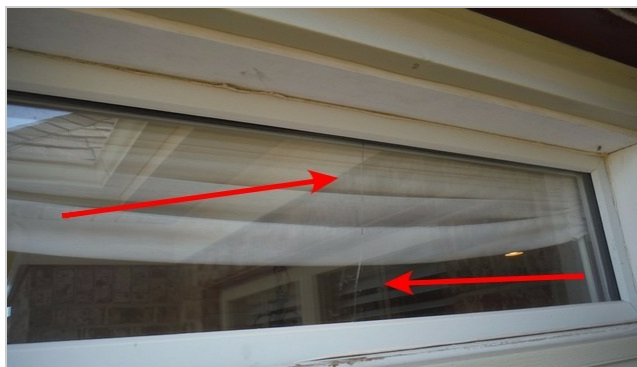
Cracked window pane-rear entry door

Window pane above rear entry door of the home was cracked at the time of the inspection. This is a damage concern. Recommend repairs by a qualified contractor.

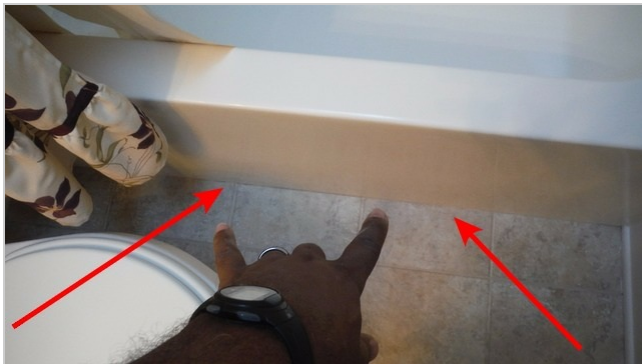
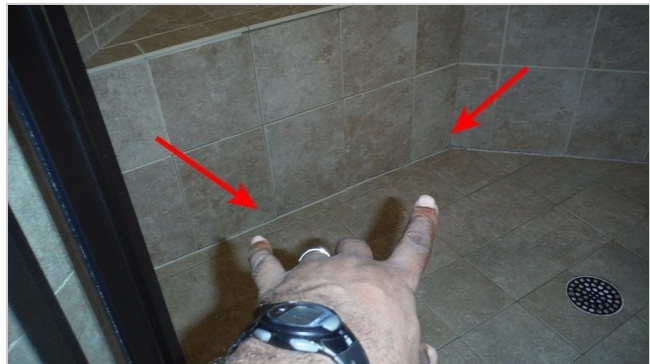
Unsealed areas at bath surrounds in the master and upstairs bathrooms. This is a water penetration/substrate damage concern. Recommend repairs by qualified person.

Upstairs bathroom surrounds

Master bathroom shower surrounds

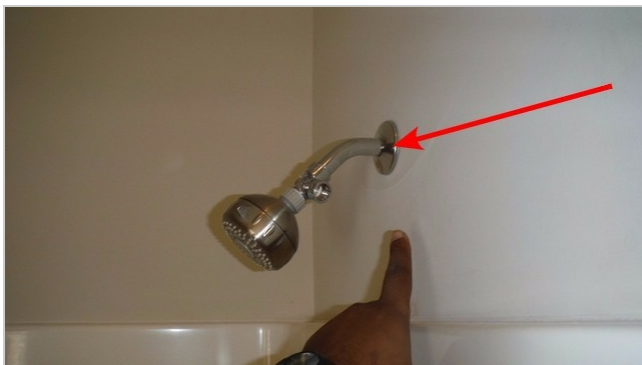
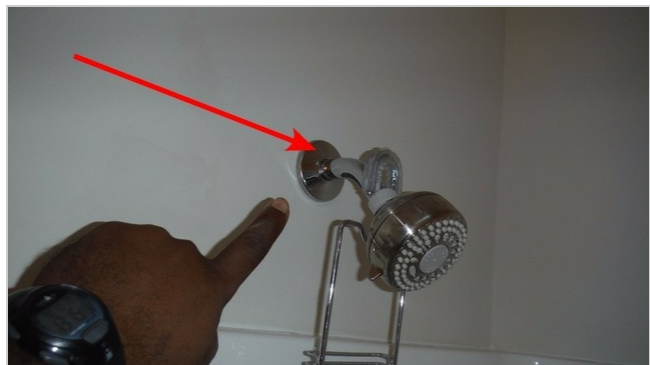
Observed loose shower stems in the upstairs and downstairs hallway bathrooms. This is a movement concern. Recommend repairs by a qualified person.

Downstairs hallway bathroom shower stem

Upstairs bathroom shower stem

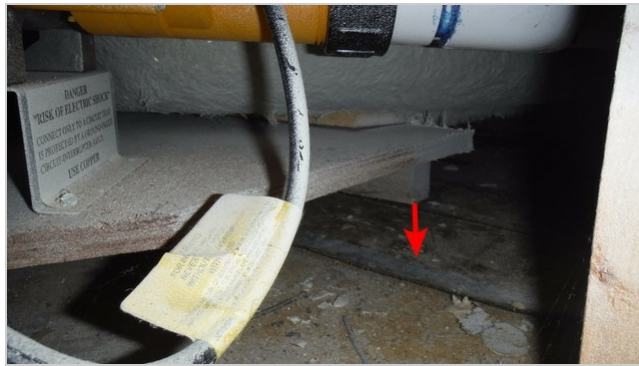
Jetted tub-master bathroom

Gap observed between bottom of jetted tub and subfloor. This is a support/damage concern. Recommend repairs by a qualified contractor.

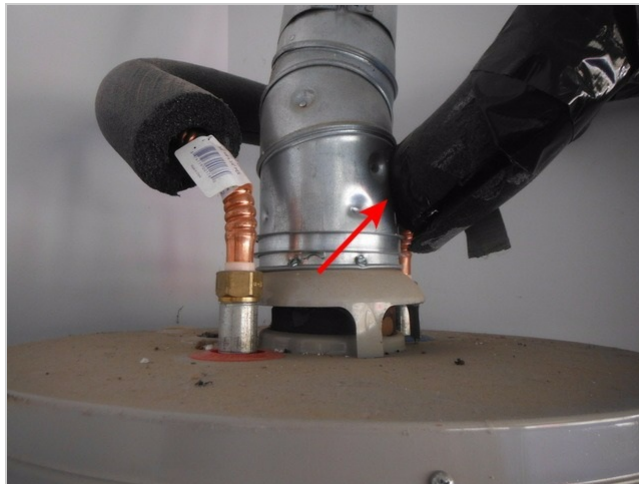
Contacting combustibles

Water heater exhaust vent is contacting combustibles near unit. There is typically a 1 inch gap to combustibles to minimize safety/damage concerns. Recommend repairs.

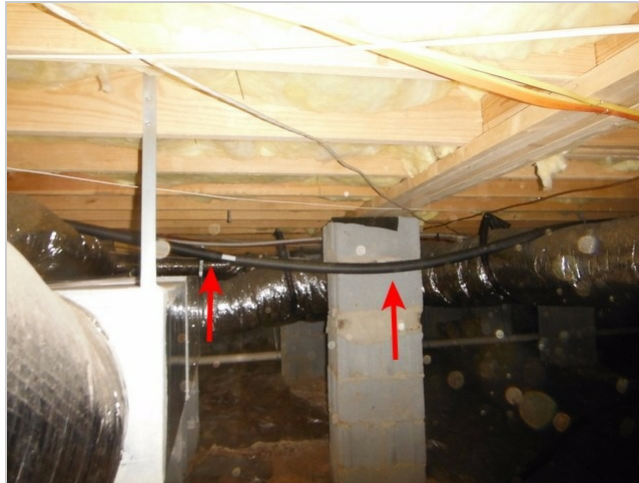
Water line not fully supported

Water lines in areas at but not limited to the center of the crawlspace are not fully supported. This is a movement/damage concern. Recommend repairs by qualified person.
