HOME INSPECTION REPORT

Tom and Sue Brown
123 Main Street
Anywhere, NC 12345

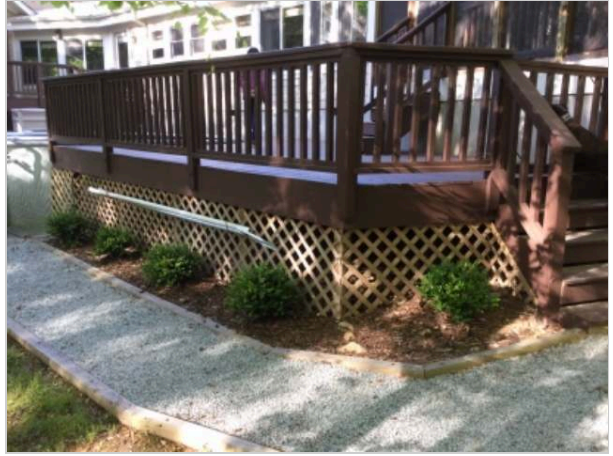
At the lower deck, there are attachment bolts with no hardware. This may impact stability. Have a qualified contractor install and tighten all hardware as required.

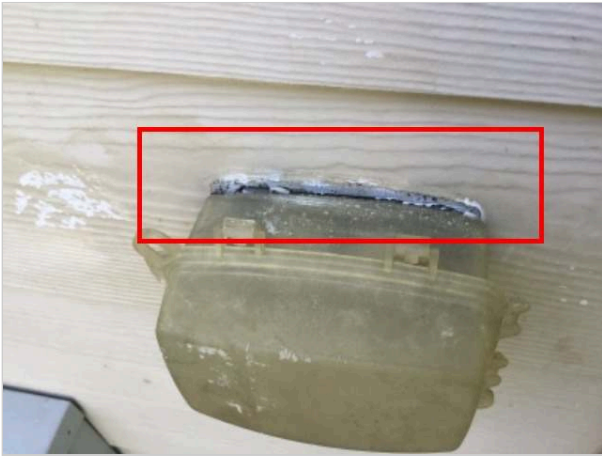
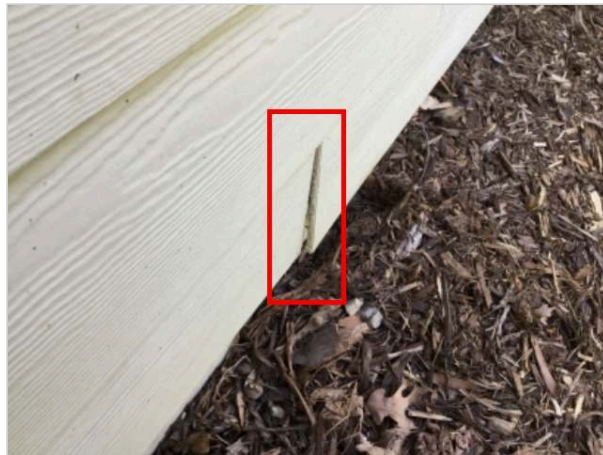
Loose siding was noted on the right side of the home. If left, this condition can allow water infiltration behind the siding. Have a qualified contractor repair the siding.

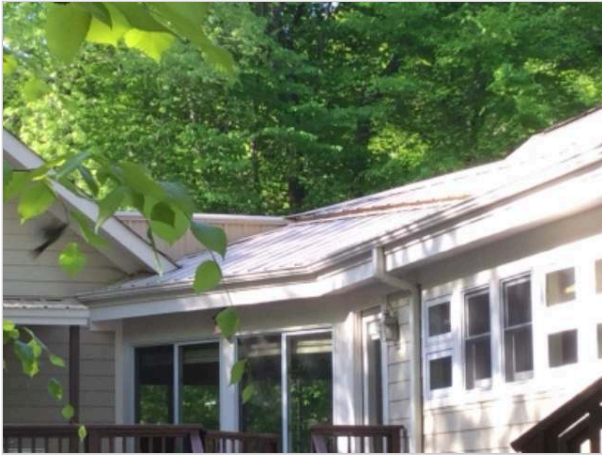
On this roof, one shingle appeared to be in poor condition. Further, there was one curled shingle and one that appeared to be pushed up by a nail. Broken, loose curled and/or cracked shingles can allow the infiltration of water and lead to damaged structural components. Have a qualified contractor to evaluate and repair as required.

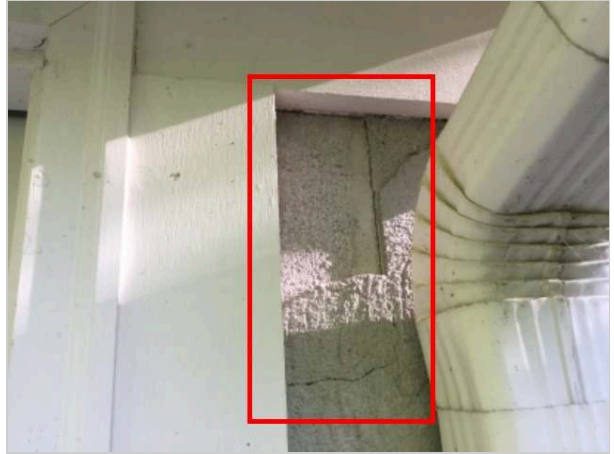
Foundation cracked here

On the rear of the home, the foundation is cracked. This crack is not open and there is no differential movement.. There was no apparent structural movement in the living space above. Have a qualified structural engineer evaluate and advise.

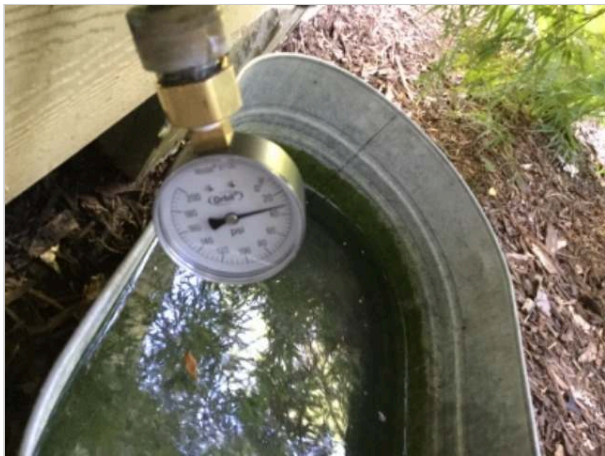
The water pressure and flow seemed deficient in the home. When running multiple fixtures at the same time, the flow drops off considerably. Have a qualified plumbing contractor evaluate the water flow in the home and adjust or repair as required

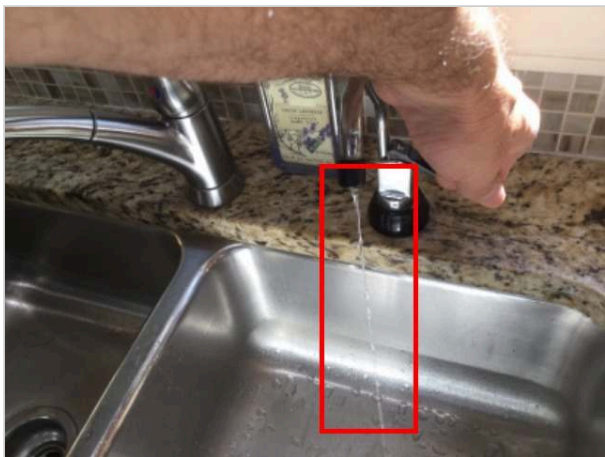
At the kitchen sink, the filtered water dispenser operates as if the filter is clogged. that is, there is good flow for a couple of seconds and then the flow diminishes greatly. Have a qualified plumbing contractor evaluate and repair as required.
