HOME INSPECTION REPORT

On Thursday, February 9, 2023 The HomeTeam Inspection Service made a visual inspection of 123 Sample Street, Myrtle Beach, SC 29572. Enclosed please find a written, narrative report of our findings in accordance with the terms of our Inspection Agreement.

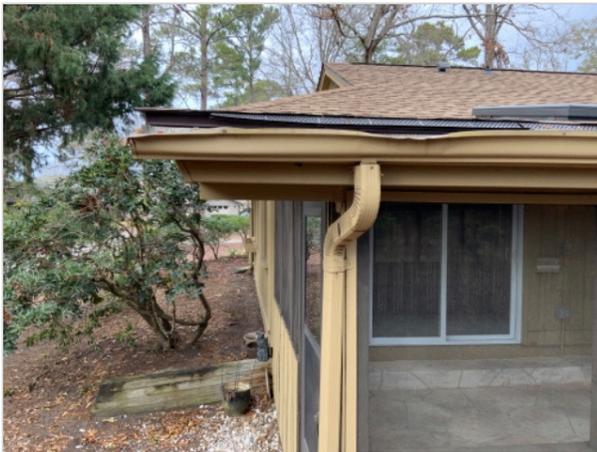
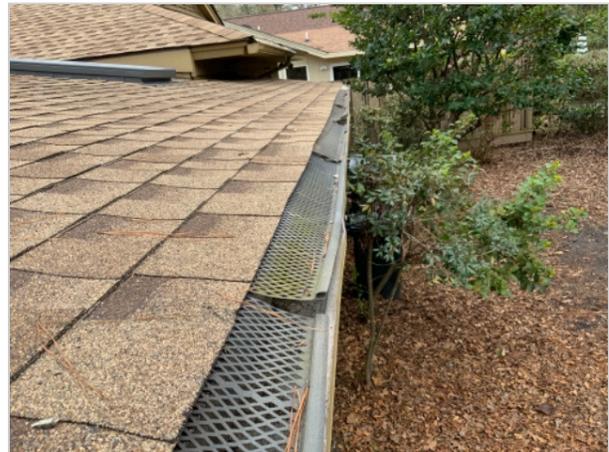
Gutters were in need of repair at the time of the inspection. Clogged or damaged gutters can cause roof drainage water to drain at the base of the foundation, causing foundation water problems. Overflow from gutters can cause damage to fascia that is not visible or apparent at the time of the inspection. Recommend that the gutters be repaired.

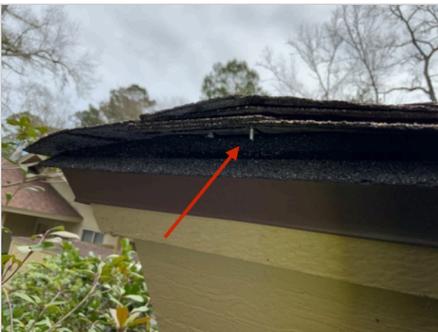
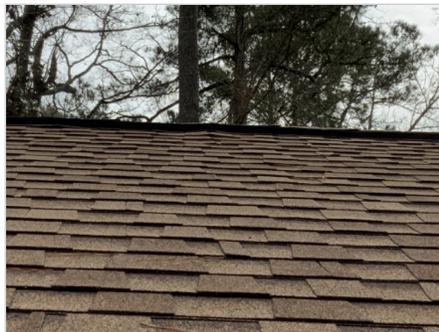
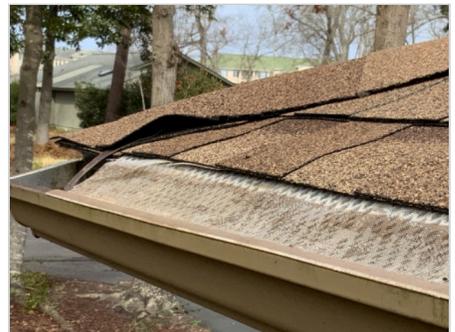
One or more popped nails were noted on the roof at the time of the inspection. A popped nail can be identified by a lifted corner on a shingle. The heating and cooling of the roof will often cause roofing nails to lift under the shingles, causing the corner to lift. While it is not likely that the condition is causing a leak, it is recommended that the nails be reset and sealed to prevent wind from getting under the shingle and possibly lifting the shingle off the roof. Consult with a qualified roofer for repair.

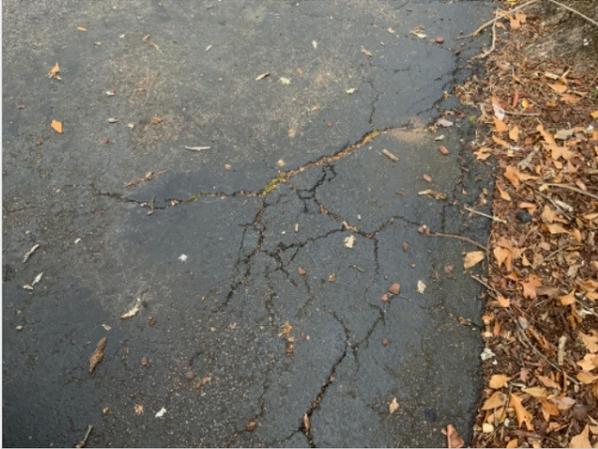
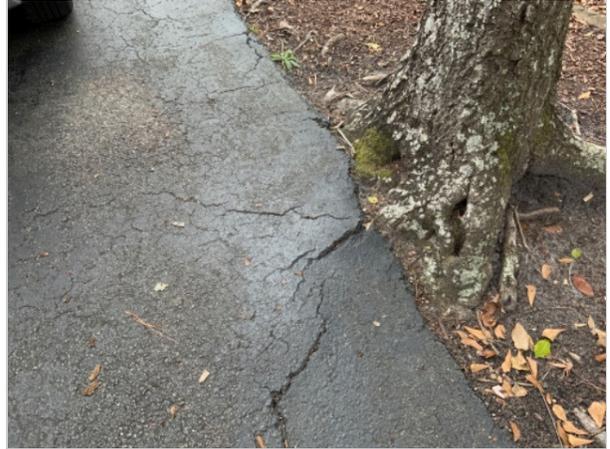
Several areas of the driveway have settled. This condition indicates a possible void under the driveway. Driveway settling may lead to potential tripping hazards. Recommend that the areas be monitored and repaired as needed.

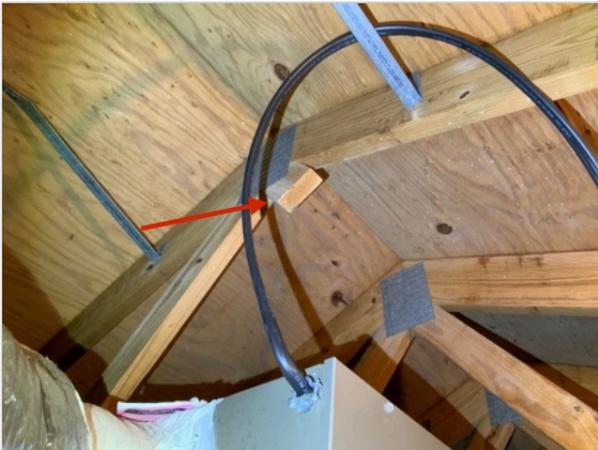
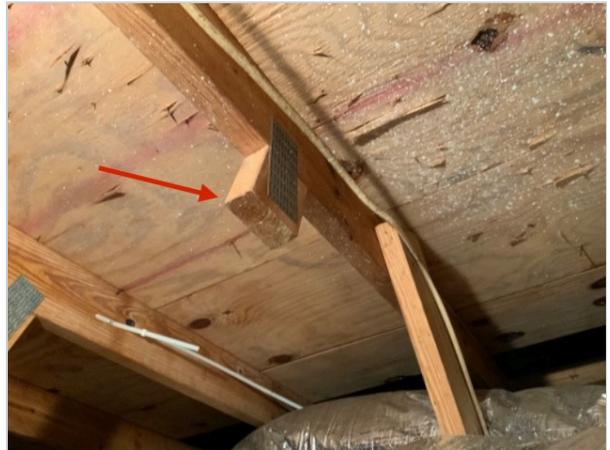
Cut truss(es) observed in the attic. This is a support/installation/damage concern. Typically, truss modifications/repairs are to be approved by the manufacturer or structural engineer. Modifications to trusses can alter the design load. Recommend review and repairs as directed by a structural engineer with repairs performed by a qualified contractor.

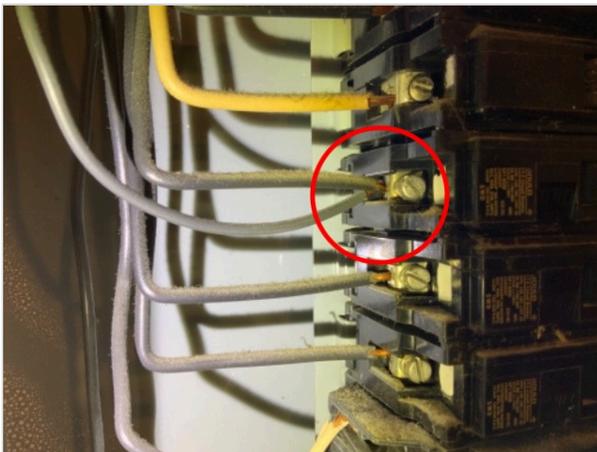
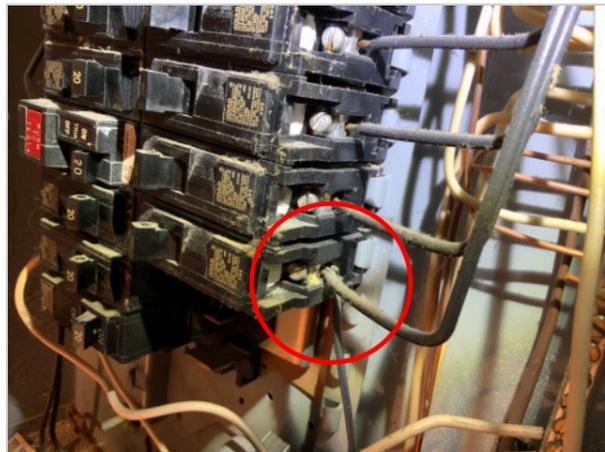
Circuit breakers in the electric panel had two attached circuits (wires). Each circuit should have its own dedicated breaker to prevent nuisance tripping and ensure good terminal contact, which may help prevent overheating. This situation is commonly referred to as a "double-tap". Recommend that an electrician repair this condition and further assess the panel for any additional required repairs.

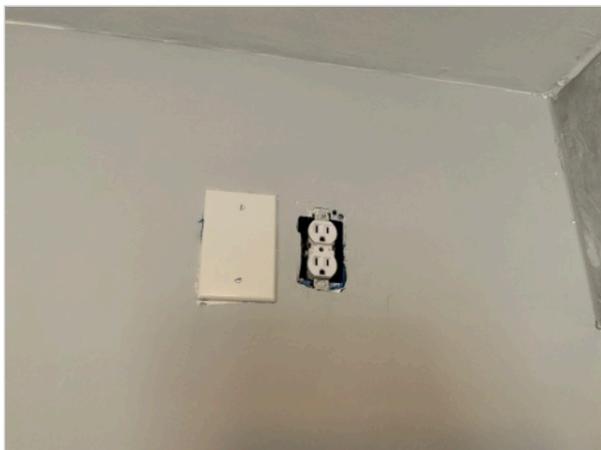
Kitchen

Missing switch or outlet covers were observed in the living area. Recommend all switch and outlet boxes be properly covered to avoid a shock hazard.

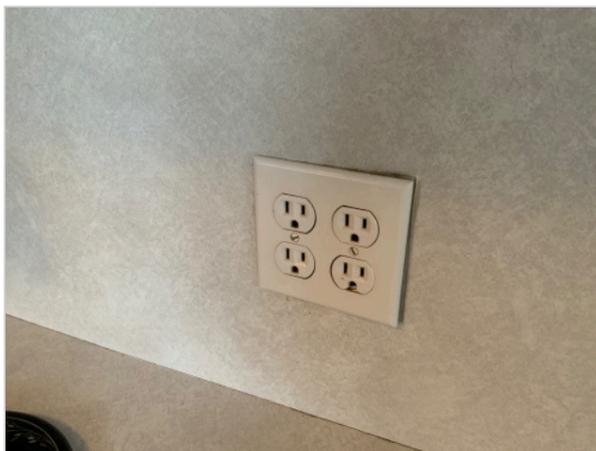
Kitchen

Loose receptacles, switch or outlet covers were observed in the kitchen. Recommend all switch and outlet boxes be properly secured to avoid a shock hazard.

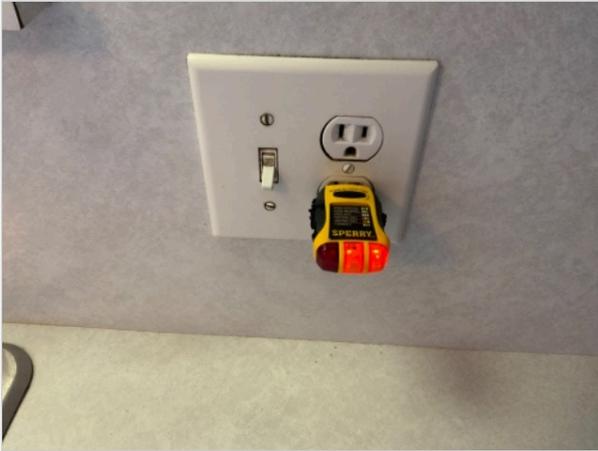
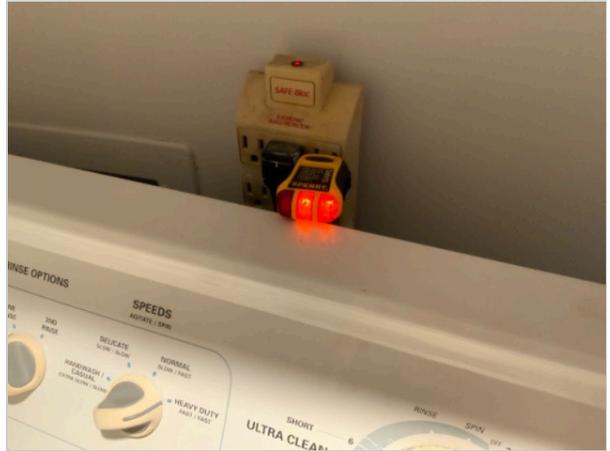
The electrical outlets in the laundry area and exterior lack GFCI protection. Although possibly not required at time of construction, this is a potential shock/safety concern due to proximity to a water source. Recommend repairs by a qualified contractor or electrician as required.

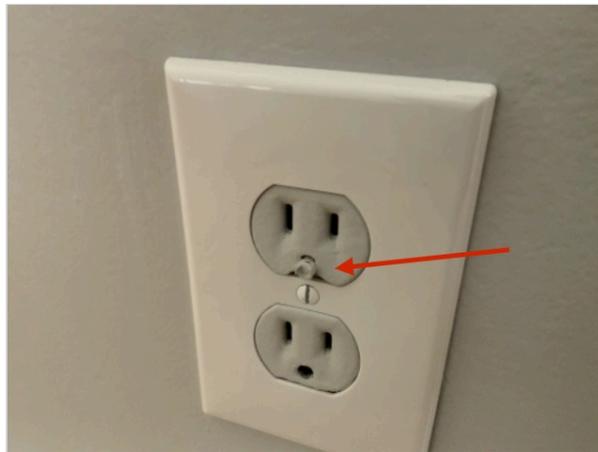
Living room

A blocked opening was observed in the electrical outlet in the living room. This is a damage/safety concern. Recommend repair by a qualified person.

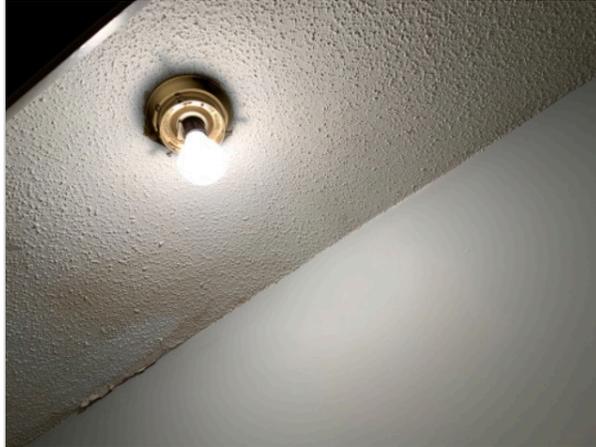
The structure has closets with lights without covers installed. Objects should be kept 12 to 18 inches away from any incandescent lights to avoid a potential fire hazard.

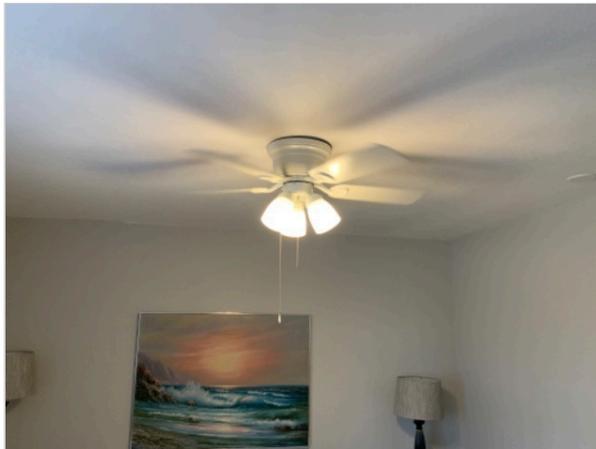
The overhead ceiling fan/light in the front bedroom were not operated by a light switch.

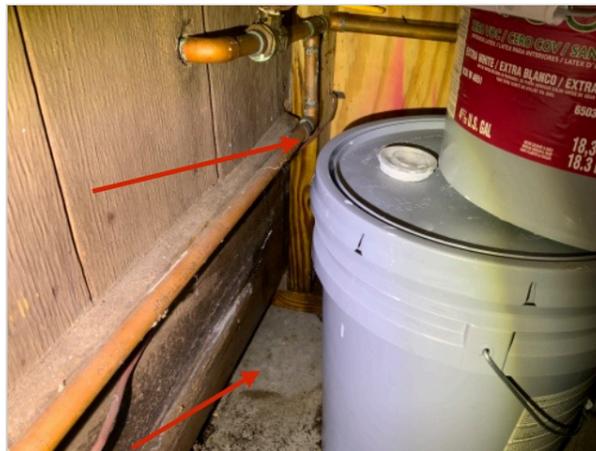
exterior storage closet

Active water leaks were present at supply lines the time of the inspection. Recommend the affected areas be repaired, and nearby or associated plumbing lines should be further assessed at the time of the repair.

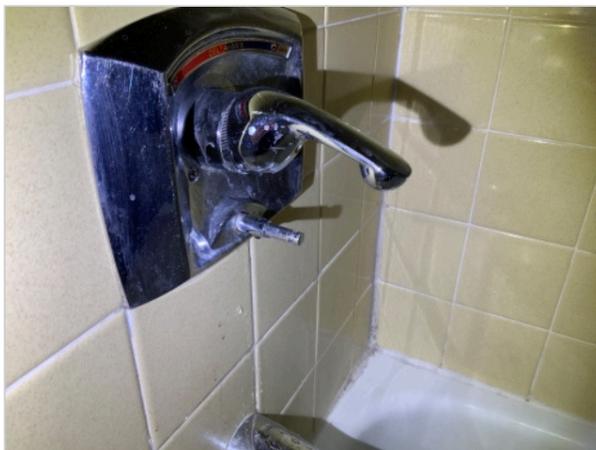
A leak was observed at the faucet to the hall bathroom shower. Recommend that the faucet be repaired or replaced to prevent water intrusion.

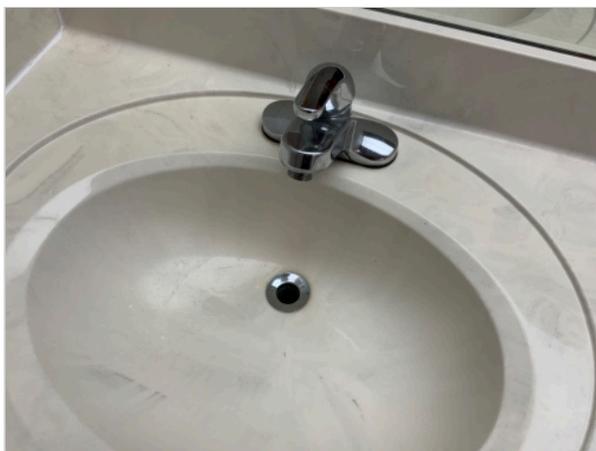
Drain stopper(s) in the hall bathroom were missing or non-functional at the time of inspection.

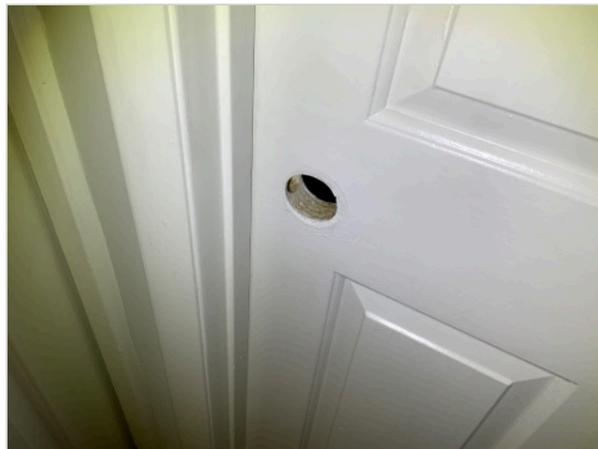
Rear bedroom

The door to the master bedroom does not latch. Recommend that the door, frame, and/or latching mechanism be adjusted to allow for proper operation of the door.

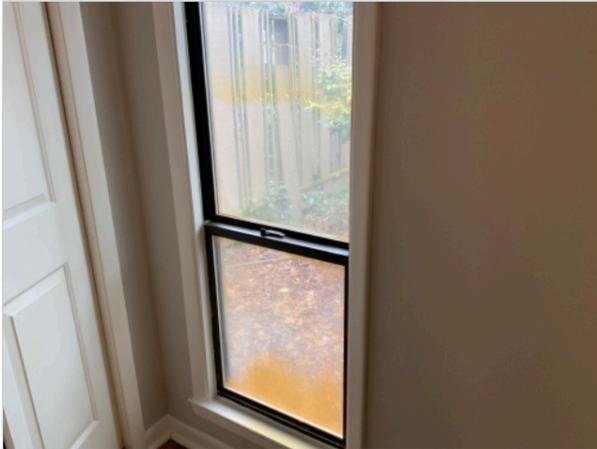
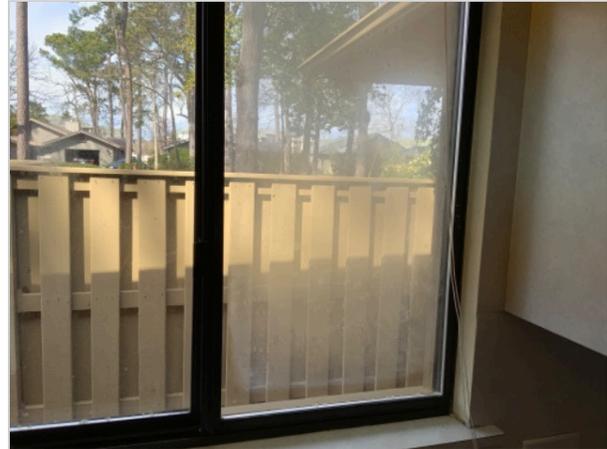
Two windows in the structure had a broken thermal seal. A window with a defective thermal seal will show a slow but gradual "fogging" effect, and the insulation value of the window is marginally reduced. HomeTeam recommends having the affected window(s) repaired or replaced and further assessed.

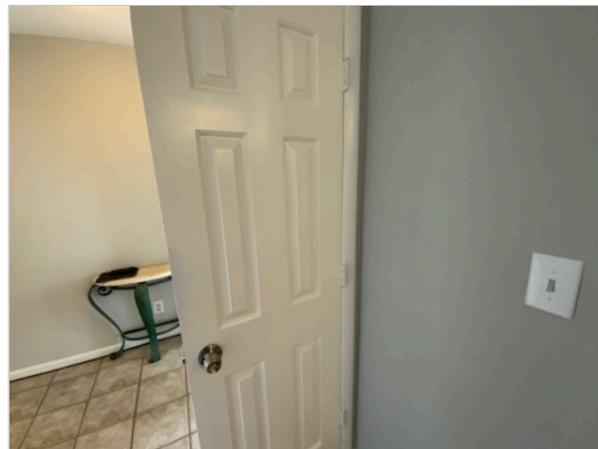
The left bedroom door was not functional at the time of inspection.

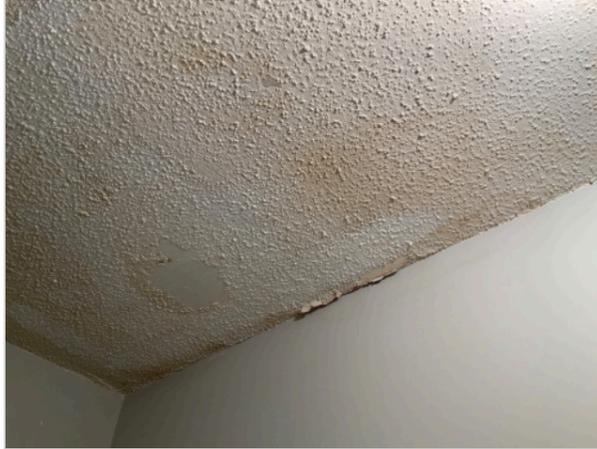
Water stains were present on the ceiling of the structure. The moisture levels of the stains were dry at the time of the inspection and should be monitored for any future moisture.

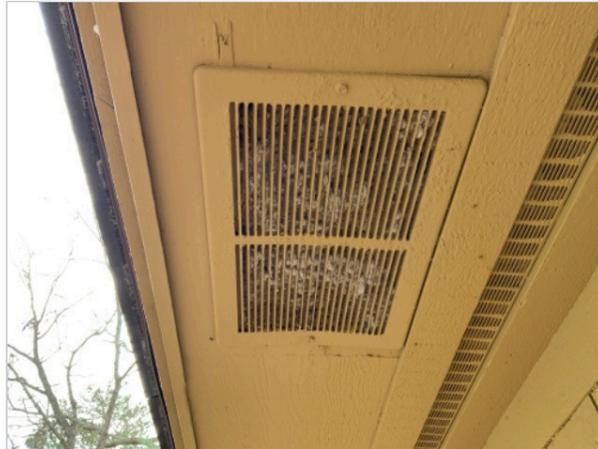
The exterior dryer vent screen was clogged with lint. It is recommended that screens be removed from dryer vents to prevent dryer fires from occurring.
