# HomeTeam<sup>®</sup>

### HOME INSPECTION REPORT

The HomeTeam Inspection Service made a visual inspection of 123 Main Street, Anytown, USA 55555. Enclosed please find a written, narrative report of our findings in accordance with the terms of our Inspection Agreement.

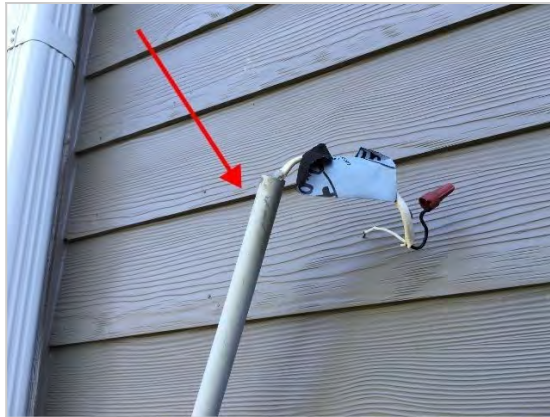
Photo 2

**Exposed or un-terminated live wires were observed on the exterior.** The wires should either be disconnected at the source or properly terminated in an approved, covered electrical box. Consult with a qualified electrician for repair and further assessment.

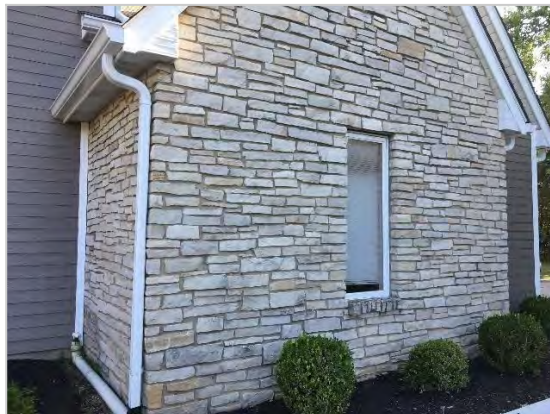
Photo 3

NOTE: The structure has a manufactured stone veneer (MSV) cladding. Structures with MSV can develop moisture intrusion problems even when properly constructed according to industry standards. The problem can develop because of moisture buildup behind the veneer that is unable to drain, and this moisture can cause significant structural damage that is not visible during a non-destructive test. Specific areas of concern include areas around the windows that may have been subjected to prolonged water exposure. Other areas of likely penetration are around chimneys, decks, and any other penetration points. Water intrusion is more likely at these points. In all cases, HomeTeam recommends having MSV-clad structures professionally inspected by an MSV-qualified technician prior to purchase and again each year. Typically, this type of test involves drilling several holes and inserting moisture meters to determine if any moisture is present behind the veneer.

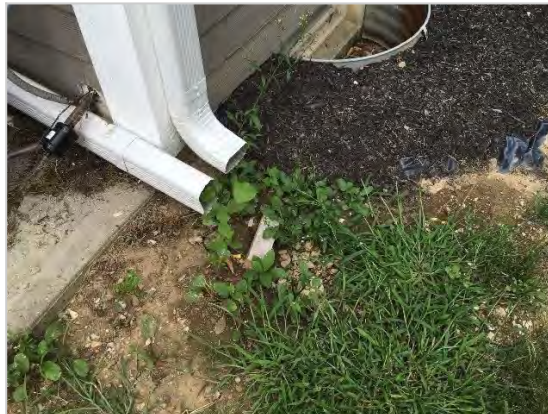
Photo 4

**A downspout was draining at or too close to the base of the foundation.** To reduce the likelihood of water problems at the base of the structure, all roof drainage should be directed at least six feet from the base of the foundation.

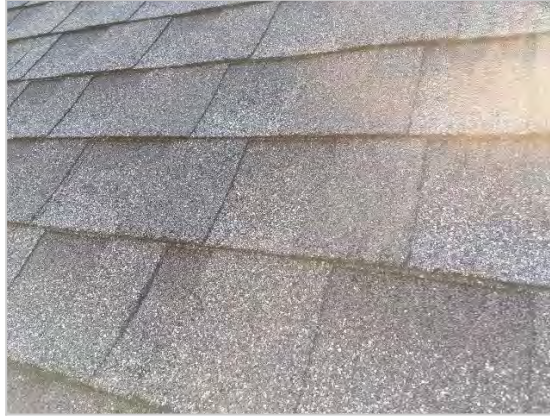
Photo 5

The roof was a gable design covered with asphalt/fiberglass shingles. Observation of the roof surfaces and flashing was performed from a ladder at the eaves due to excessive pitch. There was one layer of shingles.

The roof shingles exhibited no curling and light surface wear. Several areas were tested for lifted edges, and lifted edges were not observed. Nail pops were not observed. Evidence of a hail event was not observed.

These conditions indicate the roof shingles were near the middle of their useful life.

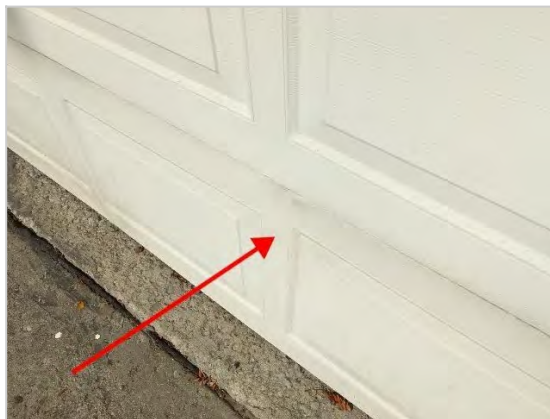
Photo 6

**The widest of the three garage door is dented from what appears to be impact.** The door was operating correctly at the time of the inspection. Care should be exercised to ensure that the door is not subjected to further impact, as the door may crack or fail.

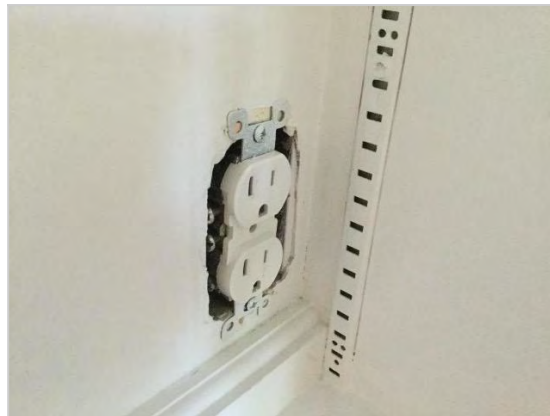
Photo 10

**Missing switch or outlet covers were observed in the living area.** All switch and outlet boxes should be properly covered to avoid a shock hazard. Electrical repairs should be performed by a qualified electrician.

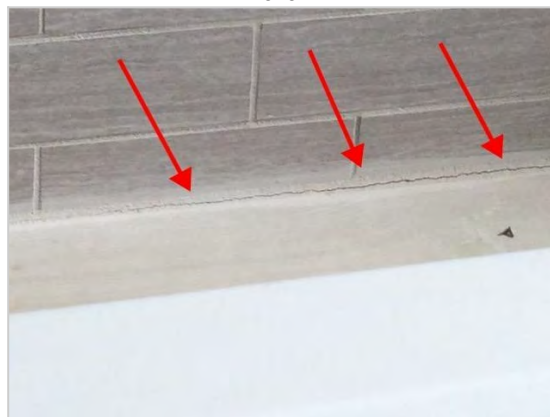
Photo 11

**Some of the caulk was missing from around the tub in the master bathroom.** These areas should be sealed to prevent moisture penetration. Failure to keep walls sealed can cause deterioration and extensive moisture damage including mold growth to the interior walls, which is not always visible at the time of the inspection.

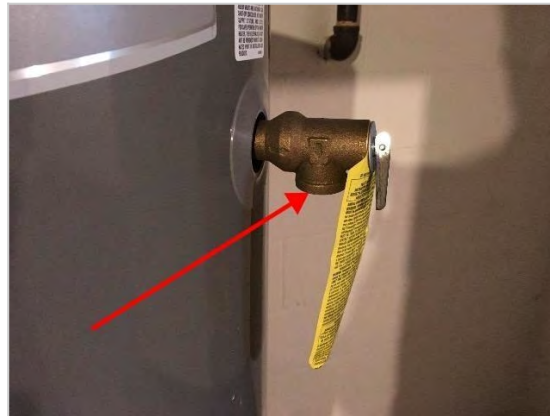
Photo 12

There was no drip leg installed on the T&P valve of the water heater. The drip leg directs water from the T&P valve toward the floor. A drip leg terminating within six-inches of the floor should be installed.

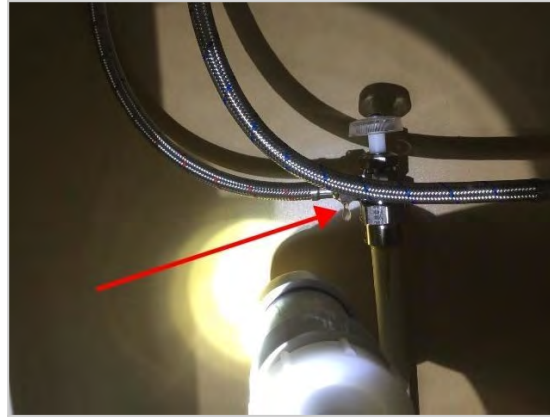
Photo 13

**Active water leaks were present at supply lines the time of the inspection.** The affected areas should be repaired, and nearby or associated plumbing lines should be further assessed at the time of the repair.

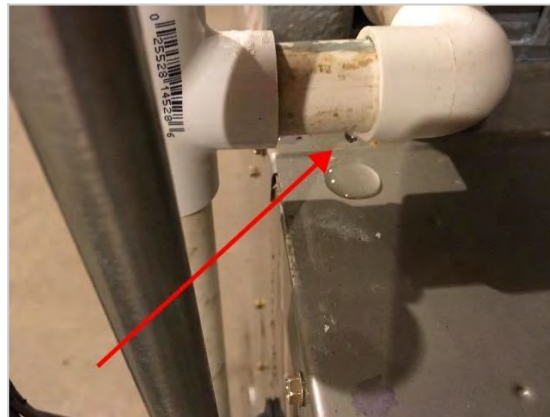
Photo 16

**A condensate leak was noted on the air handler drain line.** Repairs should be made by a qualified contractor.

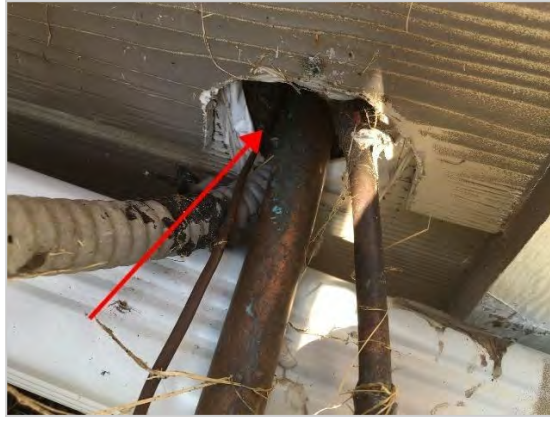
Photo 23

**The insulation on the exterior air conditioning line set is missing.** This could affect the efficiency of the system and should be replaced.
