**123 Main St
Anywhere, NC**

HOME INSPECTION REPORT

File Number: **655439**

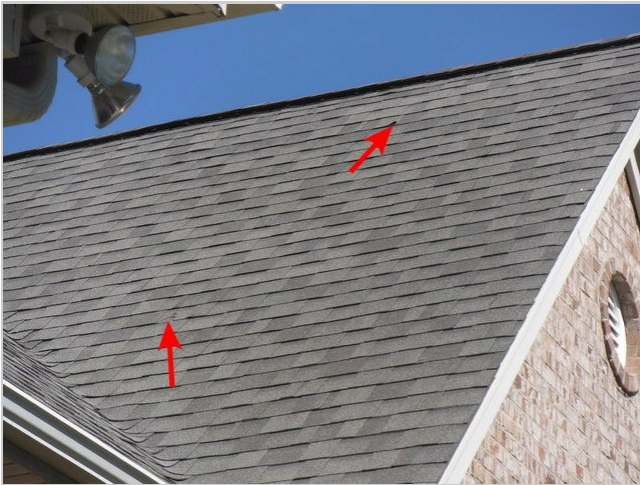
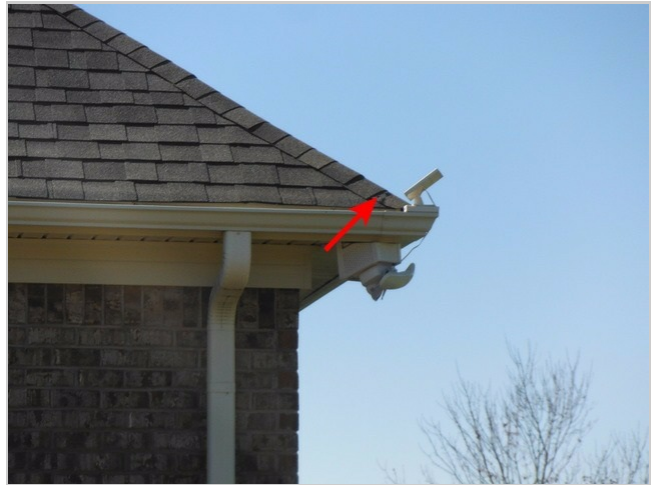
1. ***Raised shingles at but not limited to the front and rear roof of the house. This is a water penetration/wind lift/nail wear through concern.***
2. ***Damaged shingles observed on areas at but not limited to the front, rear right, and rear roof. This is a water penetration/substrate damage concern.***

Damage-Front

Damage-Rear

Damage-Front right

Recommend review and repairs as directed by qualified contractor.

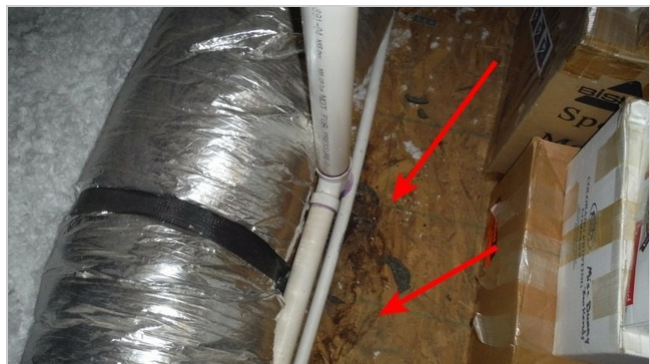
Exhaust vent stack in the right rear attic space had light visible around boot area and stained OSB decking below indicating possible leak. This is a possible leakage/damage concern. Recommend review and repairs as directed by qualified contractor.

Penetrating daylight-attic

Deck staining below exhaust vent-attic

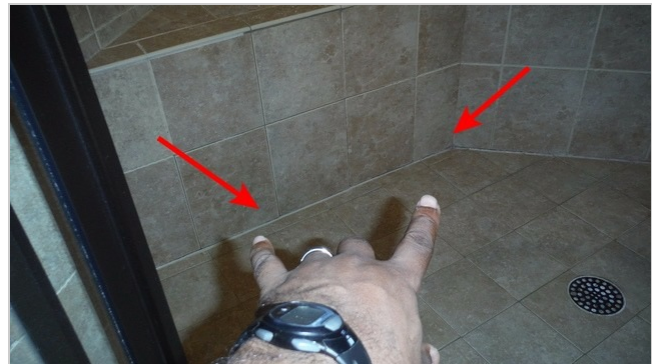
Unsealed areas at bath surrounds in the master and upstairs bathrooms. This is a water penetration/substrate damage concern. Recommend repairs by qualified person.

Upstairs bathroom surrounds

Master bathroom shower surrounds

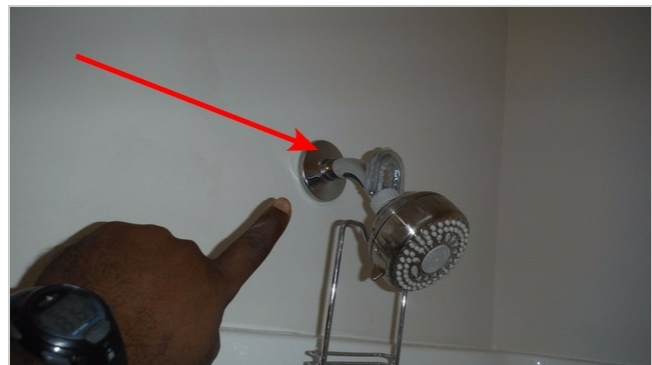
Observed loose shower stems in the upstairs and downstairs hallway bathrooms. This is a movement concern. Recommend repairs by a qualified person.

Downstairs hallway bathroom shower stem

Upstairs bathroom shower stem

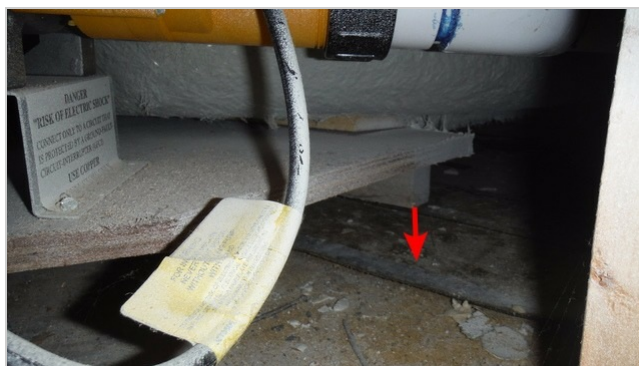
Gap observed between bottom of jetted tub and subfloor. This is a support/damage concern. Recommend repairs by a qualified contractor.

Jetted tub-master bathroom

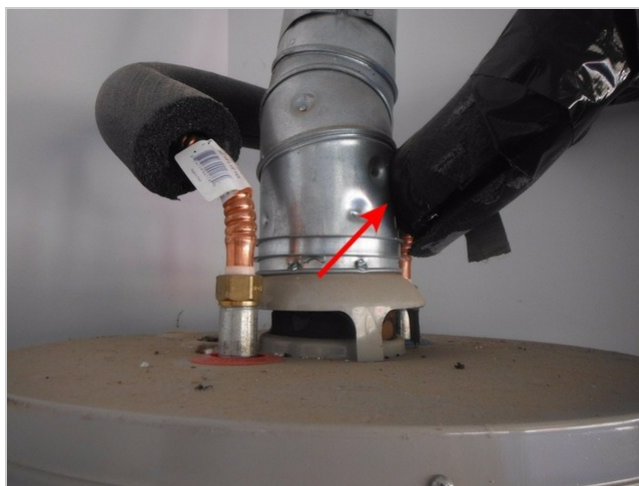
Water heater exhaust vent is contacting combustibles near unit. There is typically a 1 inch gap to combustibles to minimize safety/damage concerns. Recommend repairs.

Contacting combustibles

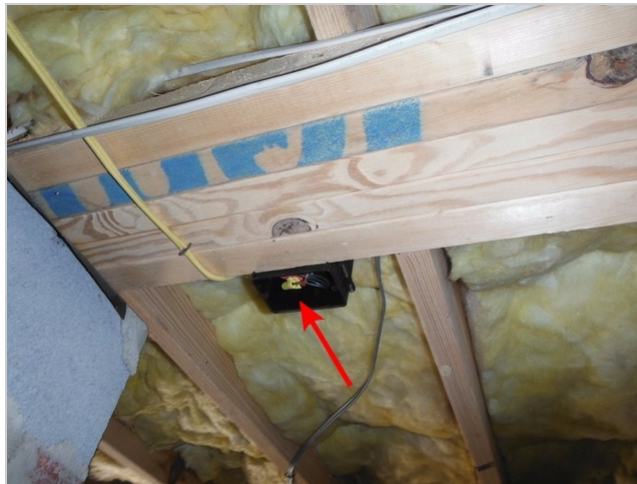
Open junction box observed at but not limited to the rear left of crawlspace. This is a damage/shock concern. Recommend repairs by a qualified person.

Open junction box-Crawlspace

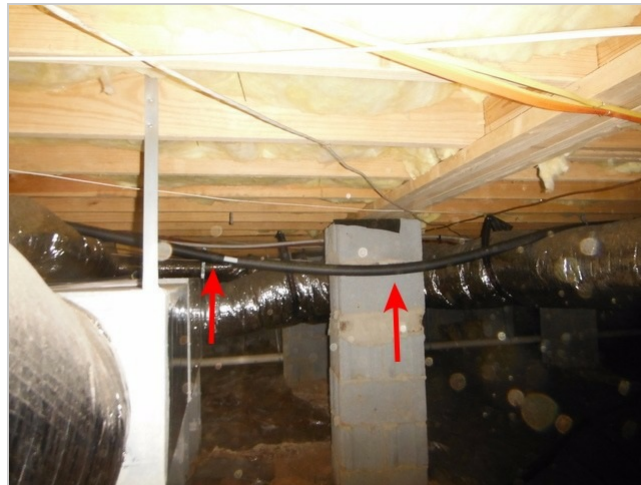
Water lines in areas at but not limited to the center of the crawlspace are not fully supported. This is a movement/damage concern. Recommend repairs by qualified person.

Water line not fully supported

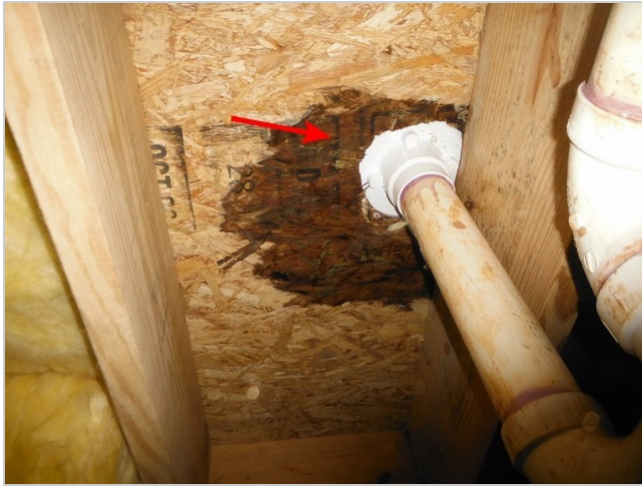
1. ***Staining/elevated moisture underneath master bath stall shower. This is a leakage/substrate damage concern.***
2. ***Leaking observed around master bath jetted tub into the crawlspace. This is a leakage/substrate damage concern.***

Staining/elevated moisture-Stall shower

Recommend evaluation and repairs as directed by qualified contractor.

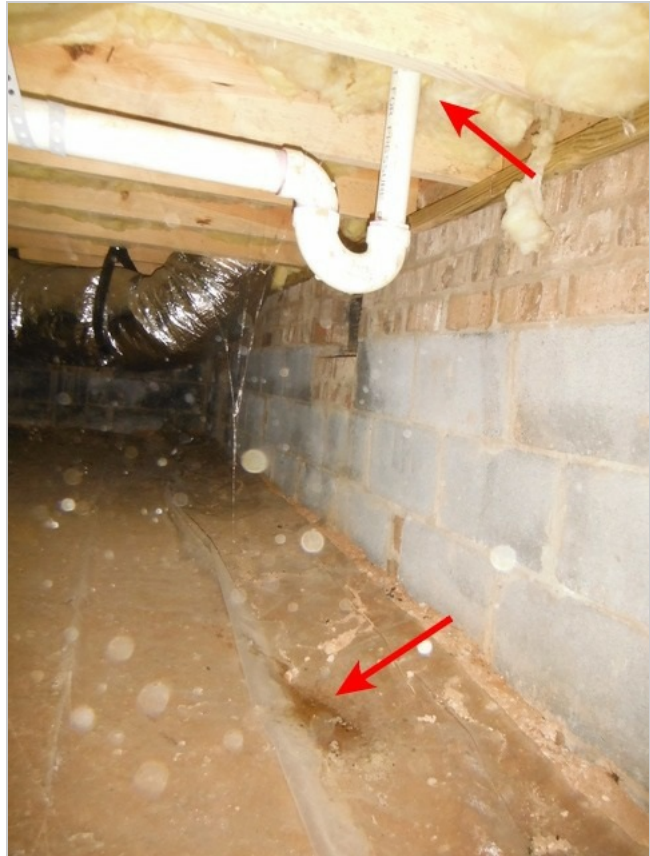
Leaking-Jetted tub
