HOME INSPECTION REPORT

The HomeTeam Inspection Service made a visual inspection of 123 Main Street, Anytown, USA 55555. Enclosed please find a written, narrative report of our findings in accordance with the terms of our Inspection Agreement.

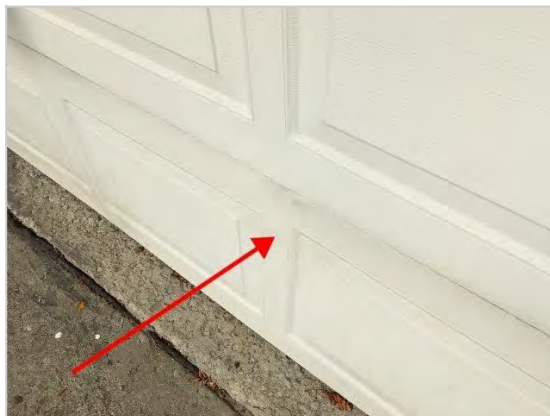
Photo 6

The widest of the three garage door is dented from what appears to be impact. The door was operating correctly at the time of the inspection. Care should be exercised to ensure that the door is not subjected to further impact, as the door may crack or fail.
