HomeTeam[®]

INSPECTION SERVICE

HOME INSPECTION REPORT

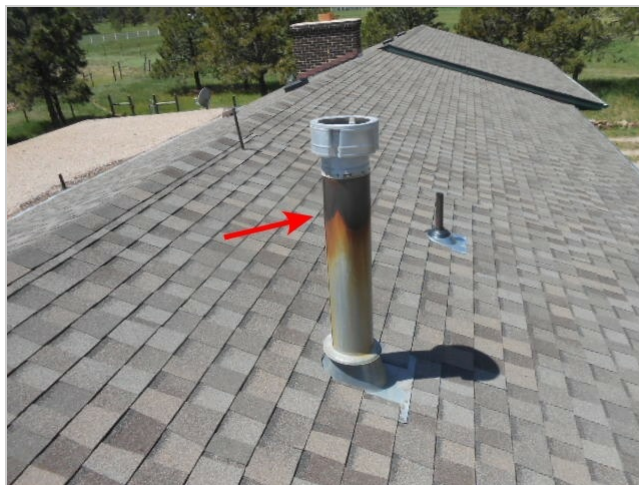
The furnace vent pipe (which penetrates the roof line) is rusted or deteriorated and is recommended to be replaced by a qualified HVAC contractor or roofer, prior to closing.

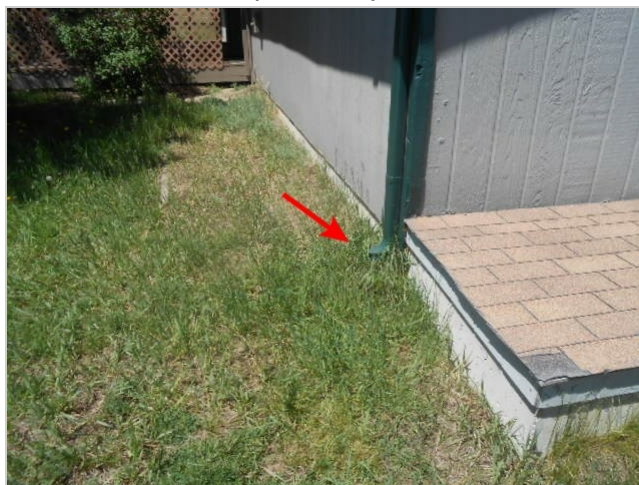
One of the downspouts on the left, rear of the home was missing the extension. This condition can allow for rain water to accumulate along the home and the possibility of water in the crawlspace if not repaired.
