File Number: **XXXX**
Address of Inspection: **123 Sample Drive**

INSPECTION SERVICE

Wednesday, May 30, 2018

123 Sample Drive
RE: Anytown, MI 55555
Inspection #: XXXX

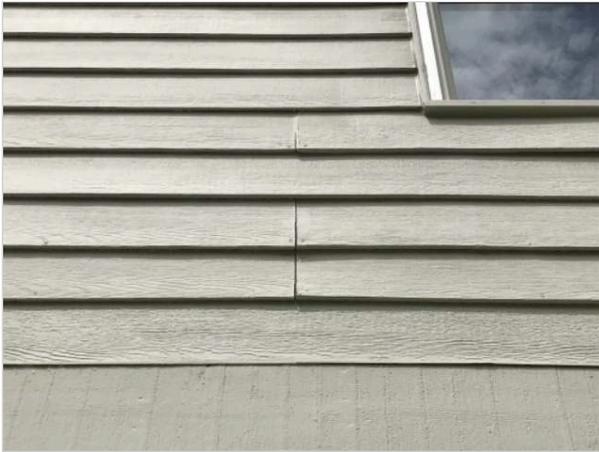
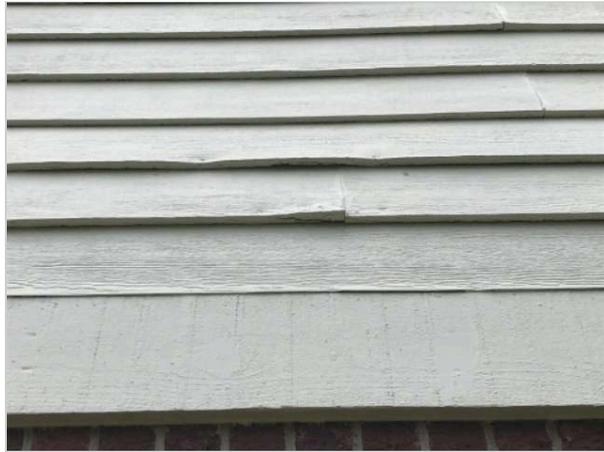
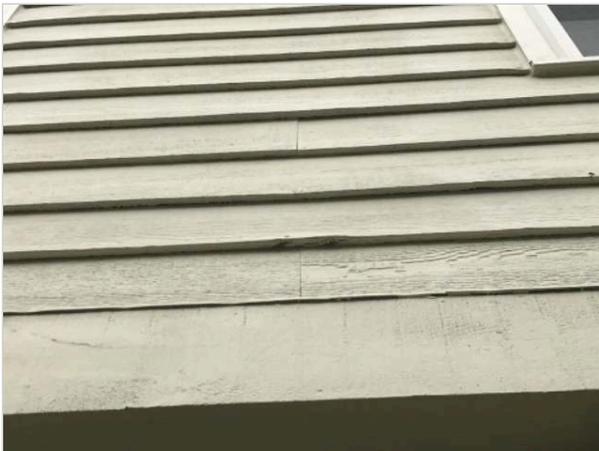
There were major visual defects at the siding on the exterior of the home. Damaged siding was noted on one or more areas of the home. The siding was faced nailed in several areas. Corrections will help prevent future damage. Damage areas behind the siding could exist but may not be visible.

- There were major visual defects at the siding on the exterior of the home. Damaged siding was noted on one or more areas of the home. The siding was faced nailed in several areas. Corrections will help prevent future damage. Damage areas behind the siding could exist but may not be visible.

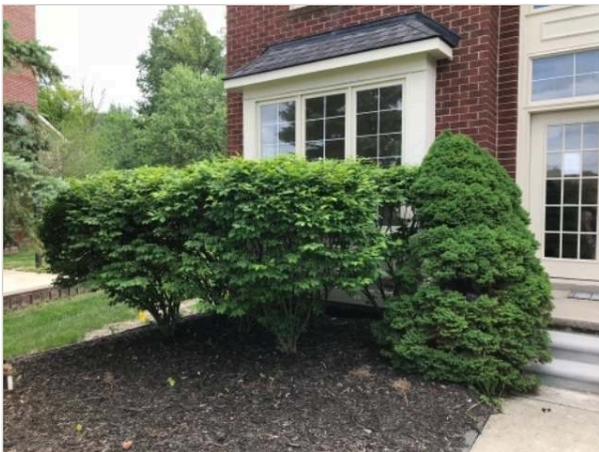
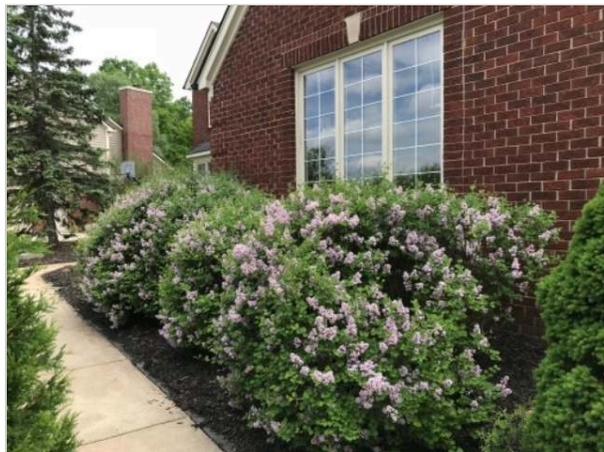
Extensive plant growth was observed against the home, in one or more area(s). Recommend removing this growth away from the siding to prevent possible damage including insect infestation. Damaged areas may not be visible.

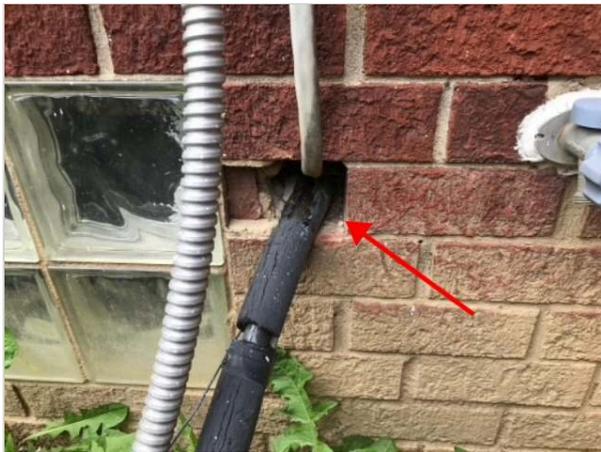
Seal around suction line where it enters the home.

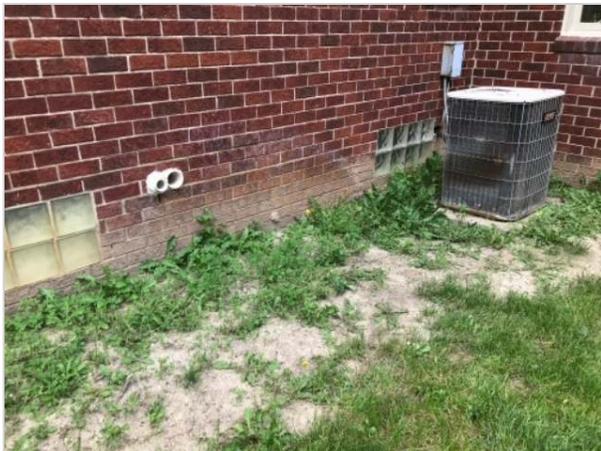
The general grade around the home appeared to be inadequate in a few places to direct rainwater away from the foundation.

- The general grade around the home appeared to be inadequate in a few places to direct rainwater away from the foundation.
- Although the heating system was operational, there was rust and metal rusted debris in the bottom of the combustion chamber.

The grade around the home, when possible should slope away from the foundation, at about a half inch per foot for about three to six feet from the foundation. Directing water away from the home can help with water entry into the home.

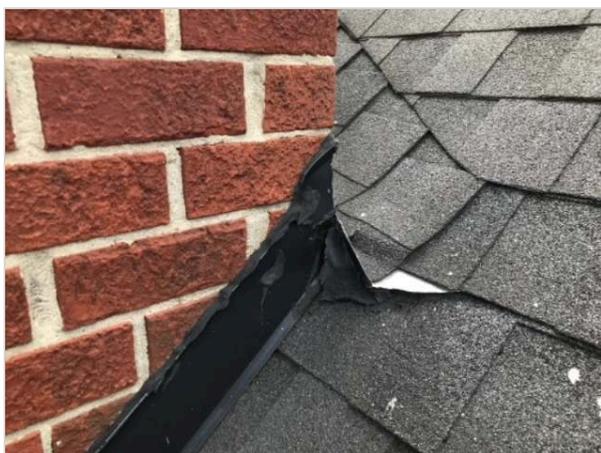
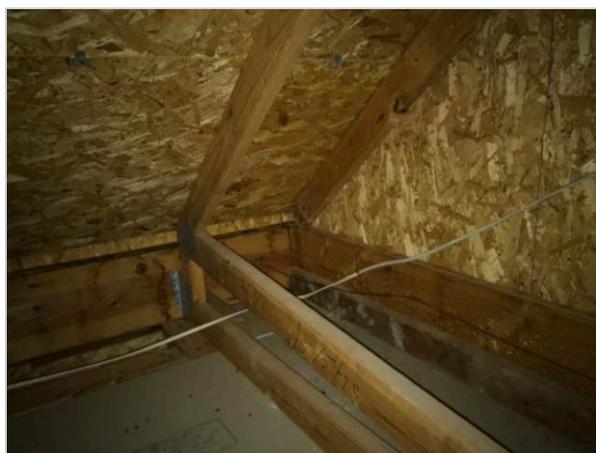
The flashing at the dormer needs to be sealed. (At the garage valley). Water damage could occur.

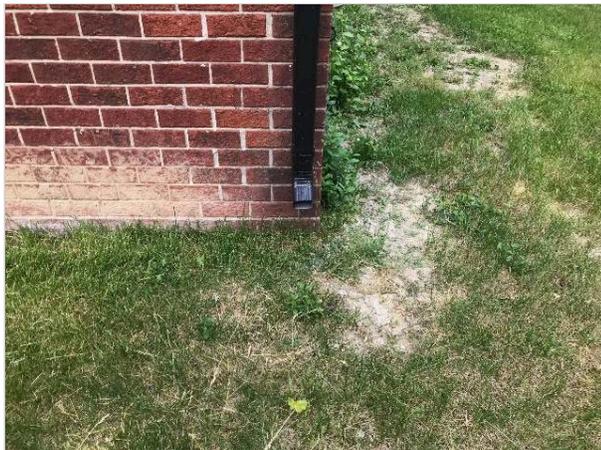
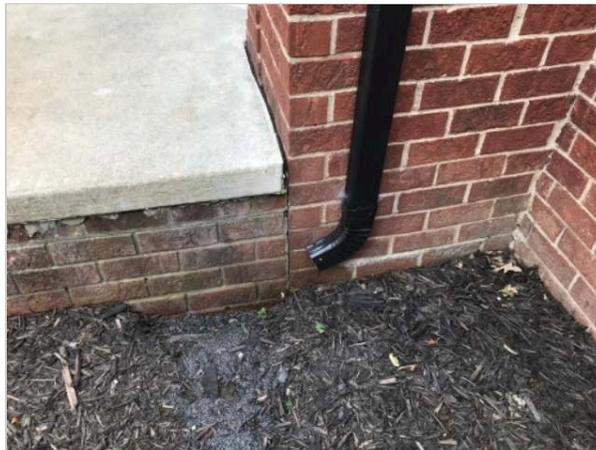
One or more downspout (s) were draining at or too close to the base of the foundation. All roof drainage should be directed at least six feet from the base of the foundation. Directing water away from the home can help with water entry into the home.

- The dishwasher was not tested although it did appear to be functional, it was brand new but the water line was turned off.
- One or more downspout (s) were draining at or too close to the base of the foundation.

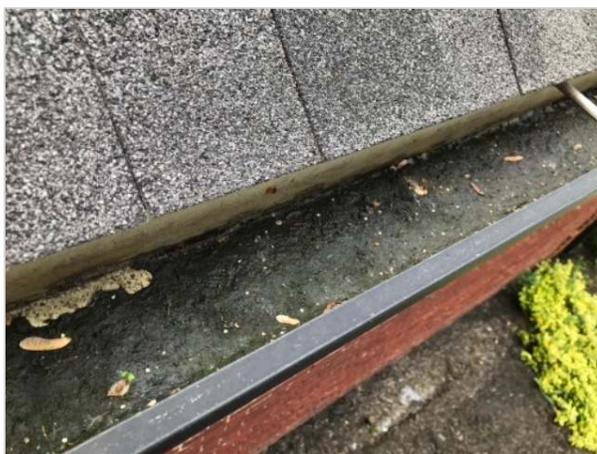
The gutters need to be cleaned. Clogged gutters can cause roof drainage water to back up and cause damage to the structure, soffit and fascia. Keeping gutters clean will help move water away from the foundation which could lead to basement water problems.

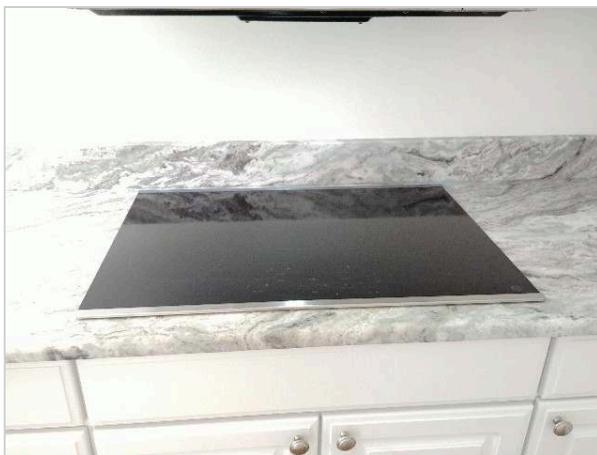
The electric built-in oven and counter top range was inspected and was not tested. The breaker was shut off. The accuracy of the clock, timers and settings on ovens are not within the scope of this inspection.

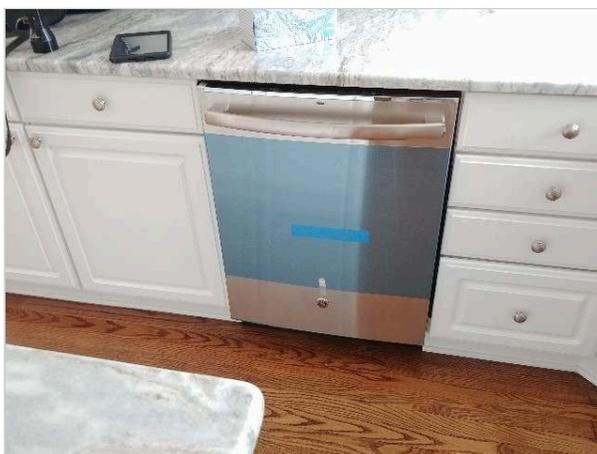
The dishwasher was not tested although it did appear to be functional, it was brand new but the water line was turned off.

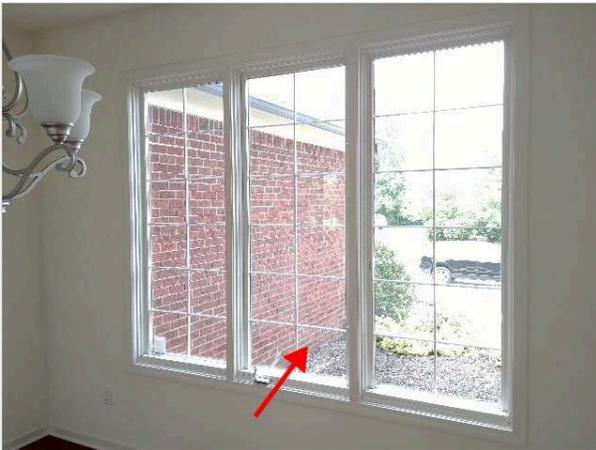
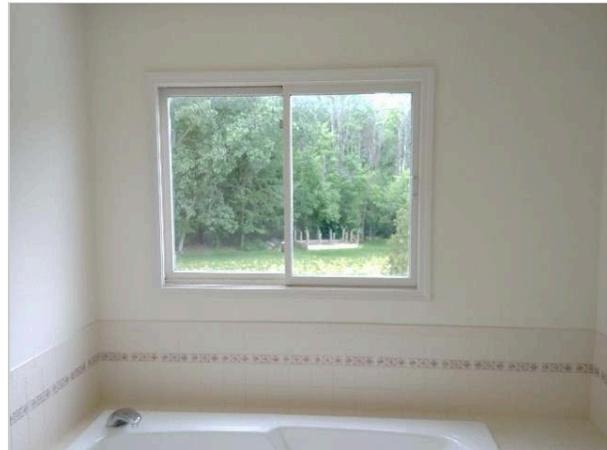
The casement windows in the dining room and office, along with the master bath slider window were painted shut and could not be operated to verify operation or check for defects. Also egress could be an issue. The window(s) need maintenance to free them for opening and further inspection.

- The casement windows in the dining room and office, along with the master bath slider window were painted shut and could not be operated to verify operation or check for defects.

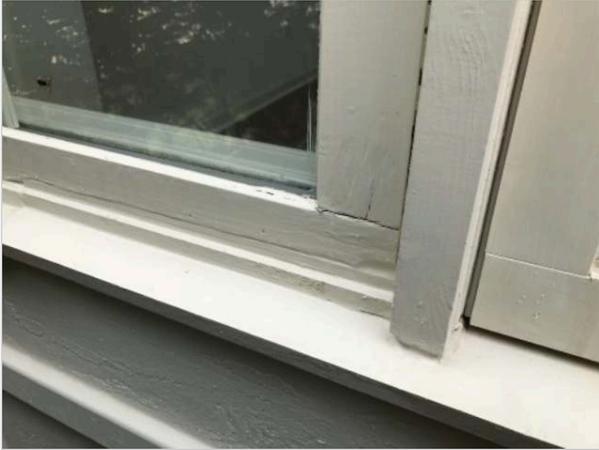
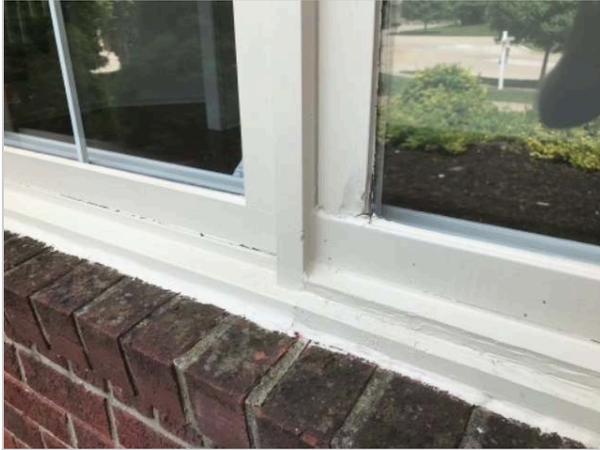
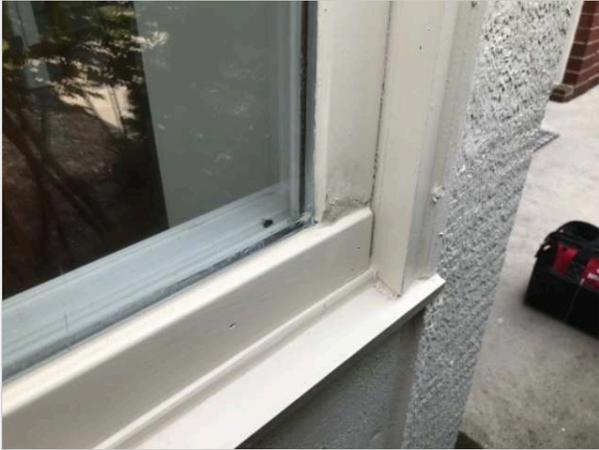
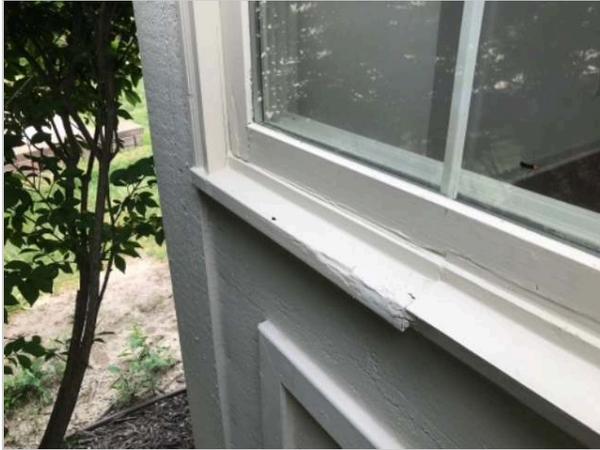
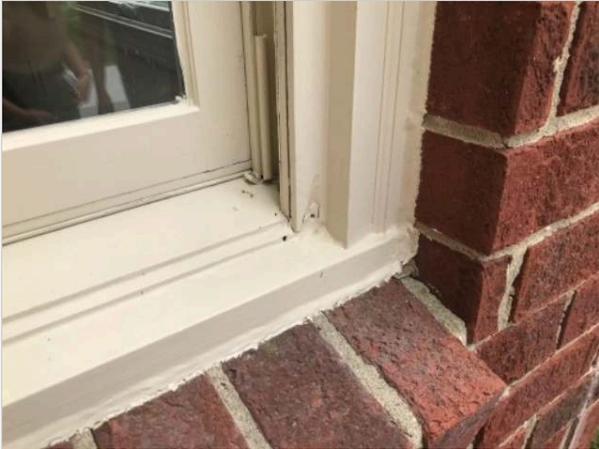
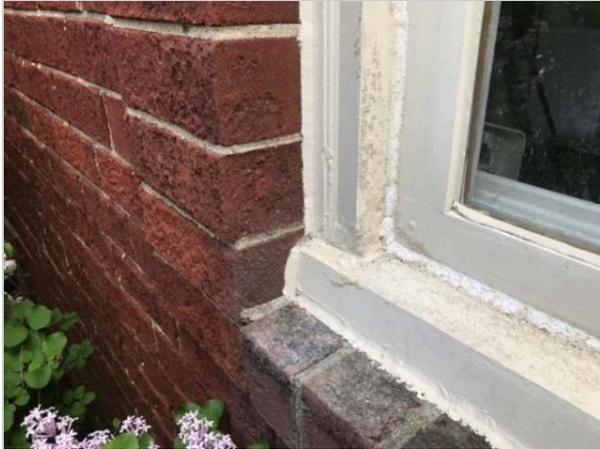
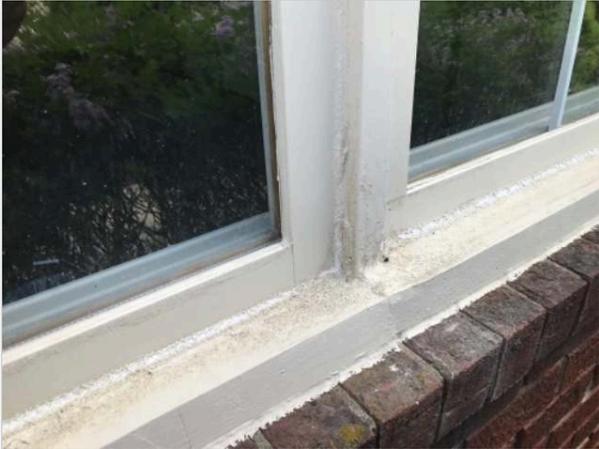
There were major visual defects at the windows on the exterior of the home. There was wood rot at one or more windows. Wood rot could lead to the window not functioning or leaks. Corrections will help prevent future damage. Damage areas could exist but may not be visible. To determine exactly how many areas or the extent of the rot further evaluation would be needed

- There were major visual defects at the windows on the exterior of the home. There was wood rot at one or more windows. Wood rot could lead to the window not functioning or leaks. Corrections will help prevent future damage. Damage areas could exist but may not be visible. To determine exactly how many areas or the extent of the rot further evaluation would be needed

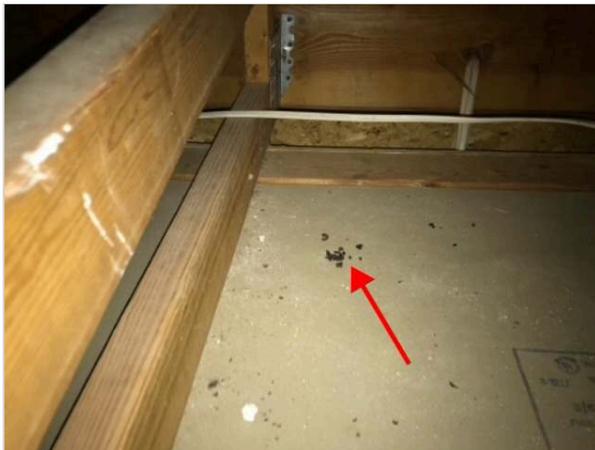
It appears there are or has been Bat(s) in the attic. Bat droppings were noted in an isolated area, in the garage attic. Bat droppings may be a health concern. Bats are a protected species.

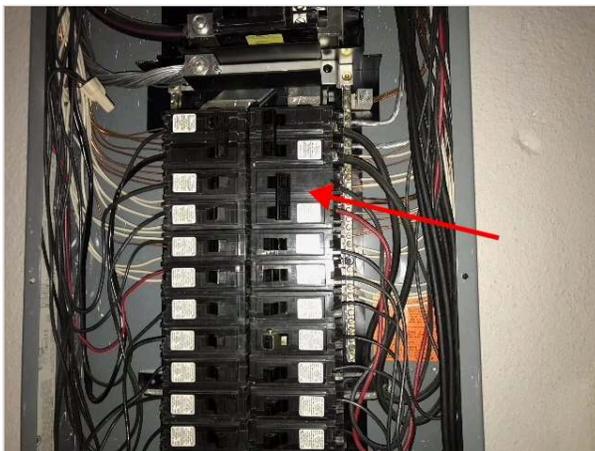
The breaker to the stove top was off at the time. The stove top was not tested. Consult the seller as to why the breaker was off. Further evaluation may be needed.

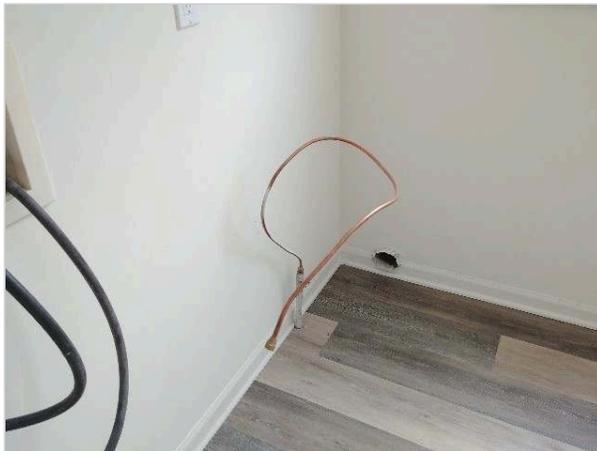
The dryer gas line was not capped. Gas lines need to be capped after a shut off valve to prevent the loss of gas or injury could occur.

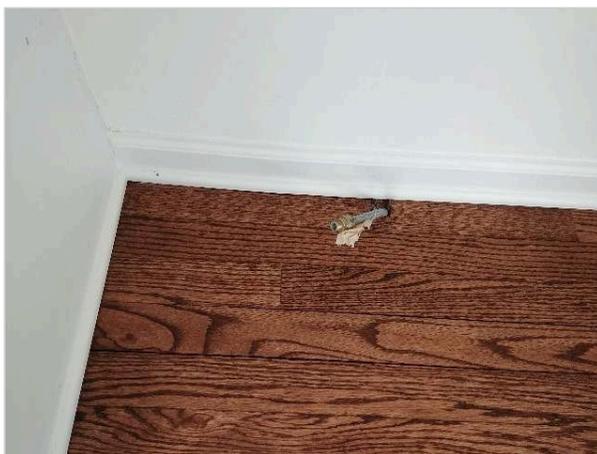
The refrigerator water line was not capped. Water lines need to be capped after a shut off valve or leaks could occur.

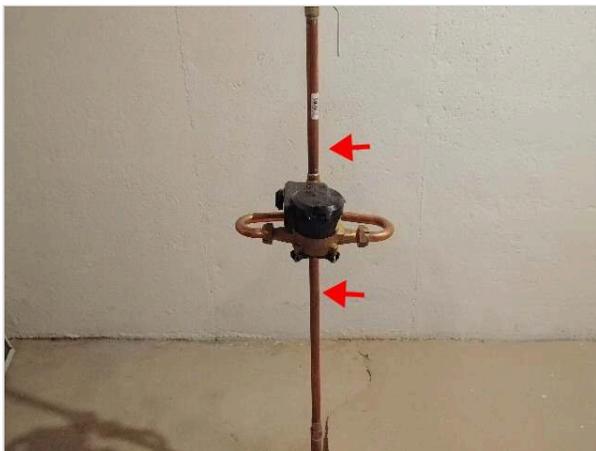
The ground wire was missing or not properly attached at the water meter. Grounding provides a path back to earth ground and helps prevent fire and shock.

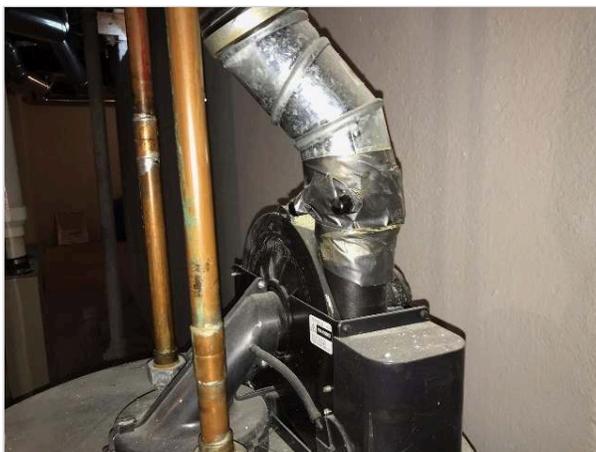
The water heater exhaust pipe was taped. Carbon monoxide could be expelled into the home when these conditions exist.

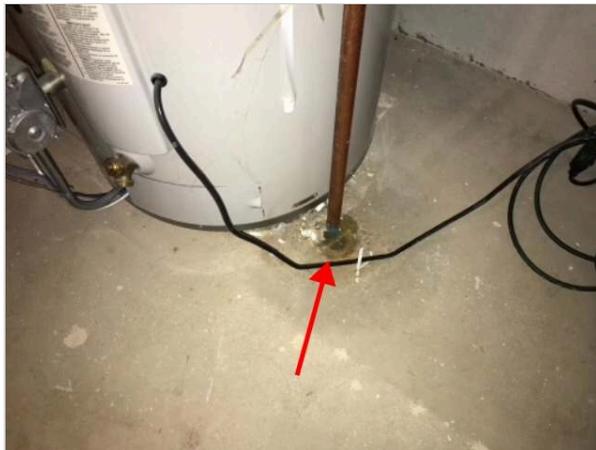
The T&P valve on the water heater was leaking at the time of the inspection. If the water pressure and temperature within the unit are within the normal range the valve may defective.

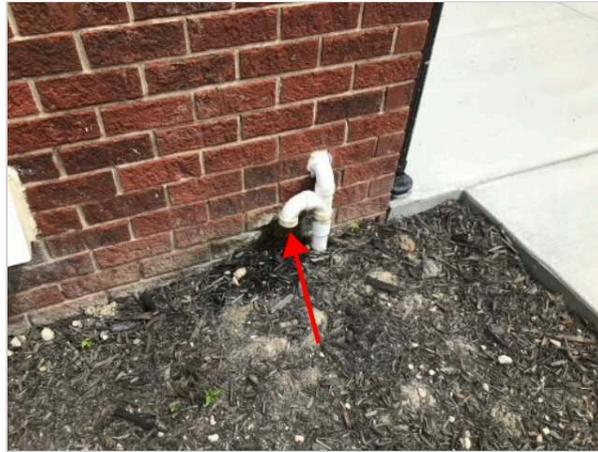
It appears the discharge line for the sump is plugged. Water was running through the overflow pipe.

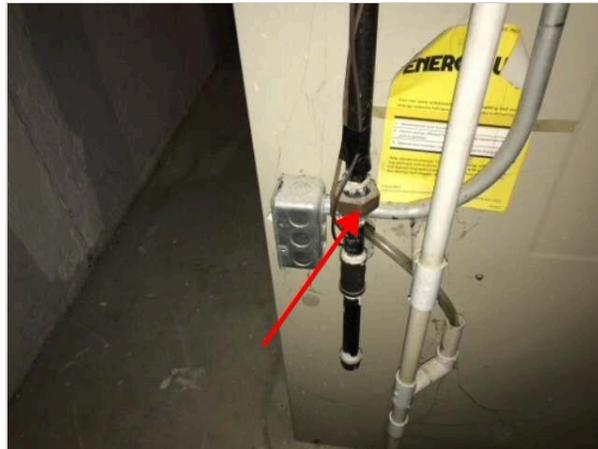
There was a gas odor detected at the gas supply line to the furnace. Further evaluation is recommended as to the cause of the odor.

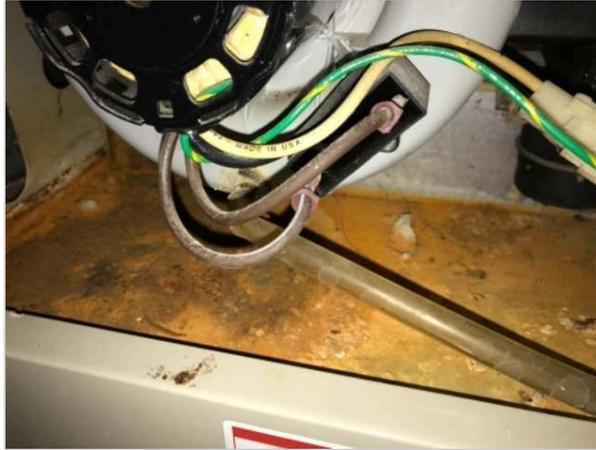
Although the heating system was operational, there was rust and metal rusted debris in the bottom of the combustion chamber. This limited our view and service is recommended.

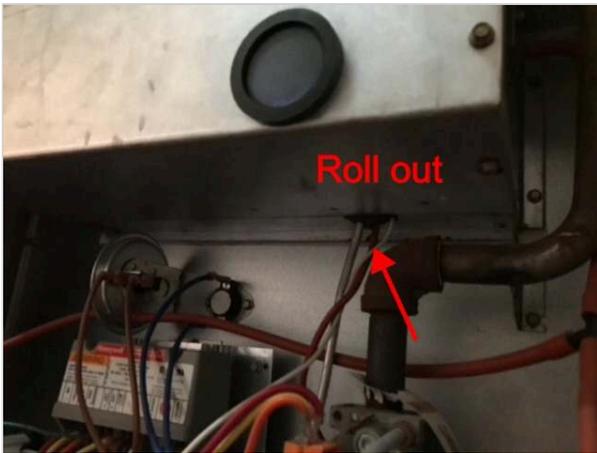
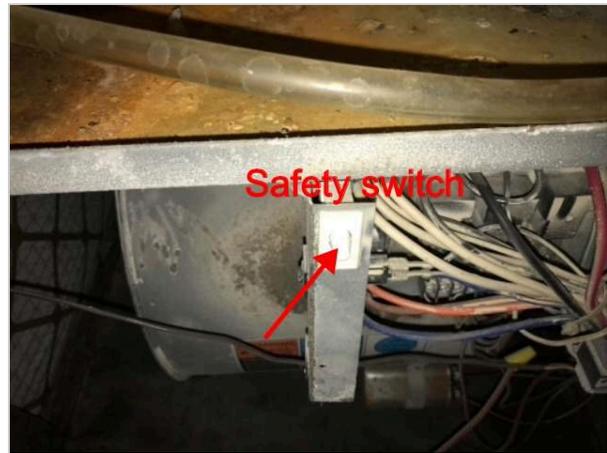
When the burners fired up there was roll out (flames). The burners may be plugged. The safety switch in the blower housing sticks. Further evaluation is recommended prior to closing.

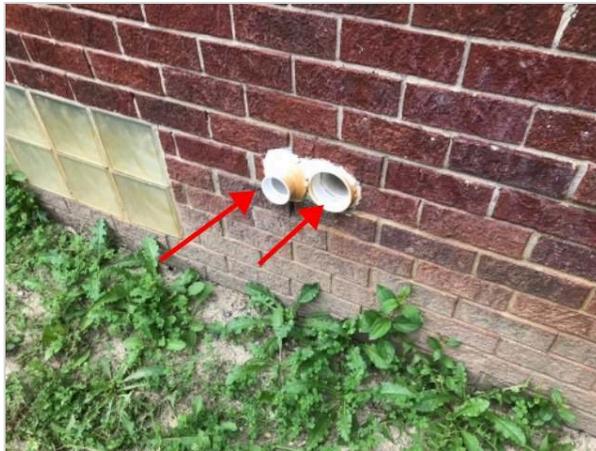
There were missing PVC parts to th exhaust system for the furnace.

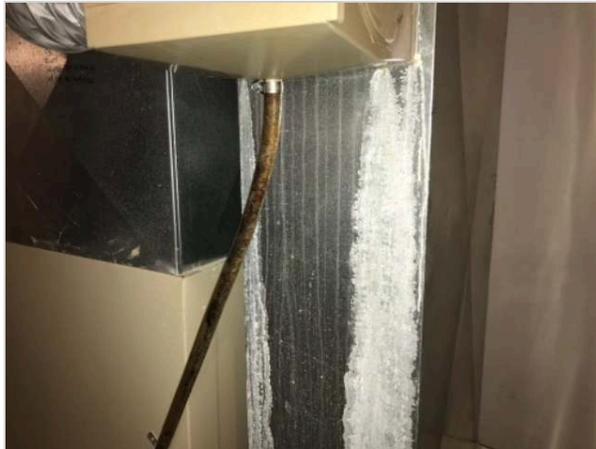
There was a prior leak at the humidifier. Monitor this area.
