On Thursday, August 3, 2017 The HomeTeam Inspection Service made a visual inspection of 123 Sample Drive Anytown, MN 55555. Enclosed please find a written, narrative report of our findings in accordance with the terms of our Inspection Agreement.

HOME INSPECTION REPORT

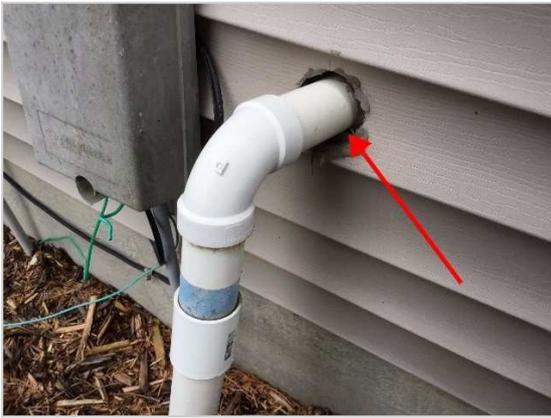
Photo 3

Suggest caulking around pipe on left side of structure to prevent insect/water intrusion.

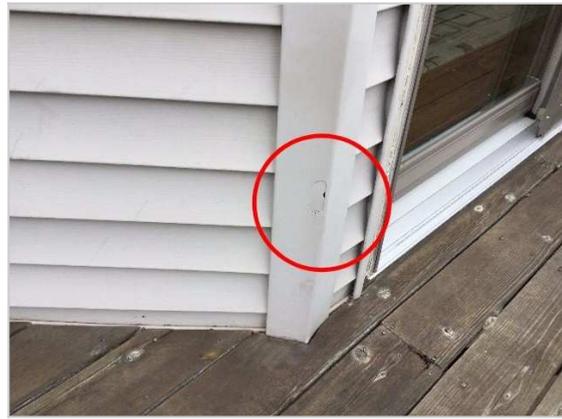
Photo 4

Damage to siding on back deck.

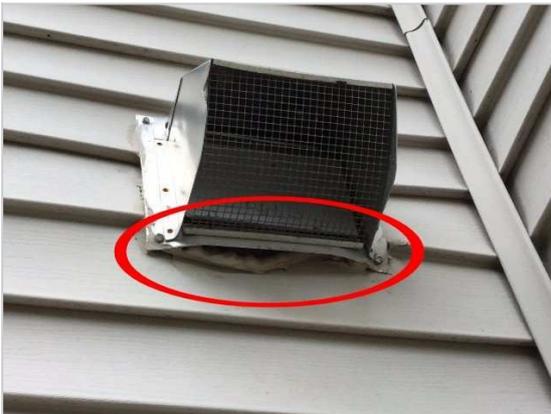
Photo 5

Suggest caulking/sealing under vent in back.

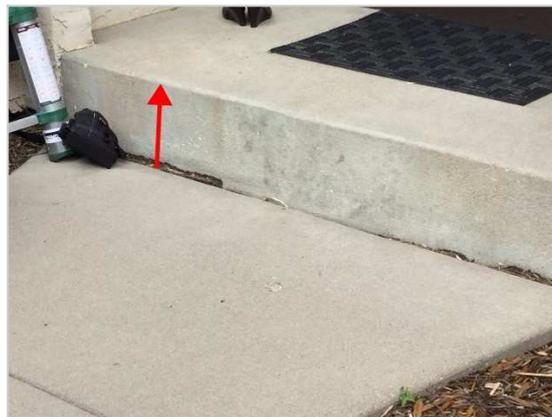
Photo 6

The vertical distance between stairway risers appeared to be excessive, which may be a tripping hazard. Generally, riser height should not exceed 8 1/4 inches. Caution should be exercised on the stairway, or other repairs should be made.

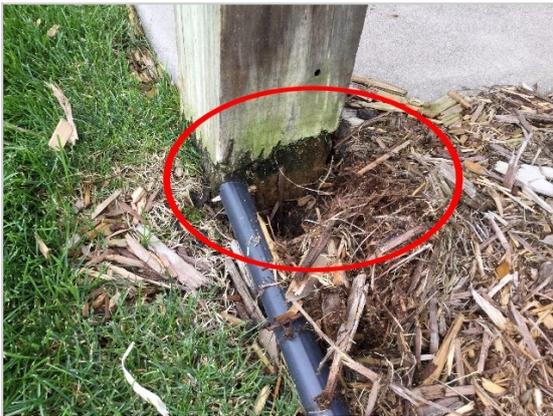
Photo 9

Monitor deterioration of deck support and repair/replace as necessary.

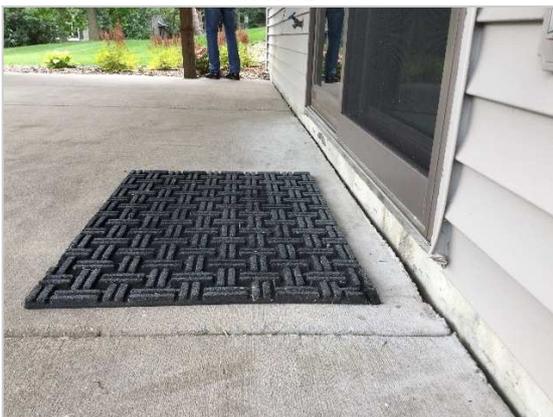
Photo 10

A concrete patio was located in the back of the structure. There appeared to be settling of the patio surface.

Appears to lean toward the home. Monitor and repair as necessary.

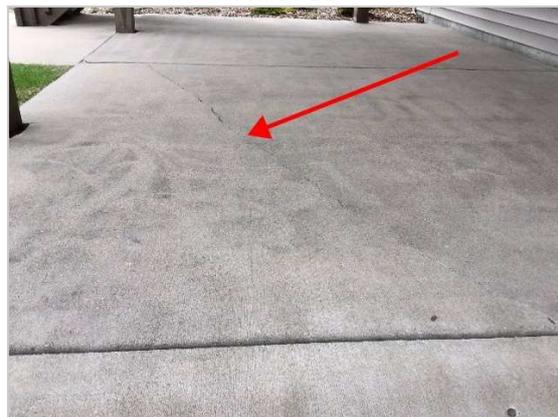
Photo 11

Recommend sealing crack in patio to prevent water intrusion.

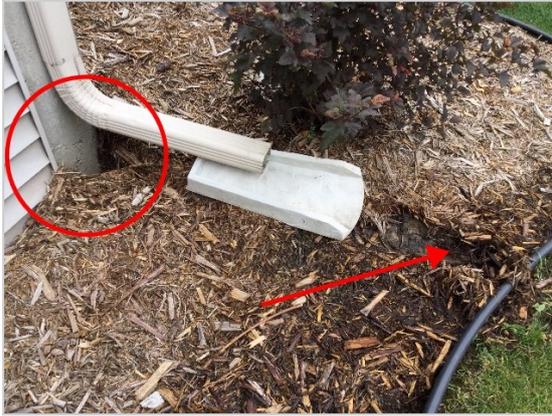
Photo 14

Several downspouts were draining at or too close to the base of the foundation. To reduce the likelihood of water problems at the base of the structure, all roof drainage should be directed at least six feet from the base of the foundation.

Back left downspout has a hole where water was running near house and mulch is washed out from today's rain.

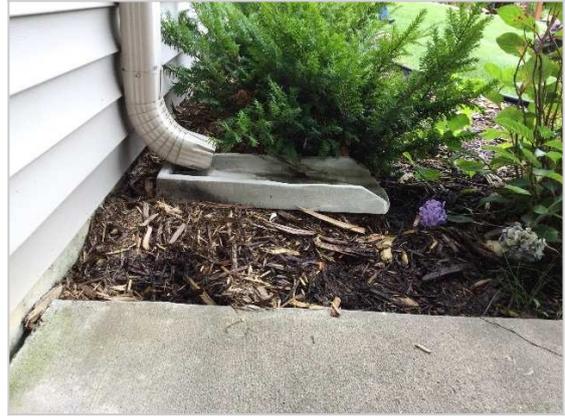
Photo 15

Rear downspout, near patio.

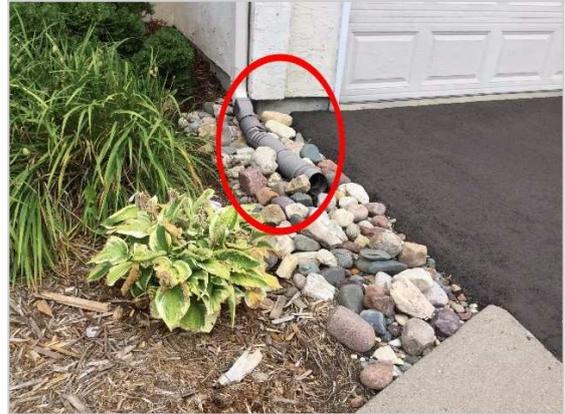
Photo 17

Front downspout near driveway.

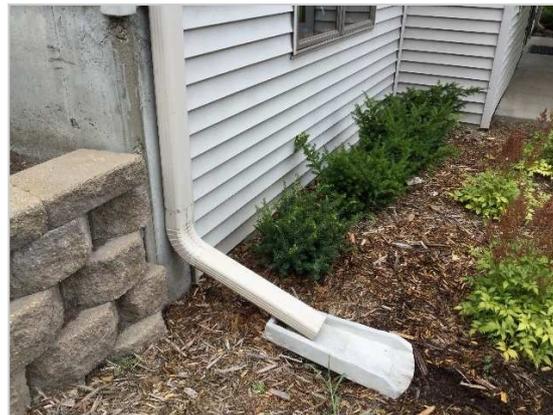
Photo 18

At least one exterior downspout is not properly secured to the structure and should be secured to prevent downspout and gutter damage.

Right rear downspout.

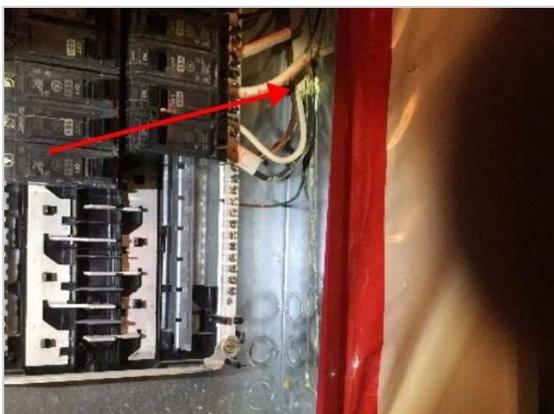
Photo 40

1. **Corrosion was observed on components in the electric panel.** Corrosion on terminal screws and wires can result in overheating of terminals and possible arcing problems in the panel. HomeTeam recommends that a licensed electrician repair and further evaluate the condition of the electrical panel.

Corrosion was observed on components in the electric panel. Corrosion on terminal screws and wires can result in overheating of terminals and possible arcing problems in the panel. HomeTeam recommends that a licensed electrician repair and further evaluate the condition of the electrical panel.

Corrosion present on wires. Appears dry at this time.

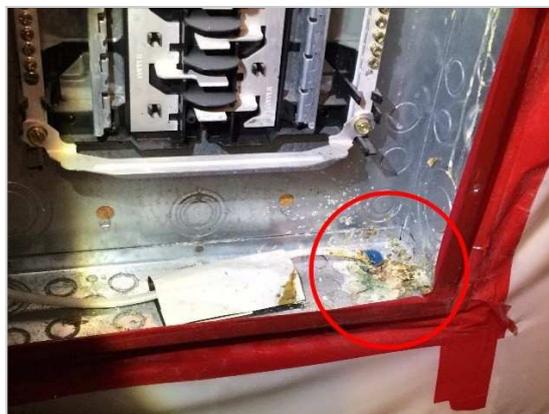
Photo 41

Corrosion drips at bottom of box.

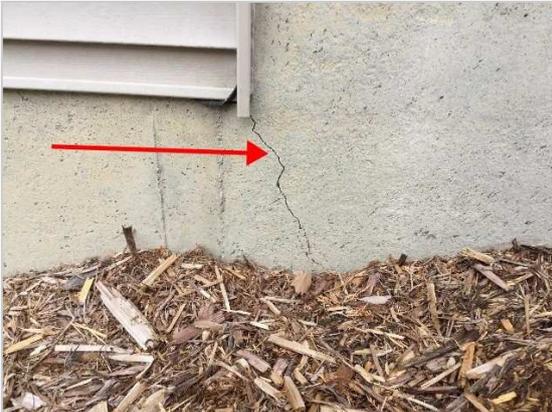
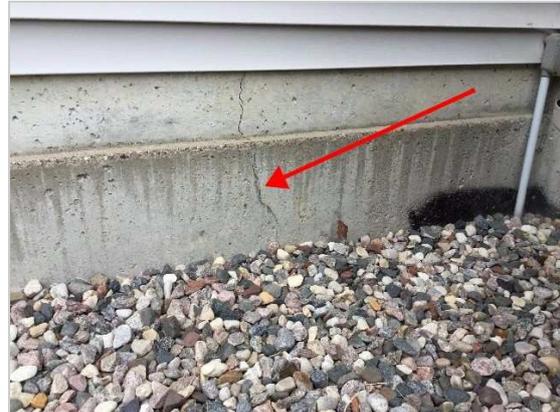
Small cracks were observed on the foundation. The cracks were 1/16th-inch or less in width. The homeowner should monitor these cracks for any changes, and if changes are noted, should contact a structural repair company for further analysis. Below-grade cracks are highly susceptible to water intrusion during times of heavy rain. Water staining from previous water intrusion was not visible. HomeTeam recommends sealing these cracks if a watertight basement is desired.
