PROPERTY INSPECTION REPORT

Prepared For:	Bill Sample		
	(Name of Client)		
Concerning:	123 Sample Drive Anytown, TX 55555		
	(Address or Other Identification of Inspected Property)		
By:	Chuck Chenoweth (# TREC #20801)	Joel Mower (# TREC #21621)	Marc Poulain (# 23085)
	(Name and License Number of Inspector)		9-21-2018
			(Date)
	(Name, License Number of Sponsoring Inspector)

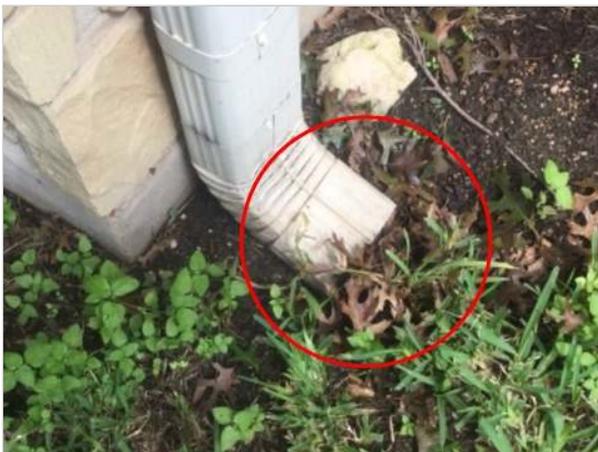
A few splash blocks were missing; allowing water to drain at the base of the perimeter beam. Gutters and downspouts were partially filled with leaves and debris. The left-front gutter downspout was missing the base elbow segment.

Clogged downspout with missing splash block

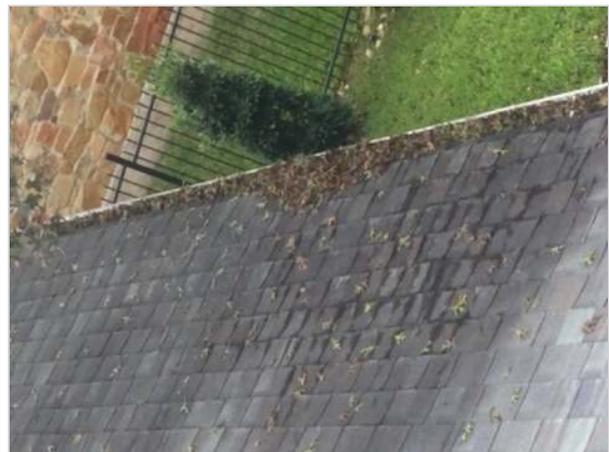
Representative leaves in gutter

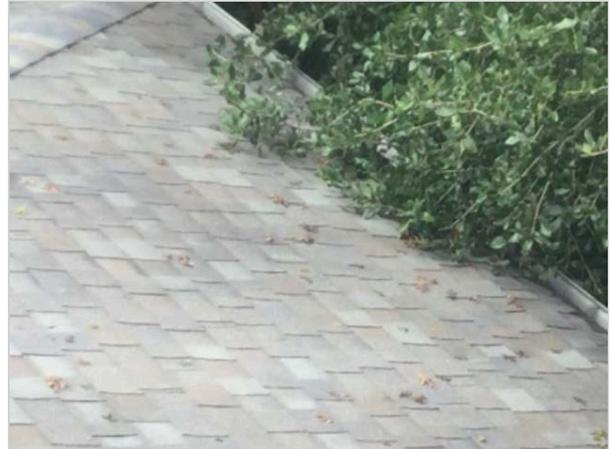
Tree limbs were in direct contact with the roof. An active leak was observed at the central heater vent pipe at the unit located in the attic above the master bedroom. Collected leaves at roof valleys.

Tree contact

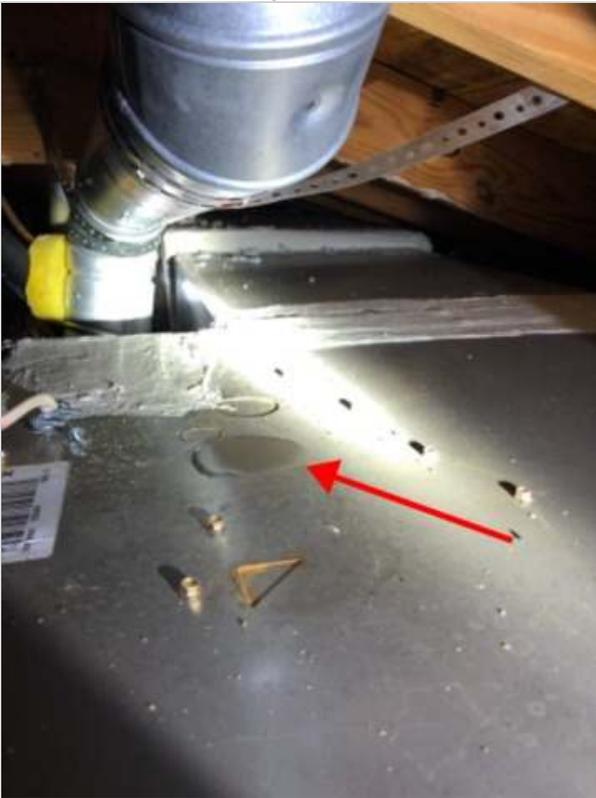
Leak

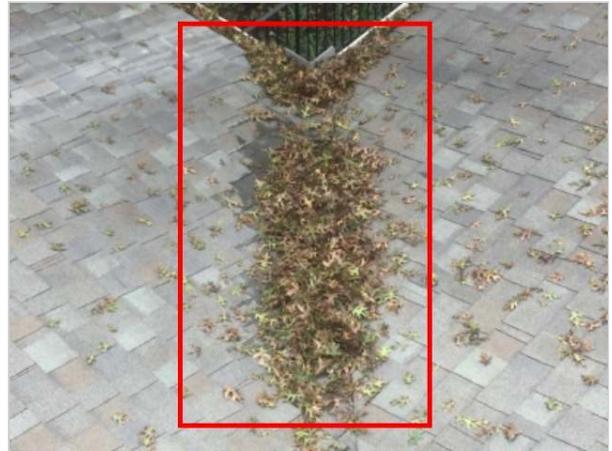
Collected leaves

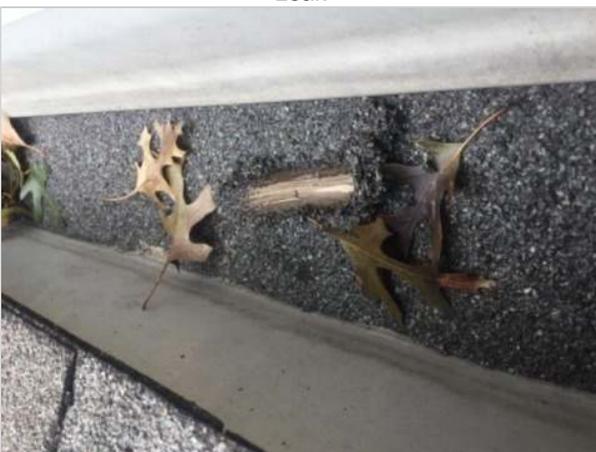
1/8-inch granule accumulation and debris in gutters

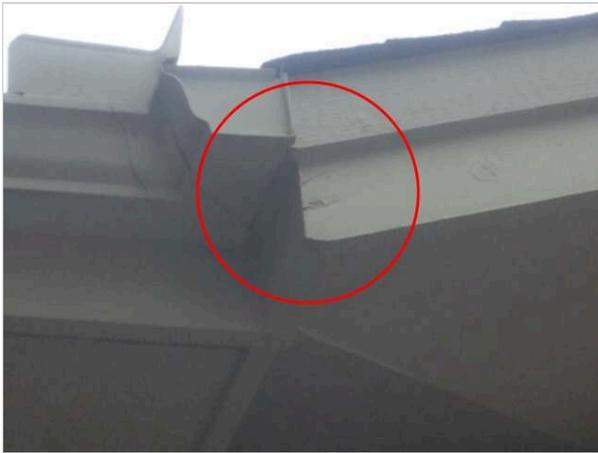
Initial deterioration located at fascia boards in several locations. An active leak was observed below the central heater vent pipe at the unit located above the master bedroom. The paint was deteriorated at fascia boards in a few locations.

Deterioration

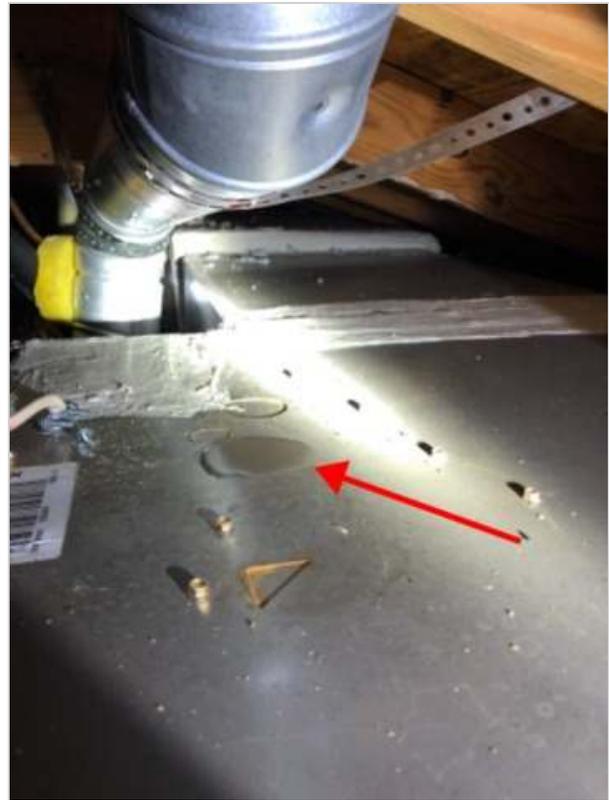
Leak

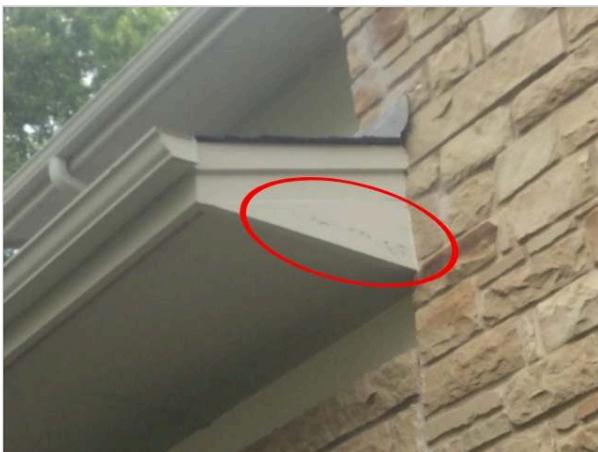
Deteriorated paint

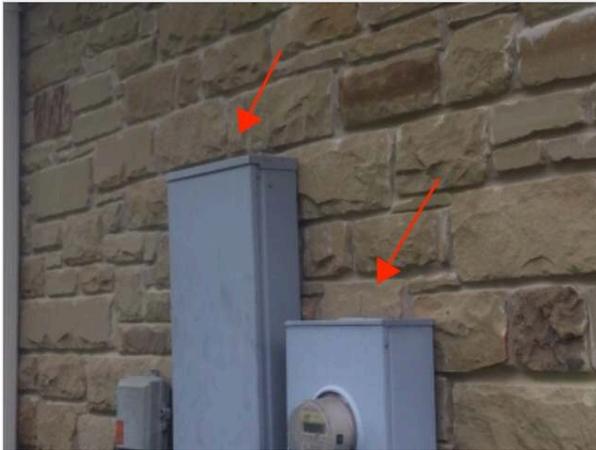
There were gaps at entrance panel and electric meter, which should be caulked to prevent water intrusion. Exposed plastic was not painted at exterior walls, which protects the plastic from the harmful effects of sunlight.

Gaps at panels

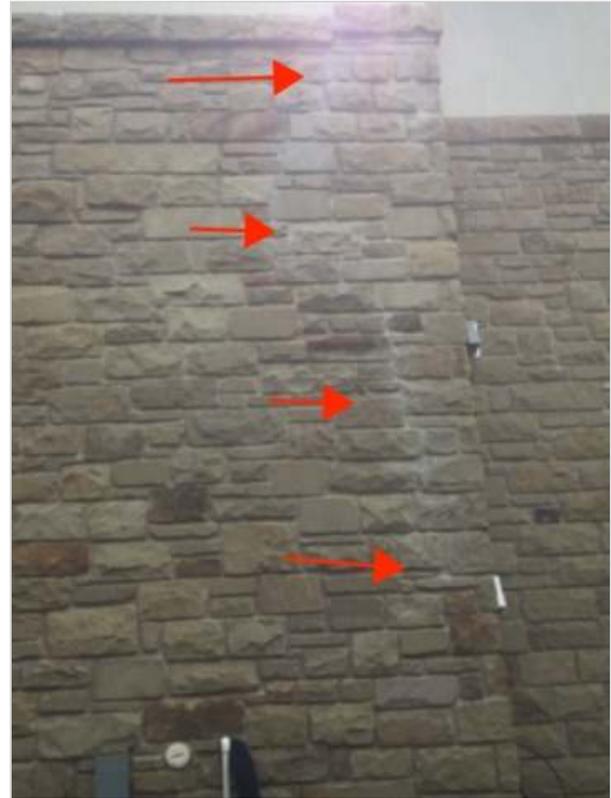
Exterior wall cladding was comprised of Exterior Insulated Finish System (EIFS) and stone veneer. A few common mortar cracks (some with repairs) were visible at exterior stone veneer walls. Wasp nests were observed at upper exterior walls and soffits. Common organic staining was observed at exterior wall and chimney structure stone veneer. Prior mortar repairs were visible at exterior stone veneer walls. We recommend trimming away shrubbery from exterior walls and windows.

Prior mortar crack repairs

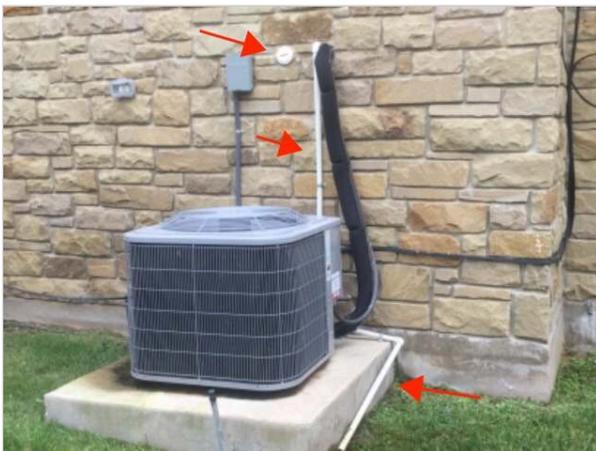
Exposed plastic

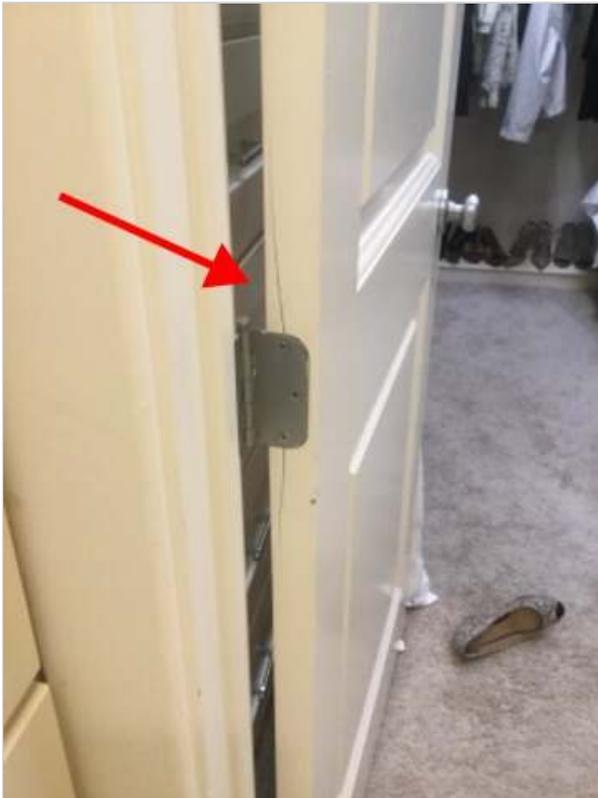
Comments:
All doors were checked. The master bedroom closet door was cracked.
Deficiencies:
The keeper plate was missing a screw at the first floor guest bedroom and closet door. One (1) door to the office did not engage the keeper plate properly. The door handle was damaged at the interior side of the fixed front entry door.

Door cracked

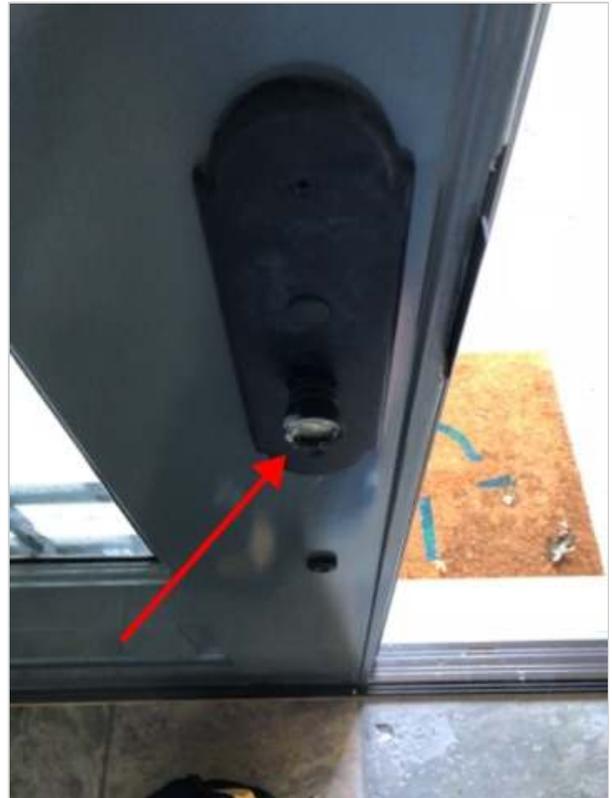
Handle damaged

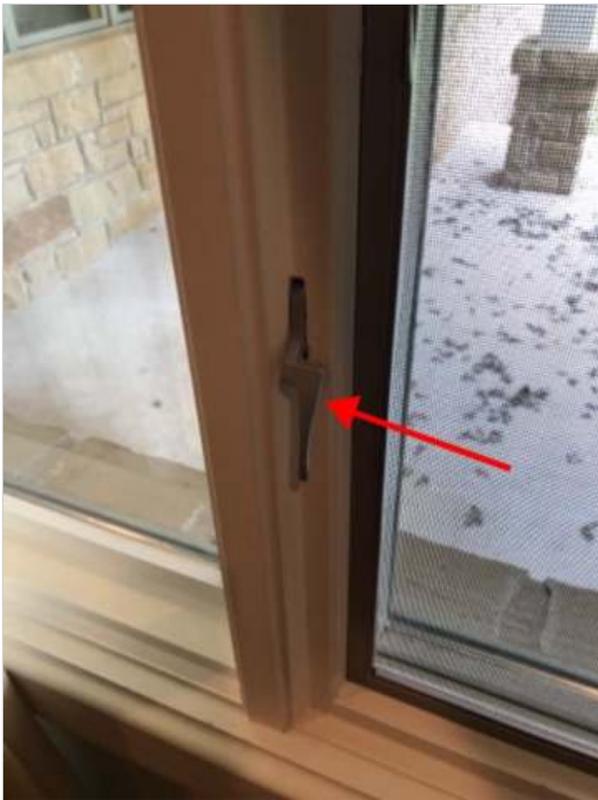
Gaps at the exterior periphery of a few windows (identified by red stickers) should be caulked to prevent possible water intrusion and/or loss of efficiency. Screens were removed from twenty-nine (29) windows. A lock handle was loose at one (1) window at the master bedroom.

Handle loose

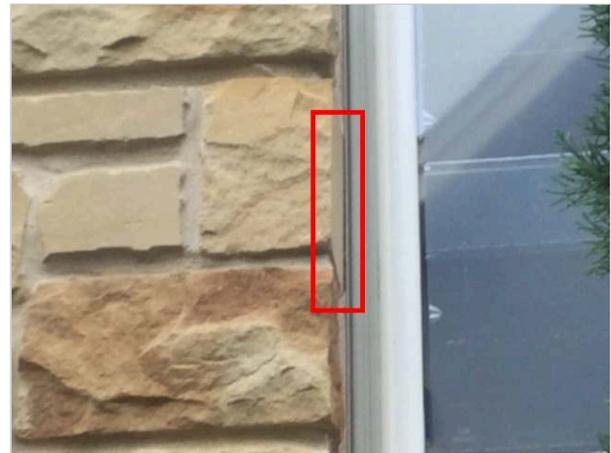
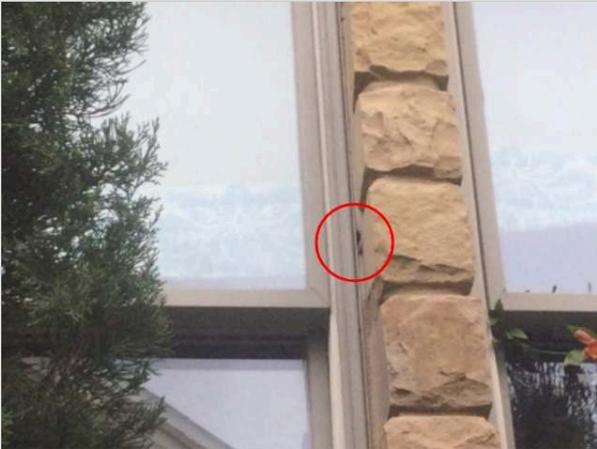
Gap at window

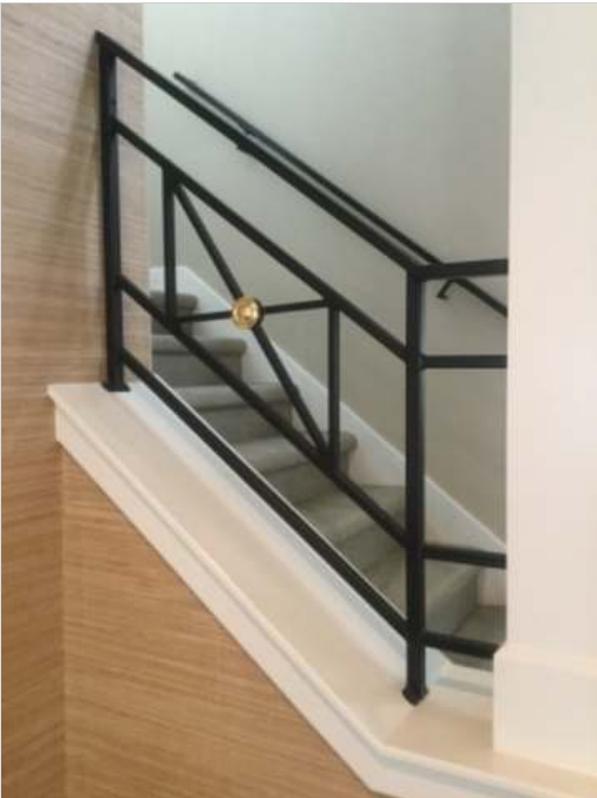
Deficiencies:
There were gaps greater than 4-inches at the interior stair railing. A handrail was not provided at the base of the interior stairway.

Gaps greater than 4 inches

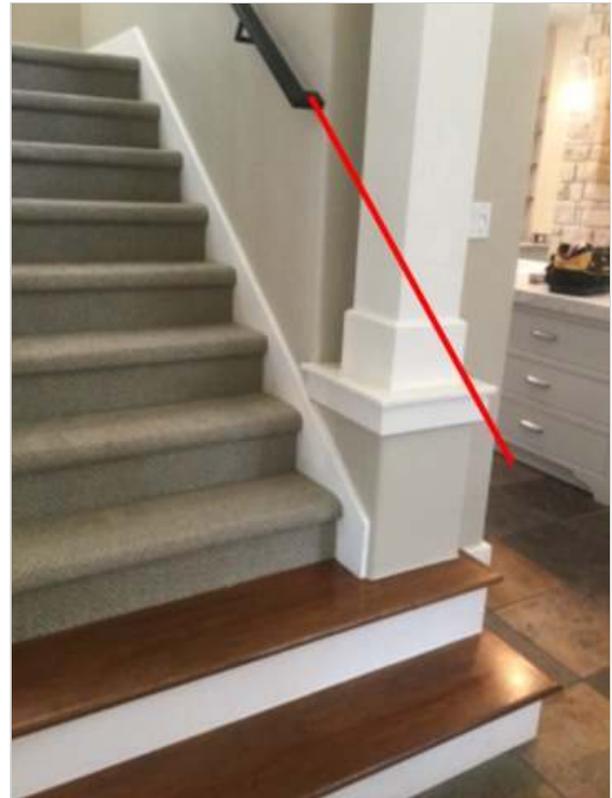
No handrail provided

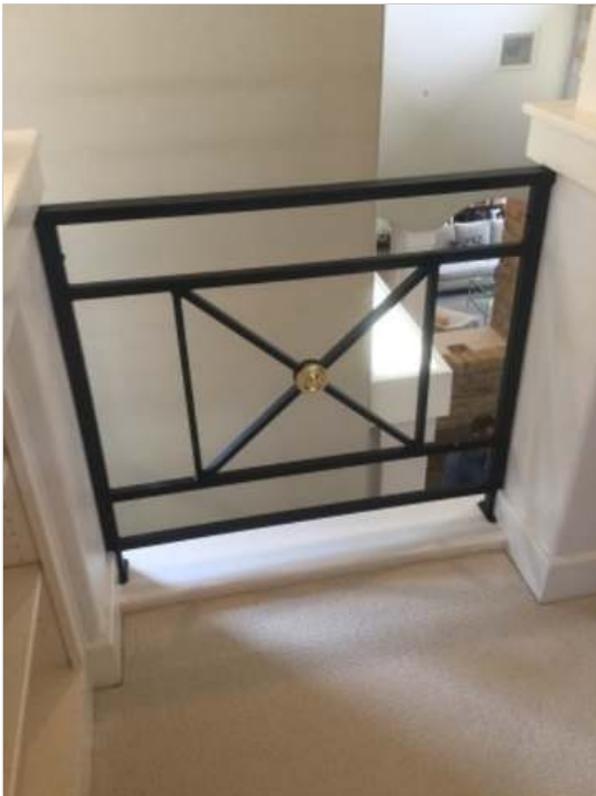
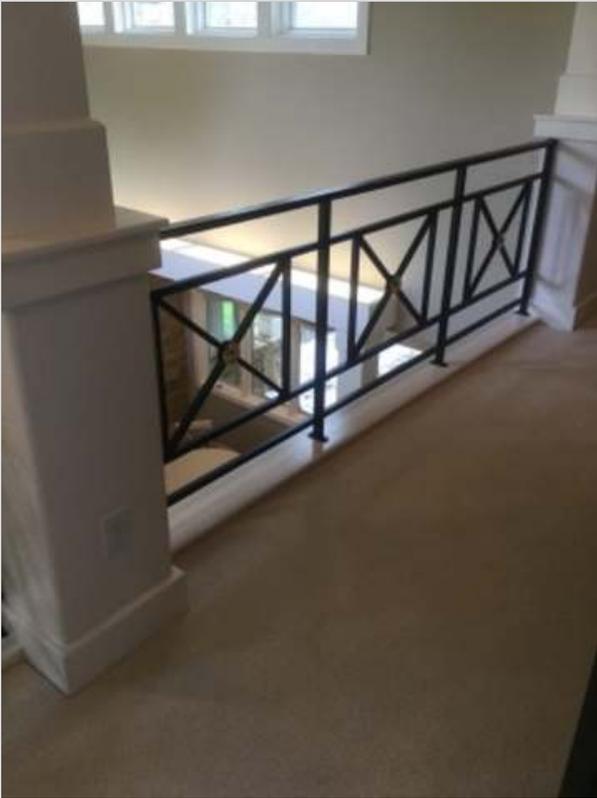
Balcony railings were not to today's standards; spindles were spaced greater 4-inches. Rust/corrosion located at the base of a steel railing spindle on the back patio.

Gaps greater than 4 inches

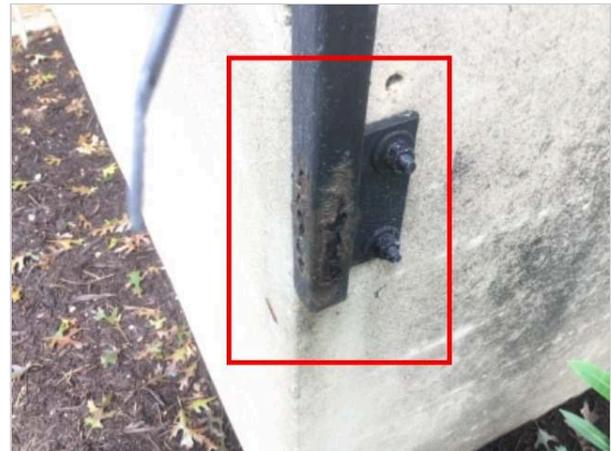
Rust at back porch steel railing spindle

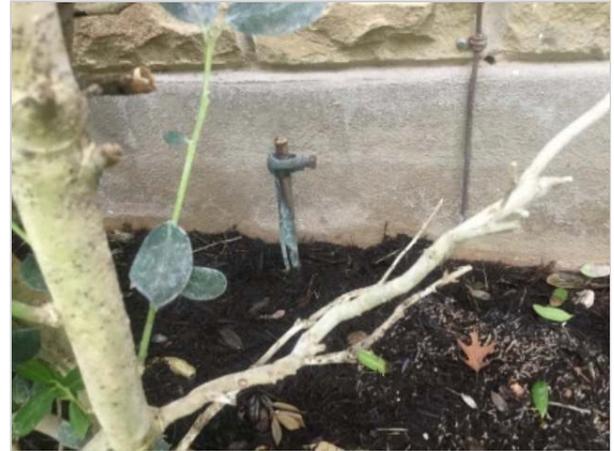
Gas lines were not determined to be properly bonded; bonding wire not visibly located. The earth grounding rod was not fully driven; approximately 9-10-inches was exposed above ground. Outer entrance panel cover hinges missing. Inner entrance panel cover securing screws were pointed.

Grounding electrode not fully driven

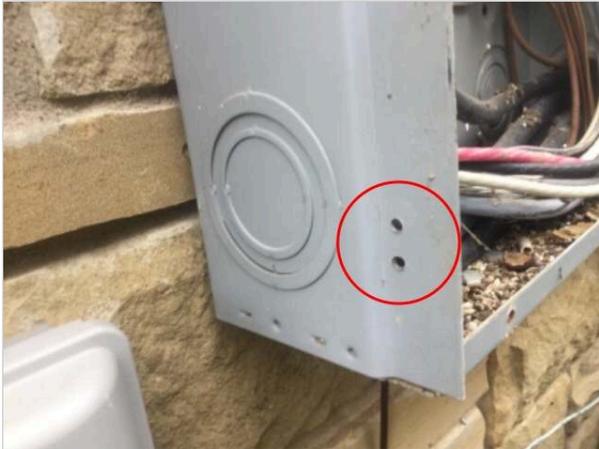
Missing hinge (1 of 2)

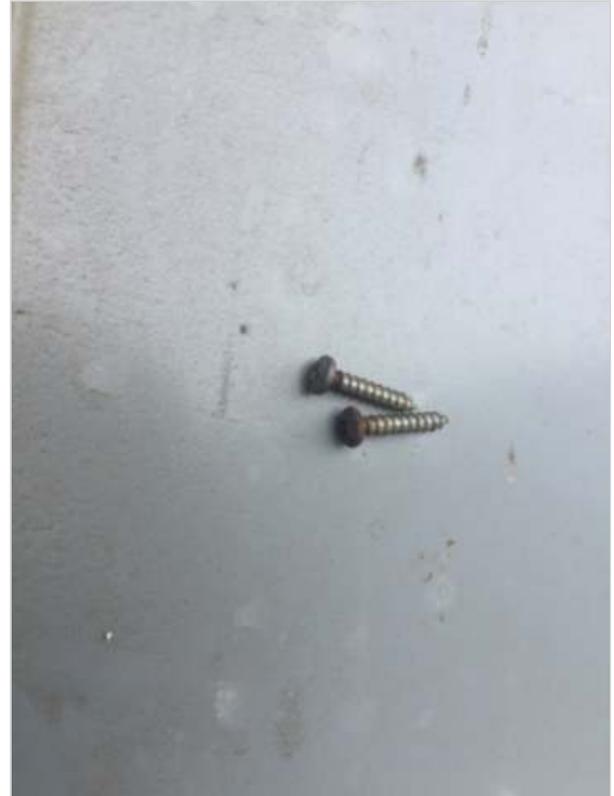
Pointed screws

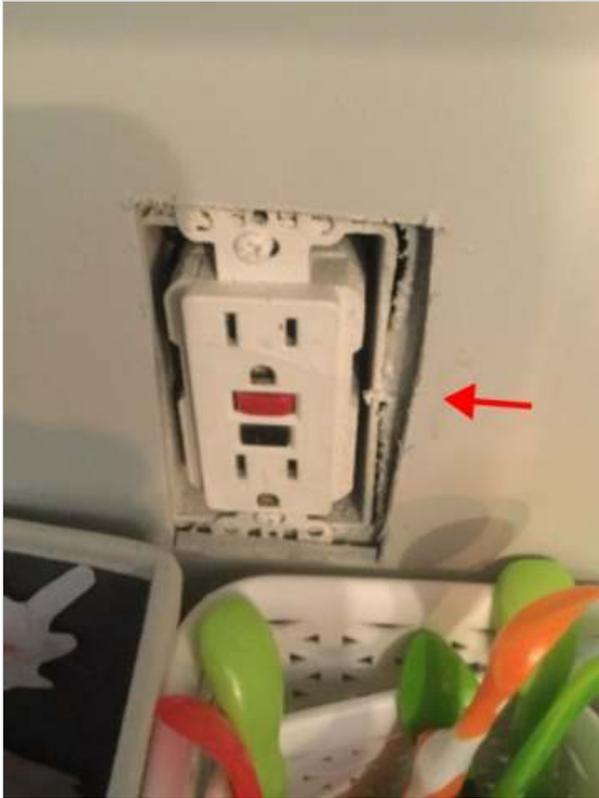
Missing cover plate

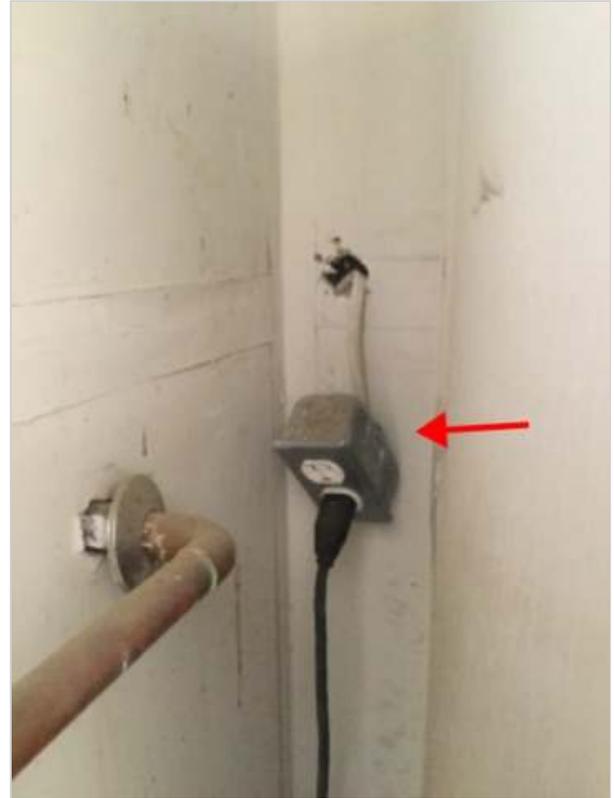
Receptacle not attached to wall

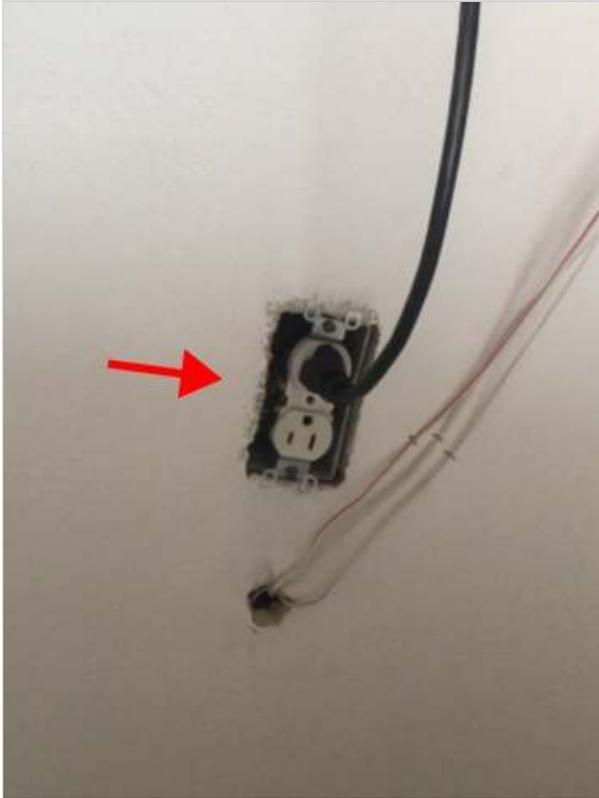
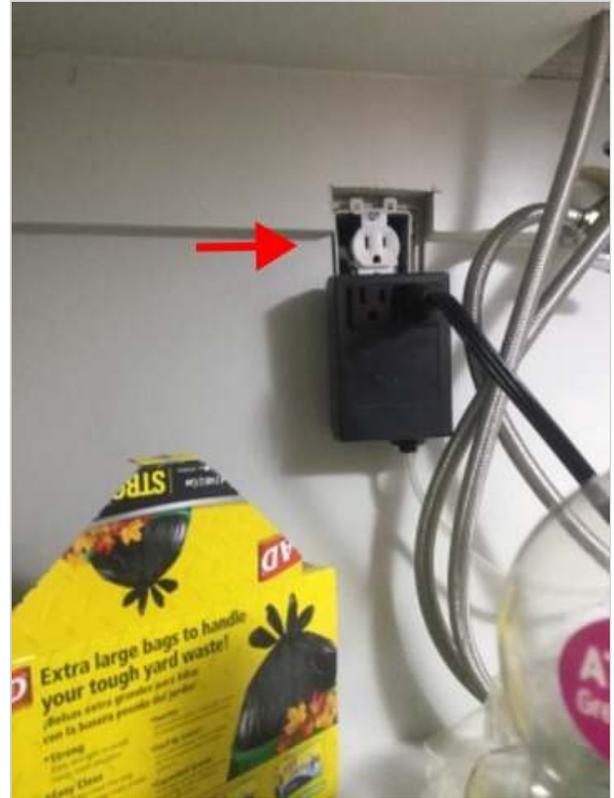
Missing protective cover plate.

Missing protective cover plate

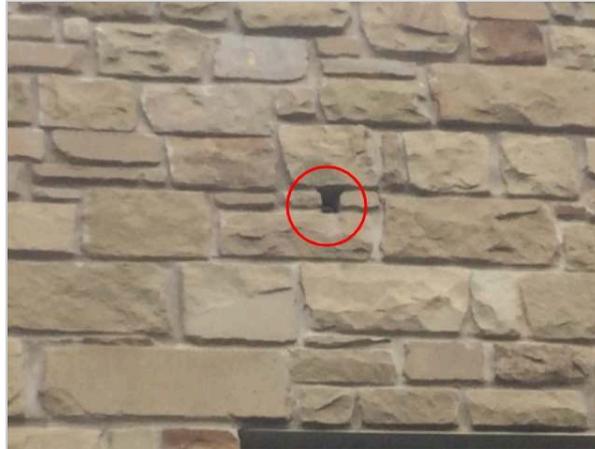
Assumed secondary condensate drain line did not penetrate to exterior

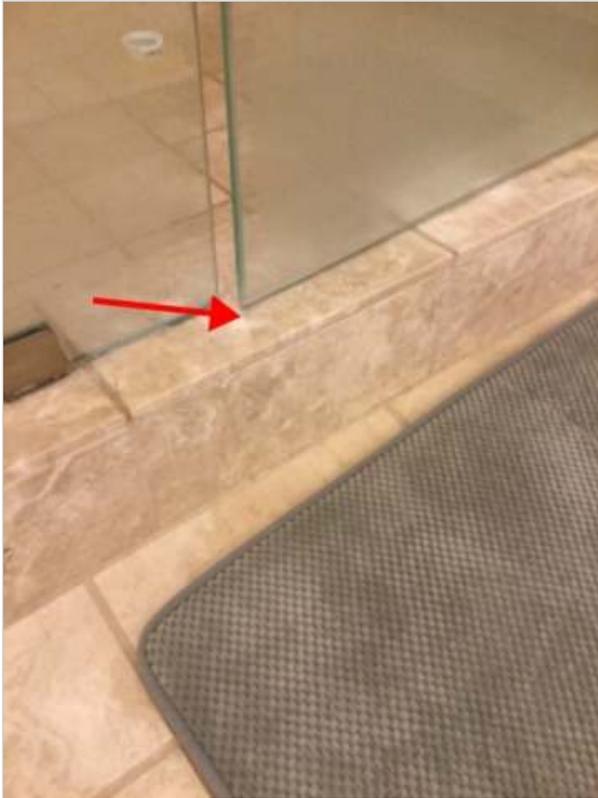
Door dragged at tile

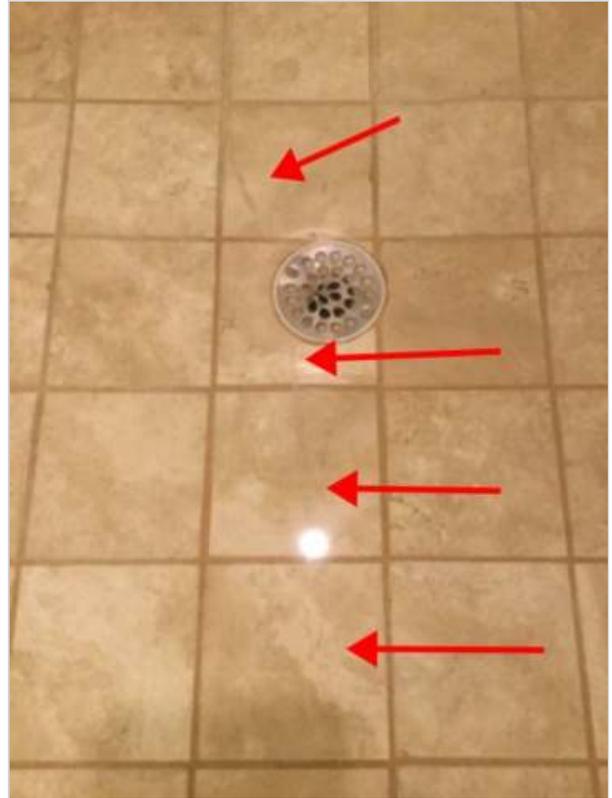
Tiles cracked

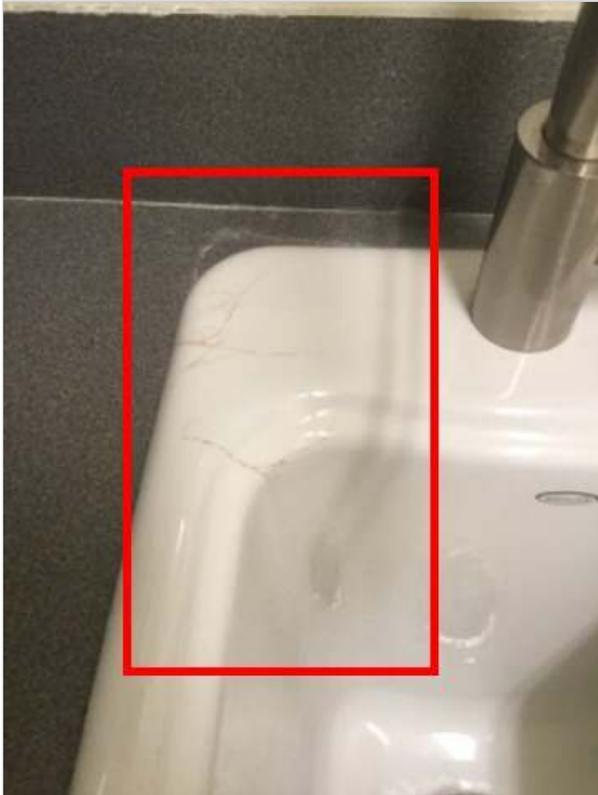
The first floor guest bathtub did not have a shower curtain; water was run through the shower head for only a brief amount of time. Control handles were loose at the master bathroom shower and bathtub. There were gaps at the master and guest bathroom shower fixtures. The shower door dragged at the tile curb at the base of the master bathroom shower enclosure. Cracked tiles were observed at the master bathroom shower floor. The bathtub faucet handle was loose at the first floor guest bathroom. The utility room sink was cracked.

Sink cracked

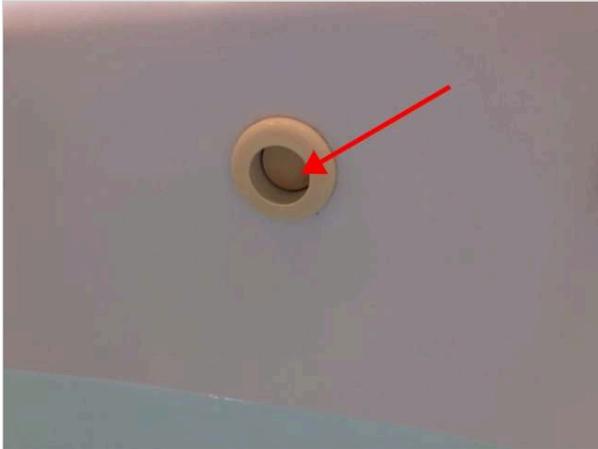
The pressure switch was inoperable at the time of inspection at the whirlpool tub. Access to the whirlpool pump was not provided; the location or condition of the pump was not determined. Gaps located at whirlpool tub intersection with tile at master bathroom.

Switch inoperable

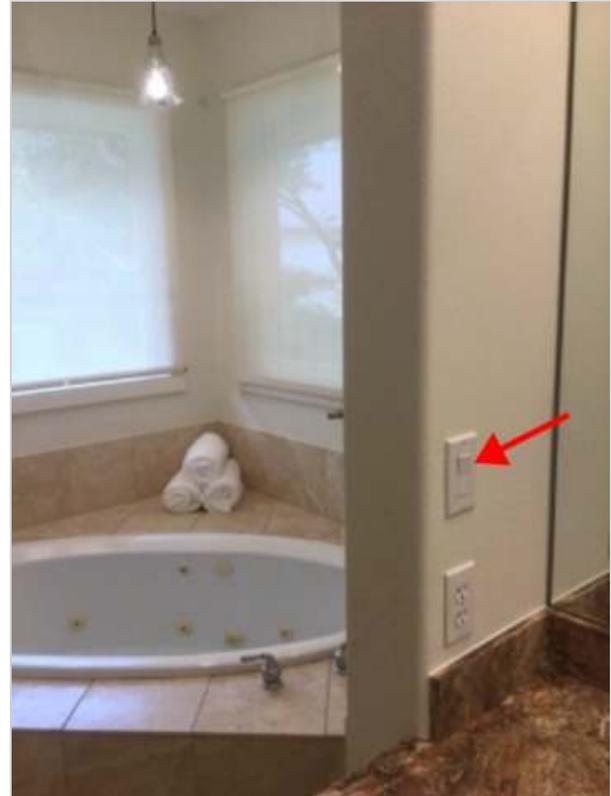
Whirlpool tub
