HOME INSPECTION REPORT

Prepared For:	John Doe	
	(Name of Client)	
Concerning:	5555 Sample Drive, Beaumont, TX 7706	
	(Address or Other Identification of Inspected Property)	
By:	Curtis Carr (# 4026) Landon Carr (# 20537)	3-4-2019
	(Name and License Number of Inspector)	(Date)
	(Name, License Number of Sponsoring Inspector)

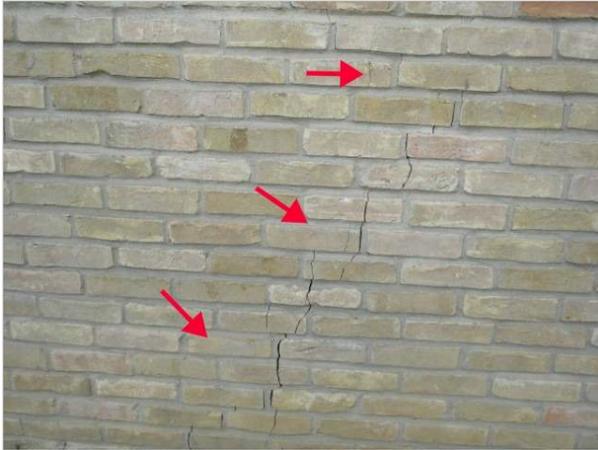
There was a large crack in the brick on the right wall with corresponding interior sheetrock cracks. It is recommended that a structural engineer perform a further evaluation of the foundation.

crack in brick wall

- There was a large crack in the brick on the right wall with corresponding interior sheetrock cracks.
- It is recommended that a structural engineer perform a further evaluation of the foundation.

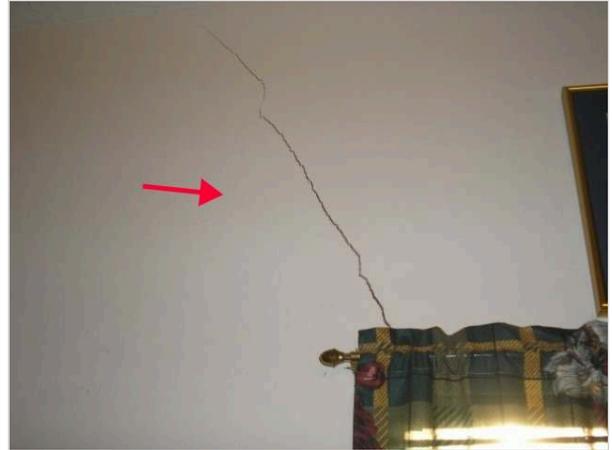
sheetrock settlement crack

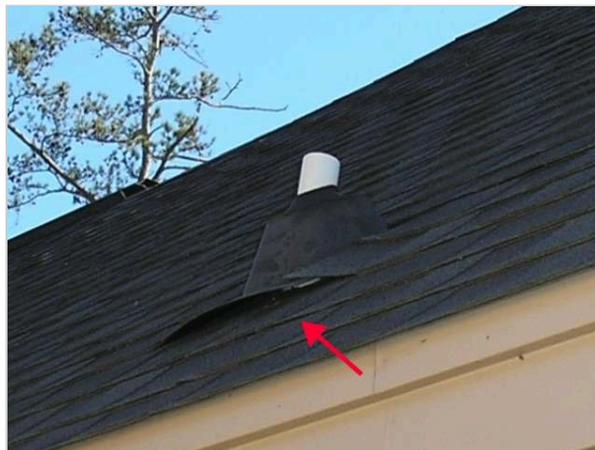
(minimal wear) There were no visible deficiencies to the shingles at the time of the inspection. The right plumbing vent flashing was raised.

raised flashing

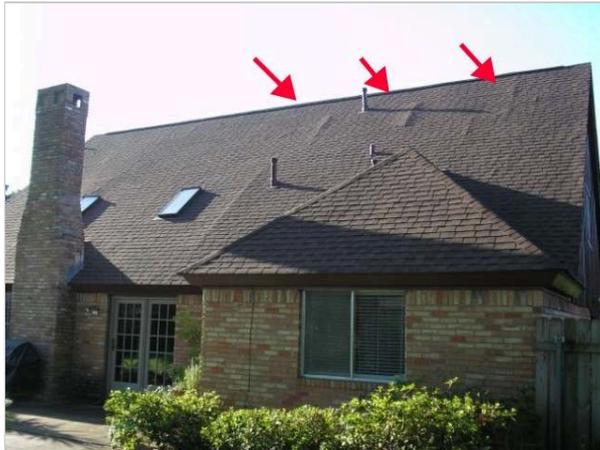
There were several roof deflections. The attic was open back down around the fireplace (no fire blocking).

deflections

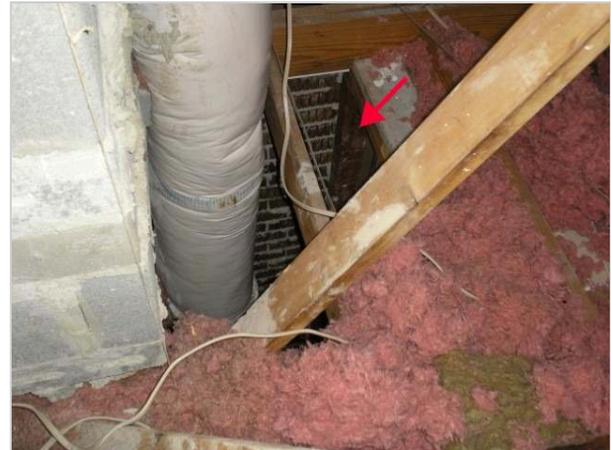
missing fire blocking

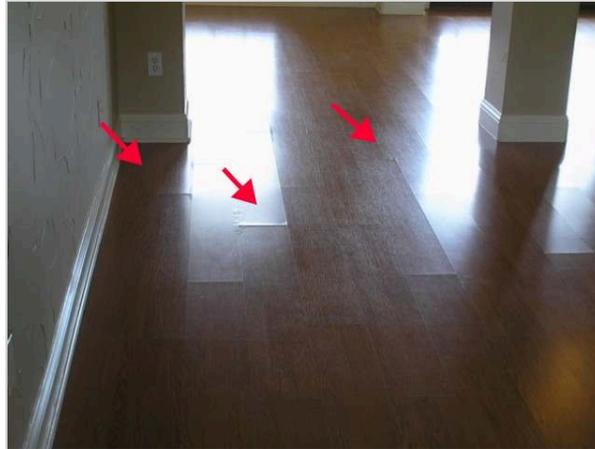
The floor covering was warped / damaged in the living room.

floor covering warped

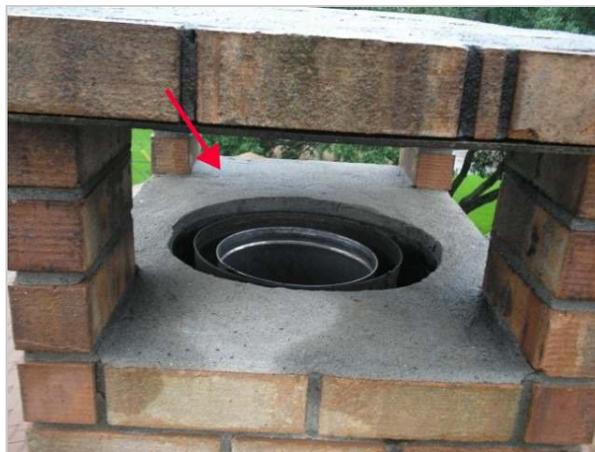
There was no cap on top of the chimney under the brick cover.

missing inner cap

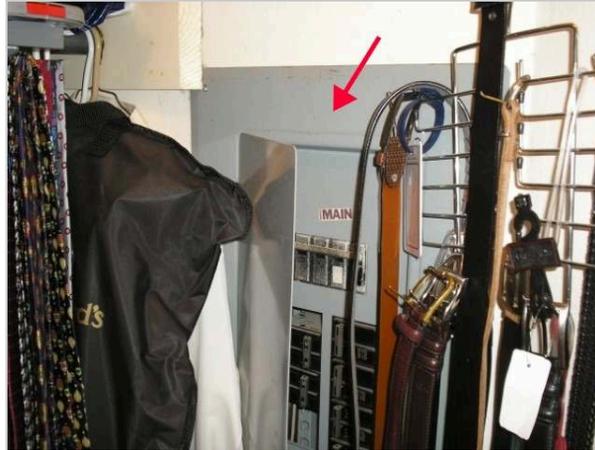
The overhead electrical service entered a panel box located in the master bedroom clothes closet. Clothes closets are considered to be a hazardous location.

panel box in hazardous location

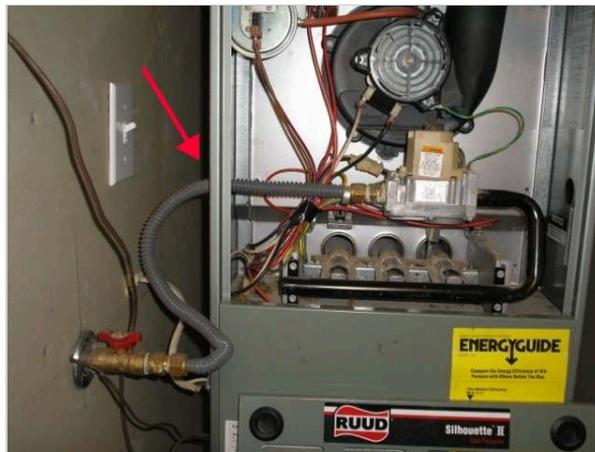
The Ruud heating unit was functioning properly at the time of the inspection. The gas line had an improper connection at the unit (flex hose through the housing).

gas line / housing

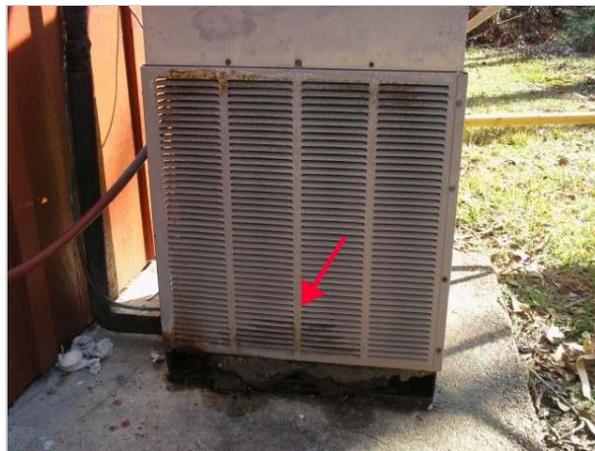
The cooling unit had a low temperature differential of 12 degrees at the time of the inspection. There was rust / damage to the outside unit. It is recommended that an HVAC technician perform a service check on the cooling unit.

rust corrosion / damage to outside unit

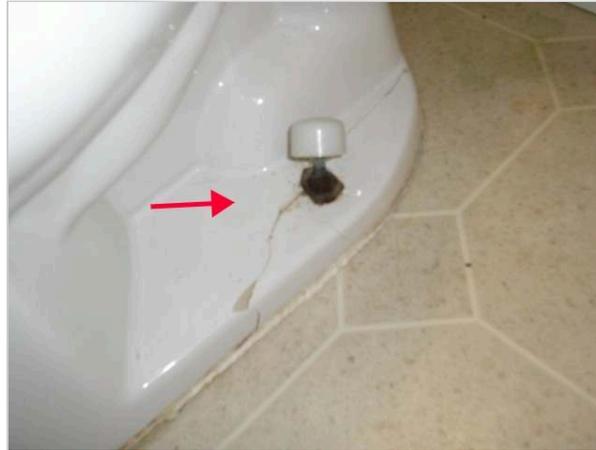
Water was run into the sink(s) and tub(s) for approximately one hour. The hall bathroom commode was cracked at the base. It is recommended that a plumber be contacted.

commode base cracked

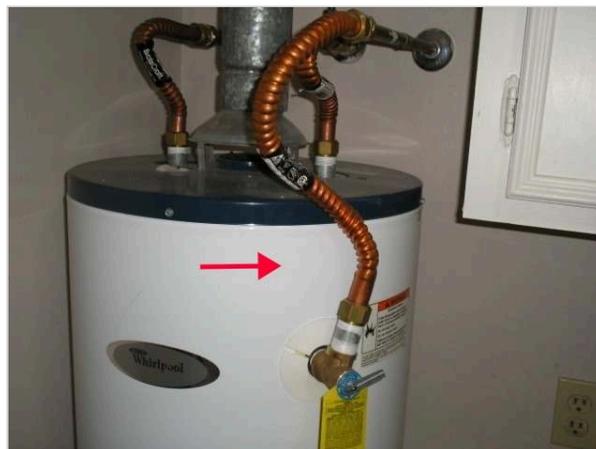
The 2016 Whirlpool water heater located in the utility room was functioning properly at the time of the inspection. The relief valve drip-leg was not gravity fed.

drip leg not gravity fed

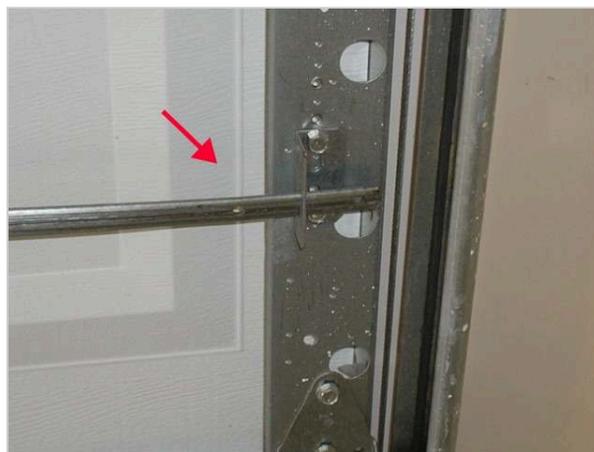
Comments:
The unit was functioning properly at the time of the inspection. However, the manual door lock had not been disabled.

lock not disabled

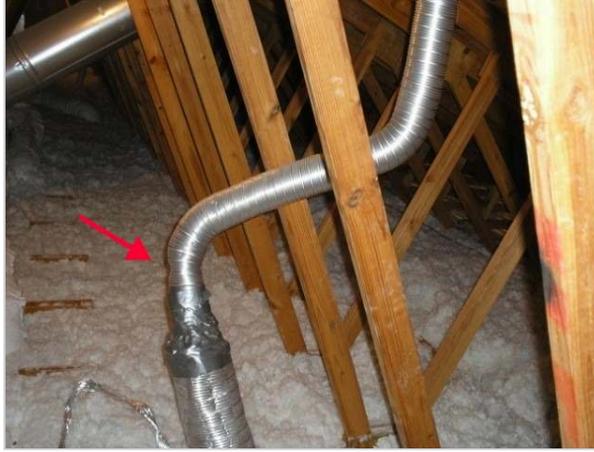
The dryer vent pipe in the attic was improperly run.

improper dryer vent pipe
