HOME INSPECTION REPORT

File Number: **SAMPLE REPORT**

Address of Inspection: **1670 Moultrie**

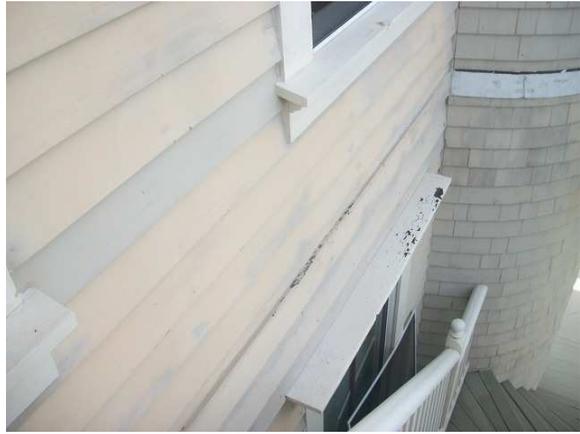
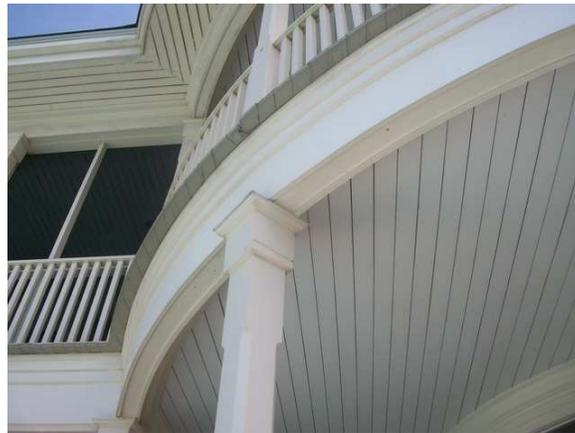
Exterior of home needs several areas of moisture damage repaired and total exterior re-painted to prevent further damage. Consult Contractor for further complete evaluation of the total exterior. Some areas of moisture damage visible are listed under maintenance concerns, Latent damage to areas of exterior are likely and may not be listed in this report.

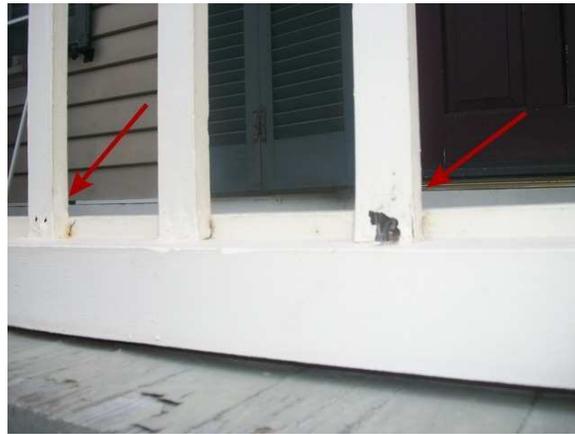
Some areas of right side porch 1st floor has moisture damage to railing/lattice work. Consult Contractor for further evaluation.

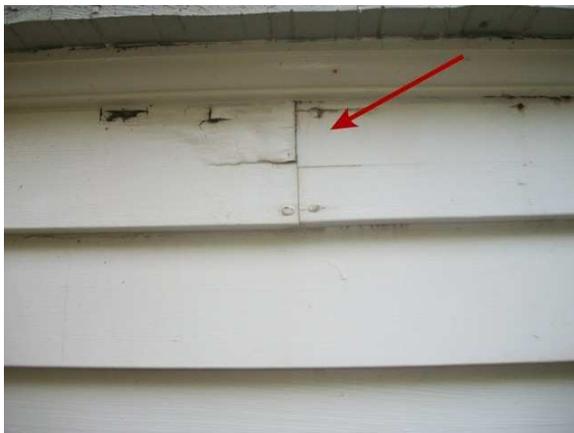
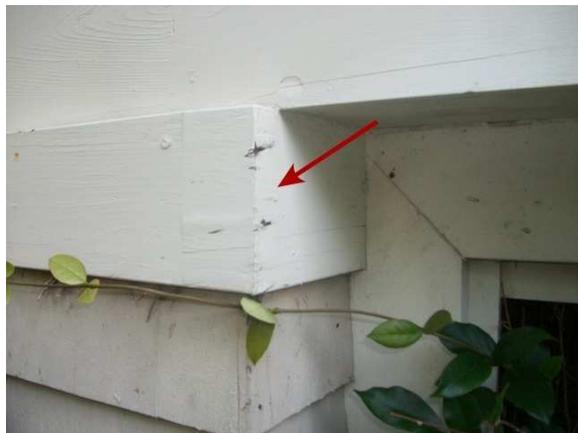
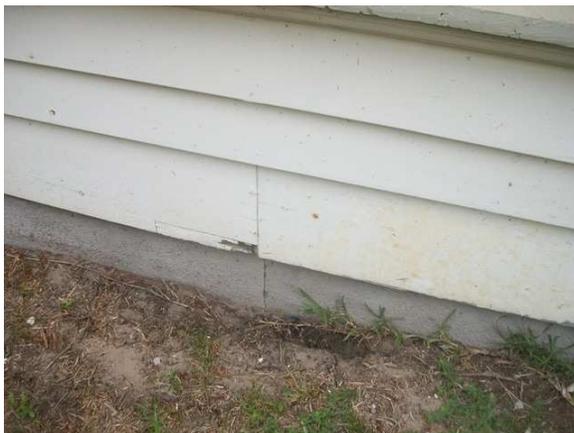
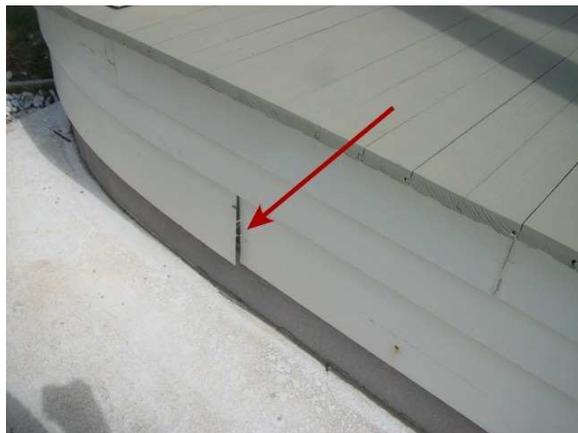
Moisture damage front and side porch 1st floor to trim along bottom under decking

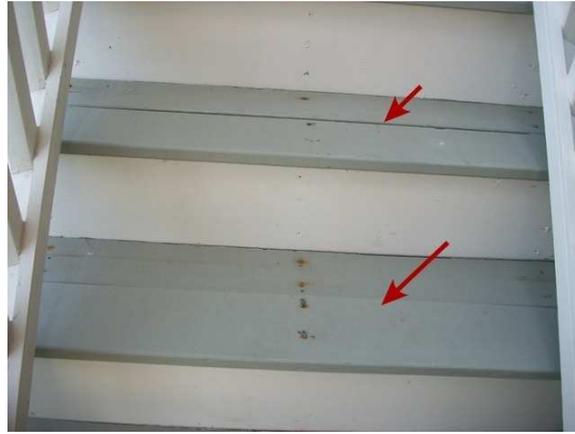
Loose treads rear right exterior steps

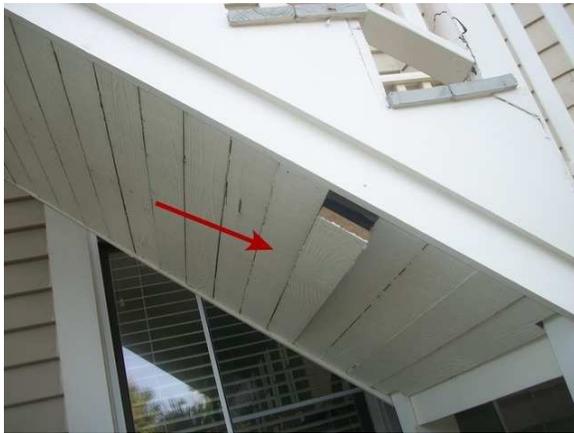
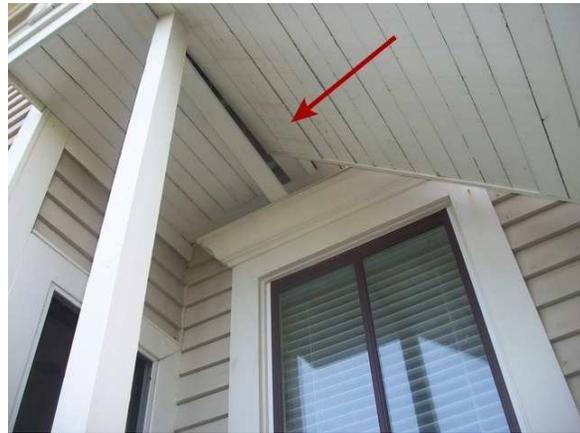
Loose trim boards under rear right exterior steps.

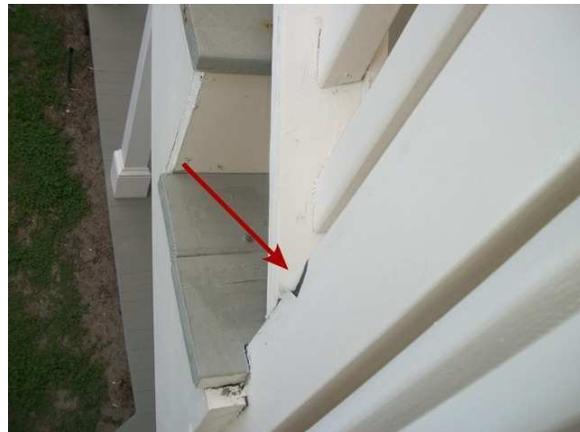
Moisture damage to rear right exterior steps railings and door /casing/ trim at top of steps.

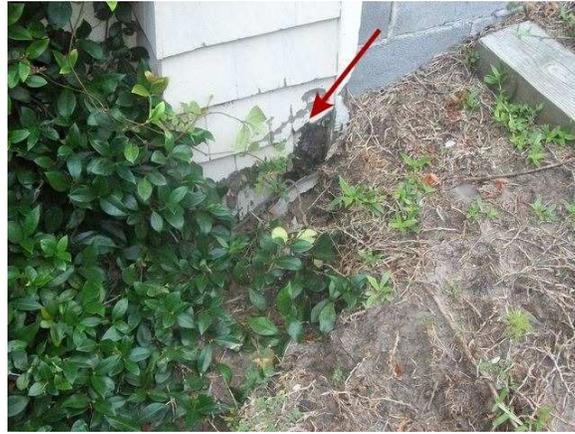
Wood to ground moisture damage visible on right side of home. Consult Contractor for further evaluation

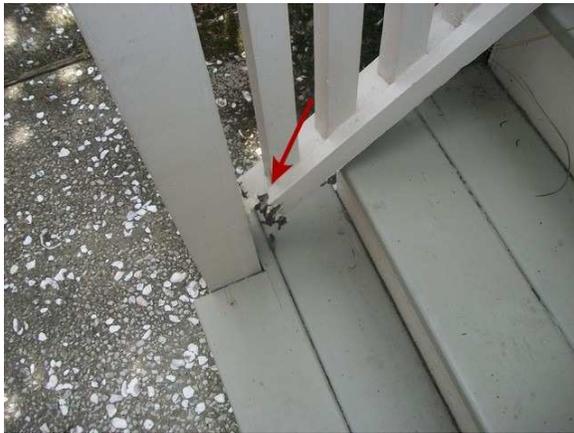
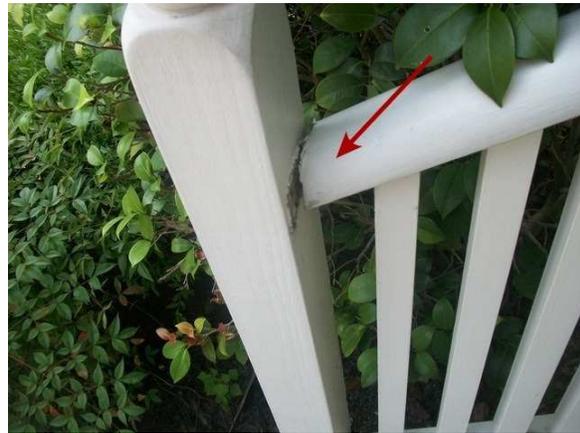
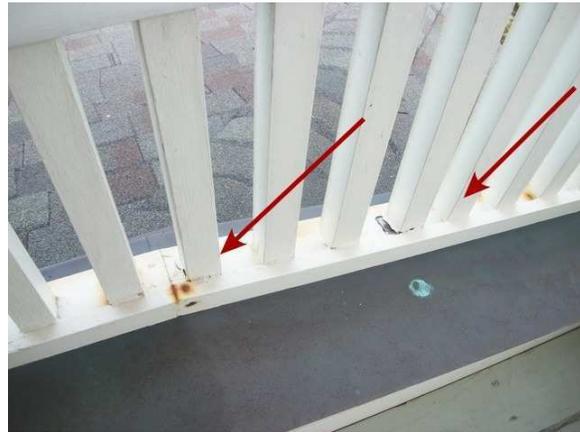
Moisture damage to front entry railings and rear porch railings

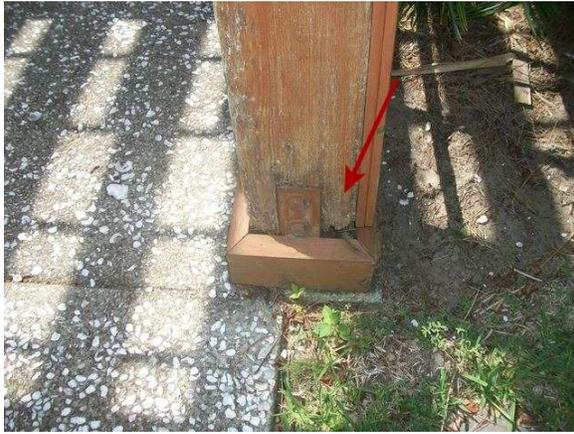
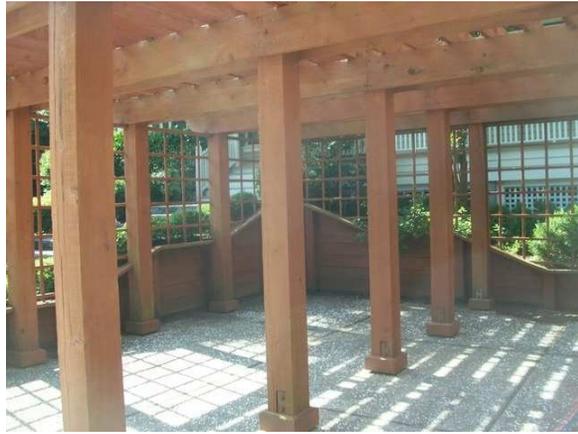
Moisture damage to carport posts (post to ground). Consult Contractor for further evaluation

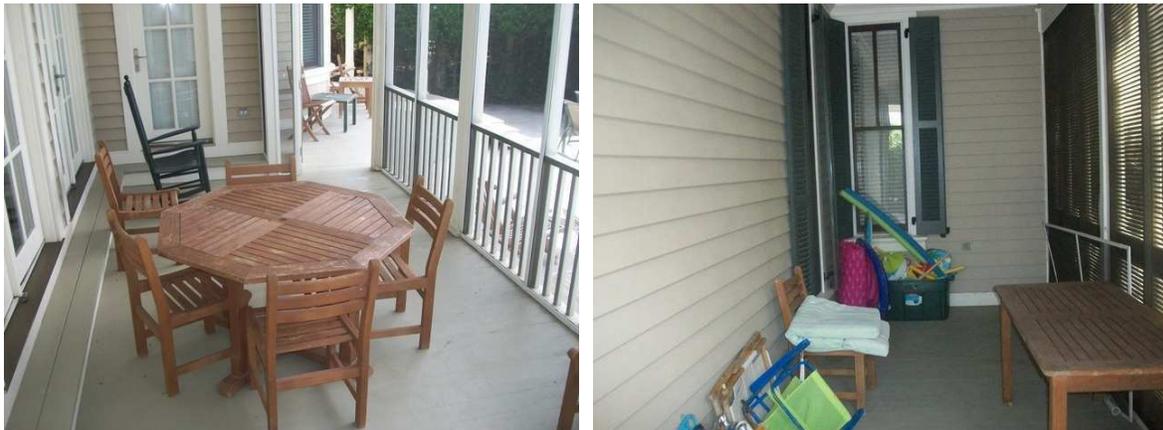
There is a screen porches located in 1st and 2nd floors of the home. There was damaged screening on porches or windows. There were not visible major defects with the screen porches

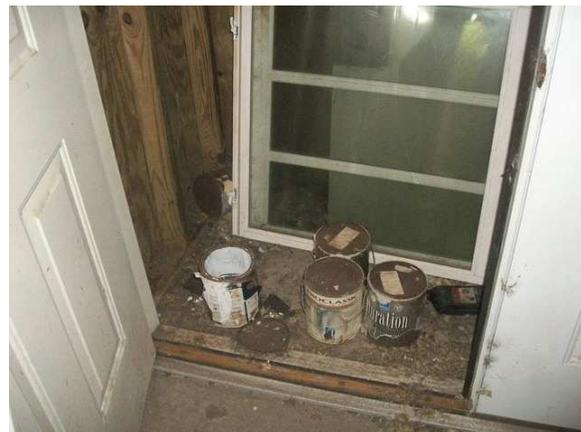
There is debris in crawl space which needs removal to prevent rodents and moisture issues.

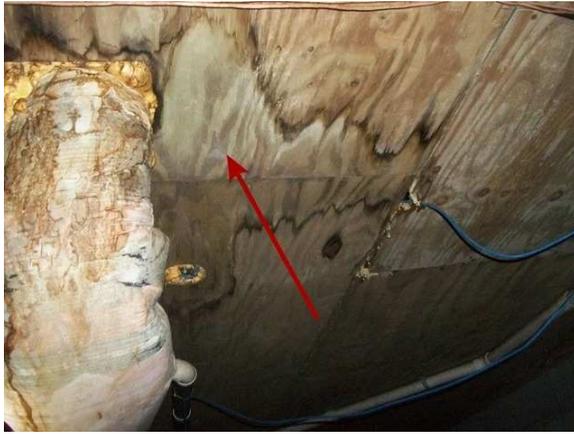
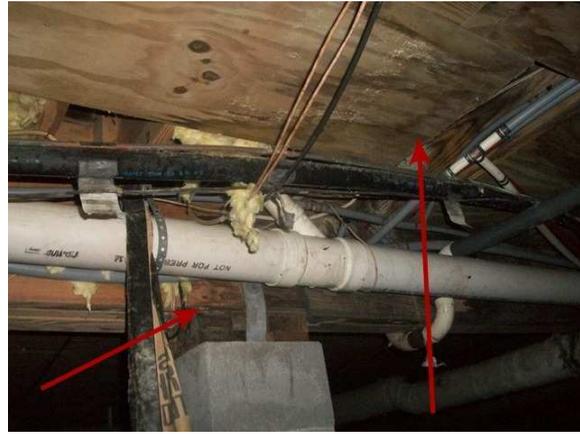
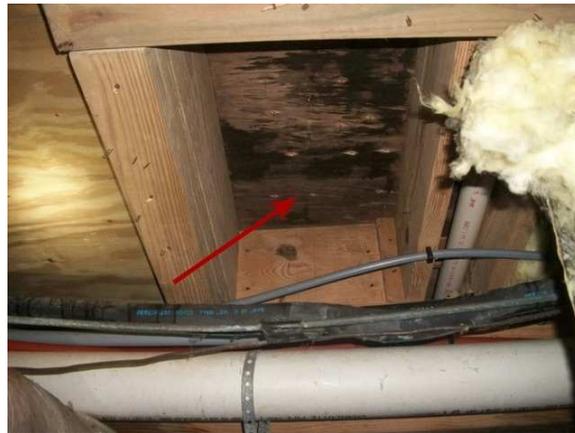
There was visible moisture damage/staining to plywood, joist and beam along left side of home under master bedroom bathroom area in crawl space. Because of plywood covering area inspector could not determine cause. Consult Contractor for further complete evaluation

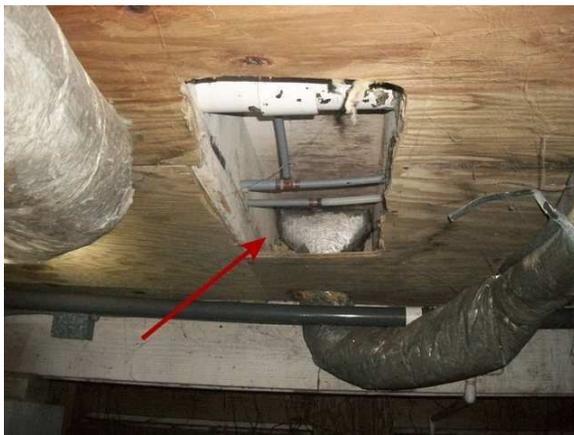
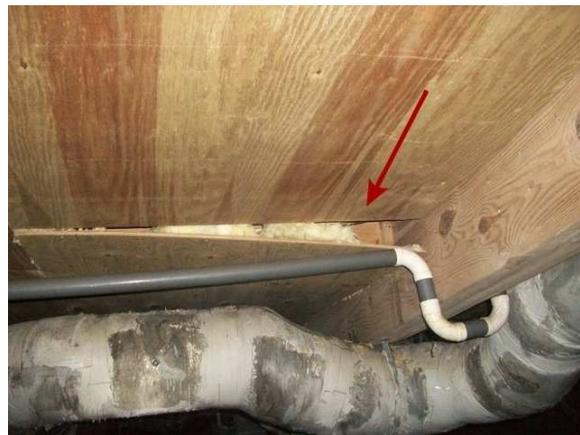
There are several areas of plywood /insulation under home covering floor structure missing. Areas should be repaired to prevent rodent entry into floor structure.

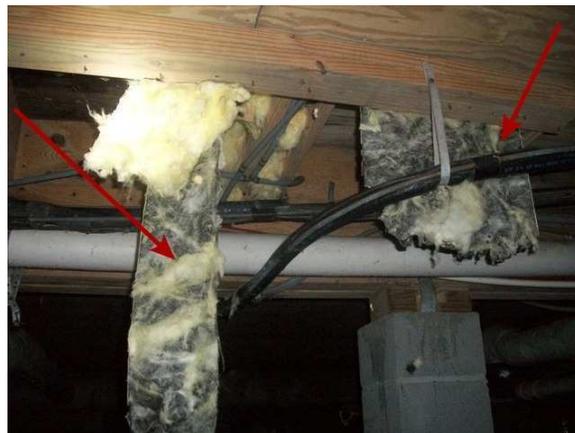
Insulation in areas of floor structure has fallen or falling.

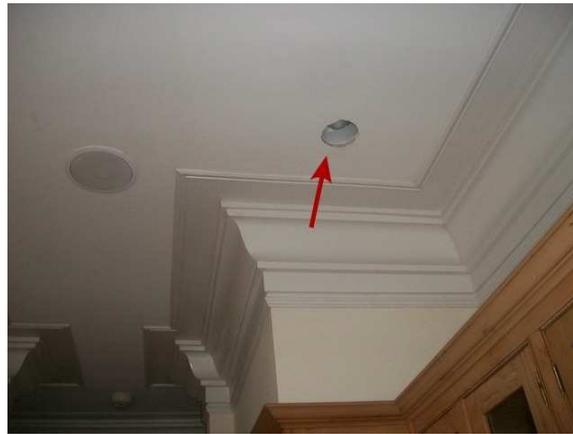
Ceiling light trim and speaker covers missing in kitchen, bathroom and bedrooms .

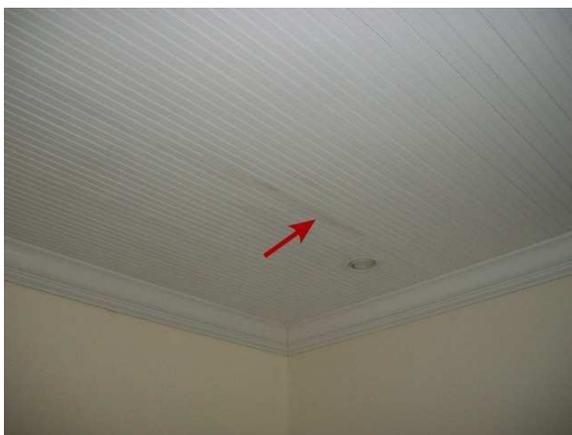
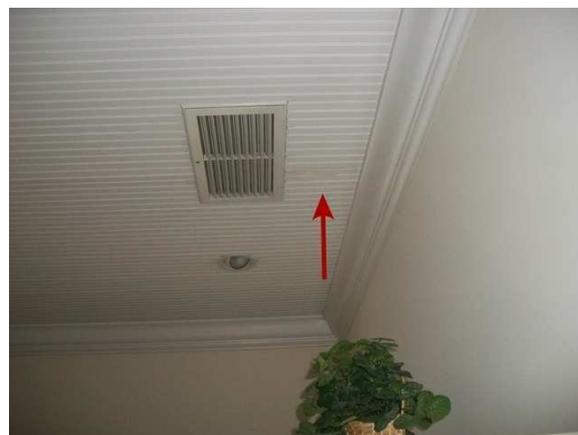
Moisture stain in 2nd floor front bedroom ceilings. No moisture present at time of inspection

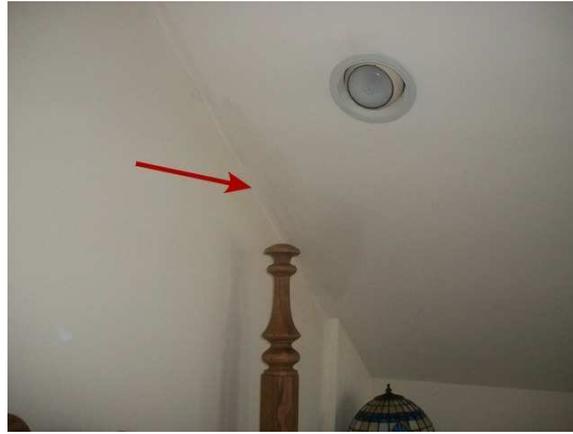
Moisture stain 3rd floor bedroom ceiling. No moisture present at time of inspection

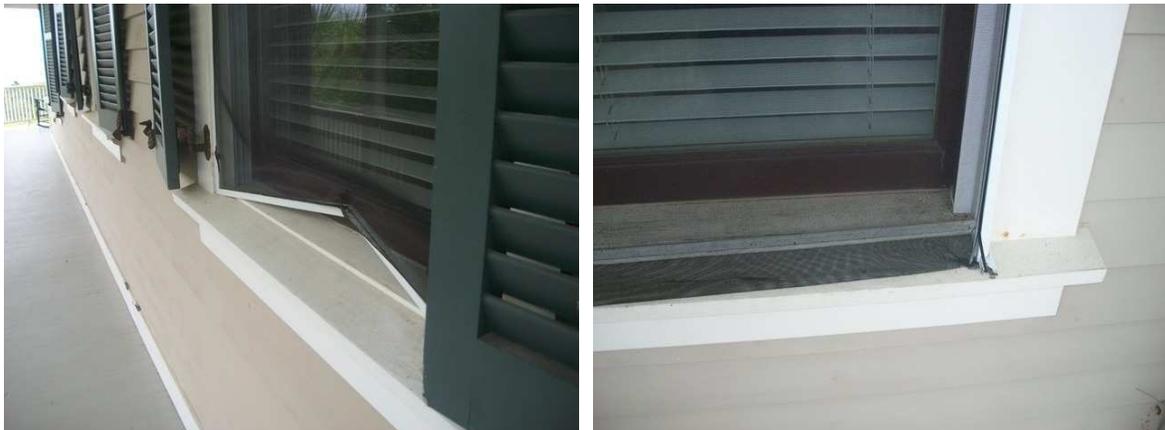
There are several damaged or missing window screens

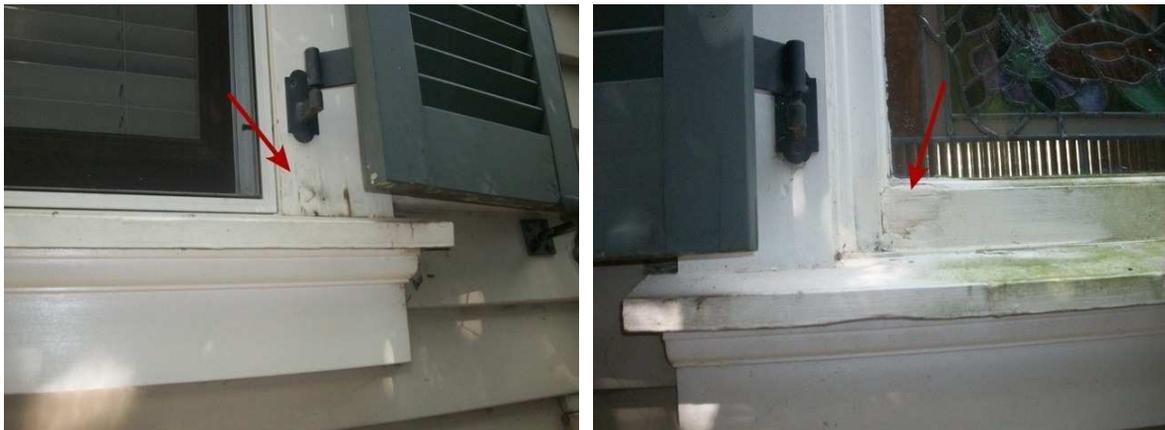
Several windows have moisture damage to casing /trim. Consult Contractor to further evaluate all windows/casing/trim

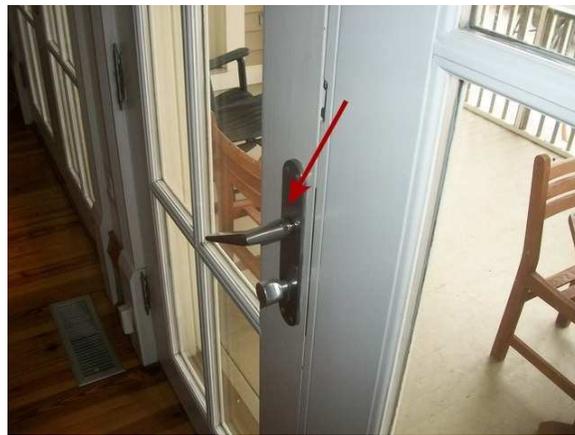
Door handles /knobs from living room /dining area to screen porch need repairs.

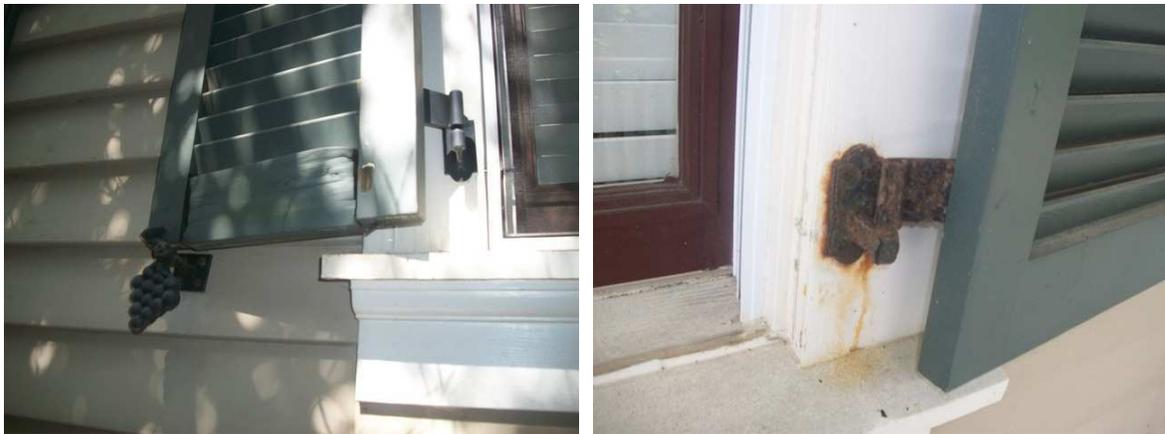
Moisture damage to exterior shutters and shutter hardware

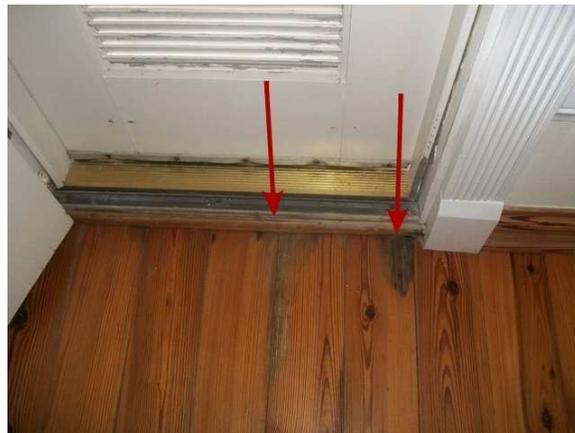
Moisture damage 3rd floor rear door/ casing/floor to deck

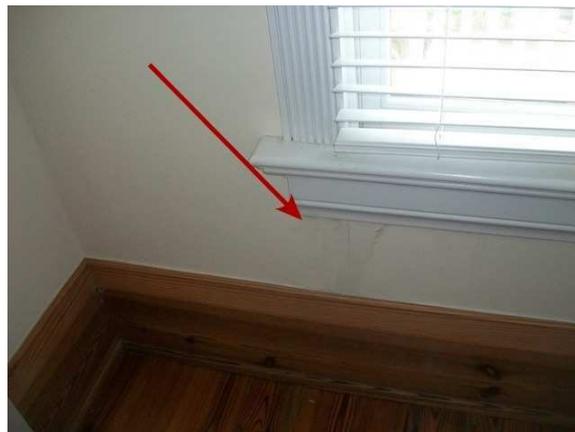
Moisture damage under windows on interior walls in dining area and 2nd floor rear den window(s)

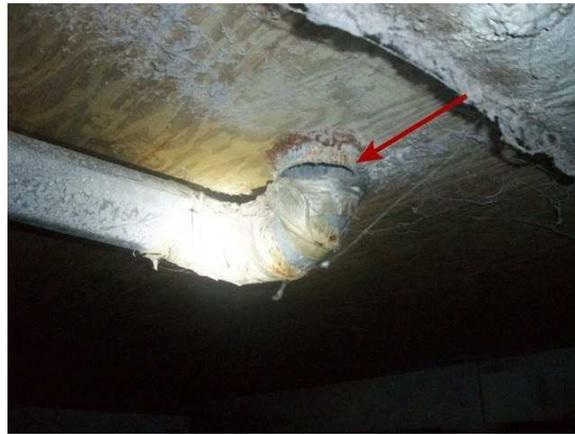
Dryer vent pipe broken loose in crawl space and needs repairs

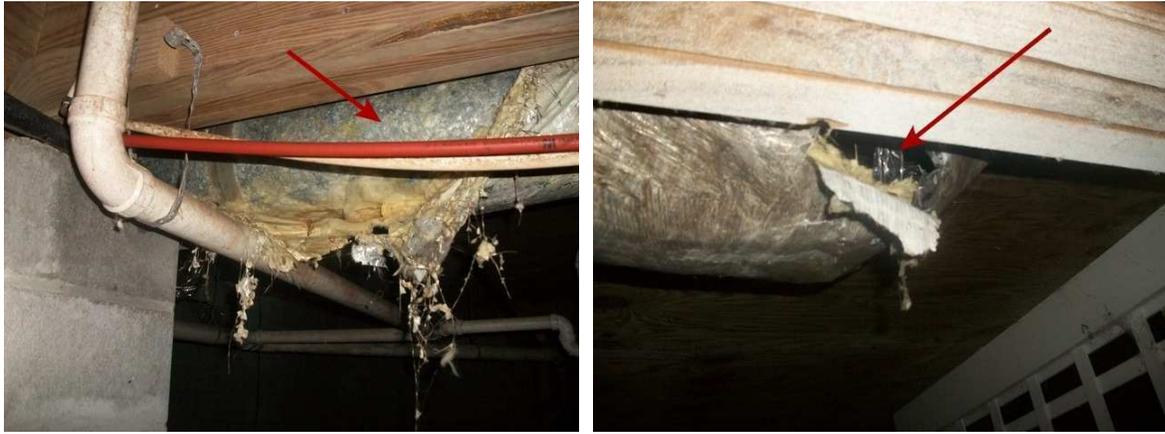
Damaged ductwork right and left side crawl space entry needs repairs

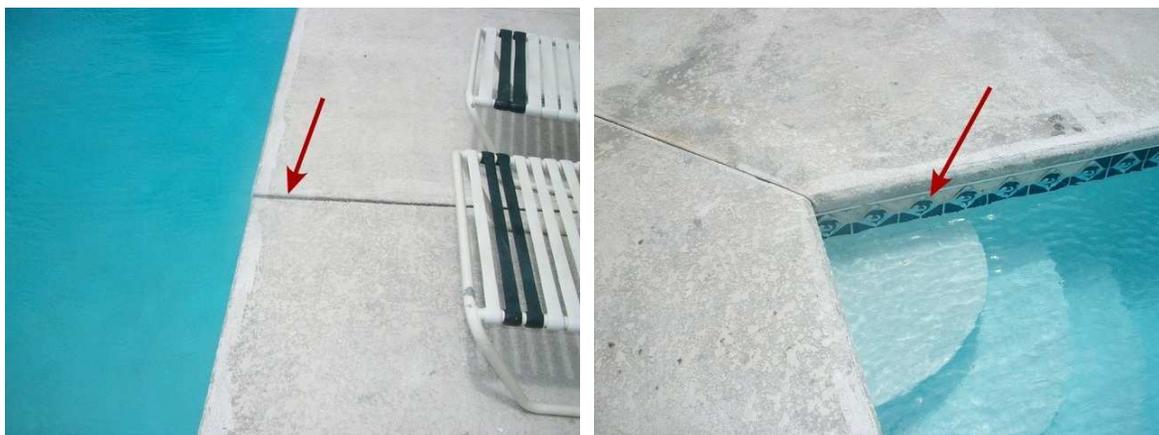
The in-ground pool was constructed of gunite. The deck surrounding the pool was constructed of concrete. There were some vertical separations and settlement cracking in the pool decking. There were visual defects observed in the pool. There are missing tile on top of pool interior wall and interior finish and pool are at near the end of its useful life and will need renovation
