HOME INSPECTION REPORT

On Thursday, June 23, 2022 The HomeTeam Inspection Service made a visual inspection of 1234 Sample Dr. Any Town, USA 55555. Enclosed please find a written, narrative report of our findings in accordance with the terms of our Inspection Agreement. Although general maintenance items may have been addressed verbally at the time of the inspection, they may not be included in the enclosed report.

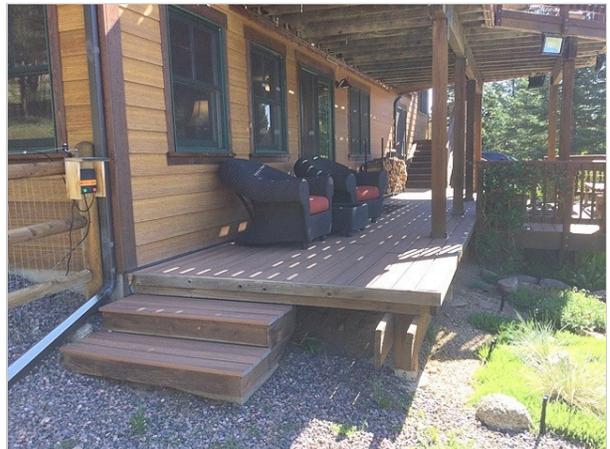
Photo 4

The grading around the structure appears to be insufficient to carry water away from the foundation.

HomeTeam recommends having the soil regraded on the right side of the structure and further assessed at the time of regrading.

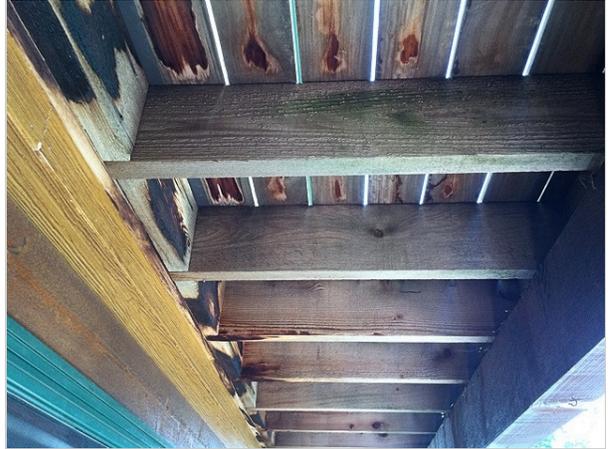
Photo 37

A few of the joist hangers on the middle deck appear to be coming loose. Recommend repairs by a qualified contractor.

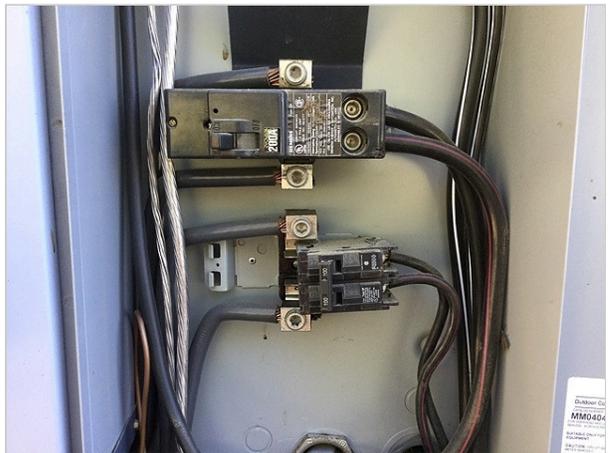
Photo 43

The main electrical service wire feeding this structure was in contact with tree branches. For safety, the local power company should be contacted to trim away the branches from the power line.

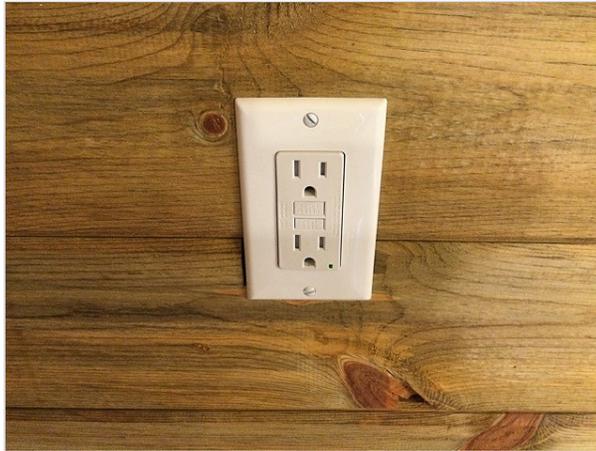
Photo 57

The GFCI outlet located in the detached garage loft is defective and should be replaced.

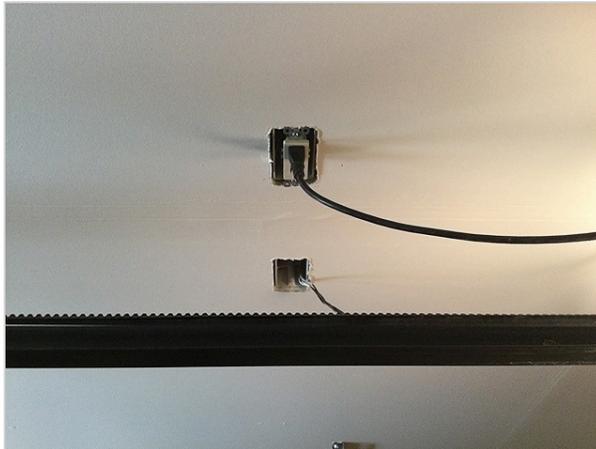
Photo 58

A missing outlet cover was observed in the garage. All switch and outlet boxes should be properly covered to avoid a shock hazard. Electrical repairs should be performed by a qualified electrician.

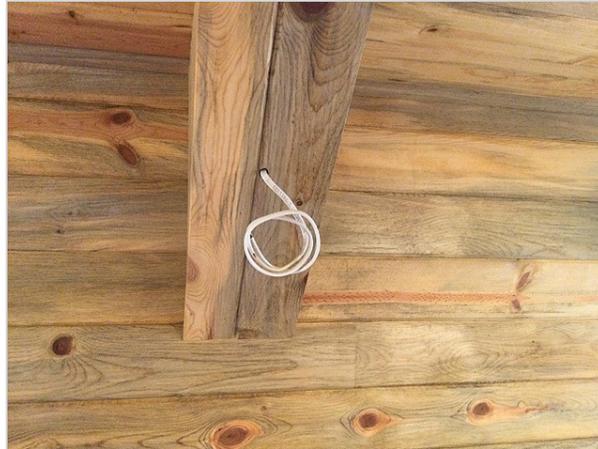
Photo 59

Exposed or un-terminated live wires were observed in the detached garage loft. The wires should either be disconnected at the source or properly terminated in an approved, covered electrical box. Consult with a qualified electrician for repair and further assessment.

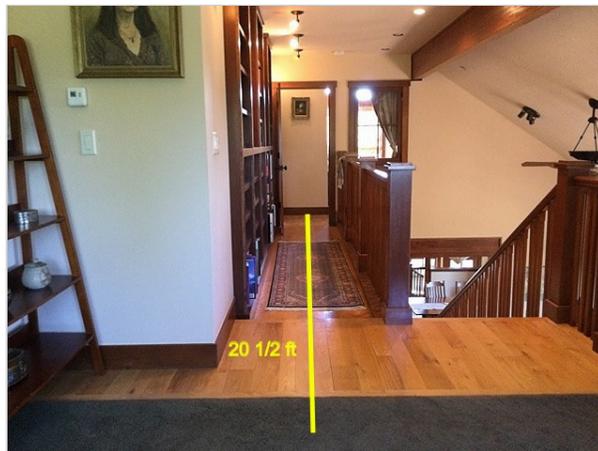
Photo 66

Per Colorado state law, carbon monoxide detectors are required to be installed within 15 feet of all sleeping areas. No carbon monoxide detectors were observed installed within 15 feet of the sleeping areas on the upper level.

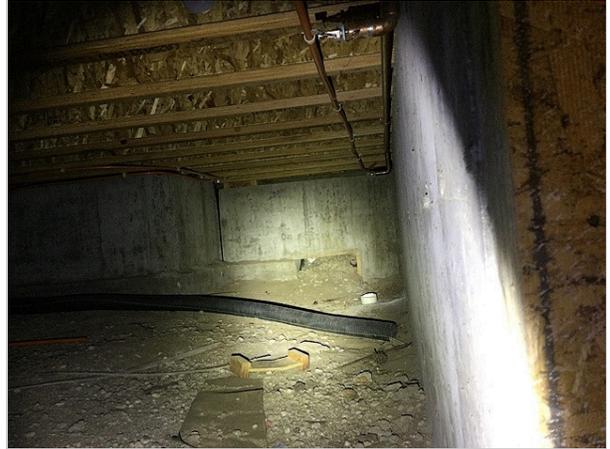
Photo 70

The sub-floor above the crawlspace lacks insulation. Adding insulation may help regulate the temperature of the living space above the crawlspace and may assist in preventing moisture intrusion.

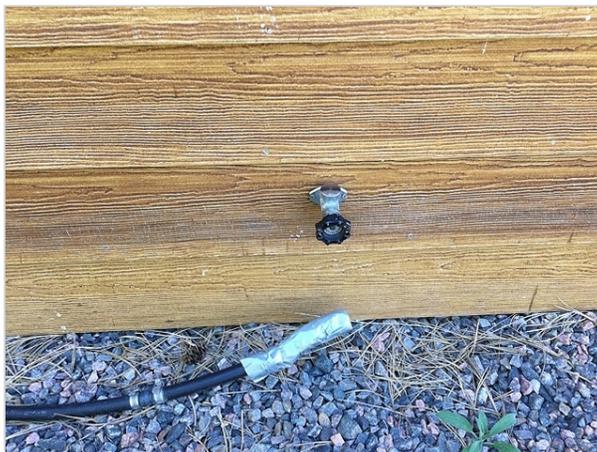
Photo 72

An exterior hose bib did not function when tested. During winter months and times of colder temperatures, homeowners often turn off hose bibs from the interior to prevent pipes from freezing and bursting. Due to the possibility of uncontrollable leaks at the faucet handle if activated, HomeTeam does not activate shutoff valves. Once temperatures remain safely above freezing the client should check the hose bibs for proper operation.

rear hose bib

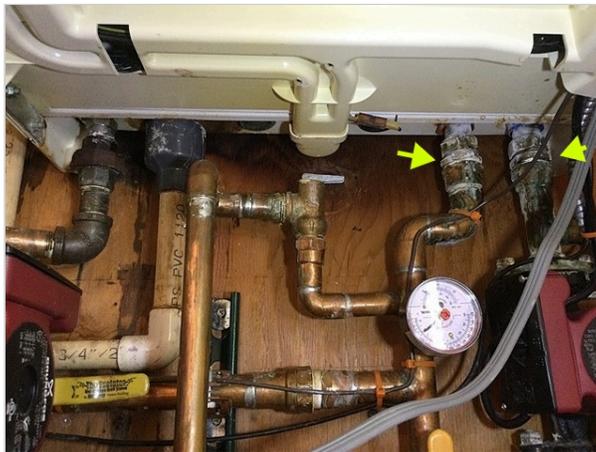
Photo 89

Corrosion was observed on the water pipes for the water heater. No water leaks were observed at the time of the inspection.

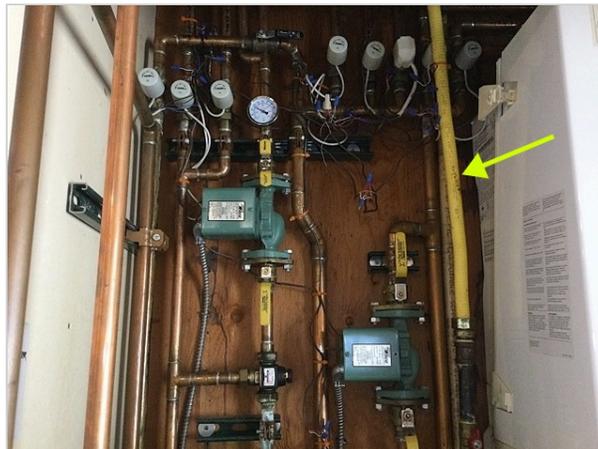
Photo 95

A bonding or grounding device is recommended to be verified and/or installed on the CSST (Corrugated Stainless Steel Tubing) natural gas system in order to reduce the chances of a natural gas leak or fire. Bonding is provided primarily to prevent a possible electric shock to people who come in contact with the gas piping and other metal objects connected to the CSST system. Nearby lightning strikes can also result in an electrical surge and can potentially puncture a hole in the CSST. Additional information regarding this type of condition can be found at: <http://csstsafety.com/>

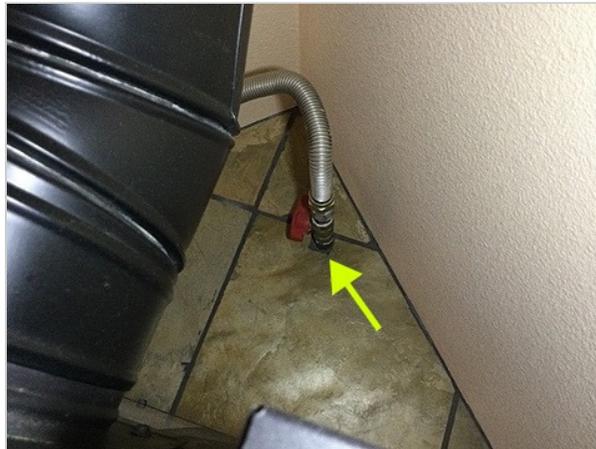
Photo 102

gas valve

The gas valve to the primary bedroom fireplace was turned off at the time of inspection and the fireplace could not be tested. Recommend seller disclosure.

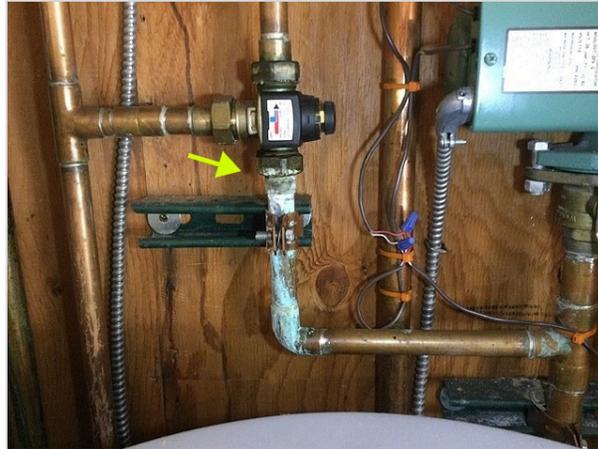
Photo 107

Corrosion was observed on the water distribution pipes for the hydronic heating system. No water leaks were observed at the time of the inspection.
