HOME INSPECTION REPORT

The HomeTeam Inspection Service made a visual inspection of 123 Main Street, Anytown, USA 55555. Enclosed please find a written, narrative report of our findings in accordance with the terms of our Inspection Agreement.

File Number: **1132 - 083016**

Address of Inspection: **123 Main Street**

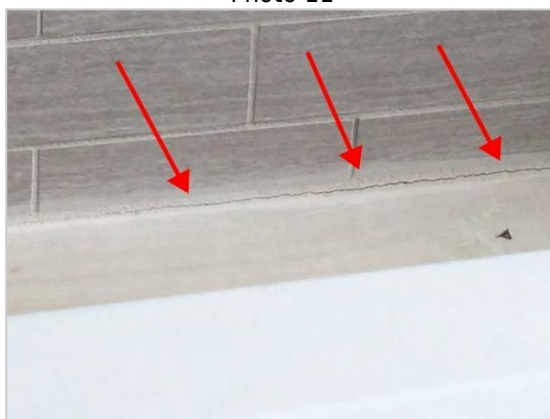
Photo 11

Some of the caulk was missing from around the tub in the master bathroom. These areas should be sealed to prevent moisture penetration. Failure to keep walls sealed can cause deterioration and extensive moisture damage including mold growth to the interior walls, which is not always visible at the time of the inspection.
