HOME INSPECTION REPORT

The HomeTeam Inspection Service made a visual inspection of 123 Main Street, Anytown, USA 55555. Enclosed please find a written, narrative report of our findings in accordance with the terms of our Inspection Agreement.

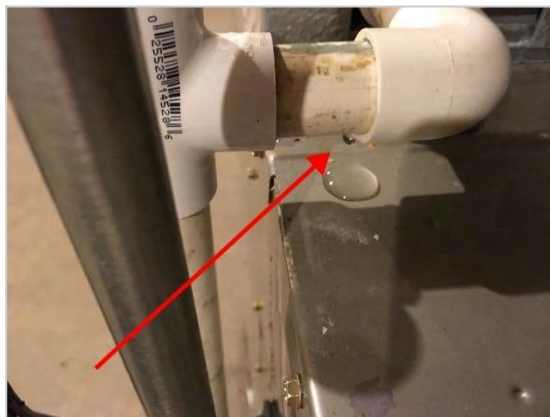
Photo 16

A condensate leak was noted on the air handler drain line. Repairs should be made by a qualified contractor.
