HOME INSPECTION REPORT

On November 19, 2016 The HomeTeam Inspection Service made a visual inspection of 123 Sample Road Anywhere, GA 55555. Enclosed please find a written, narrative report of our findings in accordance with the terms of our Inspection Agreement.

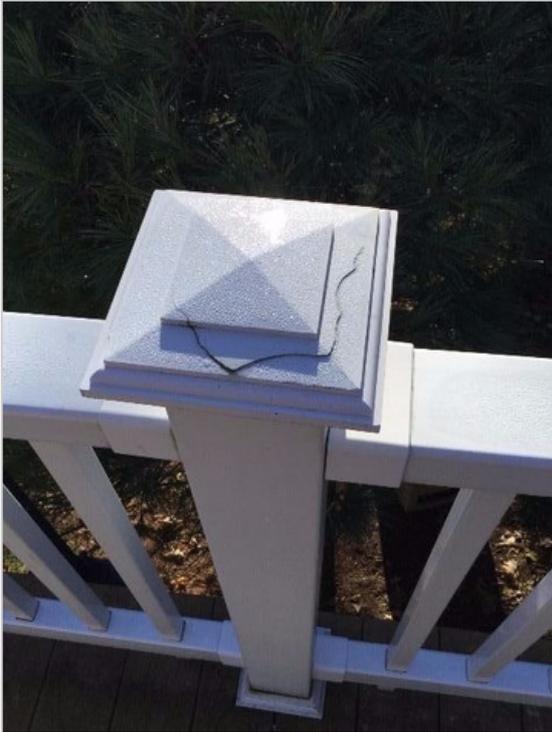
Photo 6

Crack in top cap of post. Non-structural - just visual impairment.

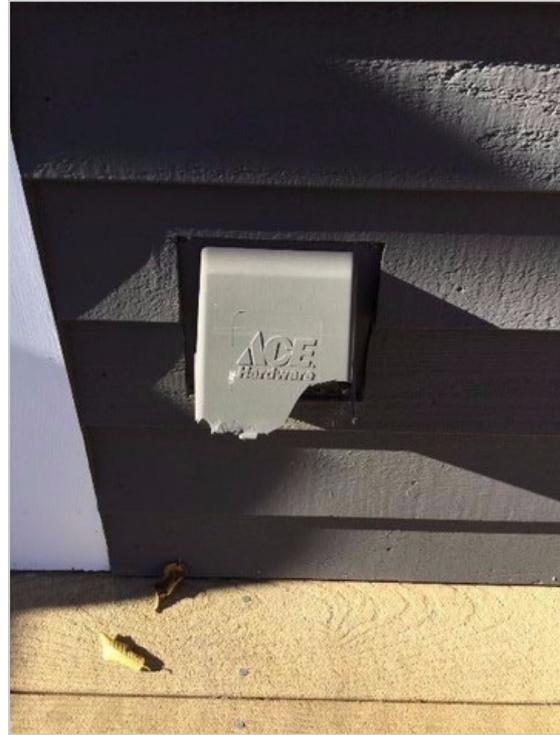
Photo 7

Cracked outdoor outlet cover should be replaced. Keeping moisture and water out of these outlets is important.

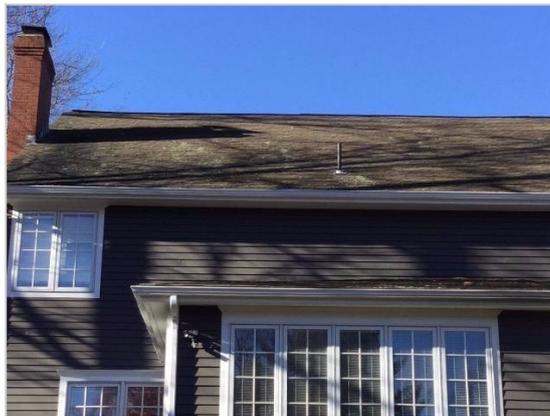
Photo 9

These conditions indicate the roof shingles were in the second half of their useful life.

Although the roof condition is adequate and seems to be weathering well within its life expectancy; the age of the roof should be indication of a deferred expense to plan for within the next 5 years.

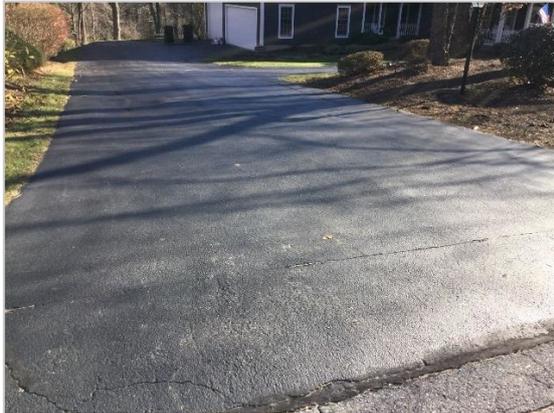
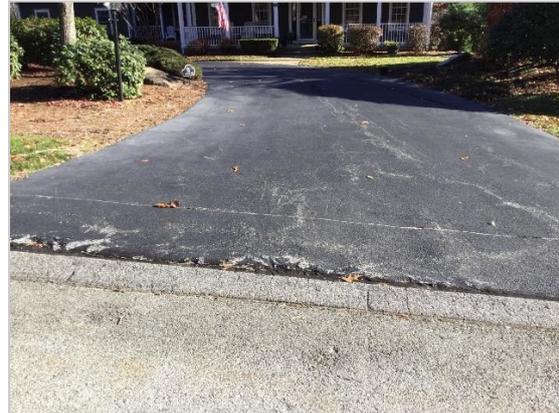
An asphalt driveway is present in the front of the structure. Cracks and spalling were observed on the driveway. Surface defects in driveways develop and progress with age and are considered normal as long as they do not create a safety hazard. Sealing defects may help slow the rate of deterioration.

Several areas of the driveway have settled. This condition indicates a possible void under the driveway. Driveway settling has led to potential tripping hazards. The areas should be monitored and repaired as needed.

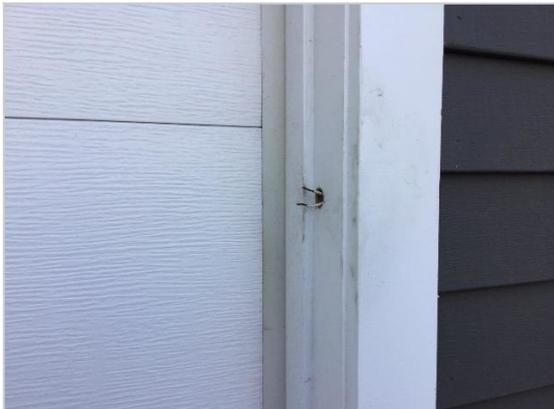
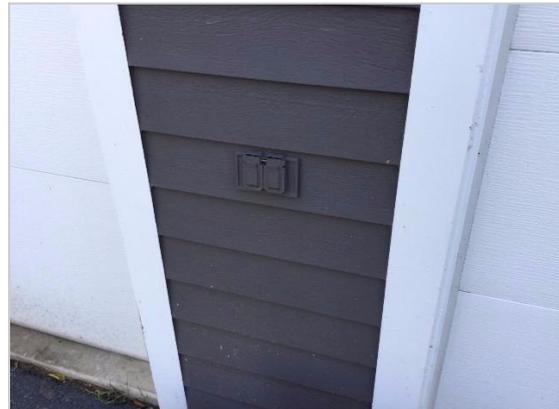
The automatic garage door opener was not functional at the time of the inspection. Consult with a

garage door service for evaluation and repair. Needs button replaced.

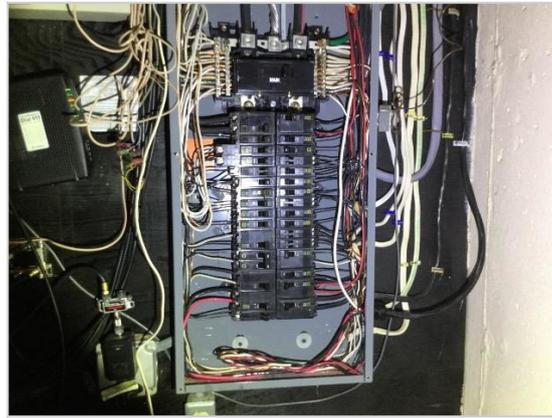
Photo 17

A circuit breaker in the electric panel had two attached circuits (wires). Each circuit should have its own dedicated breaker to prevent nuisance tripping and ensure good terminal contact, which may help prevent overheating. This situation is commonly referred to as a "double-tap". An electrician should repair this condition and further assess the panel for any additional required repairs.

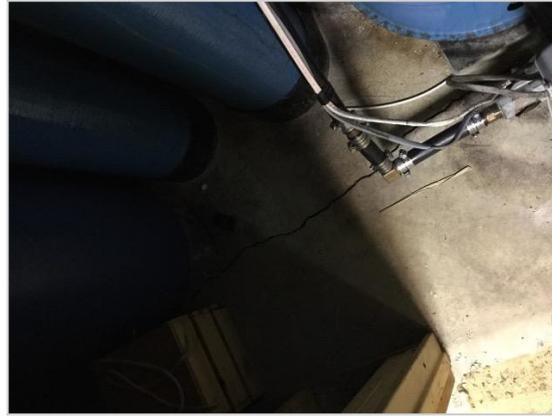
Photo 18

There were cracks in the floor in basement which show no signs of water penetration but they are larger than typical settlement cracks. One Crack had been repaired before but showed signs of moving again.

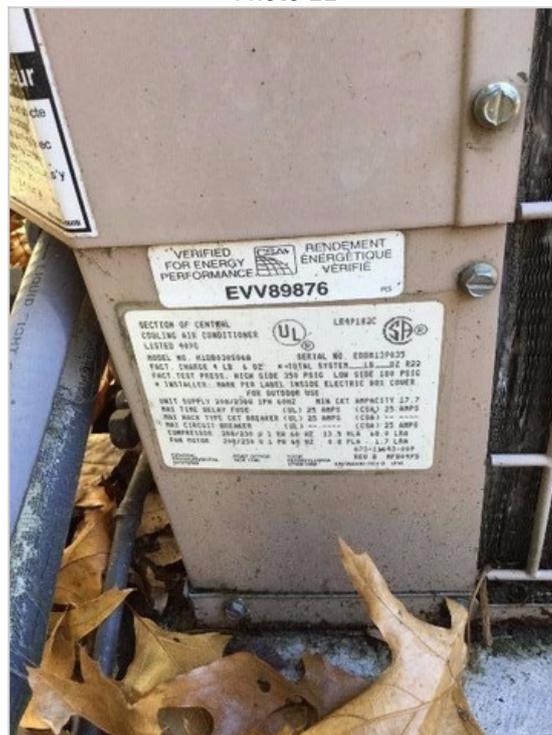
Photo 22

Because of its condition and performance at the time of the inspection, **the HVAC system requires cleaning and servicing by a professional HVAC technician.** At that time, the technician will test refrigerant levels, service the equipment to improve its performance, and perform other tests beyond the scope of the home inspection to assess and identify any additional areas that may require attention.

Gaps were observed around the HVAC air intake and refrigerant line. These gaps should be sealed to prevent moisture and pest intrusion.

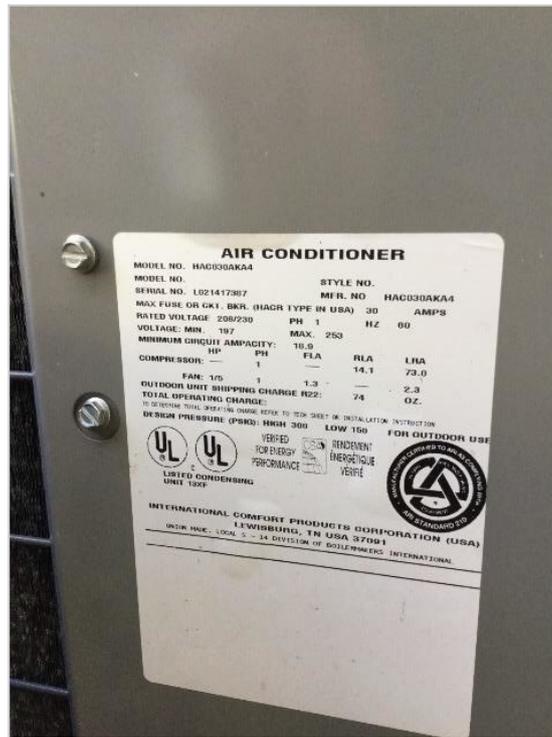
Photo 23

The fins on the outdoor compressor unit are bent. Combing or straightening the fins may improve the efficiency of the unit by aiding heat transfer.
