HOME INSPECTION REPORT

On Tuesday, March 26, 2024 The HomeTeam Inspection Service made a visual inspection of 123 Anywhere Street, Anytown, USA 11111. Enclosed please find a written, narrative report of our findings in accordance with the terms of our Inspection Agreement.

Alan Benavides
HomeTeam Inspection Service
Florida Home Inspector HI16910

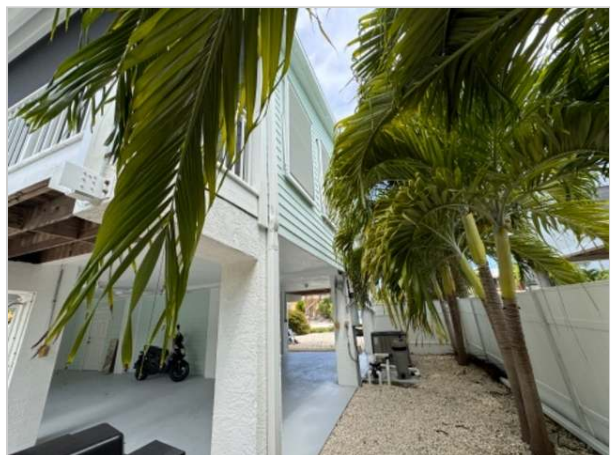
Extensive plant and/or tree overgrowth was observed against the structure. HomeTeam recommends trimming or removing this growth to prevent possible damage including insect infestation, moisture buildup, and impact damage to the roof and structure.

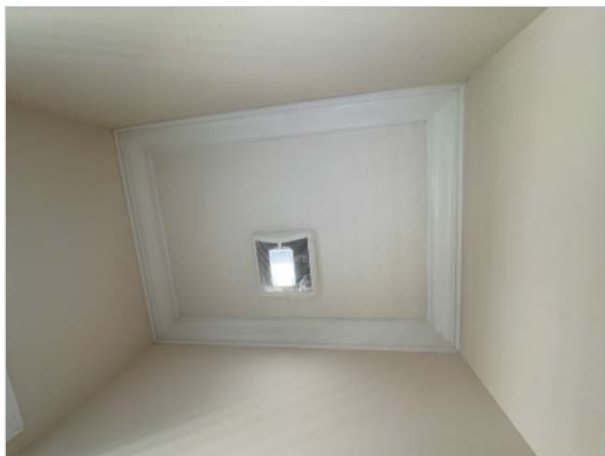
A stain was present on the ceiling of the structure. The stain appeared to be dry at the time of the inspection and should be monitored for any future moisture.

- **A stain was present on the ceiling of the structure.** The stain appeared to be dry at the time of the inspection and should be monitored for any future moisture.

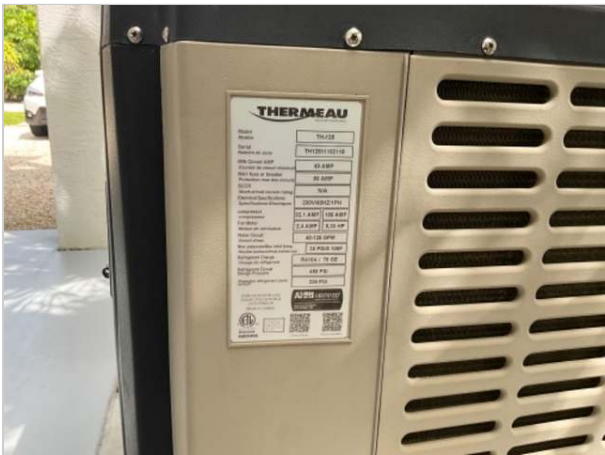
The Thermeau pool electric heater was NOT ABLE TO BE ACTIVATED at the time of the inspection. No panels were opened on the unit. A complete inspection and service by a qualified technician is recommended before closing and use. No panels are opened. Performance testing of such equipment is not within the scope of the home inspection.
