### *HOME INSPECTION REPORT*

The HomeTeam Inspection Service made a visual inspection of 123 Main Street, Anytown, USA 55555. Enclosed please find a written, narrative report of our findings in accordance with the terms of our Inspection Agreement.

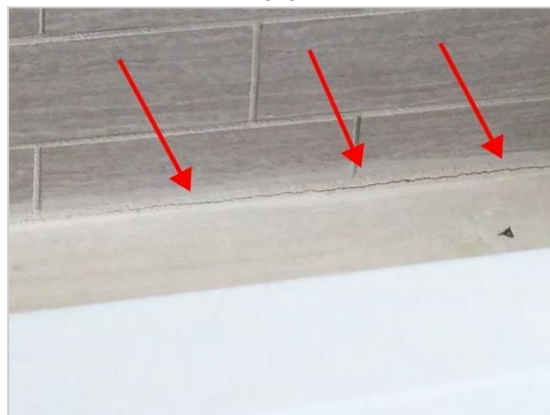
Photo 11

**Some of the caulk was missing from around the tub in the master bathroom.** These areas should be sealed to prevent moisture penetration. Failure to keep walls sealed can cause deterioration and extensive moisture damage including mold growth to the interior walls, which is not always visible at the time of the inspection.
