### *HOME INSPECTION REPORT*

The HomeTeam Inspection Service made a visual inspection of 123 Main Street, Anytown, USA 55555. Enclosed please find a written, narrative report of our findings in accordance with the terms of our Inspection Agreement.

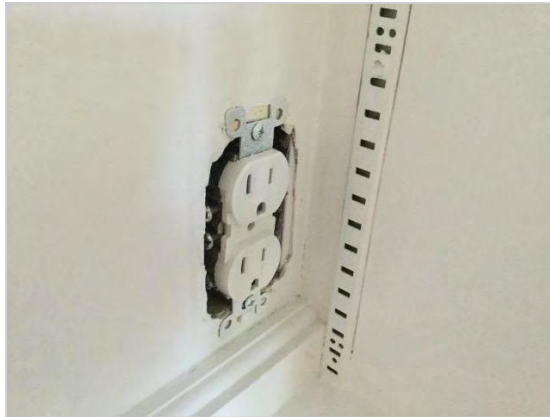
Photo 10

**Missing switch or outlet covers were observed in the living area.** All switch and outlet boxes should be properly covered to avoid a shock hazard. Electrical repairs should be performed by a qualified electrician.

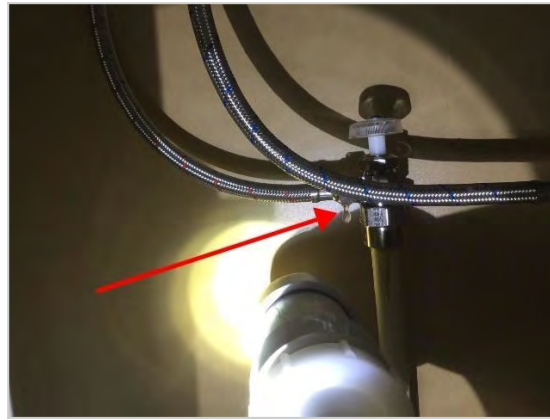
Photo 13

**Active water leaks were present at supply lines the time of the inspection.** The affected areas should be repaired, and nearby or associated plumbing lines should be further assessed at the time of the repair.
