HOME INSPECTION REPORT

**123 Sample Drive
Anytown, TX 55555**

PROPERTY INSPECTION REPORT

Prepared For:	Bill Sample (Name of Client)	
Concerning:	123 Sample Drive, Anytown, TX, 55555 (Address or Other Identification of Inspected Property)	
By:	John Rigamonti (TREC License # 25912)	5-1-2023 (Date)
(Name, License Number of Sponsoring Inspector)

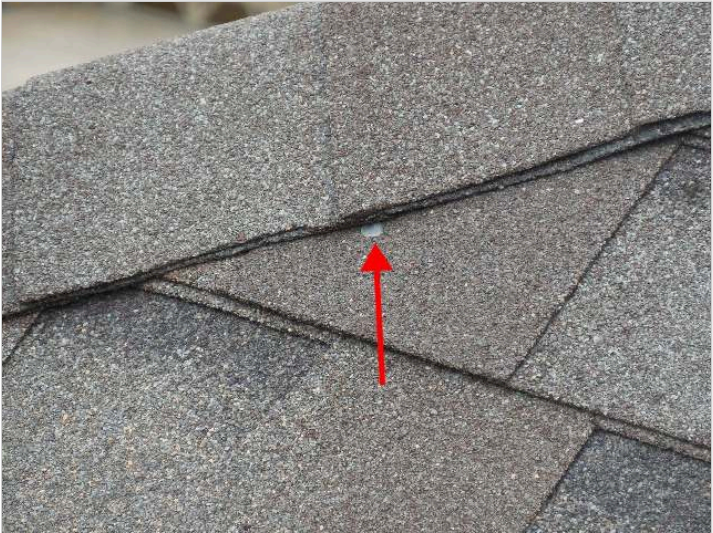
The following minor deficiencies were observed on the roof: exposed and/or rusted fasteners (nails). Recommend seal/caulking and repair to help prevent future damage.

Exposed nail head on roof.

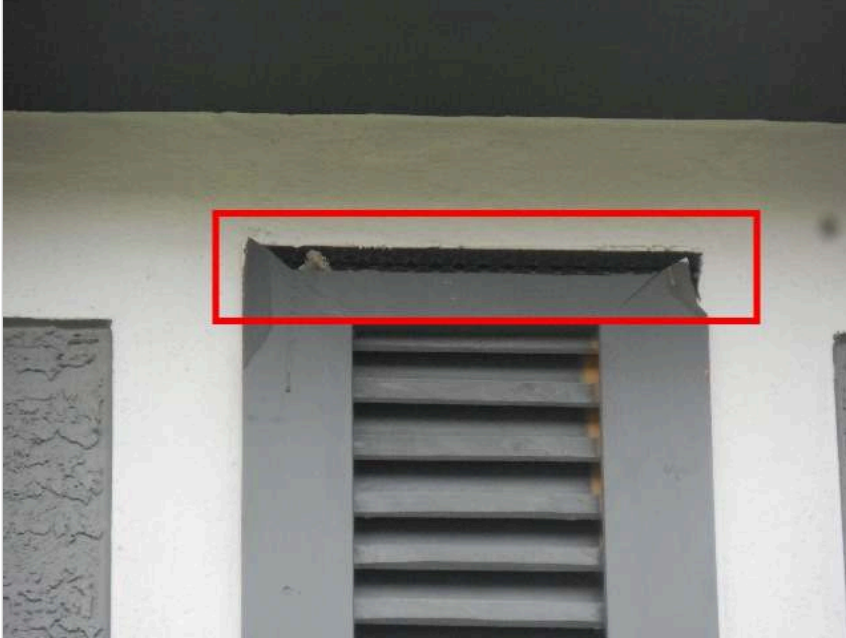
Trim was damaged at the top of the front facing gable vent. Recommend repairing and sealing.

Part of trim damaged/missing at front gable vent.

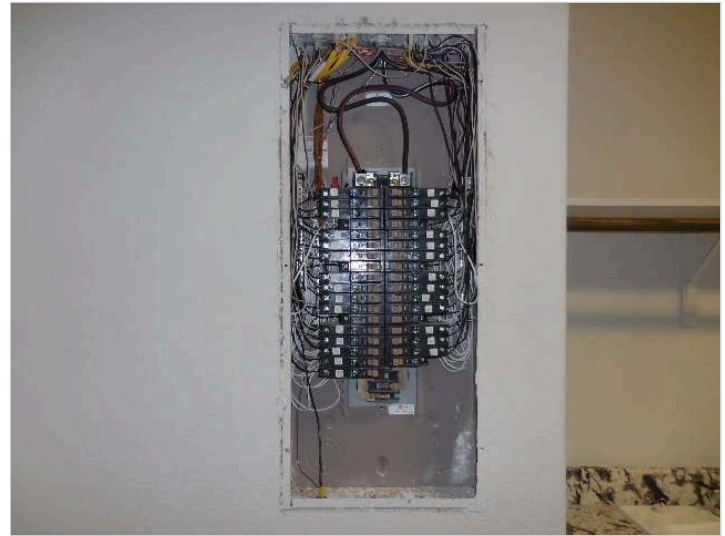
The sub-panel cover in the utility room was causing some of the breakers to trip when the panel door was closed (door hitting breaker handles). Recommend adjustment.

View of sub panel in utility room.

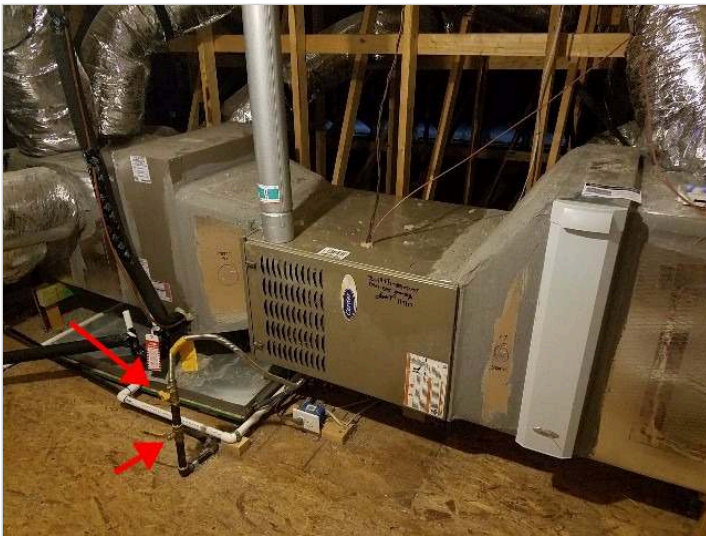
The heating units would not come on. Both unit gas valves and systems were OFF at the time of the inspection (at the units) and did not appear to be activated by the builder. After attempting to temporarily turn on the gas and units for testing they still did not respond. Recommend the builder activated the units (bleed gas lines) and demonstrate operation during final walk-through.

view of lower HVAC unit: gas and heater system off.

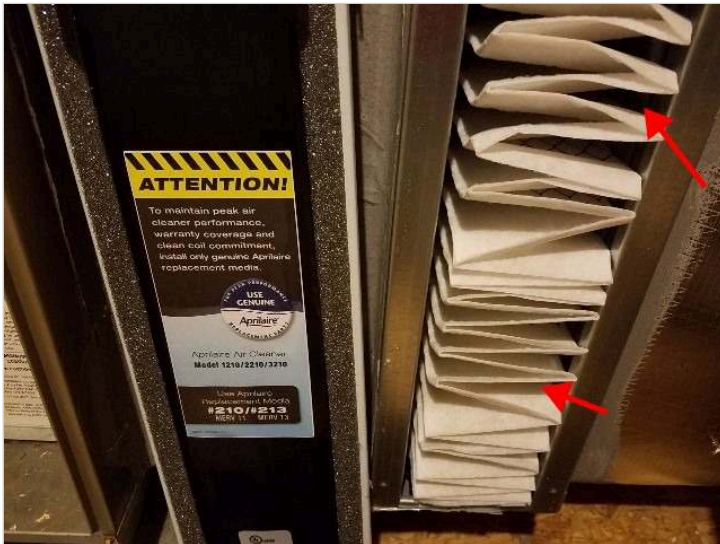
The media filter for the upper HVAC unit was installed backwards (not directed with the airflow in the system).

media filter installed backwards -- metal screen not facing suction side (upper HVAC unit).

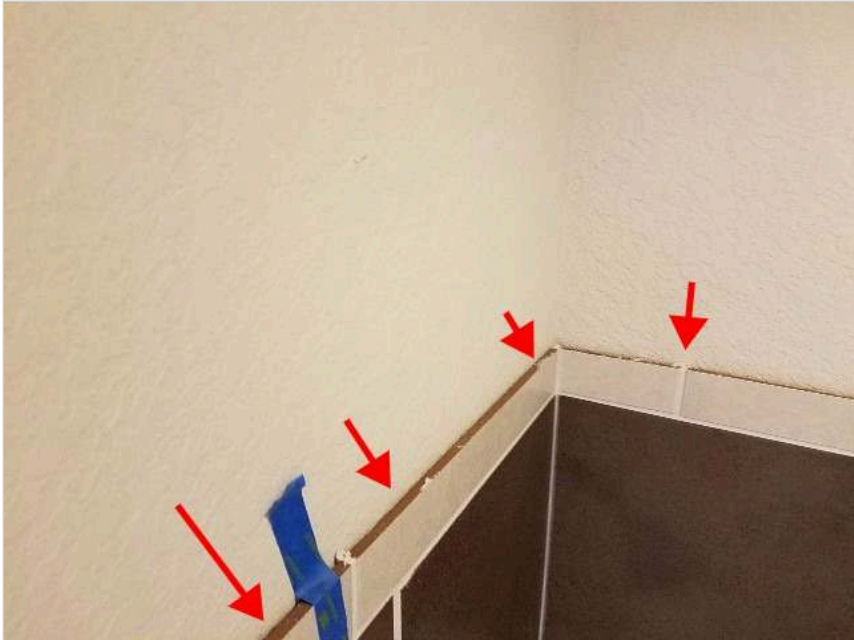
The top of the ALL bath shower enclosures were gapped at the intersection with the wall. Recommend proper caulking/sealing to help prevent damage and water penetration.

example of unsealed/caulked gaps at top of shower enclosures.

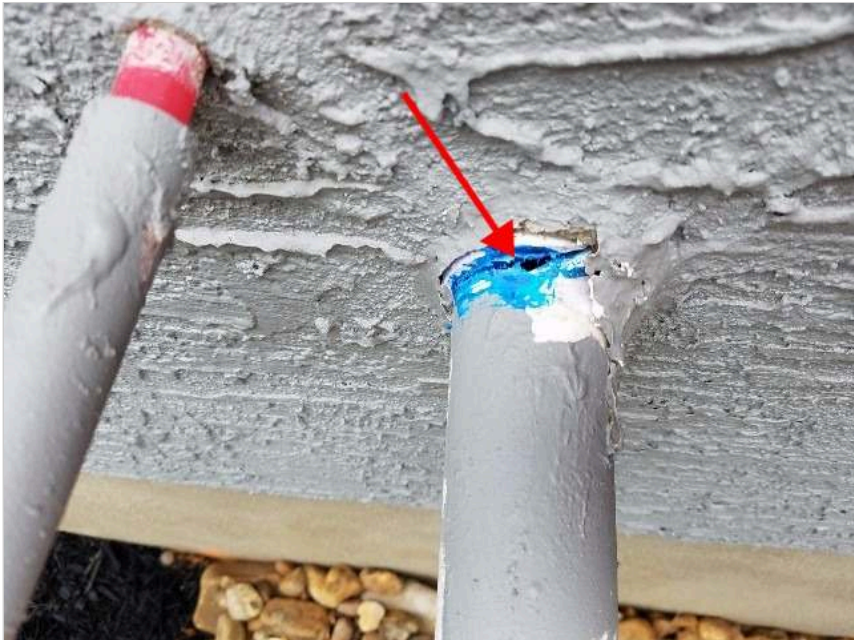
The drain line installed for an exterior back sink was broken at the wall and ineffectively glued back into place. Recommend properly repairing drain line.

Back exterior drain line broken.

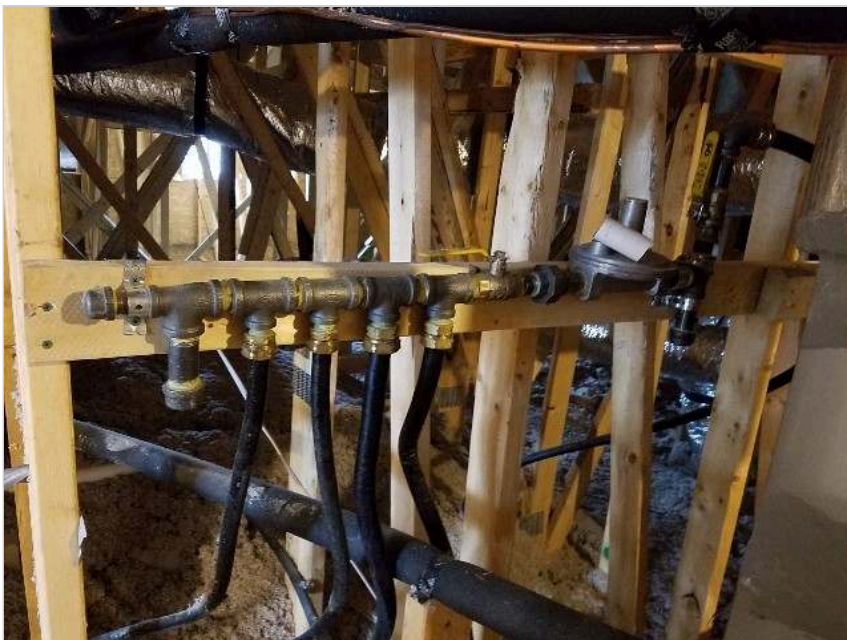
Corrugated Stainless Steel Tubing (CSST) was used in the gas supply system and we were unable to verify proper adherence to the manufacturer's bonding instructions. Bonding to the gas supply system was observed at the gas supply line next to the gas meter.

CSST manifold in attic space.

(New Homes with CSST) It is recommended that you consult with your builder and have them certify proper CSST bonding according to the specific manufacturers instructions.

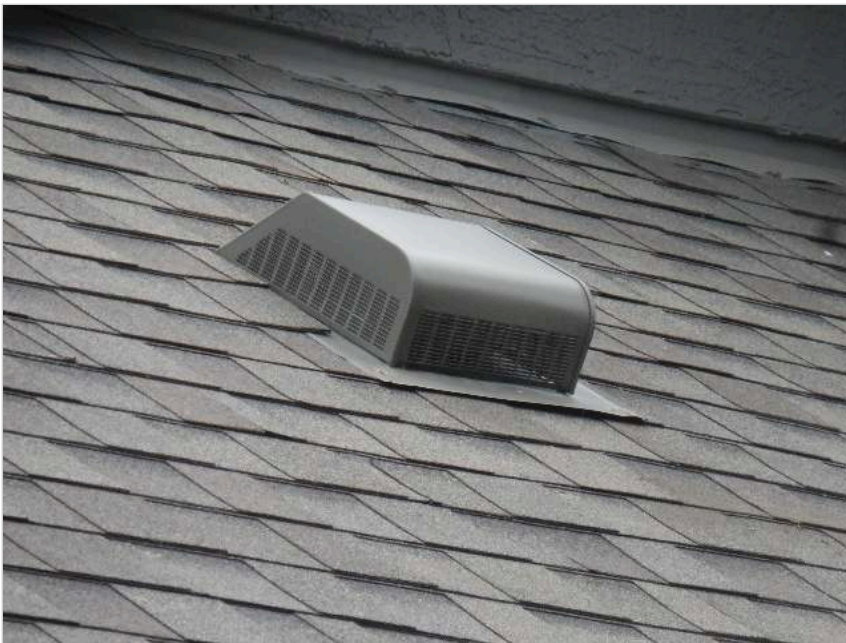
The dryer vent has a screened or grated termination cover which collects lint and is a potential fire hazard. Recommend removing and replacing with an appropriate dryer cover with back-draft damper

Screened dryer vent cover.
