# HomeTeam<sup>®</sup>

### HOME INSPECTION REPORT

On Saturday, August 4, 2018 The HomeTeam Inspection Service made a visual inspection of 123 Sample Dr, Anytown, AZ 55555. Enclosed please find a written, narrative report of our findings in accordance with the terms of our Inspection Agreement.

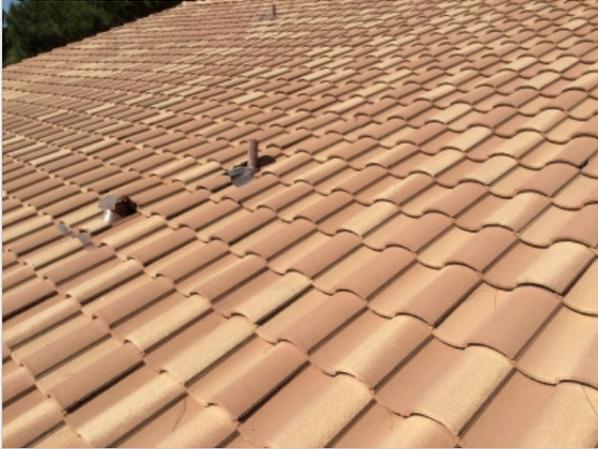
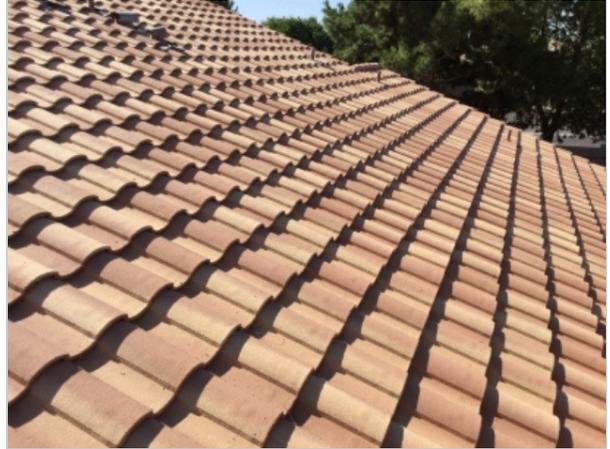
> **Concrete mortar packs missing or cracked were observed.** Suggest repair or replacement by a qualified roofing contractor.

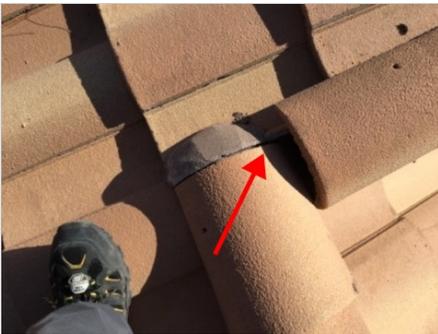
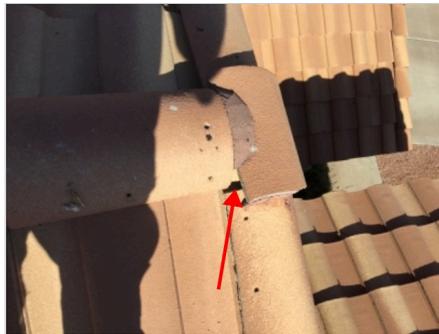
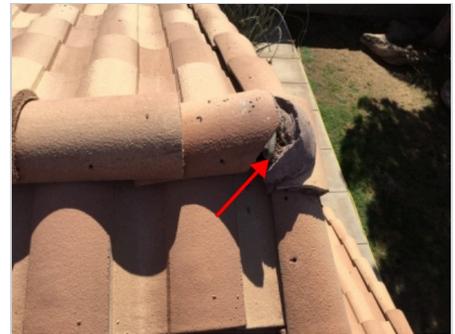
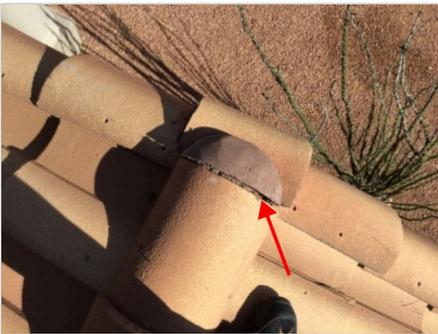
> **5 to 10 cracked, slipped, or missing concrete tiles were observed.** Suggest repair or replacement by a qualified roofing contractor.

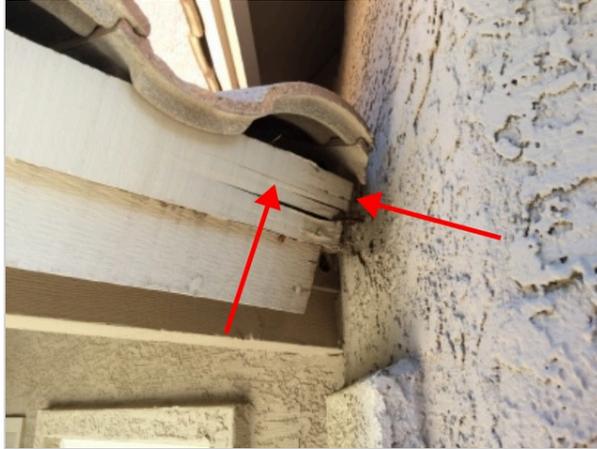
**Rear Patio Area**

**> Fascia board showing signs of previous moisture intrusion through either splitting, staining, warping or surface degradation.** Suggest evaluation by a qualified party to determine where moisture is/was being introduced. Once the moisture intrusion has been eliminated, the fascia boards should be repaired or replaced as necessary.

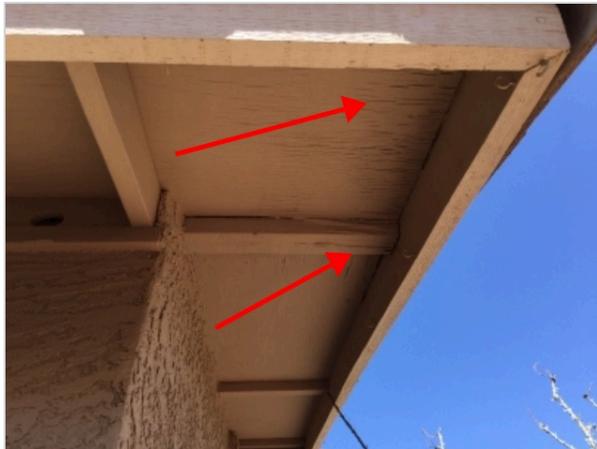
**Front Left Corner**

> **One under-eave areas found with evidence of prior moisture intrusion.** Suggest repair by a qualified roofing professional to fix moisture intrusion and assess damage to sheathing.

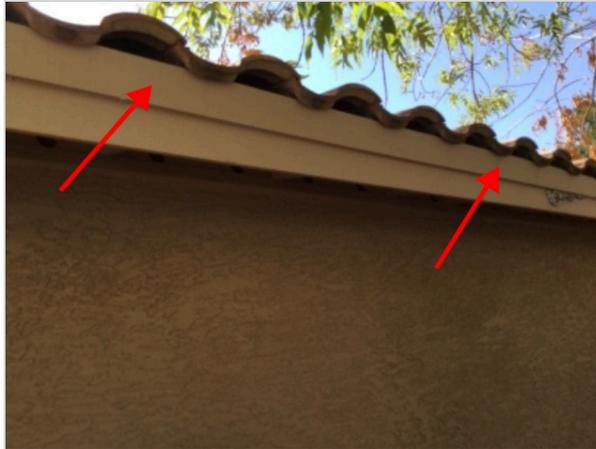
Right Side

> **Flashing is not installed at the fascia board, which may lead to water intrusion and damage.** Consult with a qualified roofer for installation or repair.

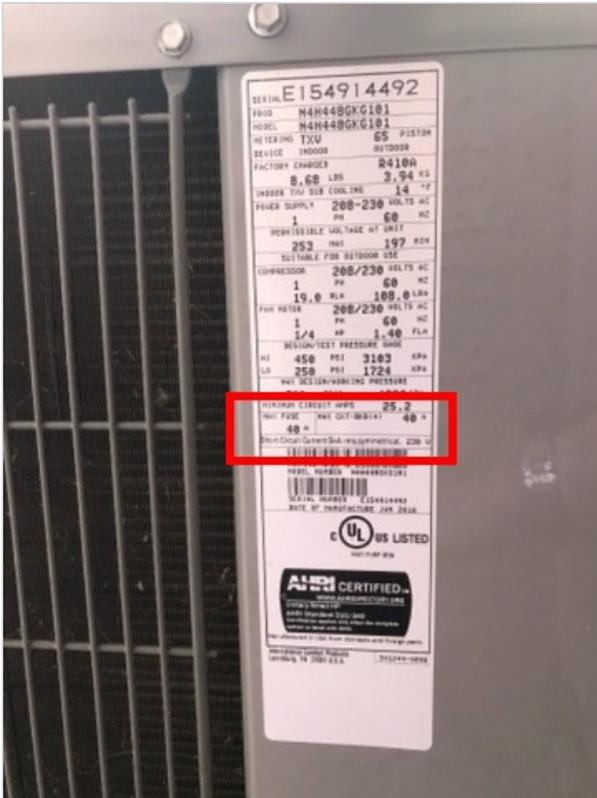
> HVAC unit does not have the correct fusing or breakers based on the information on the HVAC label. Suggest repair by a qualified HVAC technician or qualified electrician.

Outdoor Unit- Max Fuse 40 Amp

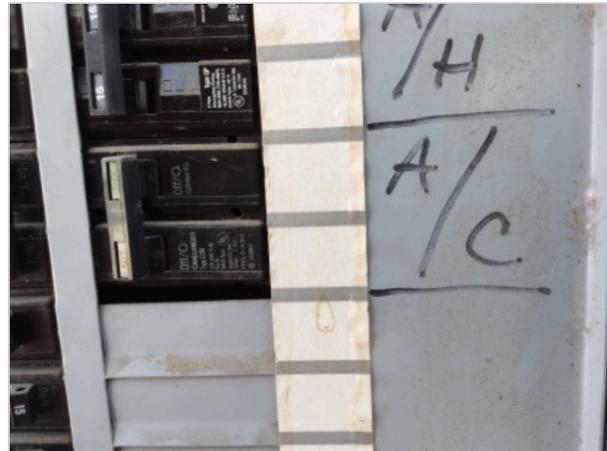
Circuit Breaker- 50 Amp

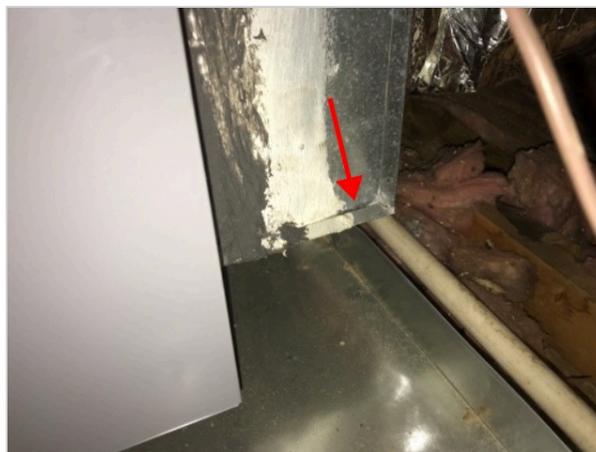
Right Side of Air Handler

> **At least one location on and around air handler where conditioned air is escaping into attic.** Suggest review and repair by a qualified HVAC technician to maximize cooling efficiency of system.

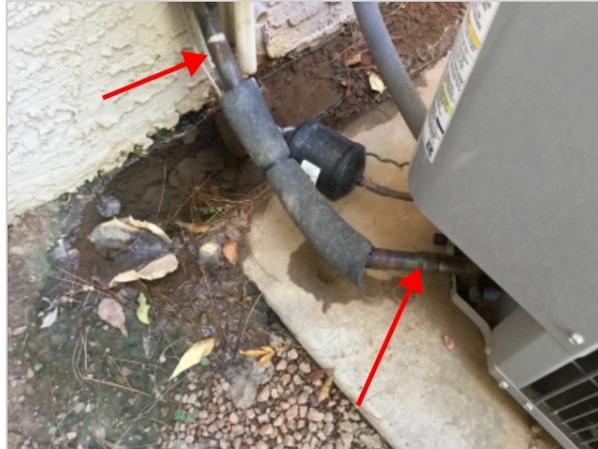
> **The insulation on the air conditioning line set is missing.** This could affect the efficiency of the system and should be replaced.

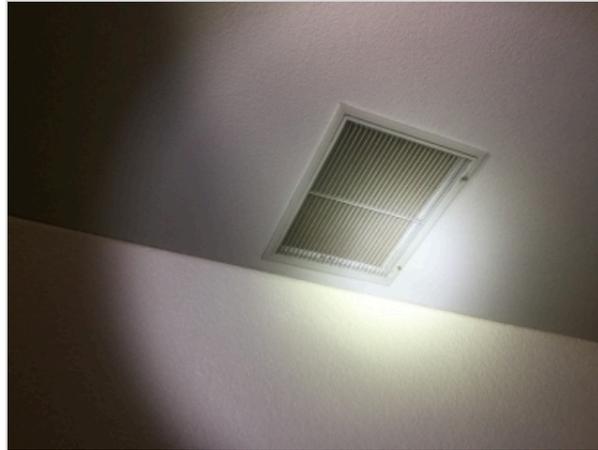
> **The air filter is very dirty and should be replaced.** Clogged and dirty filters affect the performance and efficiency of the HVAC system. A clogged filter can also cause damage to the system. The filter should be replaced immediately upon taking ownership of the structure.

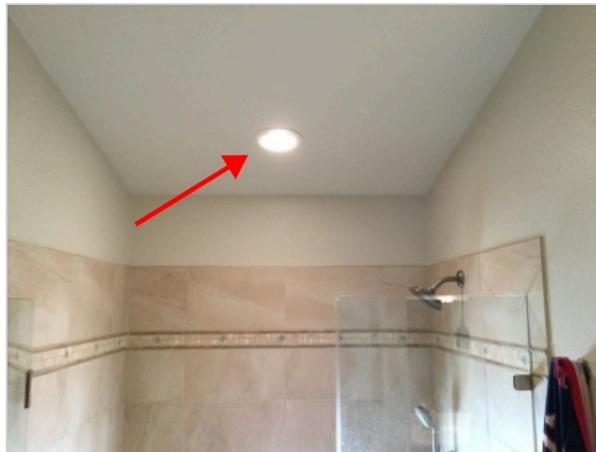
> **The shower light installed in the master bath is not suitable for use in wet locations and may present a safety hazard. The fixture should be replaced or repaired.**

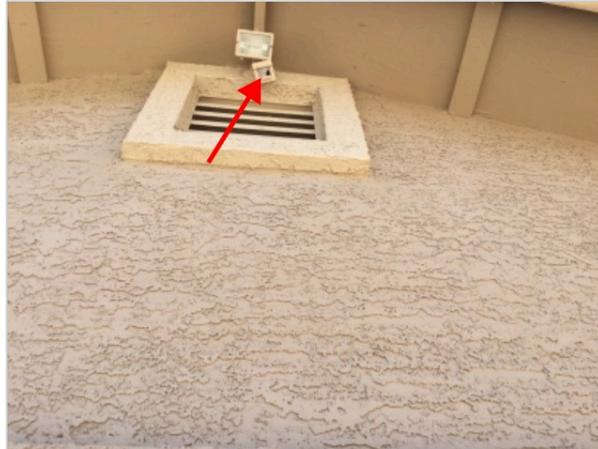
Above Garage Door

> **At least one light fixture appeared to be broken. Suggest repair or replacement by a qualified party.**

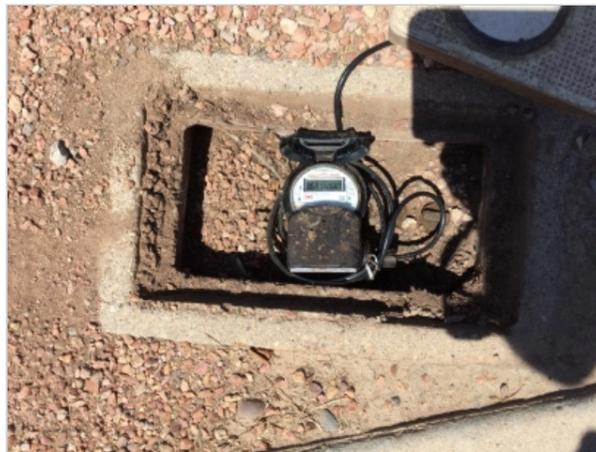
> **Water meter enclosure partially filled with rocks and dirt.** Suggest that this enclosure be cleaned out to allow access to water meter as well as meter shutoff actuation.

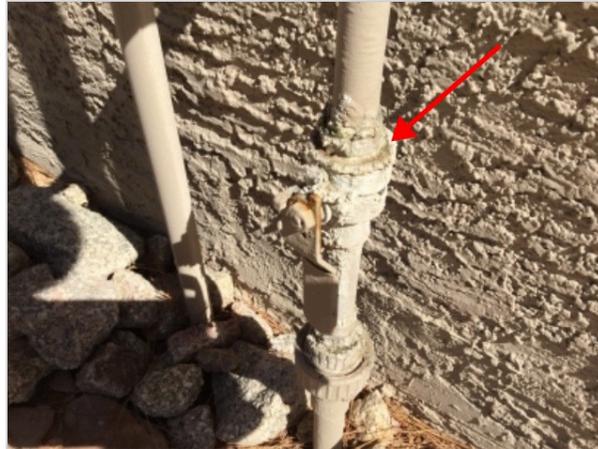
Rear Right Side

**> Active water leaks were present at supply lines the time of the inspection. The affected areas should be repaired, and nearby or associated plumbing lines should be further assessed at the time of the repair.**

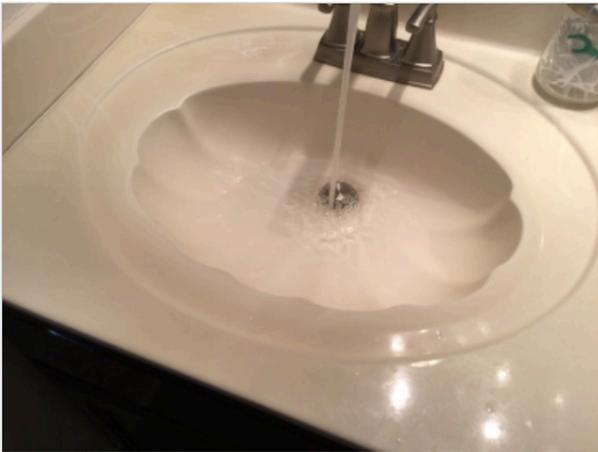
Master Bath- Left Sink

> **The sinks in both bathrooms drain very slowly,** indicating a possible obstruction in the drain line or vent.

HomeTeam recommends having the affected line cleared and other lines further assessed at the time of clearing.

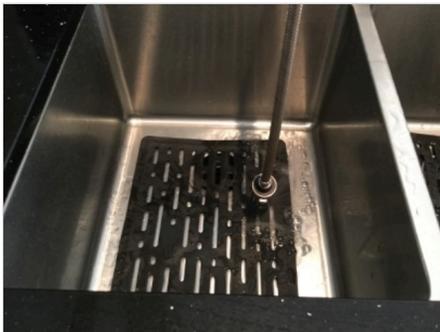
Kitchen Sink

> **Cross connections observed and noted.** Cross connections are a possibility wherever supply plumbing and solid or liquid waste could come together and contaminate potable water with waste to create a serious health issue. Home inspection standards require the inspector to look for and call out any cross connections observed.

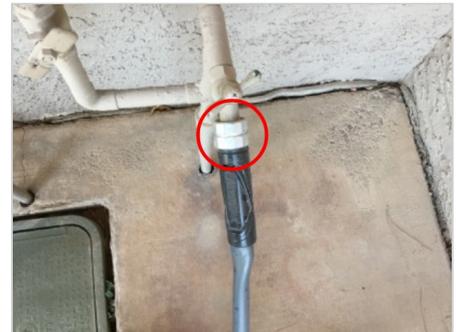
No Vacuum Breaker

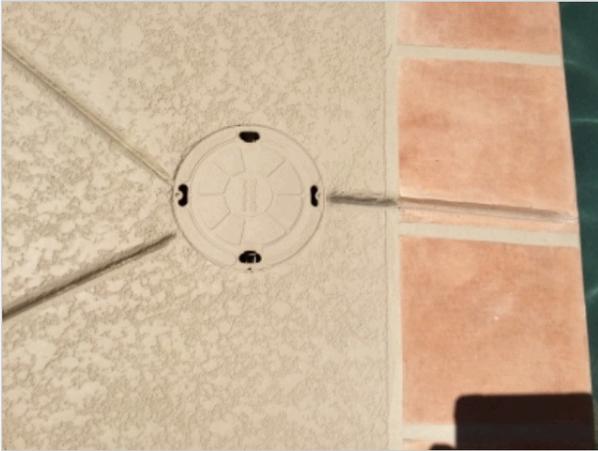
**> The self-fill system appeared to be damaged and/or inoperable at the time of the inspection. This could preclude proper water levels and functioning of the pool circulatory and filter systems. Recommend they be evaluated by a pool specialist for repair or replacement as necessary.**

Cover Painted in Place

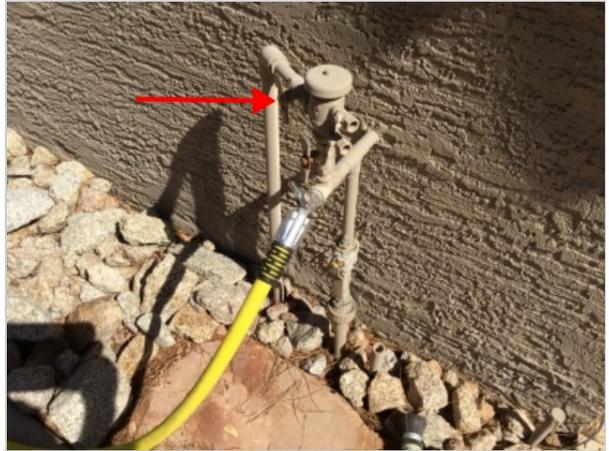
Valve Off

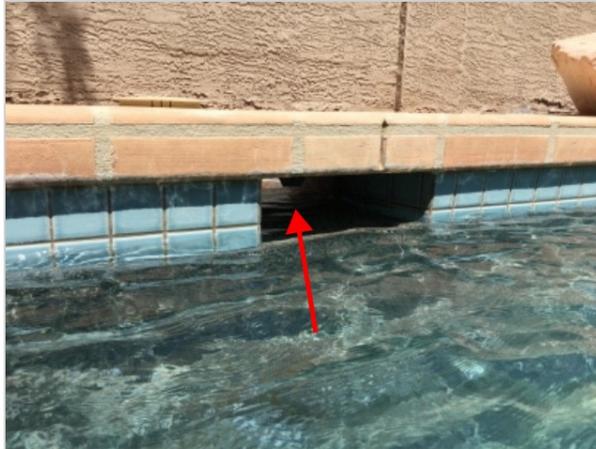
> **Weir valve on skimmer is missing or damaged.** The weir valve functions to keep debris pulled into skimmer from floating back into pool/ spa. Suggest repair or replacement by an authorized party.

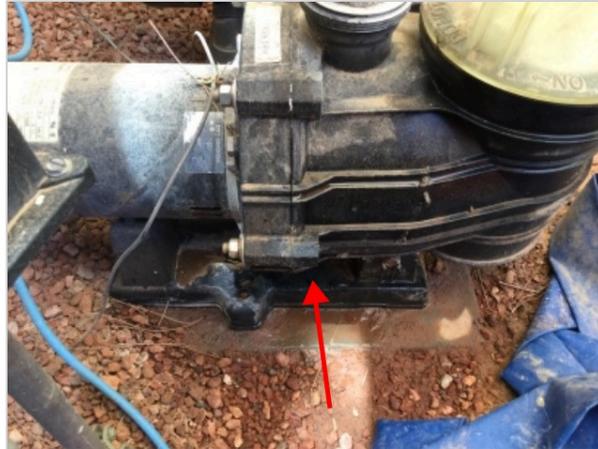
> **Leaks were observed in the pool circulatory system.** In addition to water loss and issues this could introduce air into the system and cause damage to the pump and filter. Recommend that the cause of the leak be determined and corrected by a qualified party to ensure proper function of the circulation and help prevent damage to components.

Water Feature Pump Leaking

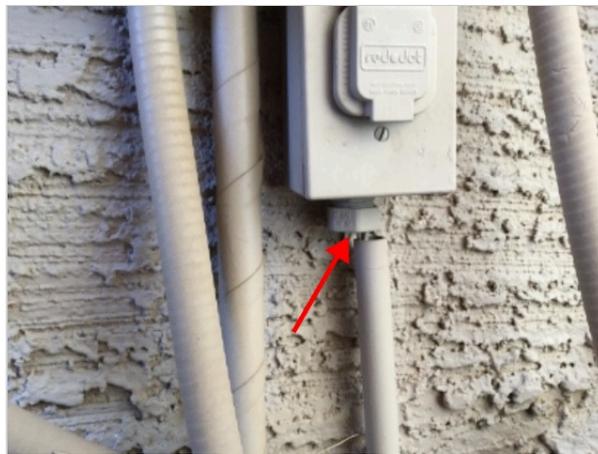
**Pool Light Power**

> **Conduit has separated in at least one area.** Suggest repair by a qualified electrician to insure that wiring is properly protected.

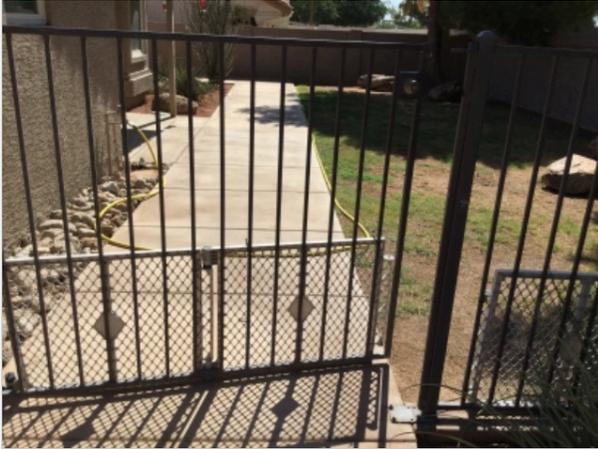
Spring Requires Adjustment

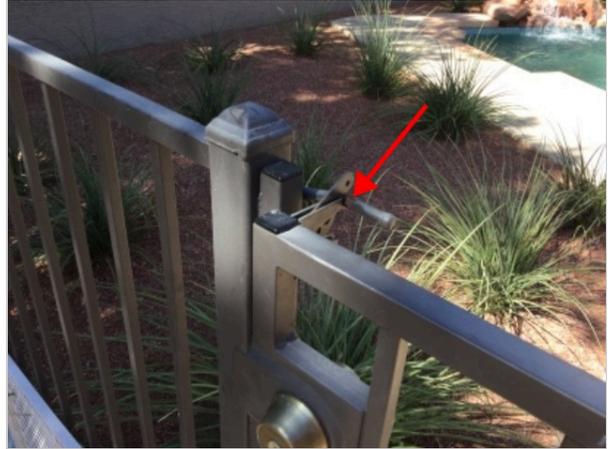
Gate Requires Adjustment
