HOME INSPECTION REPORT

On November 19, 2016 The HomeTeam Inspection Service made a visual inspection of 123 Sample Road, Charlton, MA 01507. Enclosed please find a written, narrative report of our findings in accordance with the terms of our Inspection Agreement.

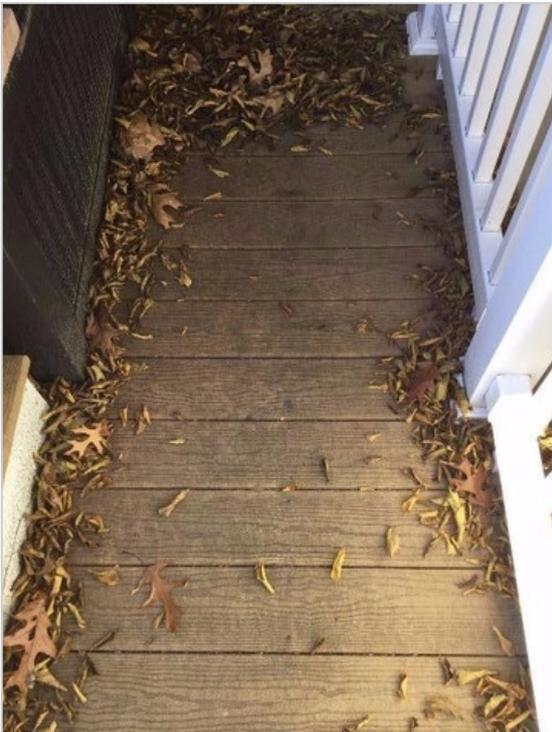
Photo 8

Gutters were in need of cleaning at the time of the inspection. Clogged gutters can cause roof drainage water to drain at the base of the foundation, causing basement water problems. Overflow from gutters can cause damage to fascia that is not visible or apparent at the time of the inspection. The gutters should be cleaned.

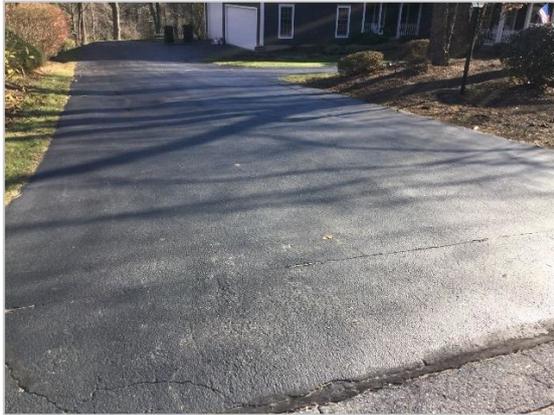
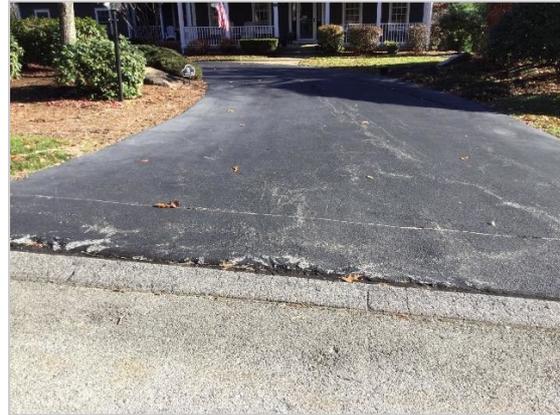
Several areas of the driveway have settled. This condition indicates a possible void under the driveway. Driveway settling has led to potential tripping hazards. The areas should be monitored and repaired as needed.

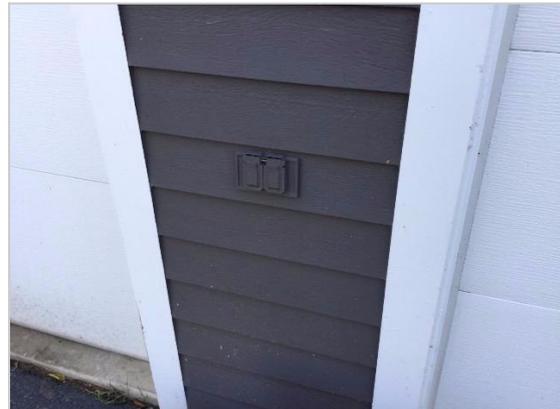
The automatic garage door opener was not functional at the time of the inspection. Consult with a

garage door service for evaluation and repair. Needs button replaced.

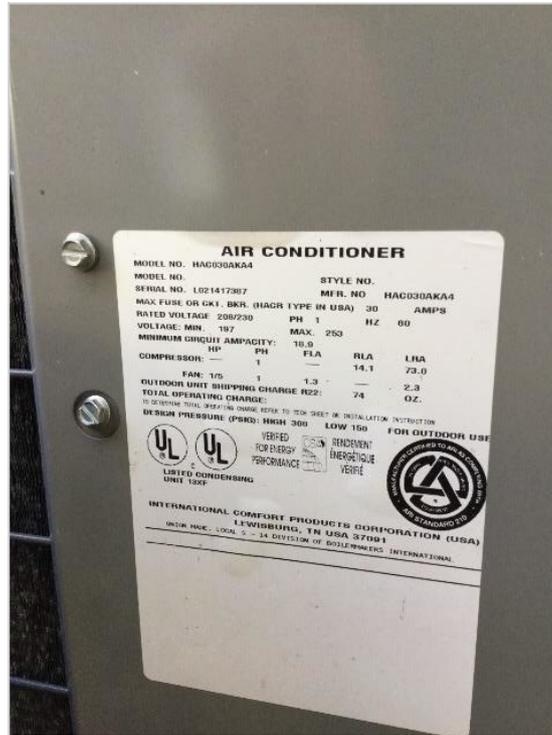
Photo 23

The fins on the outdoor compressor unit are bent. Combing or straightening the fins may improve the efficiency of the unit by aiding heat transfer.
