November 14, 2016

**123 Sample Drive
Anchorage, AK 99504
Inspection #: 00000**

HOME INSPECTION REPORT

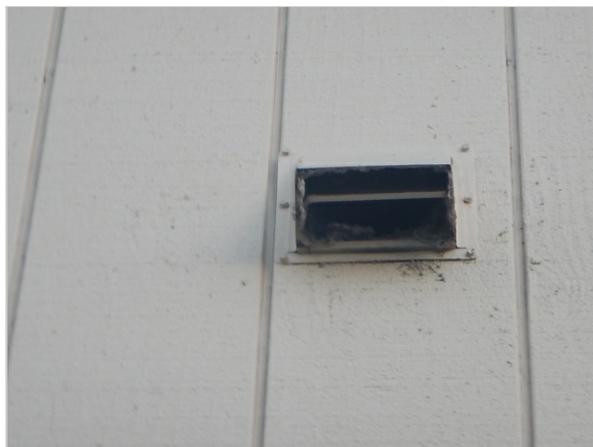
The exterior dryer vent has lint accumulation which does not allow the back draft preventer to close and is considered a fire hazard. Professionally clean the ducting from the dryer to the exterior.

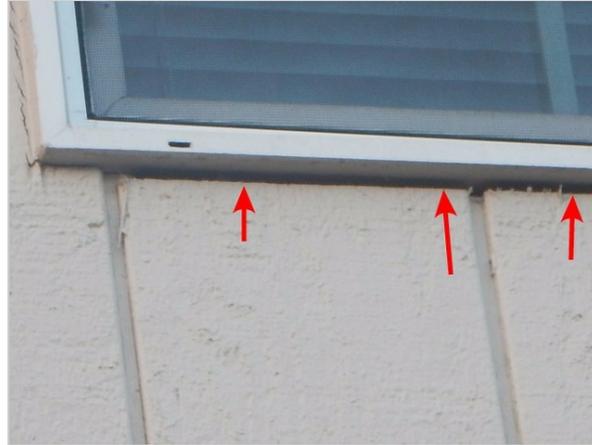
The master bedroom window is not sealed to the siding. Caulk the window to the siding to prevent possible moisture intrusion.

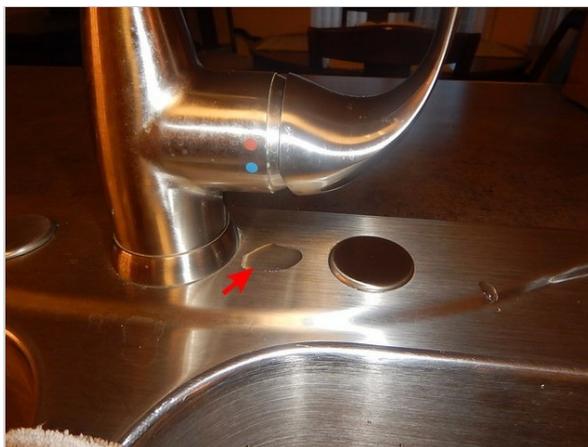
The sink faucet in the kitchen leaks at the stem. Repair or replace the faucet as needed to ensure a leak free operation.
