HOME INSPECTION REPORT

On Wednesday, March 20, 2019 The HomeTeam Inspection Service made a visual inspection of 123 Sample Dr, Anytown, MI 44444. Enclosed please find a written, narrative report of our findings in accordance with the terms of our Inspection Agreement.

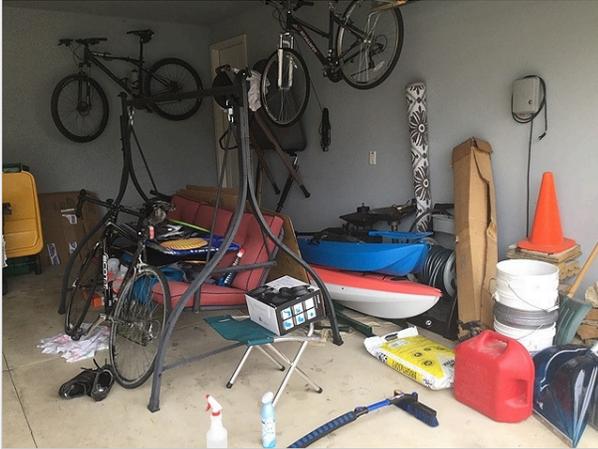
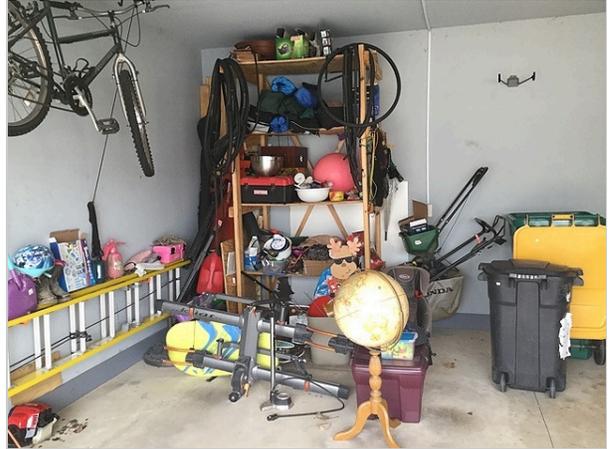
The garage was cluttered with many stored items and/or shelves at the time of inspection. The obstructed areas were not able to be visually inspected.

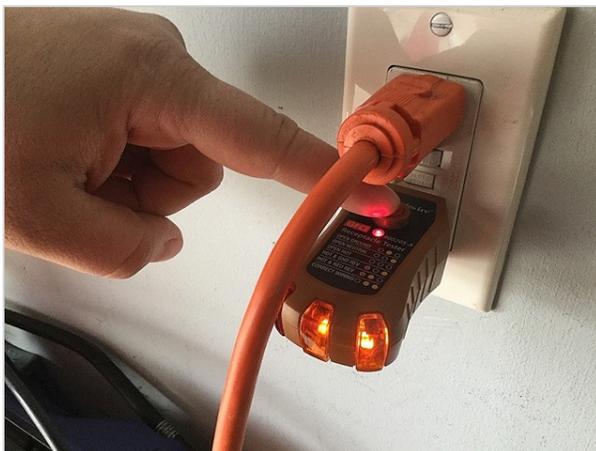
Photo 18

The GFCI in the garage appears to be miswired. Power is still present at the GFCI even after the device trips. This condition is usually caused by reverse wiring the "line" and "load" wires on the back of the GFCI outlet. This is a safety concern and should be corrected and further assessed by a qualified electrician.

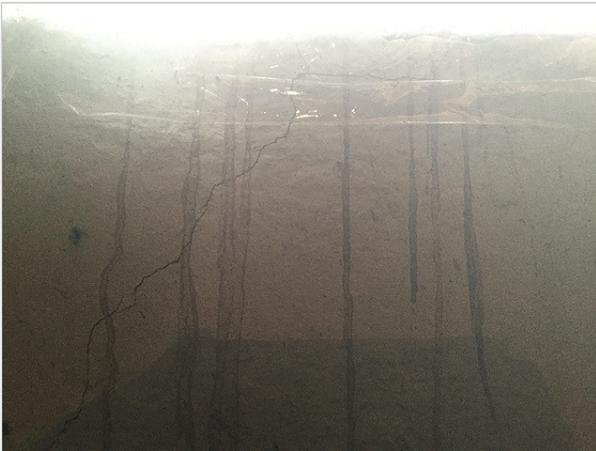
Photo 24

Cracks in the basement show signs of previous water intrusion. Below grade cracks are highly susceptible to water intrusion during times of heavy rain. The cracks should be monitored to determine if they are active. If a waterproof basement is required, HomeTeam recommends having the cracks sealed to prevent water intrusion.

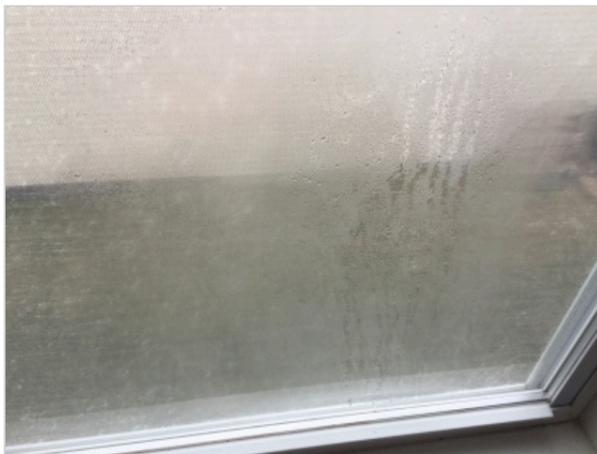
Photo 32

One of the windows in the structure had a broken thermal seal. A window with a defective thermal seal will show a slow but gradual "fogging" effect, and the insulation value of the window is marginally reduced. HomeTeam recommends having the affected window(s) repaired or replaced and further assessed.

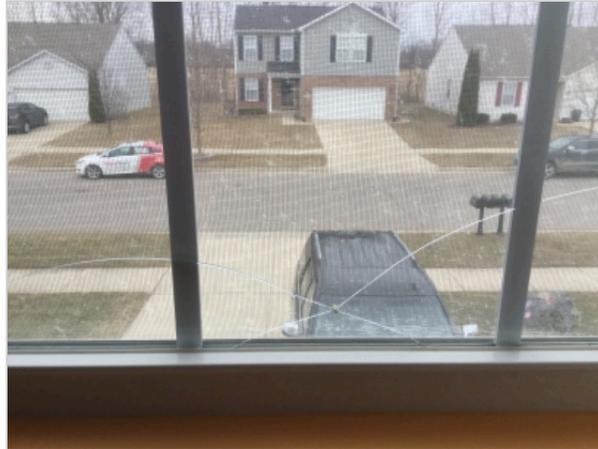
Photo 33

Broken glass was observed on the second floor window. For safety and security all cracked and broken glass should be replaced or repaired.

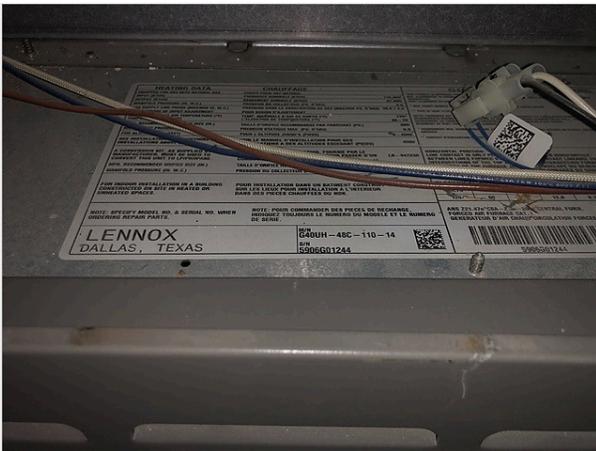
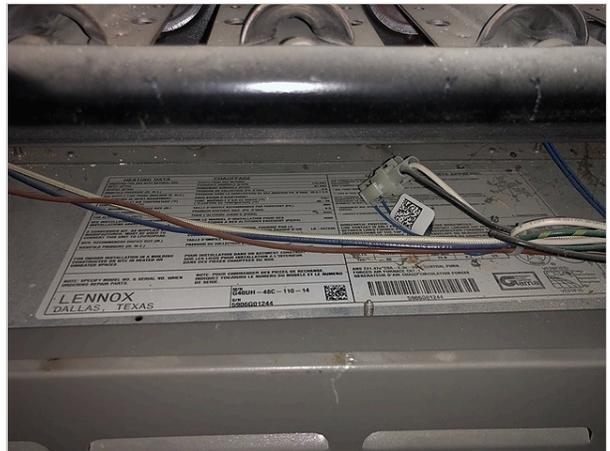
The HVAC condensate line terminated in floor drain raised above the floor drain or drain inlet. The condensate line was not trapped. The HVAC condensate line must be trapped and not in contact with wet drain inlets to prevent the possible migration of bacteria and mold into the air-handling system. The heating system was found to be functional.

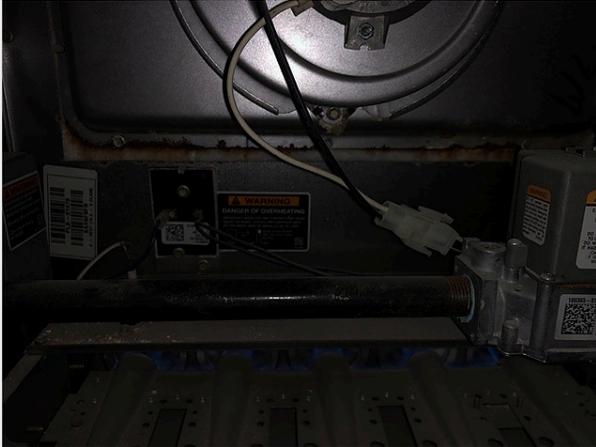
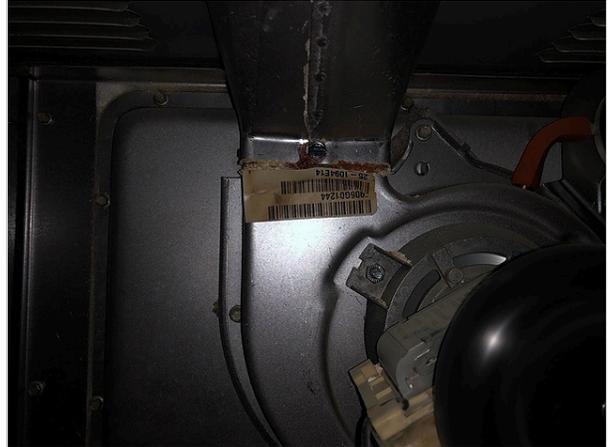
Evidence of water was noted inside the furnace compartment. The condition is most likely caused by a condensate leak in the furnace and/or air conditioning condensate drain lines. The water can also be caused by a leaking humidifier if one is installed. Water inside the furnace compartment can damage the furnace cabinet or other operational components and should be repaired. The furnace compartment was dry at the time of the inspection. Consult with a qualified heating contractor to determine the source of the water and correct the issue.

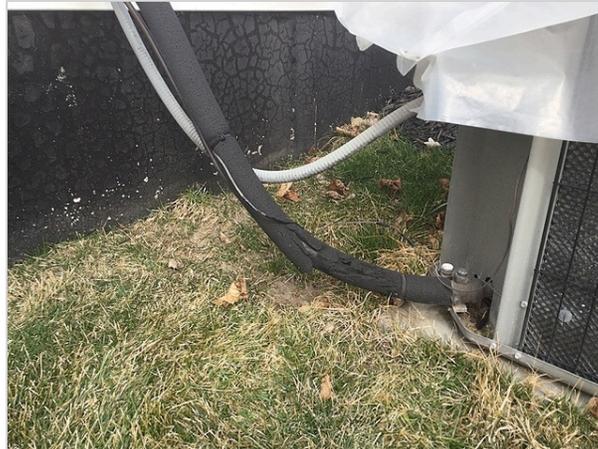
Photo 42

The insulation on the exterior air conditioning line set is damaged. This could affect the efficiency of the system and should be replaced.
