HOME INSPECTION REPORT

File Number: **XXXX**
Address of Inspection: **123 Sample Drive**

123 Sample Drive
Anytown KY, 41102

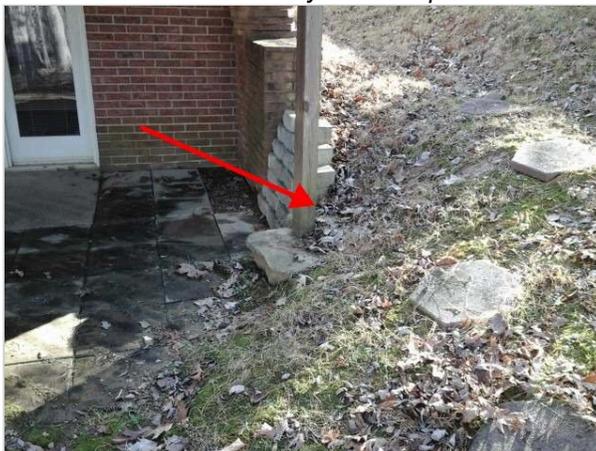
Grounds Notes: Due to the grade at the left rear it appears that water is directed toward the rear left patio. Minor landscaping should be done in this area to direct water away from the patio.

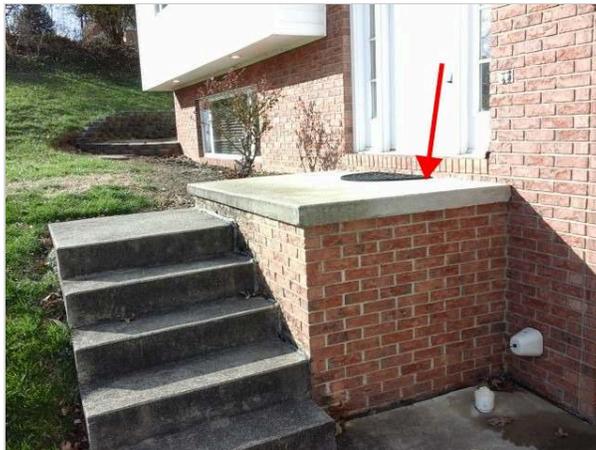
Stoop Notes: There was no handrail present on the stoop. A railing or handrail, compliant with today's standards, should be installed for safety.

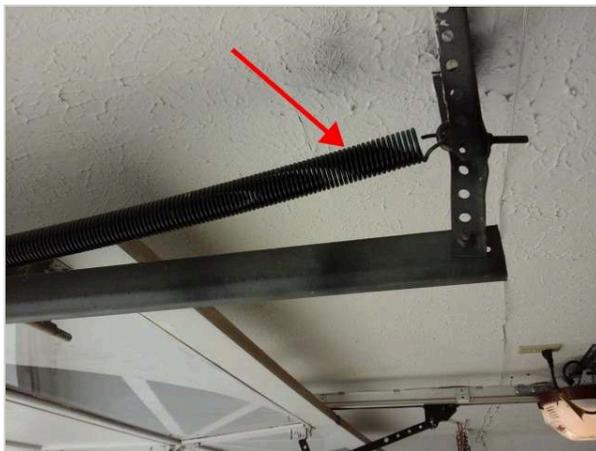
Garage Notes: The mechanical down force on both doors was tested and both are in need of minor adjustment or repair for safety. There were no safety cables present in the garage door springs. You should consider having cables installed for safety.

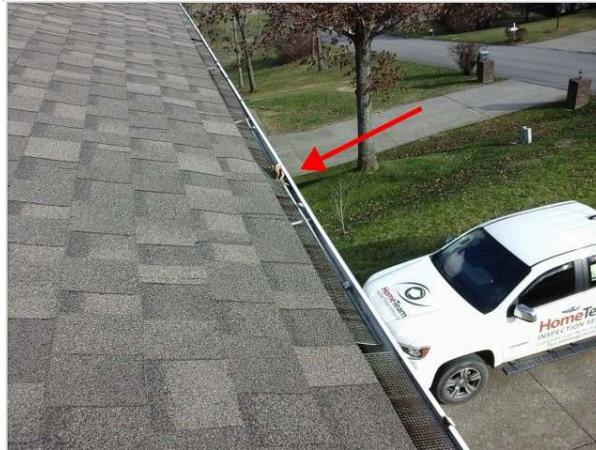
Front right

Gutter Notes: *There are screens present on the gutters that appear to be in serviceable condition. Some of the screens are collapsed and need repair/replacement.*

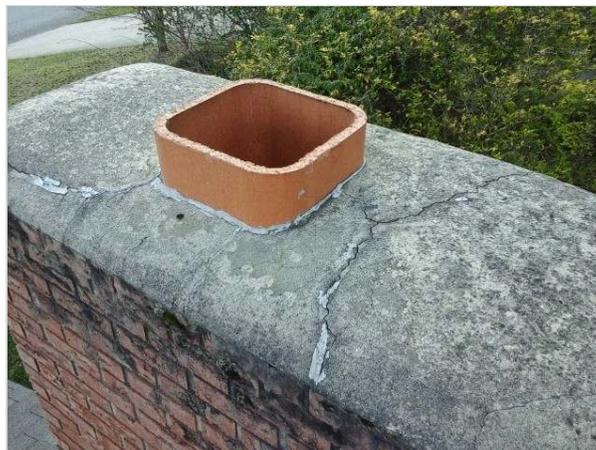
Chimney Notes: *There was no rain hat on the chimney flue. You should consider having a rain hat or spark screen to keep debris and/or animals/birds from entering. There were several cracks in the chimney wash that should be sealed to prevent moisture penetration. Cracks in the wash can lead to water penetration into the chimney interior and/or damage to the brick around the exterior.*

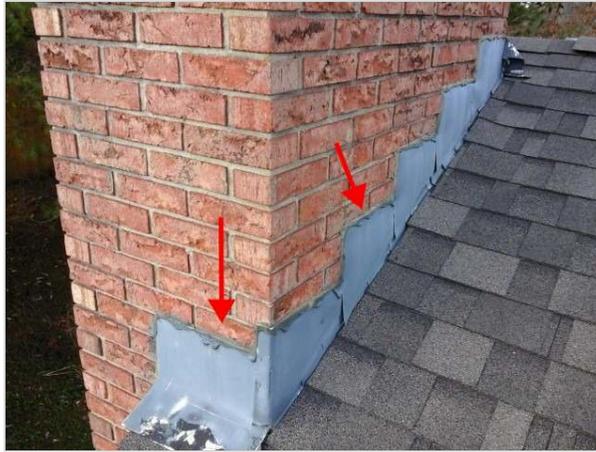
There was typical sealant/patching visible around the chimney/flashing area. Any areas where patching has occurred is an indication of past/active leaks and should be monitored periodically for drying out or cracking of the sealant used.

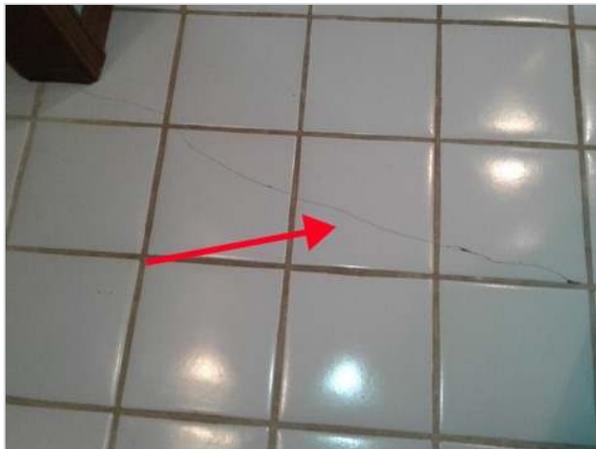
Lower Level Notes: The steps have a non-typical tread/rise at the landing. Care should be taken on them for safety. Cracked tiles were visible in the bathroom.

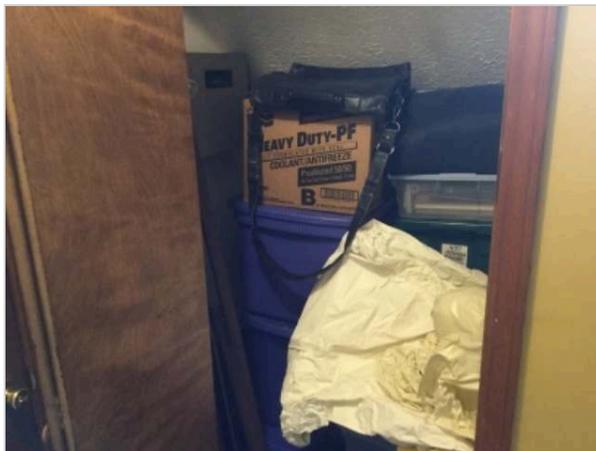
The water meter was located in the front yard. The main water shutoff valve appeared to be located adjacent to the

water service entry point under the stairs however this could not be confirmed due to excess storage in the closet.

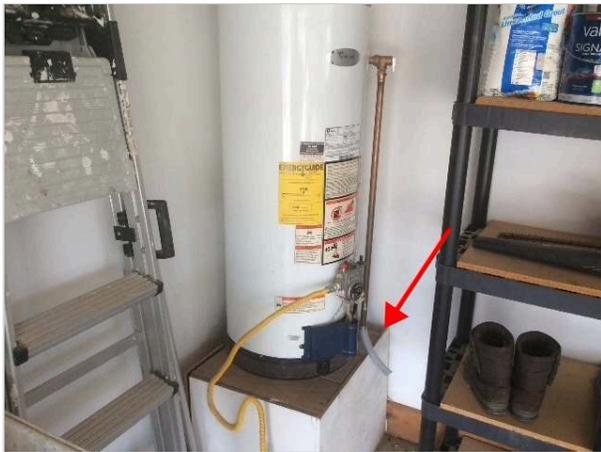
Water Heater Notes: *A properly sized overflow pipe should be installed to within 6-inches of the floor for safety.*

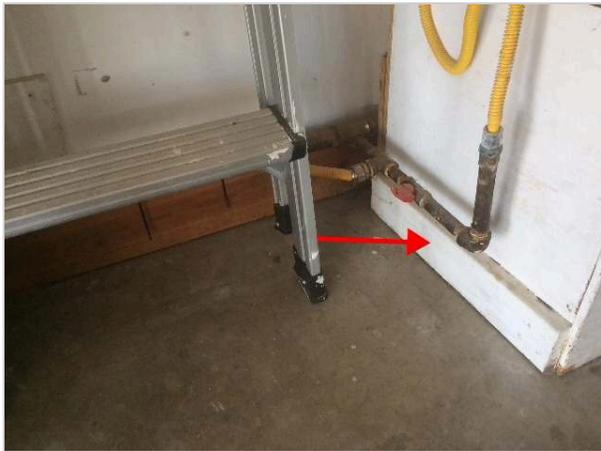
There was no sediment trap present on the gas line. You should consider having one installed to help prevent potential debris from entering the gas valve.

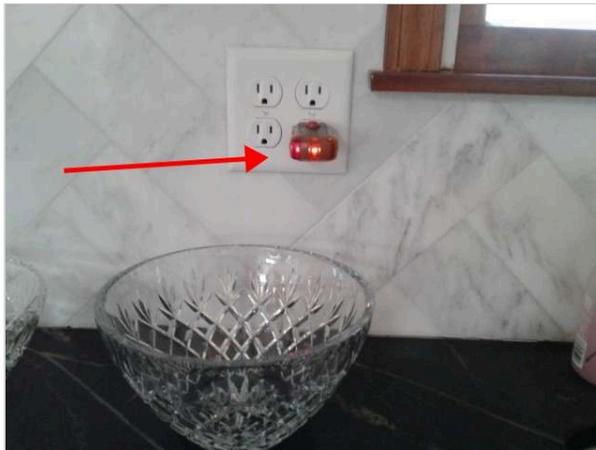
Electrical Notes: You should contact qualified electrical contractors for further evaluation, estimates and/or repairs to the following items prior to closing. The polarity is reversed on a receptacle in the kitchen.

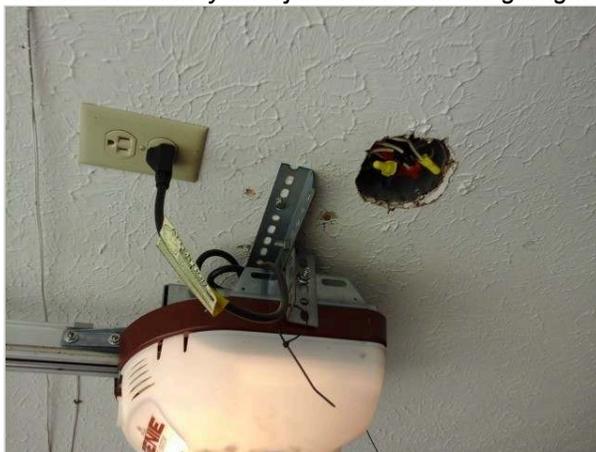
A cover is missing and should be installed for safety on a junction box in the garage.

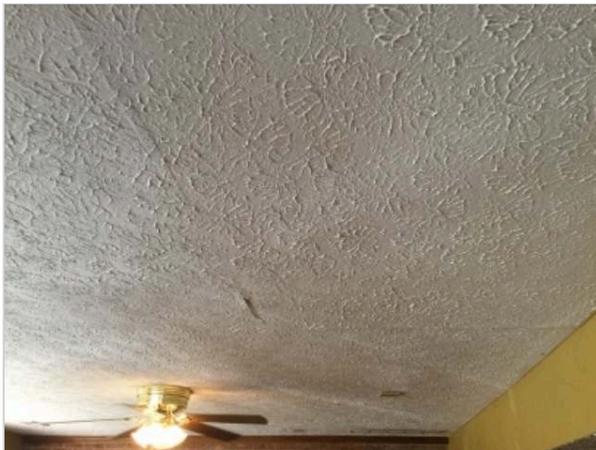
Wall and Ceiling Notes: *Typical settlement cracks were visible on walls and/or ceilings at various places, most notably on the family room ceiling below the area where the wall has been removed. These cracks appear to be normal stress cracks and do not appear to be of structural concern.*

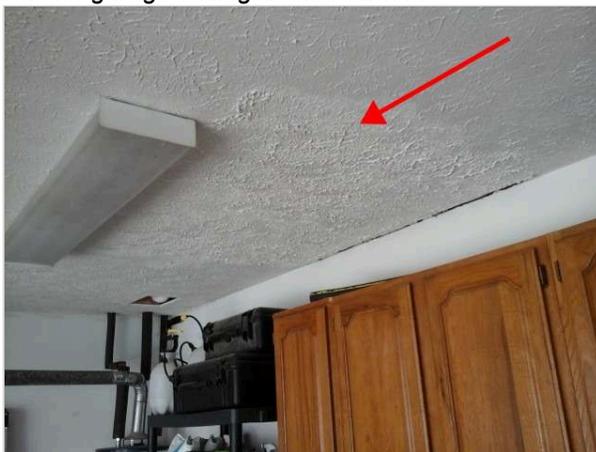
Past patching/repairs were visible at the garage ceiling at the rear left.

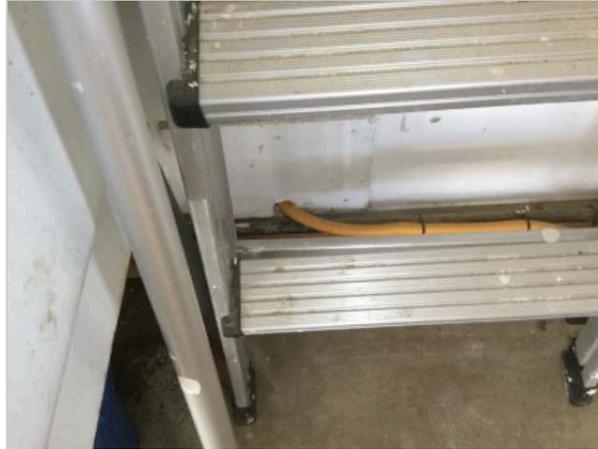
Appliance Notes: *The flexible gas line to the oven/range goes through a wall in the garage before connecting to the appliance. Solid pipe should be run into the room near the appliance with any flexible lines located in the same room and near the appliance they supply.*

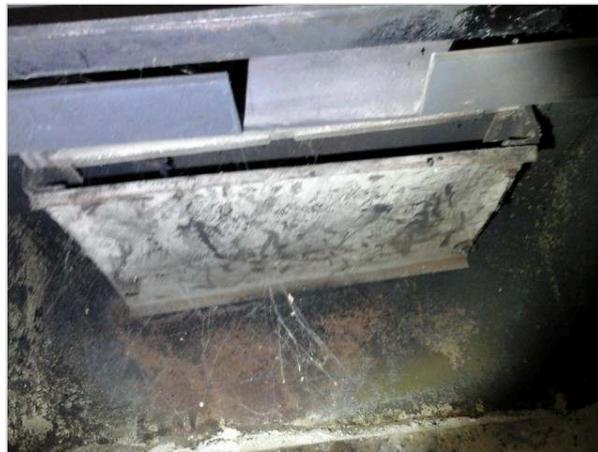
A wood-burning fireplace was located in the basement family room. *There is an insert installed in the firebox therefore we were unable to view any portion of the firebox, damper or chimney flue.* The damper on the insert was operated and was functional. There was visual evidence of creosote buildup in the firebox of the insert. There was no rust noted in the firebox of the insert.

Fireplace Notes: *You should contact a qualified chimney specialist for cleaning and further evaluation prior to using.*

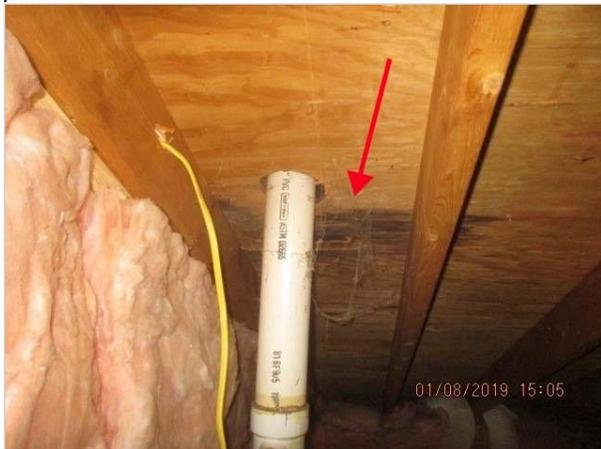
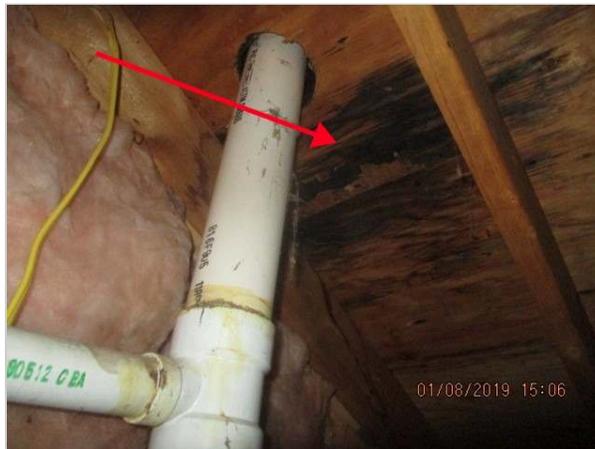
Attic Notes: *There were stains and damage visible around one of the waste vent stacks. These conditions appear to be from leaks prior to the present roof being installed, however this cannot be confirmed within the scope of a home inspection.*

Close up of damage
