HOME INSPECTION REPORT

File Number: **Sample**

Address of Inspection: **1234 Sample Street**

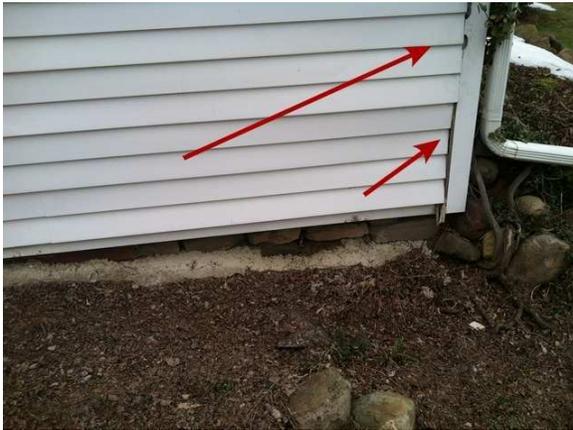
Loose siding panels

Missing/loose siding panels were noted on the exterior of the house. These siding panels should be adequately re-secured.

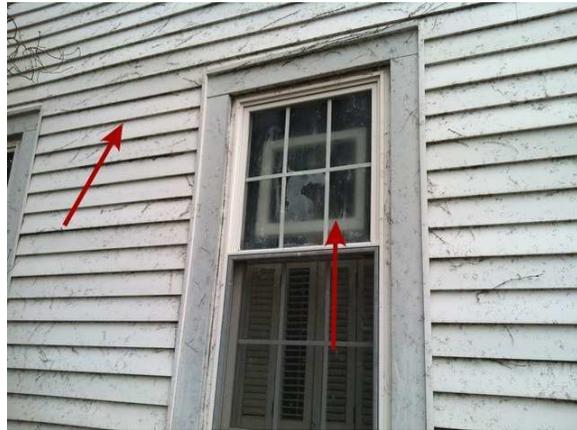
Old vines and window with broken seal

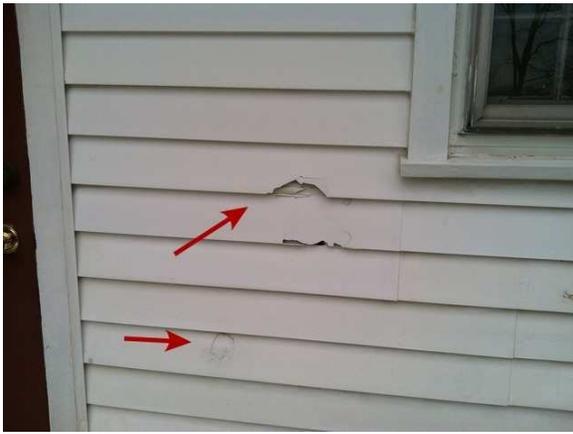
Several damaged siding panels

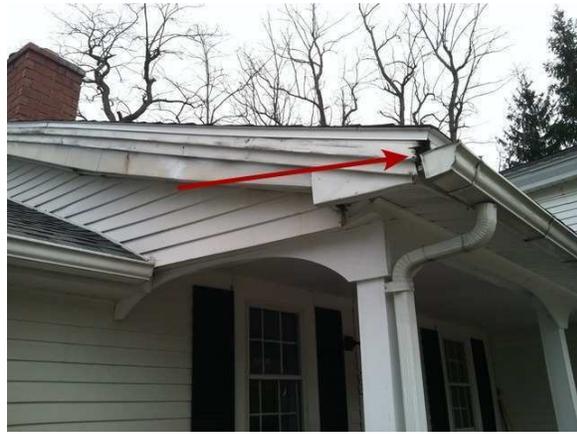
Wood fascia deteriorated, repairs needed

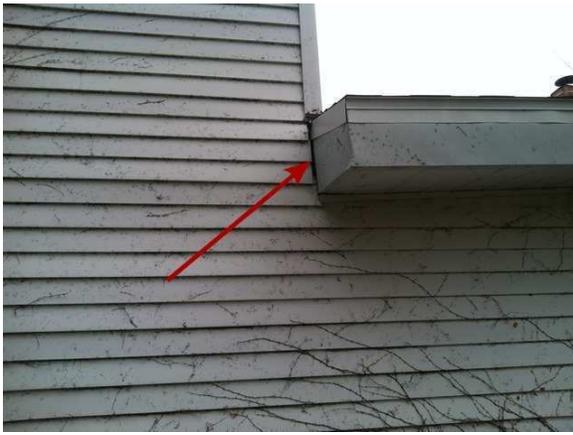
Caulking needed

The exterior caulking around the exterior doors and windows is cracked or missing in one or more areas. This caulking should be replaced to ensure the exterior of the home remains weather and water tight.

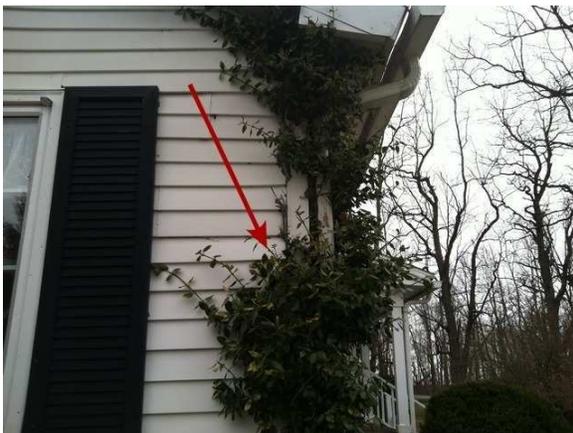
Vines have damaged siding

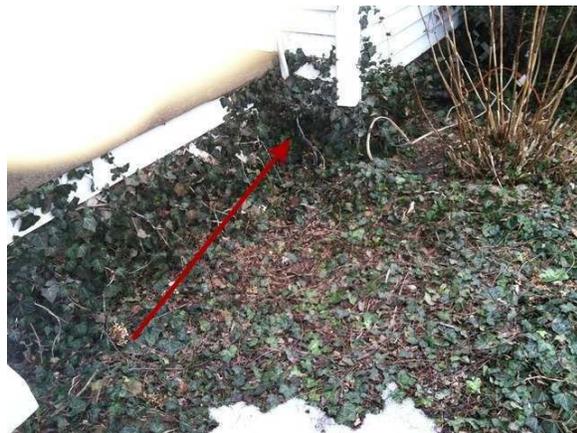
Remove overgrowth

Extensive plant growth was observed against the home, in the back and left side area of the house. Recommend removing this growth away from the siding to prevent possible damage including insect infestation.

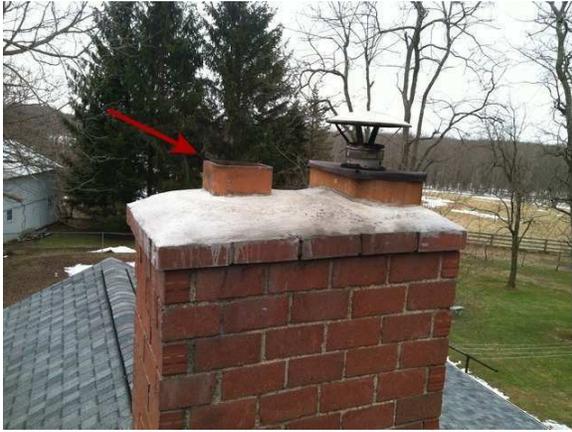
No cap.

There was no rain cap on the chimney. This device will help to prevent rainwater and snow from entering the flue and causing water damage.

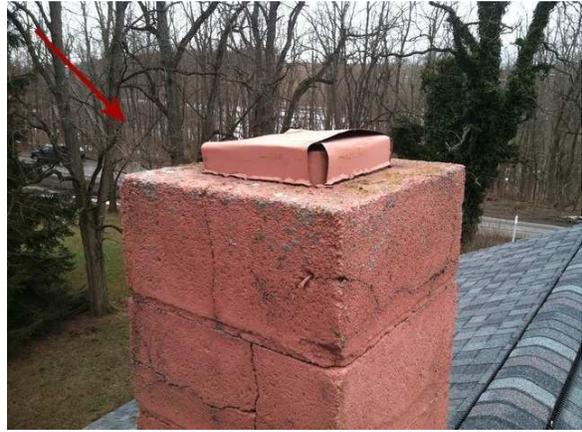
This chimney appears to have been eliminated

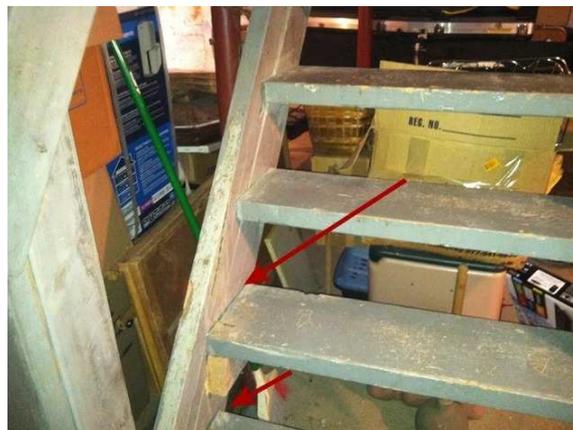
Treads have separated from stringers.

The basement stair stringers are separating from the stair treads. This condition could lead to stair tread failure. Additional fasteners should be added to the stair system.

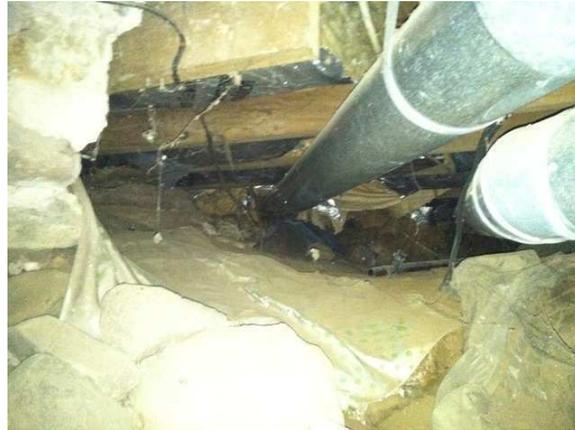
The surface of the ground was not entirely covered with a moisture barrier. A polyvinyl (minimum 6 mil) moisture barrier should completely cover the ground to keep the crawlspace dry. Crawlspace moisture can lead to wood rot and/or mold growth that could damage the floor property and pose health risks.

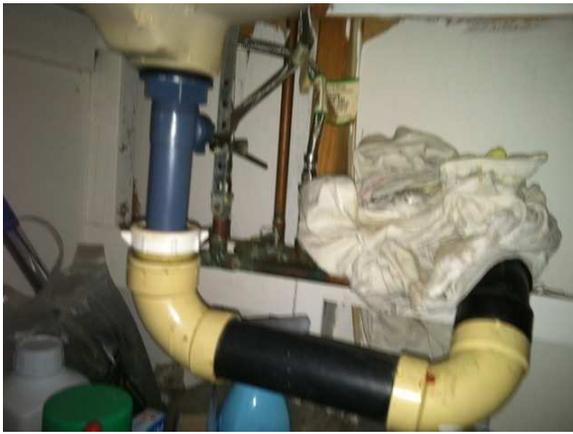
No trap below bathroom sink.

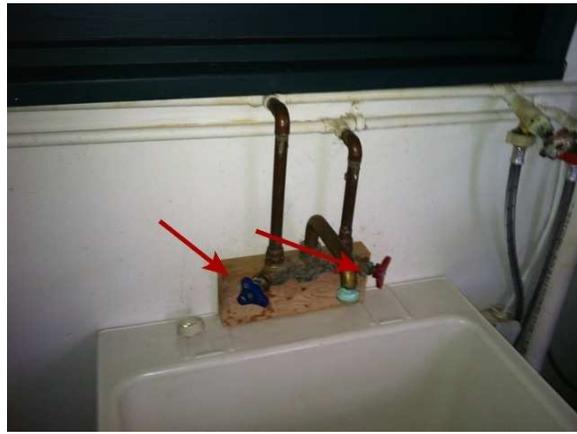
Leaks present at both valves

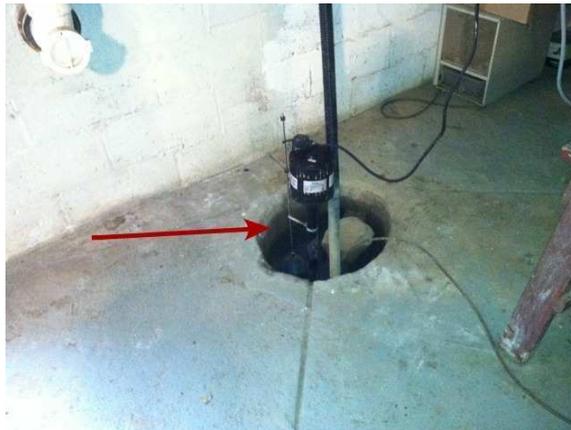
No cover

For safety reasons the sump pit should be covered at all times, the sump pit lacked a proper cover.

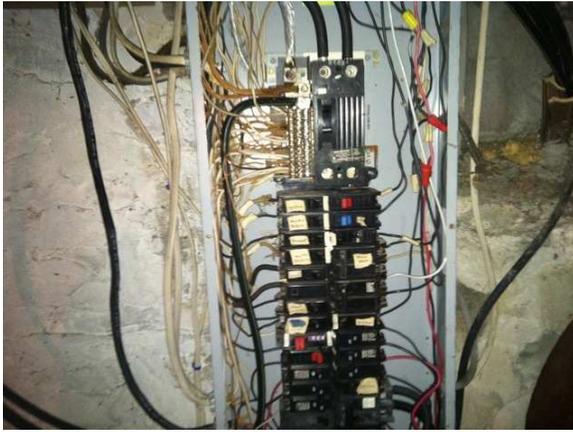
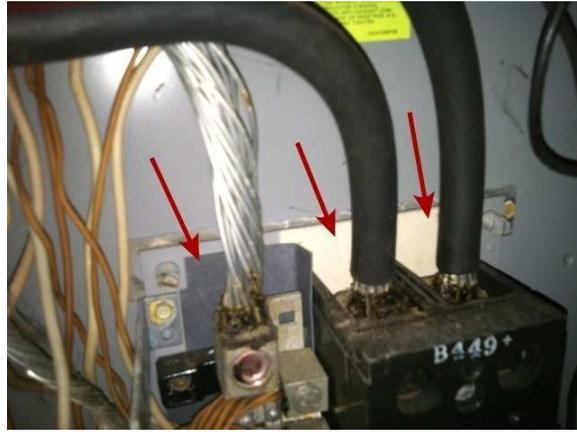
Corrosion on main lugs

Corrosion was observed in the main electric panel. Corrosion on terminal screws can result in overheating of terminals and possible arcing problems in the panel. It is recommended that a licensed electrician evaluate the condition of the service panel.

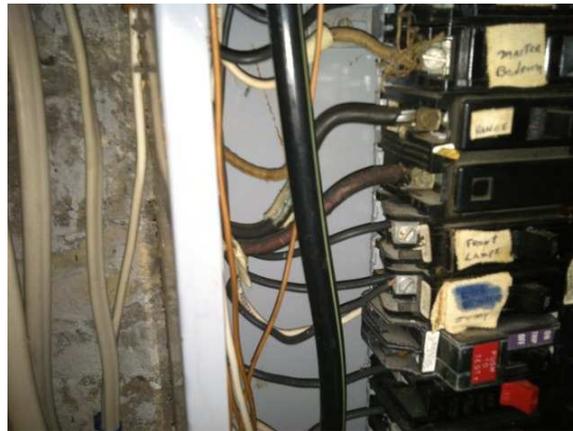
There were circuit breakers in the main electric panel that had two attached circuits. Each circuit should have its own dedicated breaker to prevent nuisance tripping and good terminal contact. One of the wires should be removed and connected to its own appropriately sized breaker by a licensed electrician.

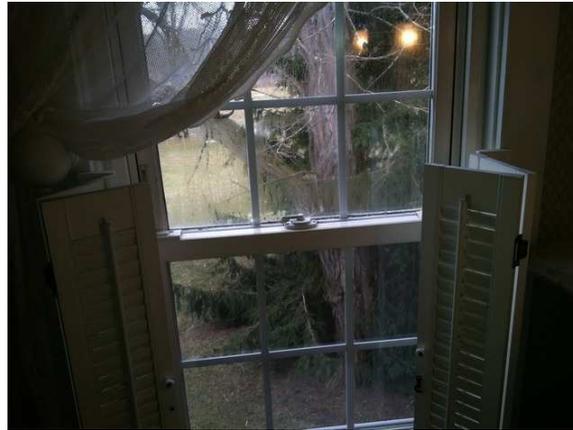
The seals on a representative number of windows (2-3+) in the home had failed causing a loss of vacuum between the panes and a resulting loss of insulation value. The most noticeable result of this failure is condensation and fogging between the panes of glass.
