### *HOME INSPECTION REPORT*

SUMMARY: The purpose of this summary is to provide a "quick view" of the results of the home inspection. Please be sure to read the full body of the inspection report, as it contains much more detail about this home. **Any recommendations for additional evaluation must be performed prior to the conclusion of the inspection contingency period.** A home inspection is not designed to eliminate all risk and cannot and should not be relied upon to discover all defects that are not disclosed by the sellers. The following is a summary of the inspection performed at 123 Sample Drive, Castle Rock, CO 80104:

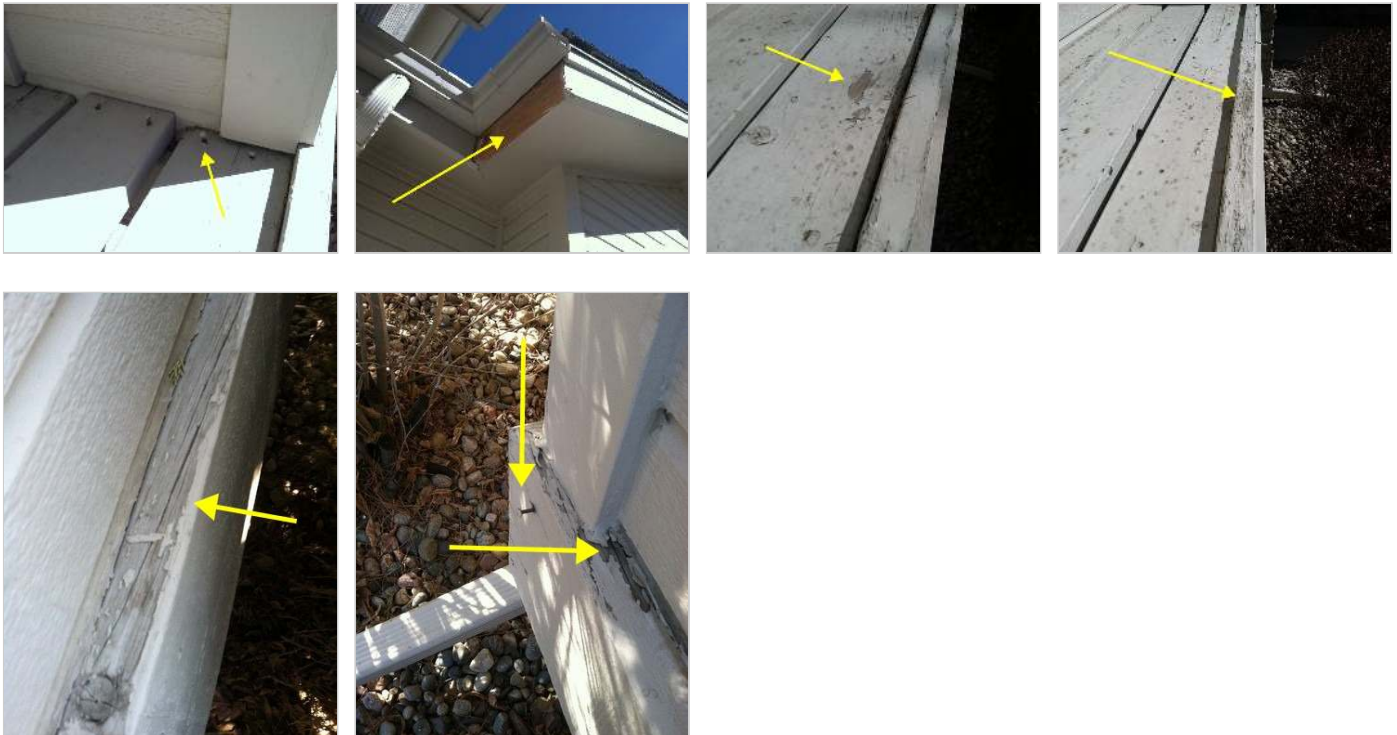
Note: there were a couple areas on the home's exterior where the trim boards were in need some repair and a coat of paint. Recommend contacting the homeowners association for repair.

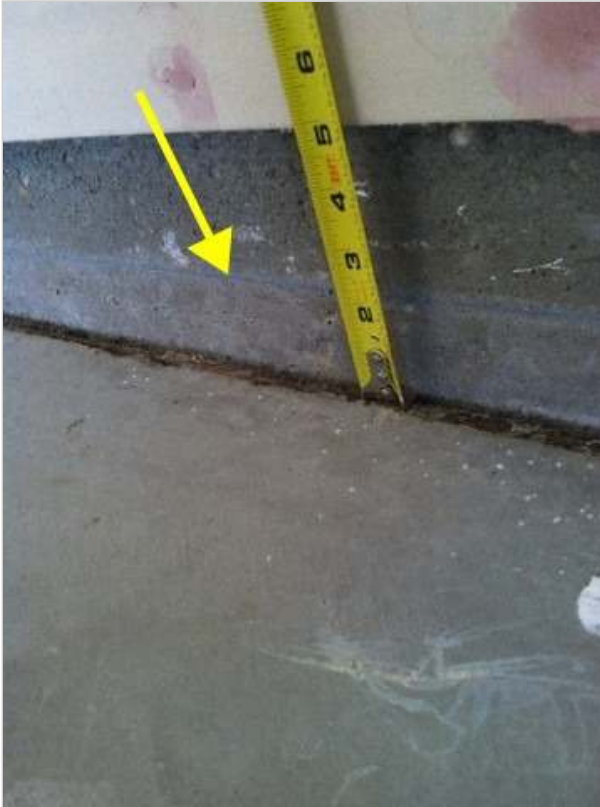
Note: settlement of the garage concrete floor was observed. The garage floor was serviceable at the time of the inspection. If the serviceability is in question, then it is recommended that the garage floor be further evaluated by a

qualified contractor.

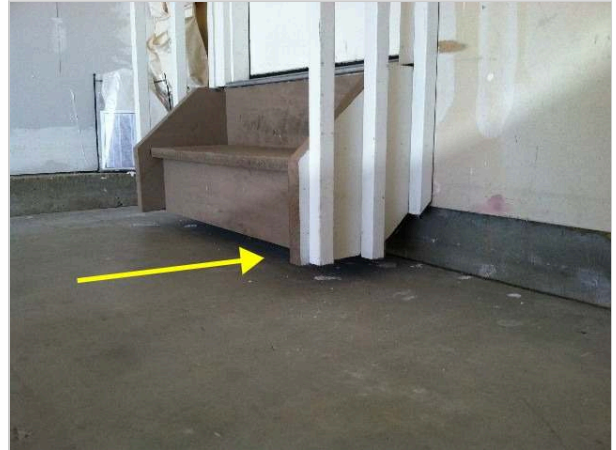
The blue chalk line appeared to be the original height of the garage floor

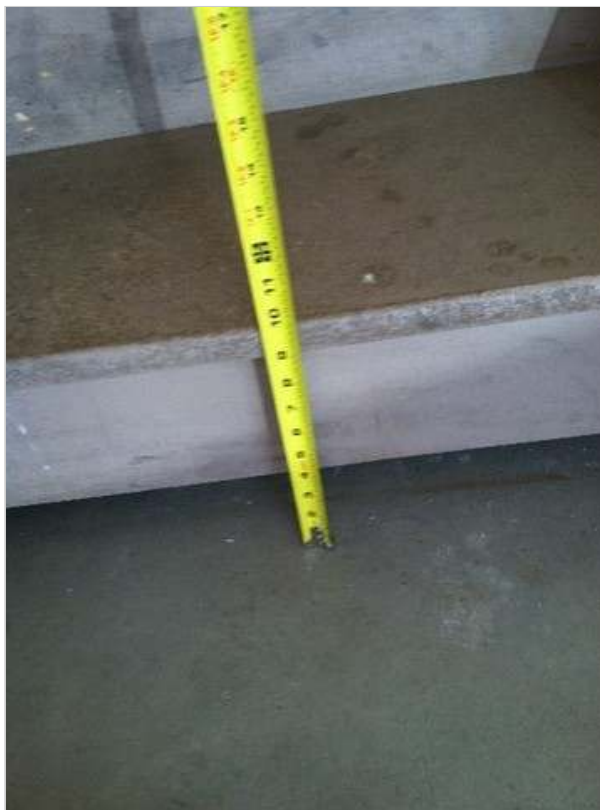
Note: the step from the garage into the home was measured at approximately 10-inches. This is a potential trip hazard. Recommend repair for safety.

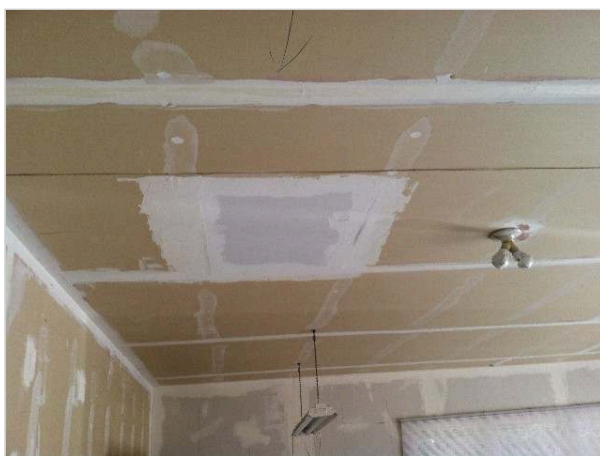
Note: a drywall repair was observed in the garage ceiling. Recommend seller disclosure.

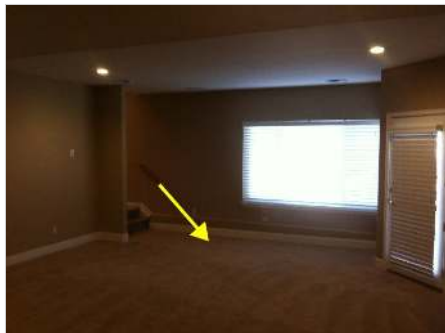
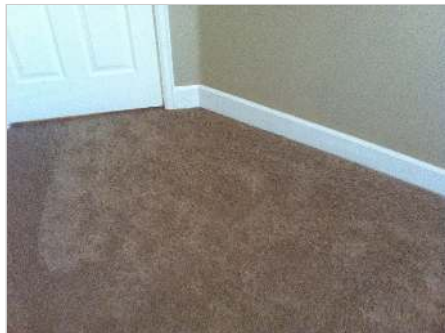
Note: there were indications of settlement of the basement concrete floor. What appeared to be repairs was observed. The basement concrete floor was serviceable.

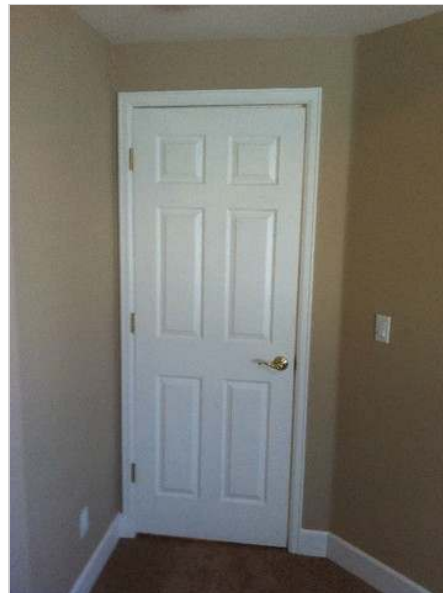
Basement bedroom door somewhat out of alignment. The door was functional during the inspection.

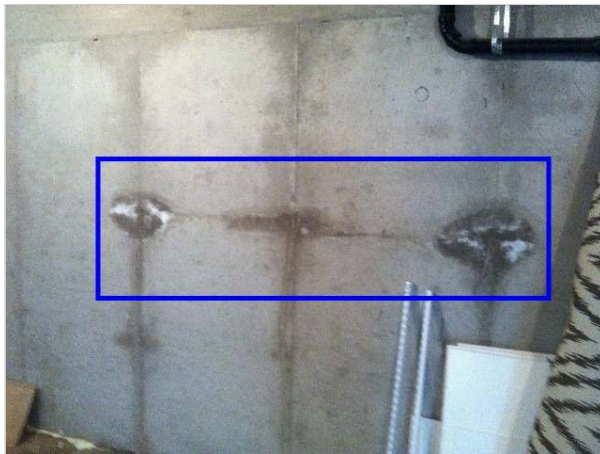
Note: there were a couple of areas of water intrusion observed on the basement concrete foundation wall. These areas were dry at the time of the inspection.

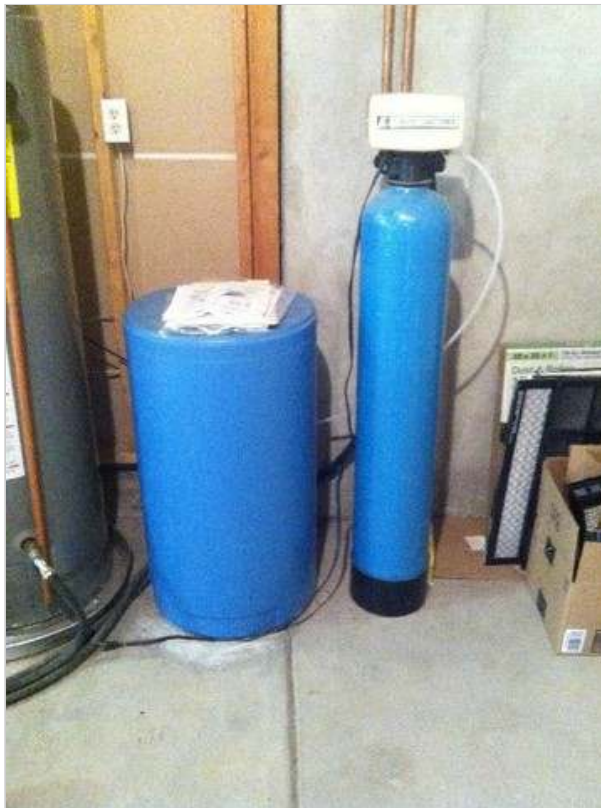
Note: an FS water conditioner water softener was installed in the utility room of the home. The water softener did not appear to be functional (the unit was unplugged and water valves closed) during the inspection. The water softener is beyond the scope of this home inspection and was not tested.

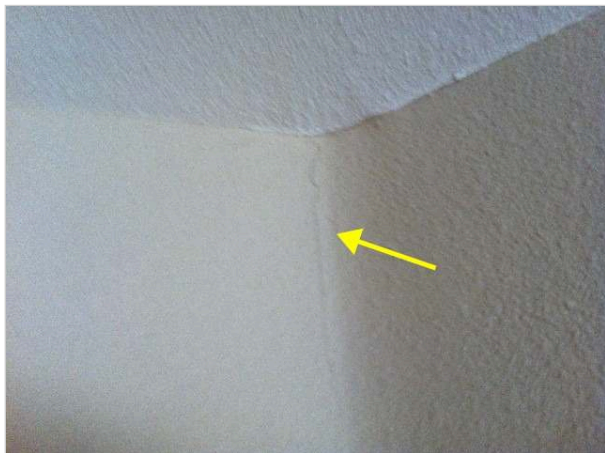
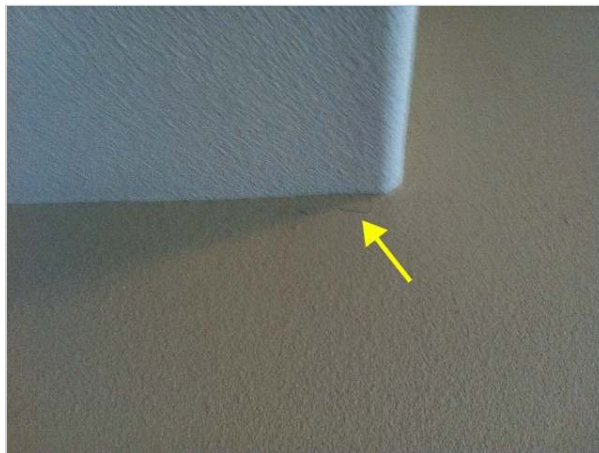
Minor settlement cracks
