Thursday, March 28, 2019

RE: 123 Sample Drive
Anytown, IN 46112
Inspection #: XXXX

HOME INSPECTION REPORT

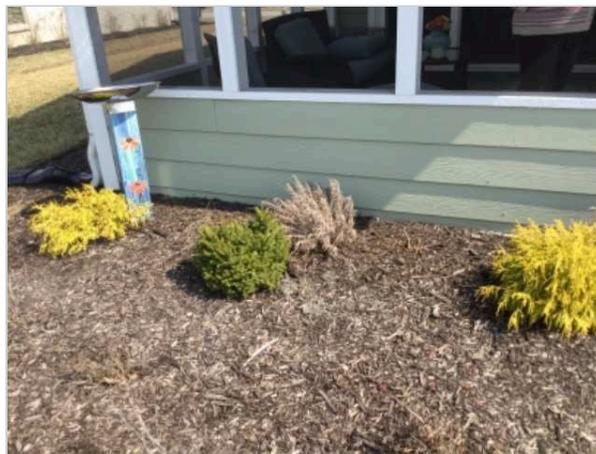
Photo 3

LANDSCAPING MULCH ON SIDING: There are areas where the landscaping mulch is too high and in contact with the siding. Even with exterior brick, mulch that is in contact with the siding can retain moisture and cause damage or insect infestation. Recommend removal of the mulch to an acceptable level.

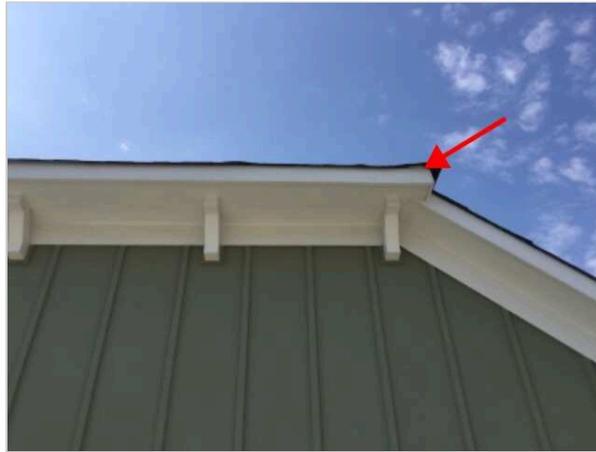
Photo 13

ROOF EAVE OPENINGS: There were opening visible at the eaves of the roof. This is a possible water or pest intrusion area. Recommend installation of drip edge or proper sealing of the areas by a licensed contractor.

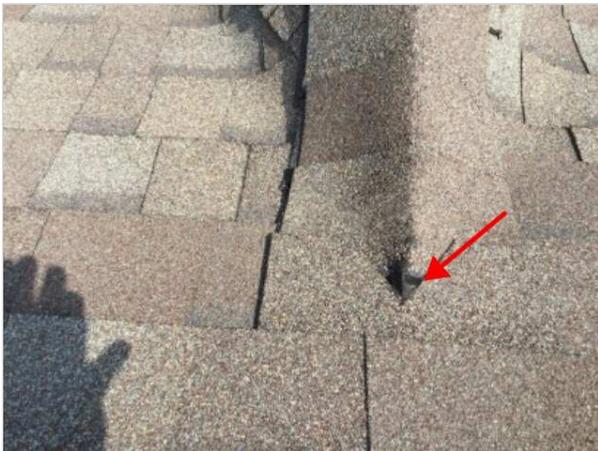
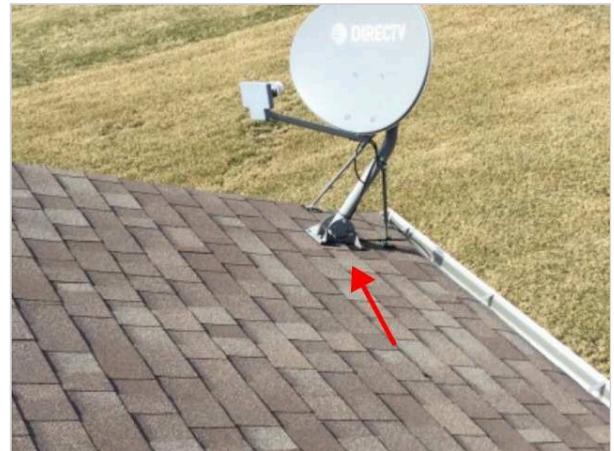
ROOFING TAR: There were areas of the roof or flashing that have been coated with roofing tar. Roofing tar is considered a temporary repair because it will eventually dry, crack and require continued maintenance.

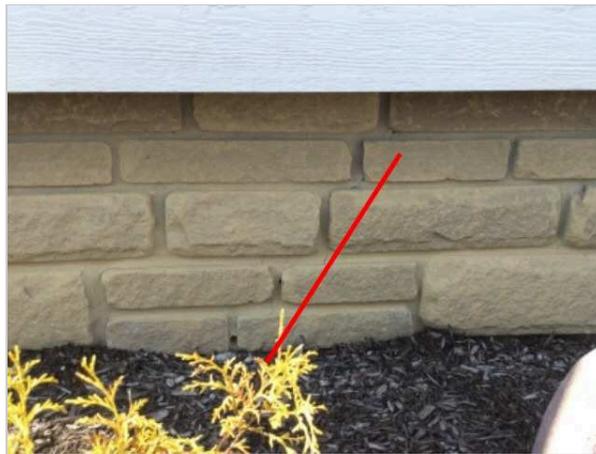
Photo 22

BRICK CRACKS: There were minor cracks in the exterior brick. The brick work on the exterior of the house is not a supporting part of the structure. The cracks did not appear to be of structural significance at the time of the inspection. Recommend the cracks be monitored to determine if movement has ceased. Also recommend keeping the cracks sealed with caulking or mortar to prevent water intrusion which can cause damage to the structure over time.

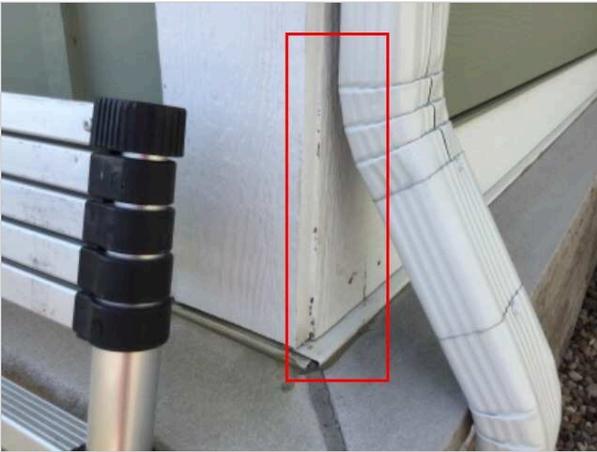
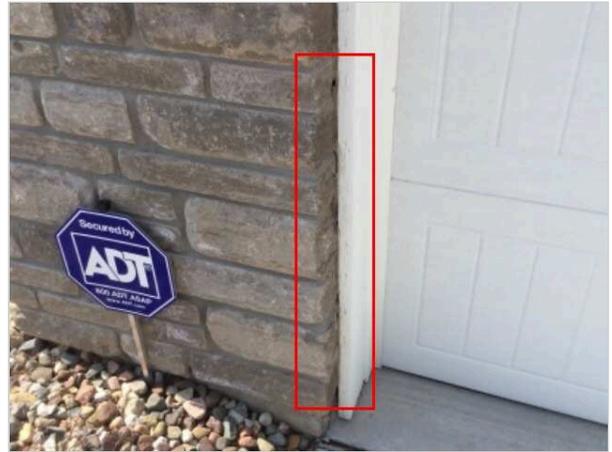
EXTERIOR CAULKING: There were areas of the caulking on the exterior of the home around the doors, trim or windows that is cracking or missing and is in need of maintenance. Recommend re-caulking the areas to prevent water intrusion and structural damage.

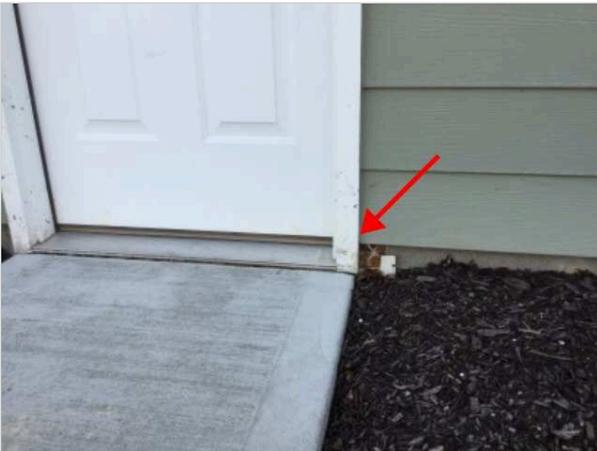
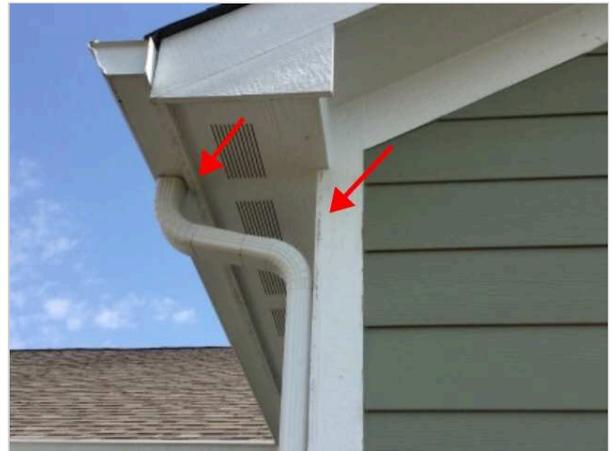
TRIM PAINTING: There were several areas of the wood trim, windows, soffit and fascia that are in need of painting. Exposed wood can deteriorate quickly if it is not painted or sealed. Painting of the wood surfaces is normal home maintenance. Recommend proper painting or sealing of the wood trim surfaces.

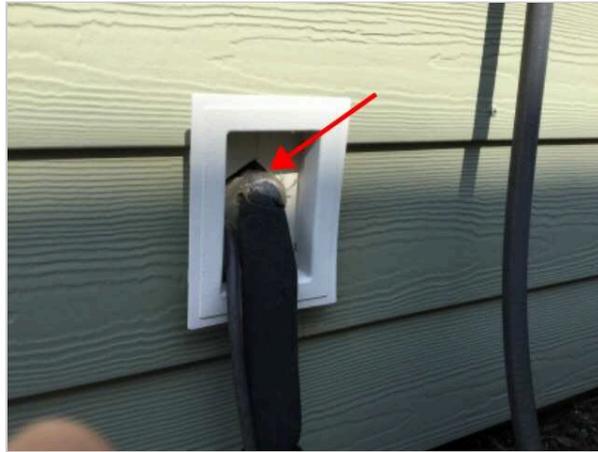
Photo 27

OPENINGS IN SIDING NEED SEALED: The opening in the siding where the air conditioning or heat pump lines go through is in need of sealing to prevent water intrusion.

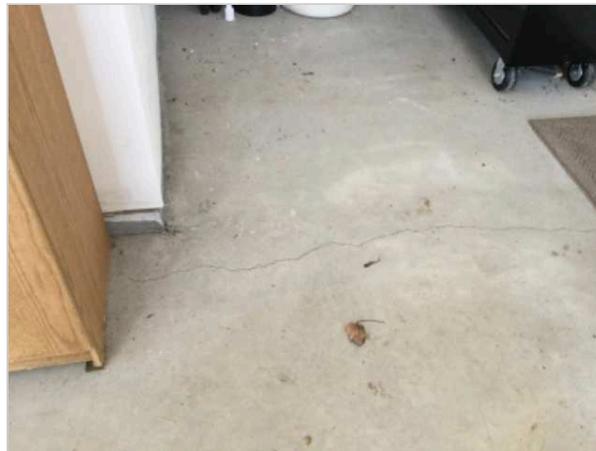
Photo 37

GARAGE SLAB: The slab in the garage shows signs of settlement and is cracked. The slab is not of structural concern to the home, and is serviceable, however repair of the concrete slab would likely fall into the major defect category.

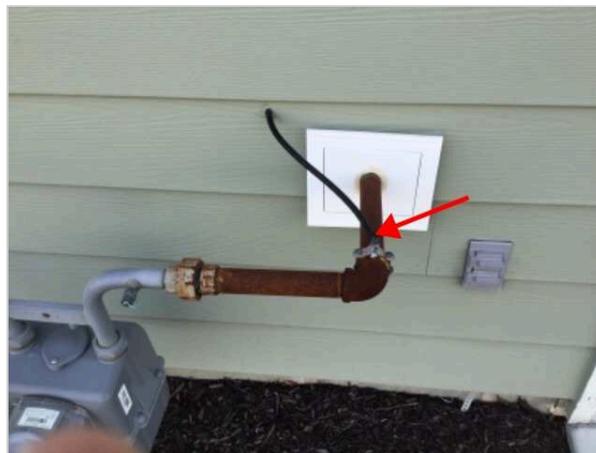
Photo 40

PIPE CONDITION: The condition of many of the visible plumbing pipes and fittings was poor. Recommend a qualified plumber to evaluate and repair to ensure no leaks occur.

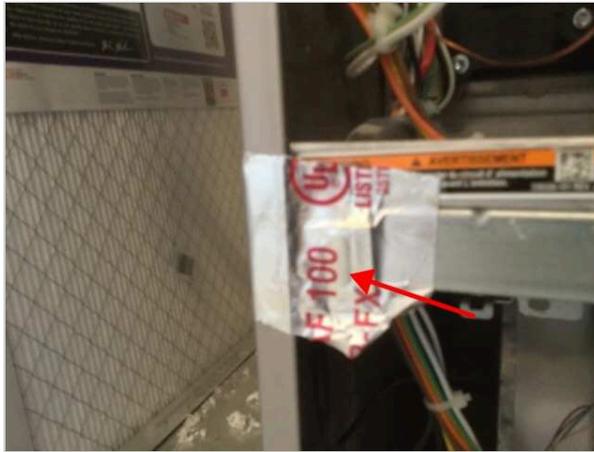
Photo 63

SAFETY SWITCH DEFEATED: The safety switch under the door of the furnace was defeated. It is recommended that the switch be in working order for your safety.

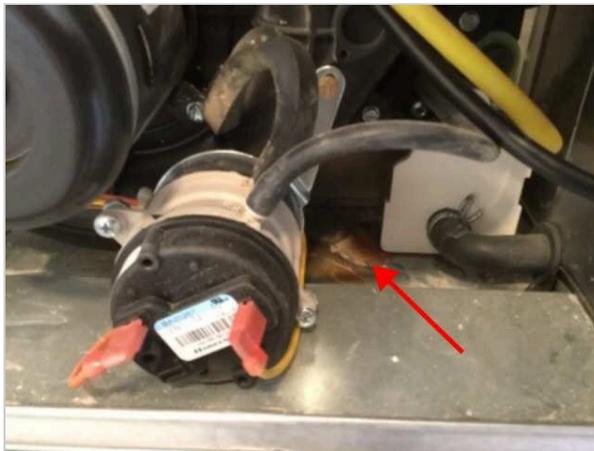
Photo 64

RUST IN FURNACE: There was rust observed inside the cabinet of the furnace. This could indicate a condensation leak or vent pipe issue. The unit should be cleaned and serviced by a licensed HVAC professional.

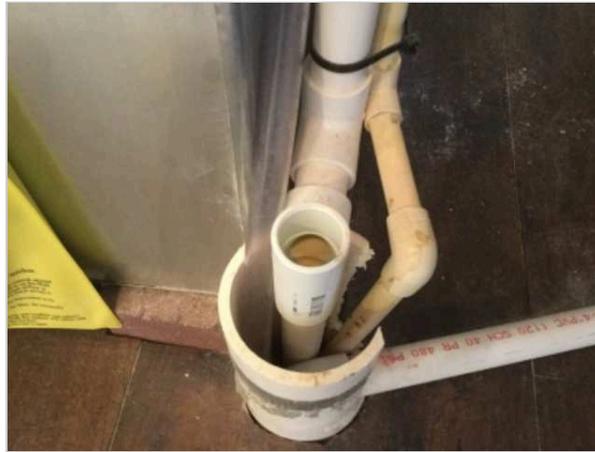
Photo 65

CONDENSATE LINES: The condensate lines from the furnace or Heat Pump are in contact with the wet drain inlet. HVAC condensate lines must be trapped and not in contact with wet drain inlets to prevent the possible migration of bacteria and mold into the air-handling system.

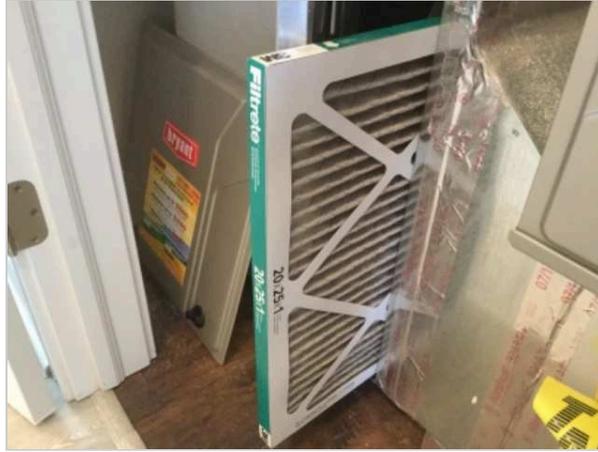
Photo 68

DIRTY FURNACE FILTER: The furnace filter was dirty and should be replaced.
