HomeTeam[®]

HOME INSPECTION REPORT

This summary provides a quick overview of the results of the inspection performed on 8/3/2015 at 123 Sample Drive, Homosassa, FL 34446:.

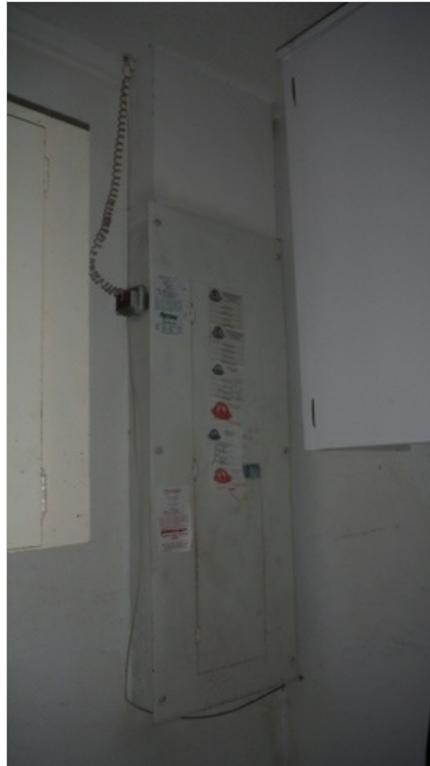
The electric panel is surrounded by cabinets and is not immediately accessible. This could create an unsafe condition in the event of an emergency.

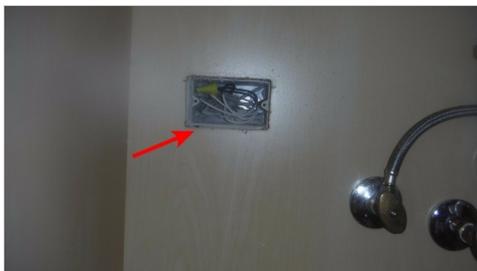
There was an open J-box under the master bathroom sink. Recommend installing a cover.

OPEN J-BOX

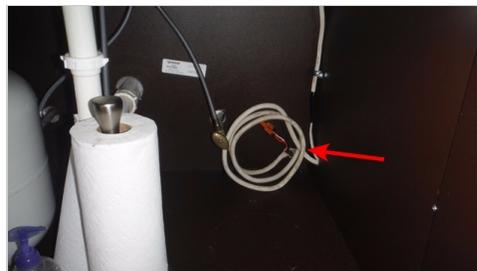
There was a capped wire under the patio sink that was capped and appeared to not have power.

CAPPED WIRE UNDER PATIO SINK

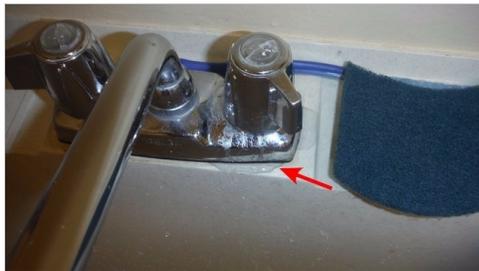
The cold water knob on the laundry room sink leaks when turned on. Recommend replacing seals and tightening.

LEAKS

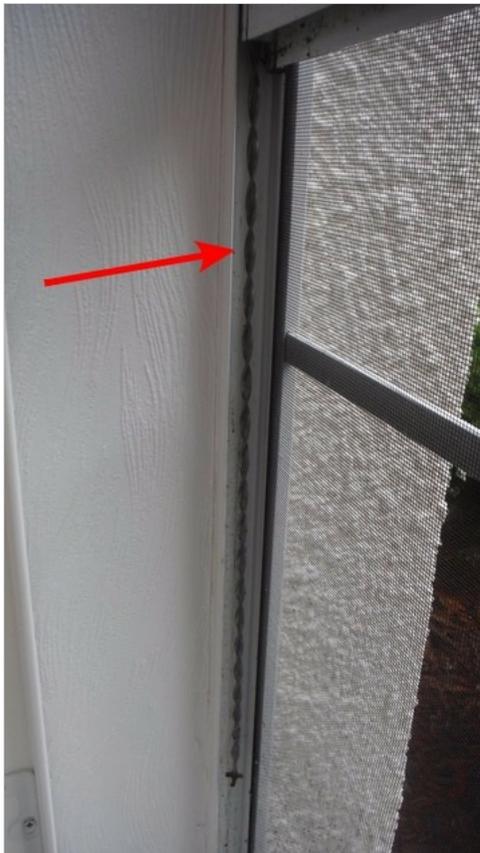
The front office window had a sprung spring on the left side.

SPRUNG SPRING

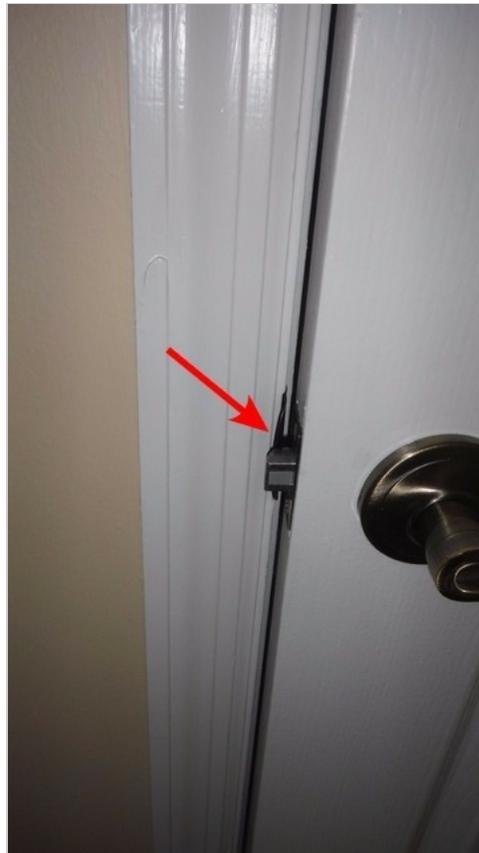
The two left side bedroom doors would not latch when closed. Recommend adjusting the catch latch.

WOULD NOT LATCH CLOSED

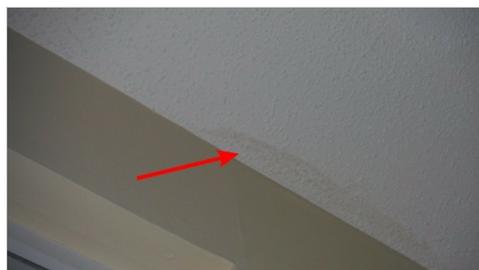
There was a small water mark in the living room above the sliding glass door. It appears to be possibly coming from the vent pipe directly above. Recommend sealing the vent pipe and if the mark appears to get bigger contact a qualified licensed roofing contractor to further evaluate.

WATER MARK

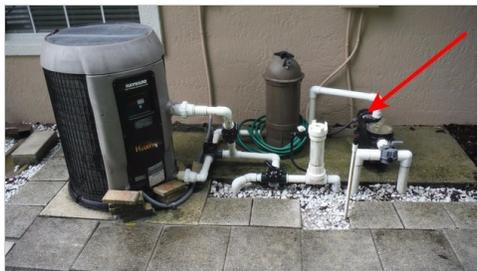
Pump

The pool pump was louder than normal. This could indicate failing bearings.
