### *HOME INSPECTION REPORT*

The inspected property consisted of a ranch wood-framed structure with plywood siding / cladding that was occupied at the time of the inspection. Minor, exterior type caulking and maintenance, painting are common on most homes and may be present but may or may not be specifically identified in this report. The approximate temperature at the time of the inspection was 70-75 degrees Fahrenheit, and the weather was sunny and clear. The utilities were on at the time of the inspection. The buyer was present during the inspection. The home was situated on a lightly sloped lot. The general grade around the home appeared to be mostly adequate to direct rain water away from the foundation. The age of the home, as reported by the building permits was said to be 37 years old.

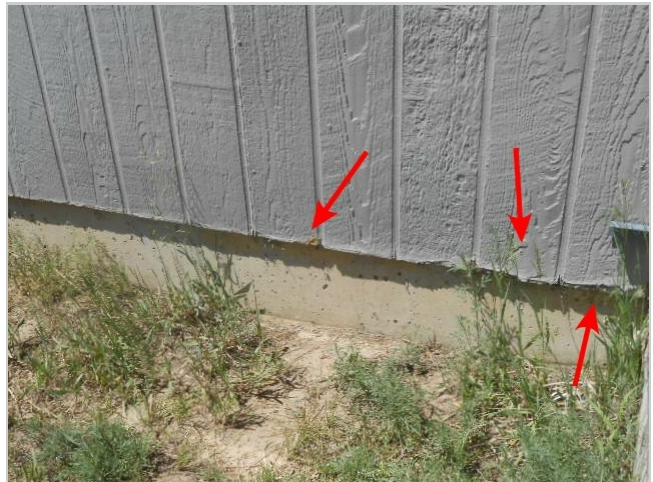
The siding and trim throughout the exterior of the home were in overall marginal condition. There were several areas throughout the exterior where the siding and trim was deteriorating and scraping, repairs, caulking and paint to match are needed. We recommend that a reputable contractor further evaluate the homes exterior and any recommendations for repairs and maintenance be completed prior to closing to prevent any further decay and to prevent possible water intrusion into the home or the homes structure.

- The siding and trim throughout the exterior of the home were in overall marginal condition. There were several areas throughout the exterior where the siding and trim was deteriorating and scraping, repairs, caulking and paint to match are needed. We recommend that a reputable contractor further evaluate the homes exterior and any recommendations for repairs and maintenance be completed prior to closing to prevent any further decay and to prevent possible water intrusion into the home or the homes structure.

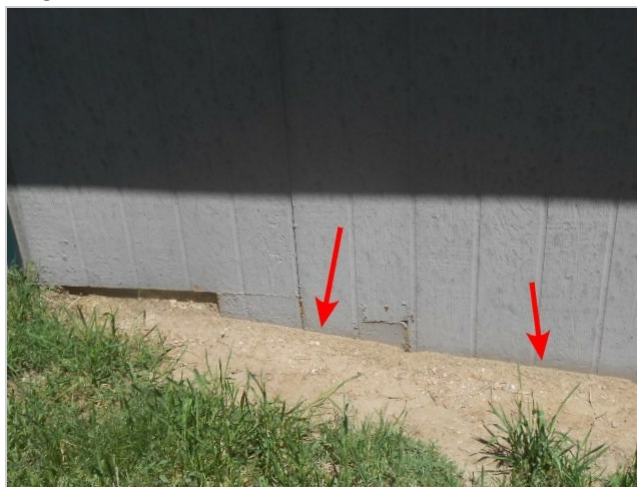
Some of the exterior siding on the rear of the home is in contact or is under the ground or earth. This condition can lead to wood rot or insect intrusion if not corrected. Further evaluation is recommended by a qualified contractor, prior to closing.

This section of siding on the rear of the home is in contact with the ground or earth.

- Some of the exterior siding on the rear of the home is in contact or is under the ground or earth. This condition can lead to wood rot or insect intrusion if not corrected. Further evaluation is recommended by a qualified contractor, prior to closing.
