HomeTeam[®]

HOME INSPECTION REPORT

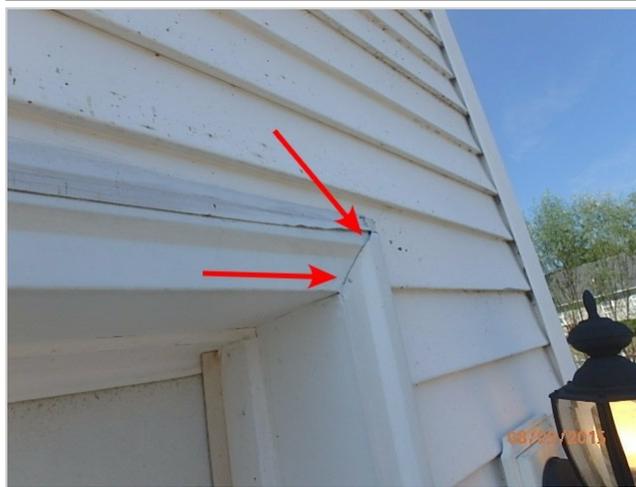
Photo 1

The aluminum trim wrap at the upper corners of the overhead garage door do not appear to be installed in a way that prevents water intrusion. Currently, the trim wrap is not overlapping, which can lead to water entering behind the aluminum trim wrap. The aluminum should be either caulked/sealed or re-installed properly to prevent water intrusion.

Garage door's aluminum wrap installed improperly

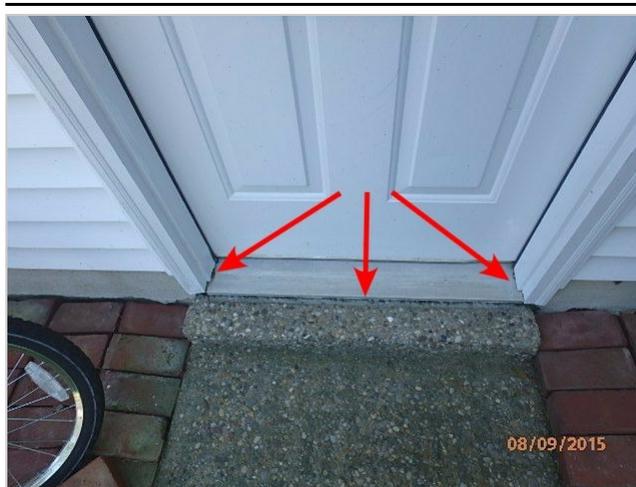
Photo 2

NOTE-Exterior caulking around the exterior doors is cracked or missing. The caulking should be repaired or replaced to help prevent water intrusion.

Recommend caulking exterior door's

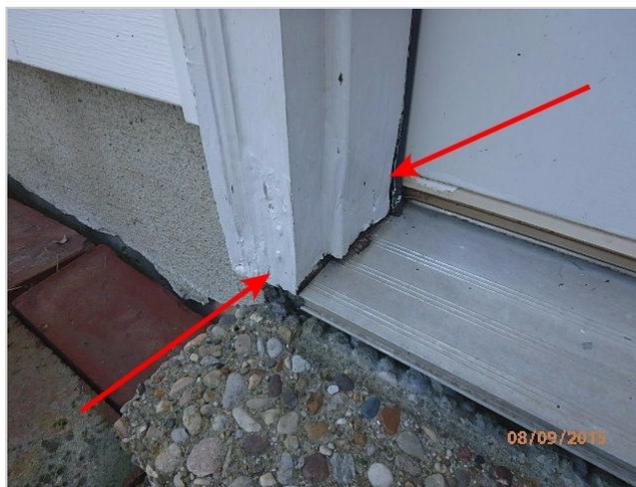
Photo 3

Rotted wood was present around the rear exterior garage door. The areas should be repaired and further evaluated at the time of repair.

Painted over wood rot at rear garage door

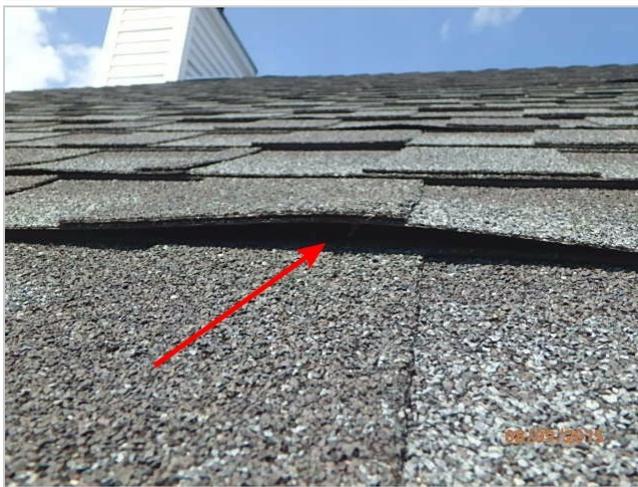
Photo 8

The roof requires routine maintenance to prolong its life (nail pops on front of roof).

Nail pops present on front roof

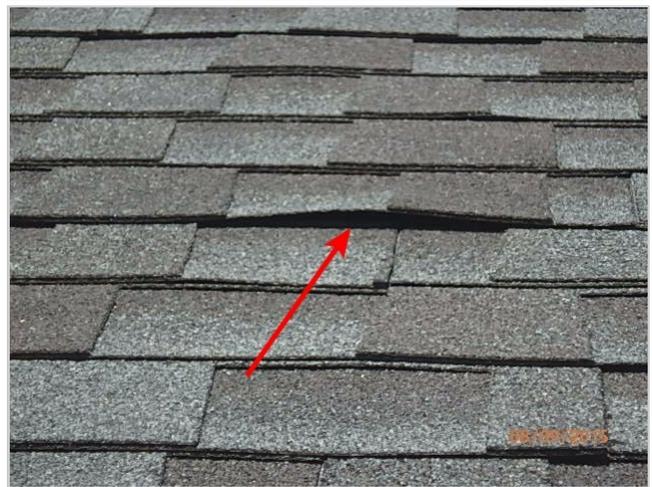
Photo 9

Nail pops lifting shingles on front roof

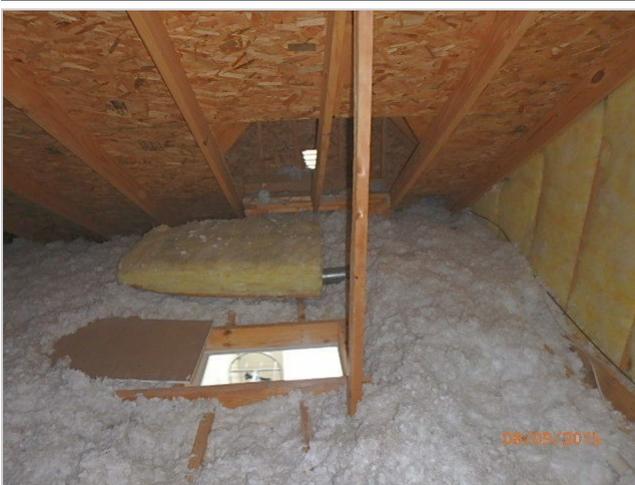
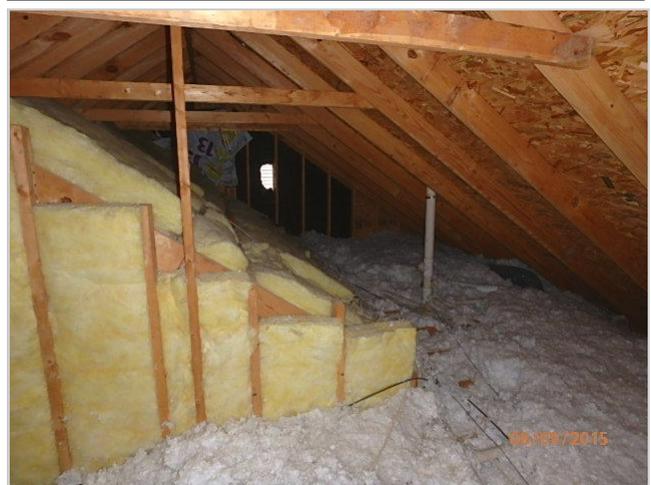
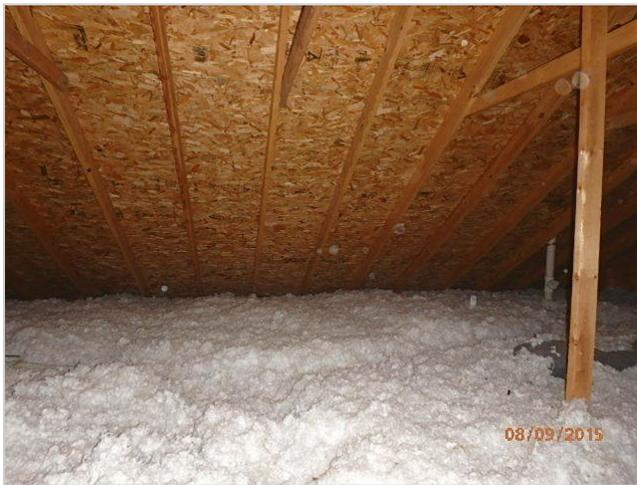
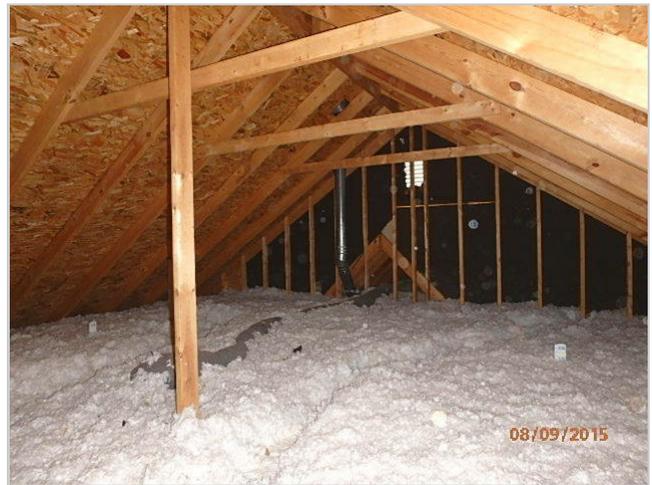
Parts of the attic show signs of previous water intrusion. The areas were dry at the time of the inspection. The buyer should maintain vigilance in monitoring the areas for any recurrence of the previous issue and should rectify any issues immediately upon observing them.

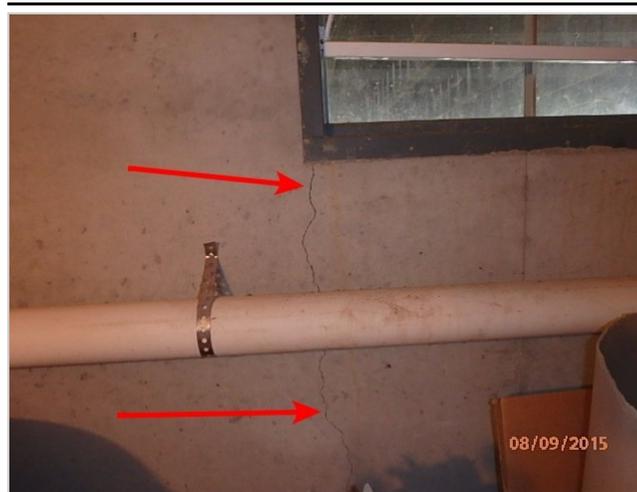
Photo 17

Small cracks were observed on the foundation (off basement window corner). The cracks were 1/16th-inch or less in width. These cracks did not appear to have structural significance at the time of the inspection. The homeowner should monitor these cracks for any changes, and if changes are noted, should contact a reputable foundation repair company for further analysis. Below-grade cracks are highly susceptible to water intrusion during times of rain. Water staining from previous water intrusion was not visible. HomeTeam recommends sealing these cracks if a watertight basement is desired.

View of foundation crack from basement window

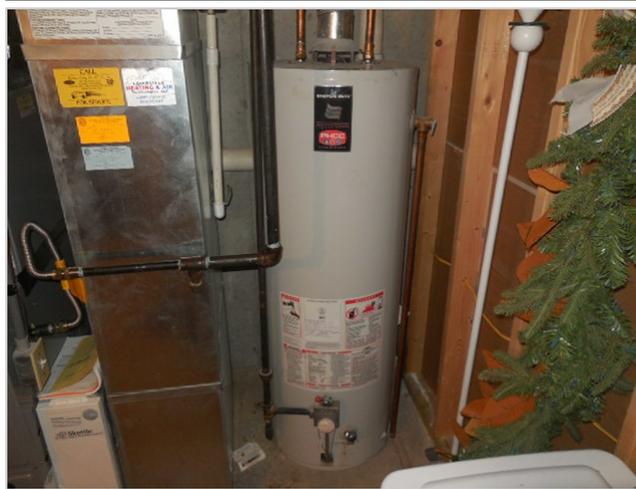
Photo 19

The water heater may be past its design life. This is an informational note only to help give an idea of future budgeting considerations. The unit was functional unless noted otherwise. Please note that since codes change, it is possible the configuration for a water heater's flue and/or discharge may need to be altered at the time of a future replacement.

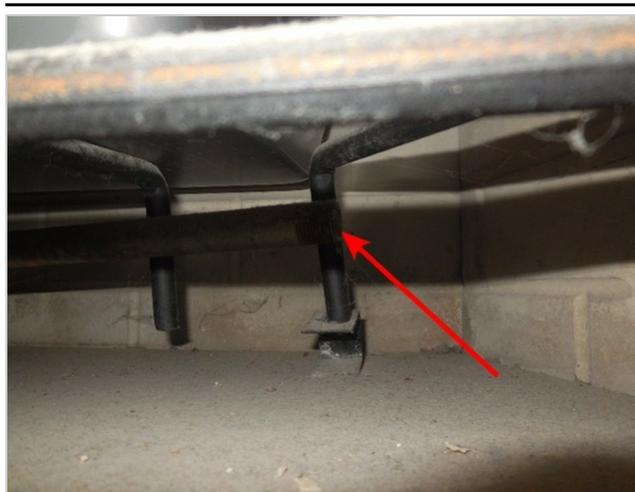
Photo 20

An uncapped gas line was present in the fireplace. The lines should be properly capped and sealed or attached to an appropriate gas-burning device to prevent inadvertent gas leakage.

Uncapped gas line in the fireplace.

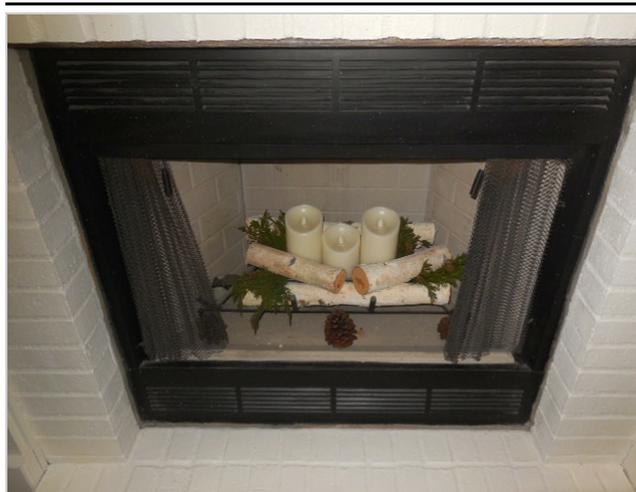
Photo 21

NOTE- The family room gas fireplace was being used as a decorative fireplace. The flue area was not sealed. No attempt should be made to burn any type of fuel in the unit. Consult with a qualified, reputable chimney and fireplace service for additional advice.
