HOME INSPECTION REPORT

File Number: **XXXX**
Address of Inspection: **123 Sample Drive**

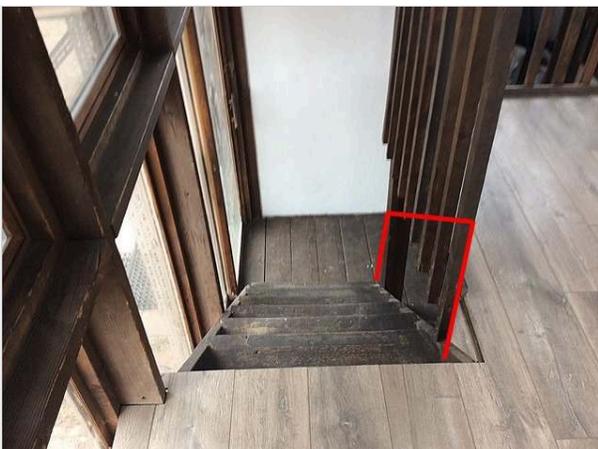
A safety railing would be recommended for this stairway in the patio conversion.

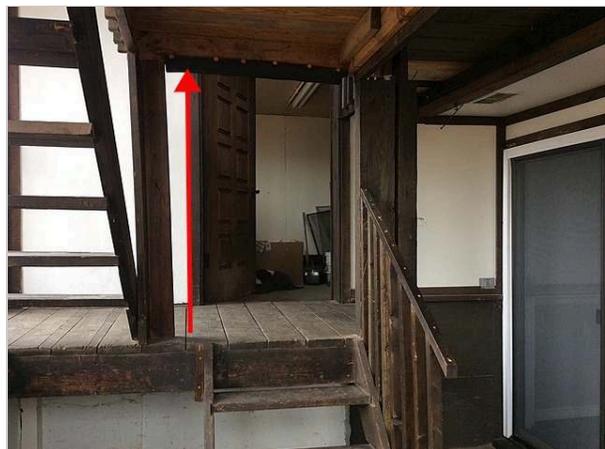
Lack of adequate head room is a safety concern in the patio conversion.

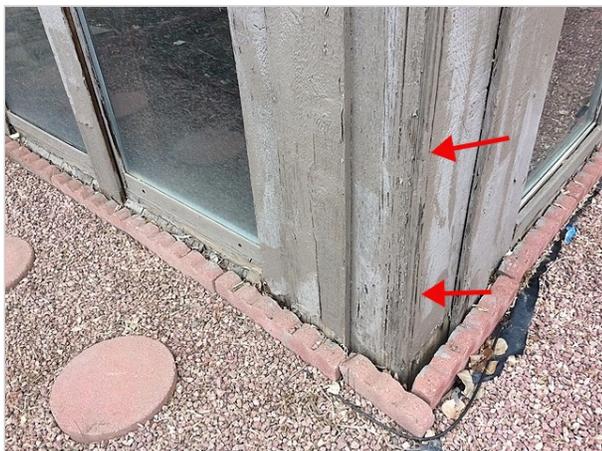
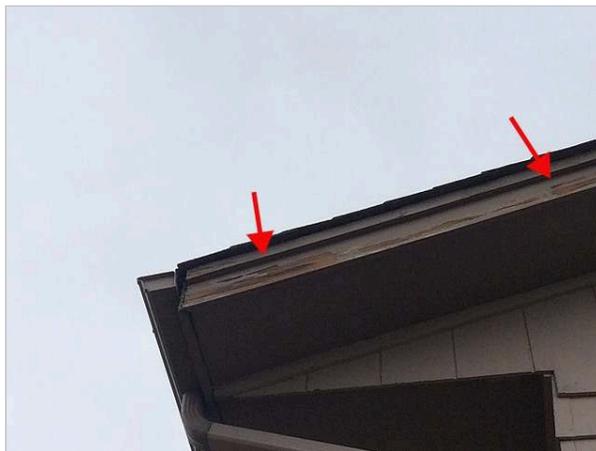
The siding and trim throughout the exterior of the home were in overall marginal condition. There were several areas throughout the exterior where the siding and / or trim was deteriorating and repairs, caulking and paint to match are recommended.

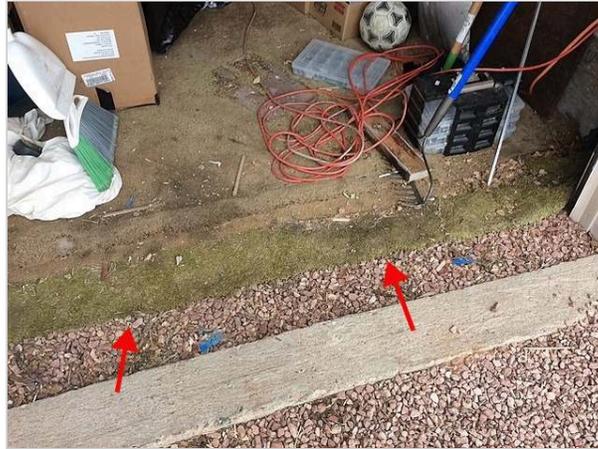
There was a garage addition on the right side of the home. There was no permit found for this addition when a check of Regional Building permits were searched for this home. It is recommended that the seller obtain and final a permit to ensure that the addition was constructed according to all Regional Building codes and standards.

The garage floor is only constructed of carpeting over rock.

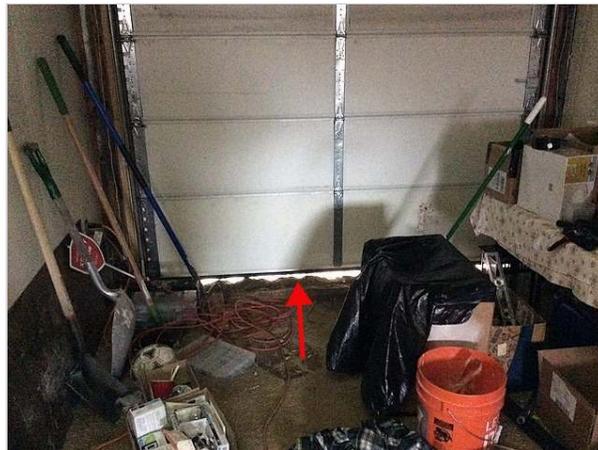
The weather seal on the bottom of the garage door does not seal fully to the garage floor. This condition could allow for cold air, moisture or rodents to enter the garage if not replaced.

Garage door does not seal fully to the floor.

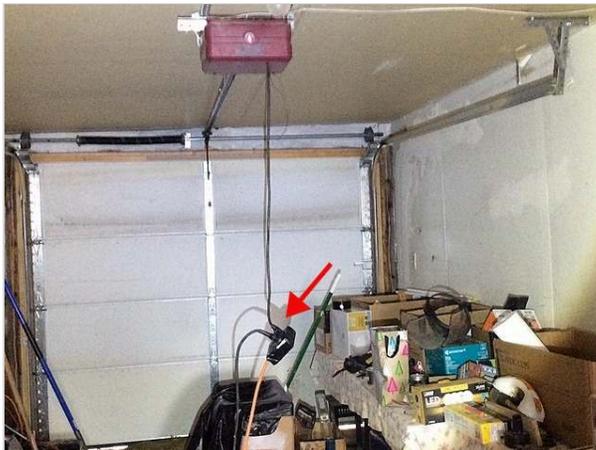
There was no dedicated power present of the garage door opener. The power for the garage door was being supplied by a common extension cord. It is recommended that a qualified electrician install a dedicated electrical receptacle that is within reach of the door opener's power cord.

The garage door opener is only powered by a common extension cord.

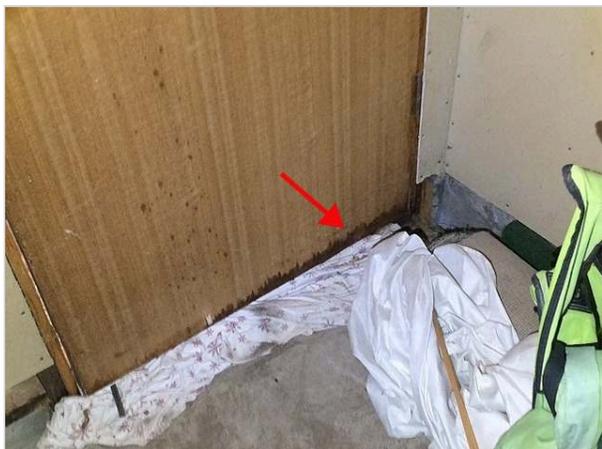
The rear exit garage door was noted to be water damaged or deteriorated on the bottom of the door indicating the need for probable replacement of the door. In addition this door does not close, latch and lock.

The rear garage exit door is water damaged along the bottom.

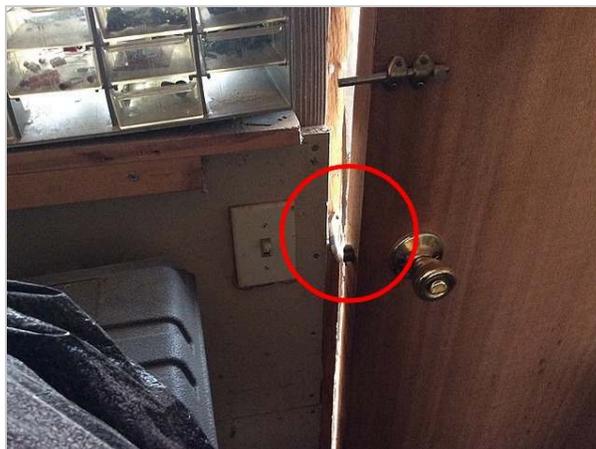
And the door does not close, latch or lock.

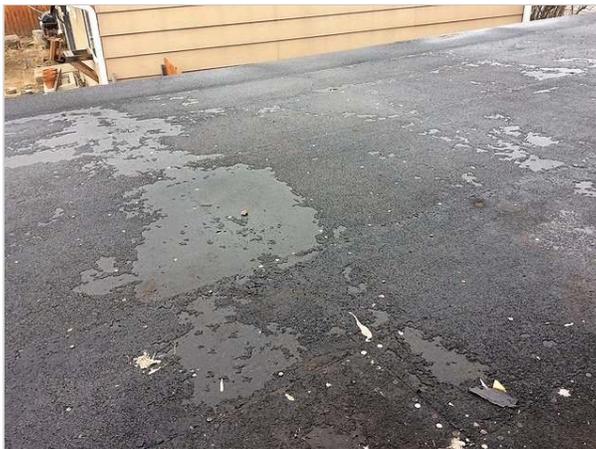
There were some areas of the roof where hail or other damage was present. It is recommended that a qualified roofer further evaluate the roof and that any recommendations for replacements or repairs to the roof shingles be completed.

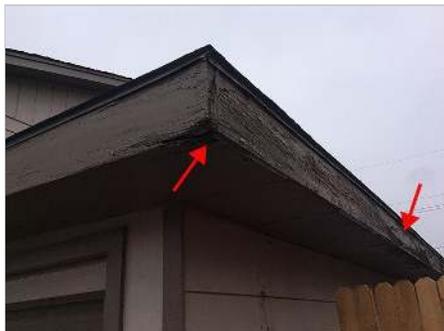
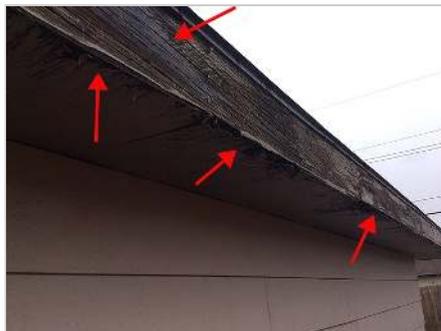
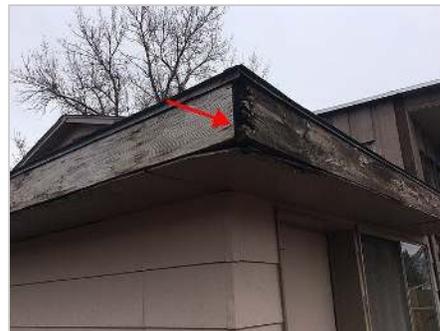
Water damage was noted to the exterior roof soffit's and fascia around the garage roof. This condition appears to be related to an absence of a gutter system for the garage roof. Further evaluation and repairs as needed are recommended by a qualified contractor.

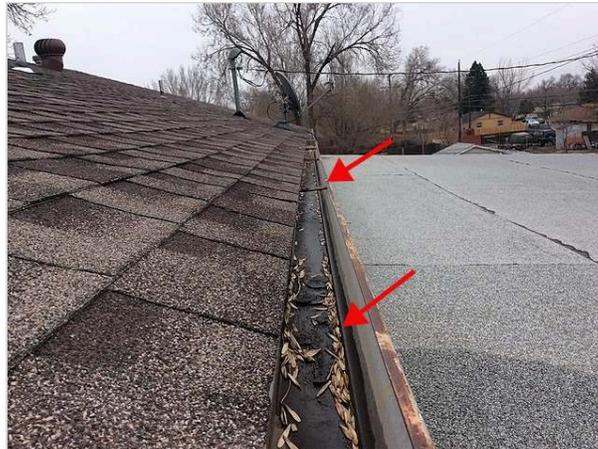
The older galvanized gutters throughout the home have rust (or loss of zinc coating) in the bottom of the gutters indicating leakage of the gutters is imminent. Further evaluation and repairs, replacements of the gutter system in this home is recommended by a qualified gutter contractor.

Rusted gutters were common throughout.

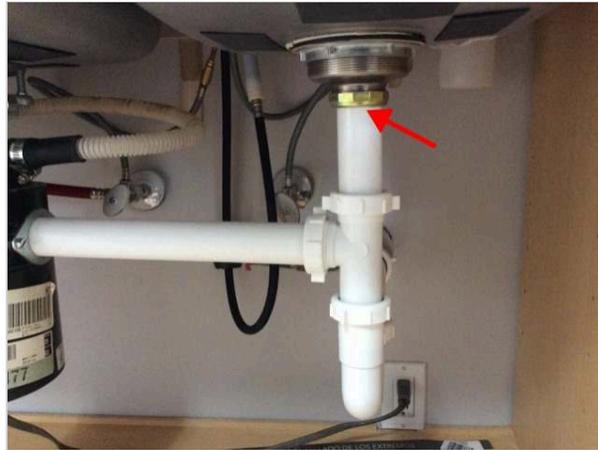
The drainage piping under the kitchen sink (right side) was noted to be leaking into the cabinet below when filled and then drained. Repairs are recommended by a qualified plumber.

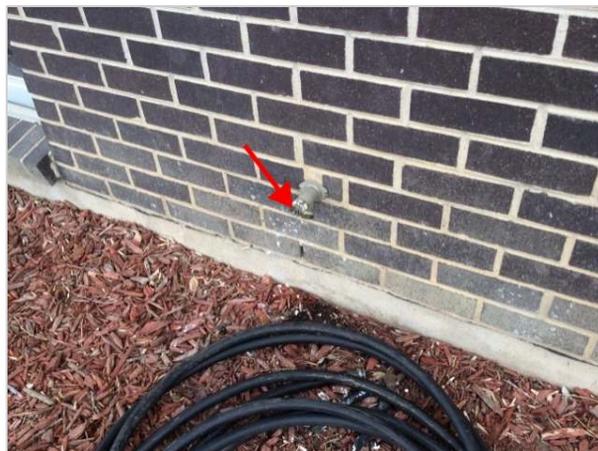
The hose bibb on the front of the home was noted to be damaged and was missing a control handle. Subsequently the hose bibb does not turn on and was unable to be tested. Further evaluation and repair or replacement of the hose bibb is recommended by a qualified plumber.

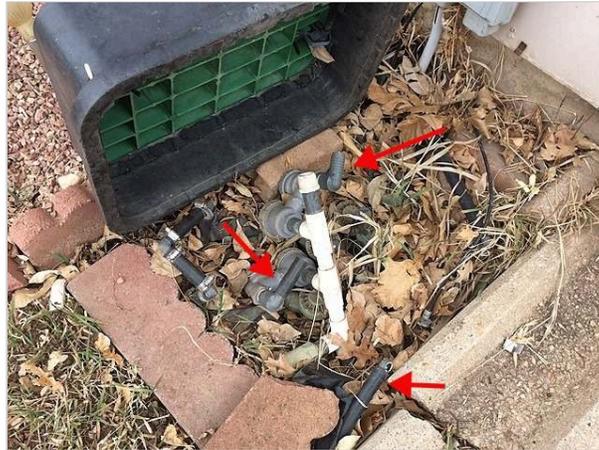
The water piping for the lawn sprinklers (on the exterior of the home) was noted to be broken and the water to the lawn sprinklers was subsequently shut off. The lawn sprinklers were unable to be tested or inspected.

Disconnected lawn sprinklers and piping.

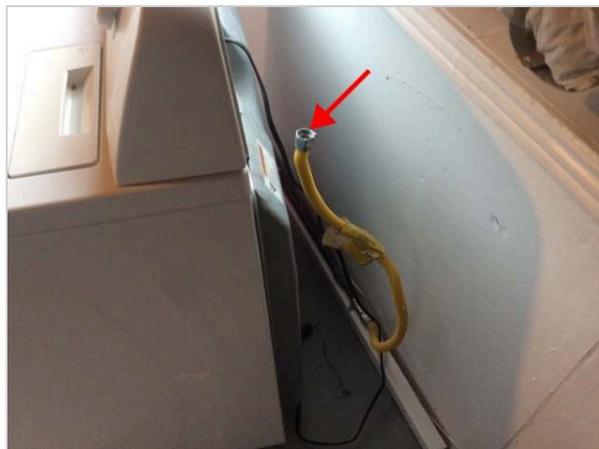
There was one open or uncapped gas line in the basement (for the clothes dryer) which is recommended to be capped to prevent a possible gas leak.

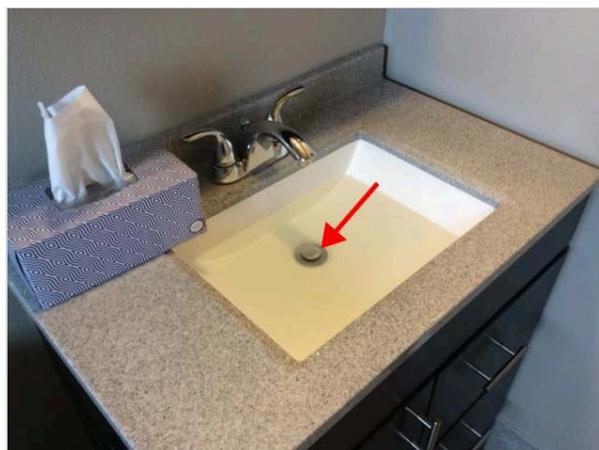
The upstairs bathroom sink drains very slowly when filled and then drained.

Sink drains slowly.

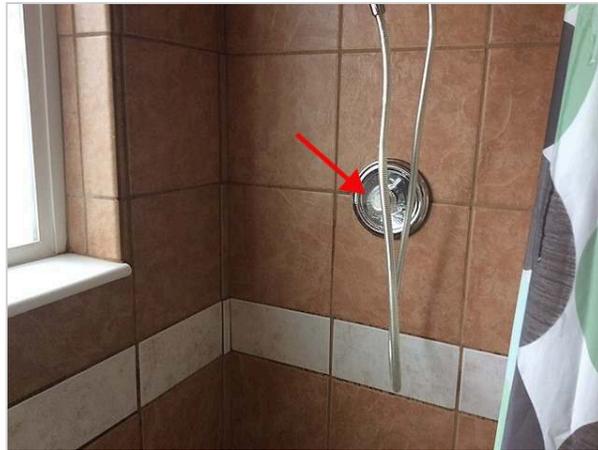
The control valve for the basement shower is out of adjustment and does not divert hot and cold water properly. Further evaluation and repairs are recommended by a qualified plumber.

Shower valve is out of adjustment.

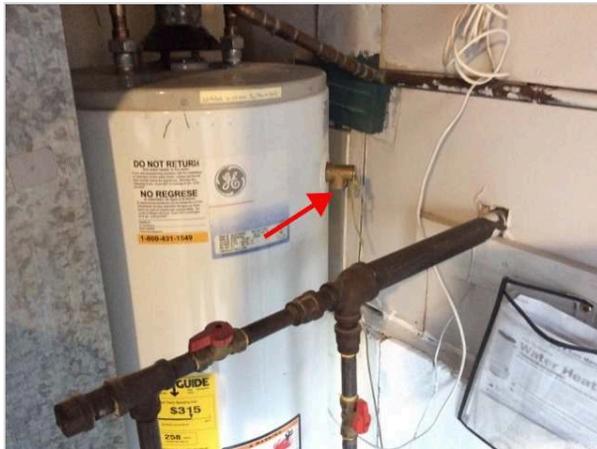
The 3/4 " drain line for the temperature and pressure (T&P) valve was noted to have been removed. It is recommended that this line be replaced as a safety concern by a qualified plumber.

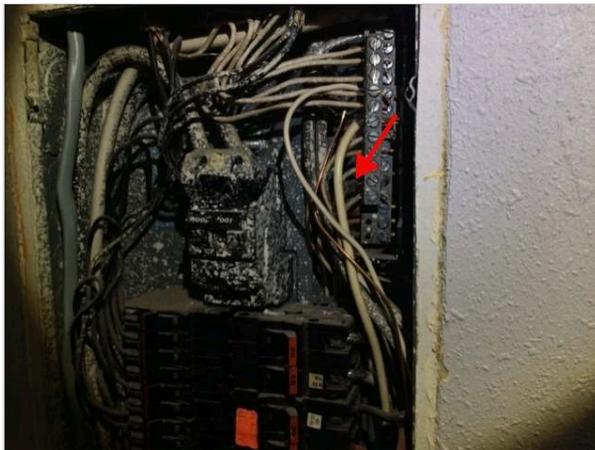
One of the white colored electrical wires (neutral) in the electrical panel was noted to have a burn mark at the time of inspection, indicating a possible electrical issue with the circuit. Further evaluation and any necessary repairs are recommended by a qualified electrician.

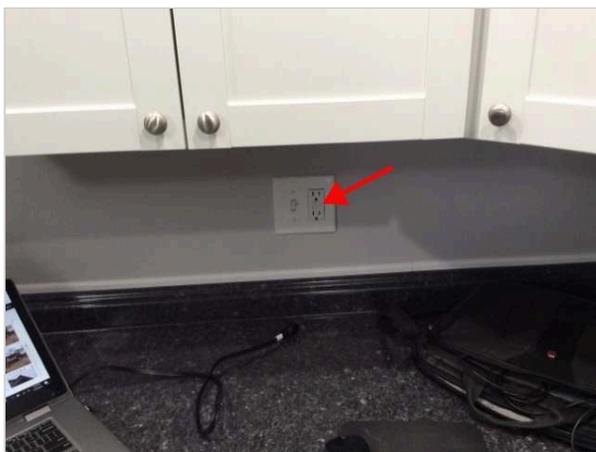
There was no electrical power found for one of the electrical receptacles in the kitchen (right side of the kitchen sink). Further evaluation is recommended by a qualified electrician.

Electrical receptacle does not have power.

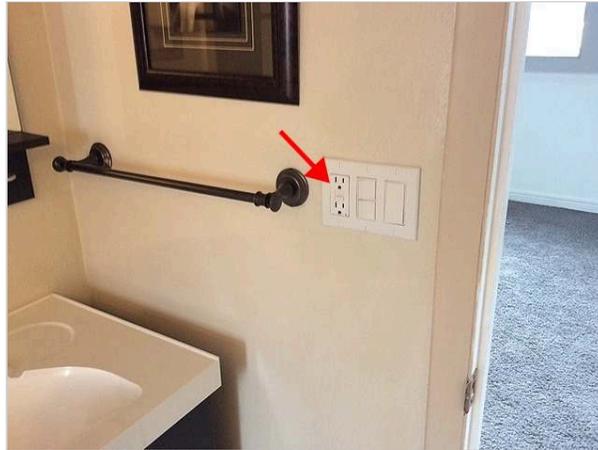
The GFCI electrical receptacle in the basement bathroom was tested and found to be non functional.

Non functional GFCI receptacle.

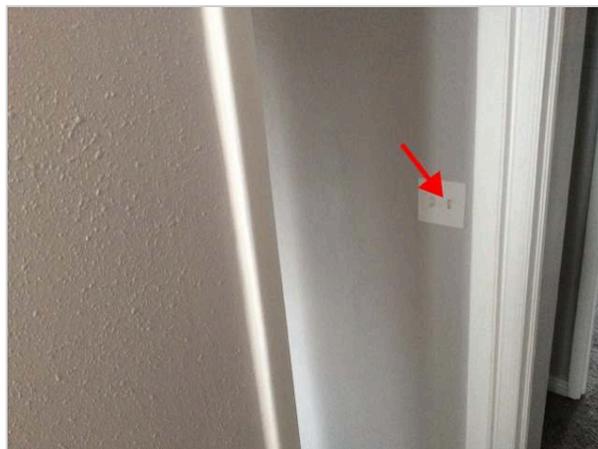
The three way electrical switches (for the stairway light fixture) appear to be wired incorrect. Further evaluation and repairs are recommended by a qualified electrician.

Three way switch for entry way light fixture is wired incorrectly.

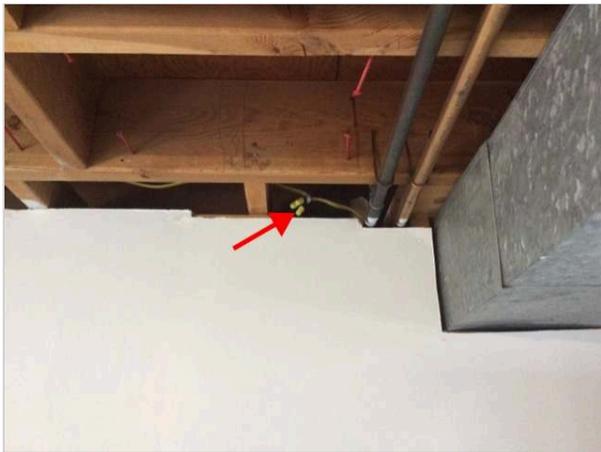
There was one open electrical splice or junction noted in the basement. Open splices or junctions can consist of wires joined together outside of a junction box, inadequate or unsafe wiring or wiring that is hanging loose or is unsecured.

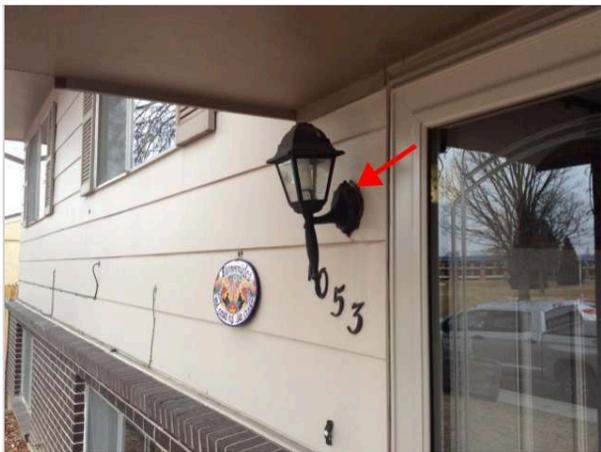
The front exterior light fixture was noted to be loose from the wall and is recommended to be additionally secured by a qualified electrician.

The front, exterior light fixture is loose from the wall.

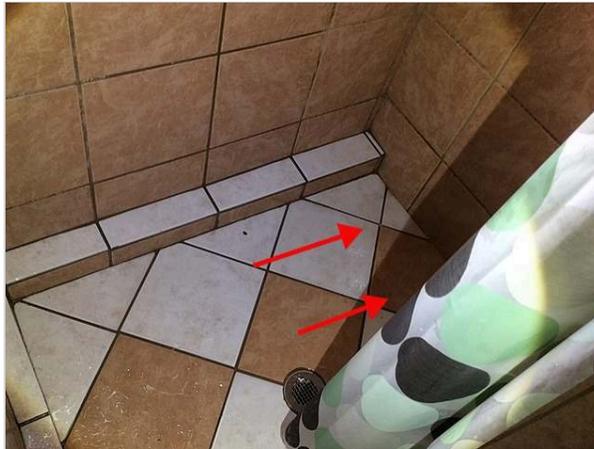
The shower in the basement bathroom does not appear to have been installed properly as the shower pan is not sloped and standing water was observed in the pan. Further evaluation is recommended by a qualified contractor.

The shower pan slopes towards the wall instead of the drain.

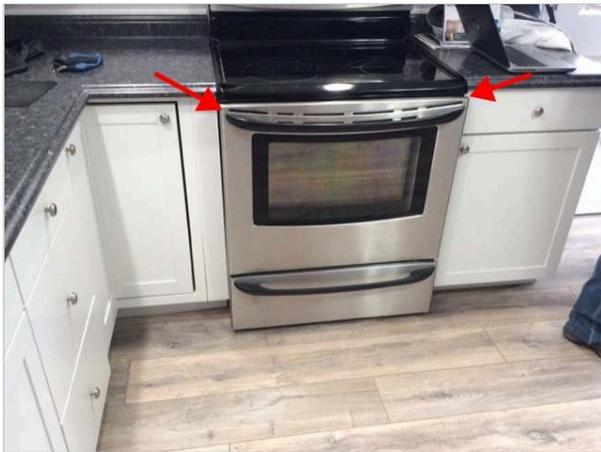
The oven door did not to close completely and is recommended to be adjusted, repaired or replaced by a qualified appliance company.
