# HomeTeam<sup>®</sup>

### HOME INSPECTION REPORT

On Tuesday, April 17, 2018 The HomeTeam Inspection Service made a visual inspection of 123 Main Street, Columbus, OH 43054. Enclosed please find a written, narrative report of our findings in accordance with the terms of our Inspection Agreement.

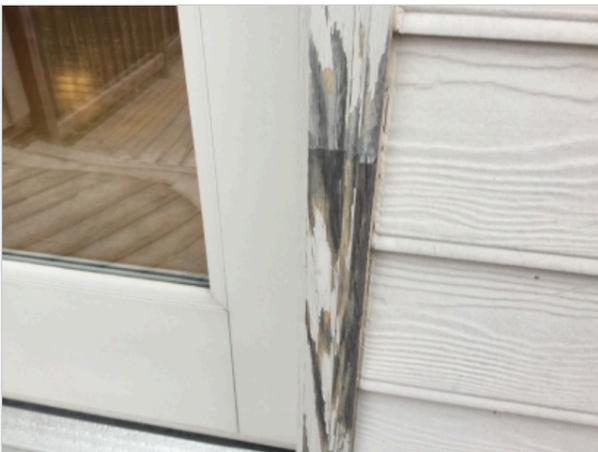
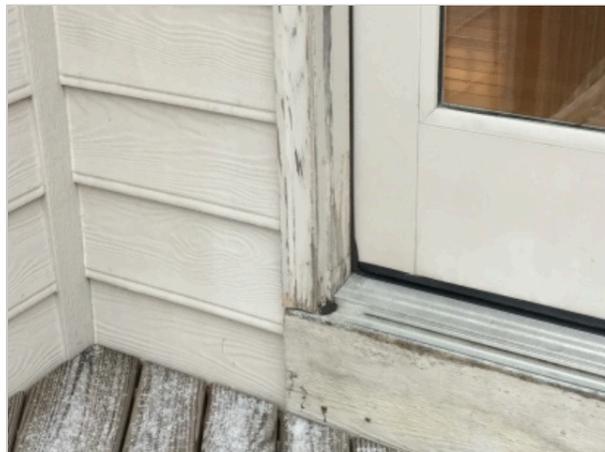
**Peeling paint was present on the exterior of the home.** In order to preserve the life of the exterior surfaces and materials, all areas should be scraped, sealed, and painted after any damaged wood is repaired. This is a routine maintenance item.

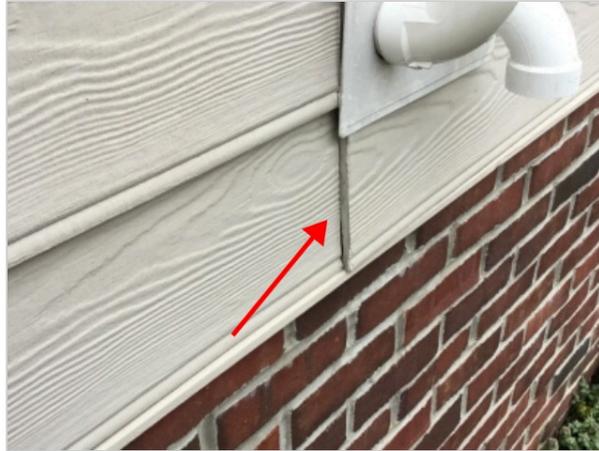
Photo 3

**Loose siding was present on the left side of the home.** The siding should be reattached.

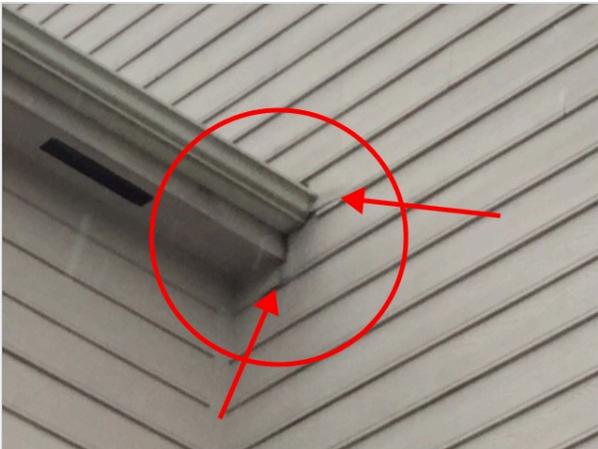
Photo 4

**Rotted or weather damaged wood was present on many areas of the exterior of the home.** The areas should be repaired and further evaluated at the time of repair.

Rear second floor

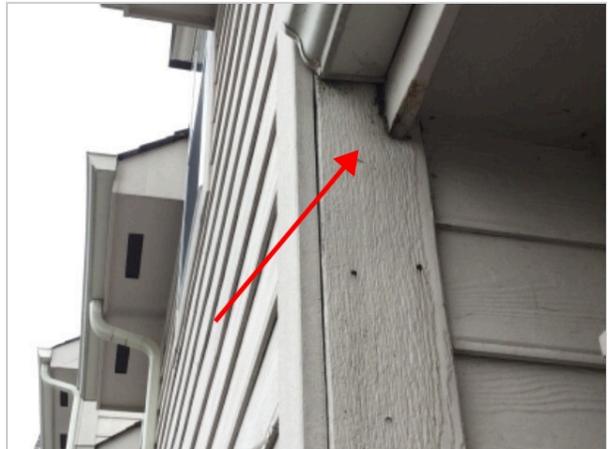
Photo 5

Front next to garage

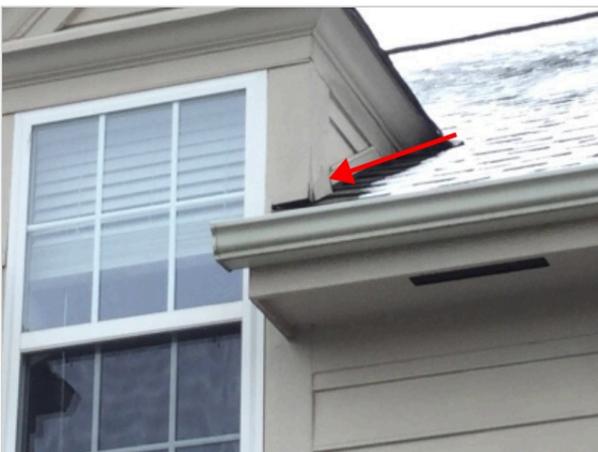
Photo 6

Front dormer

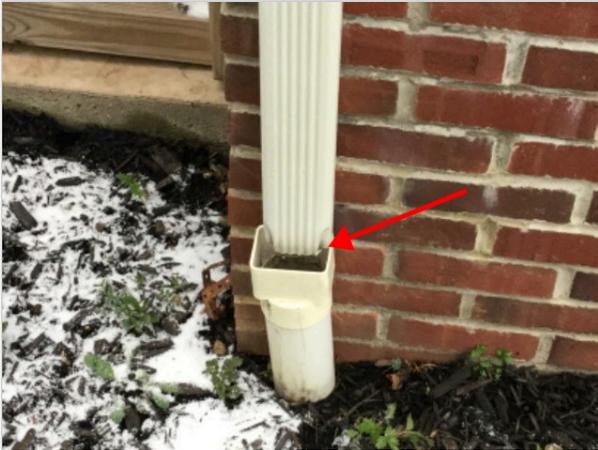
Photo 9

Noted at time of inspection was a disconnected downspout. This condition has been known to allow water from gutters to drain near foundation causing possible moisture issues with the foundation and basement. As such, we recommend reconnecting downspout with drain as needed.

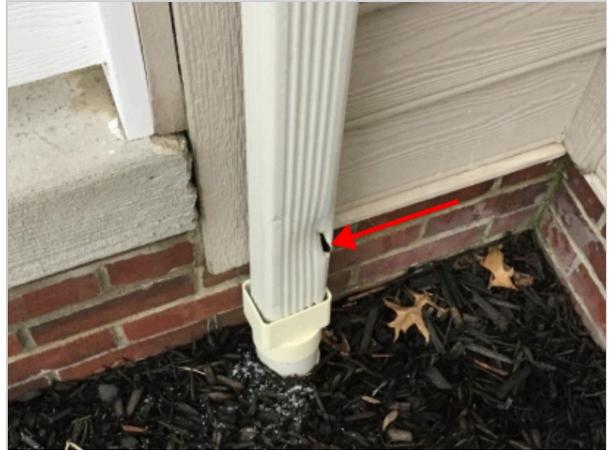
Photo 10

Damaged downspout

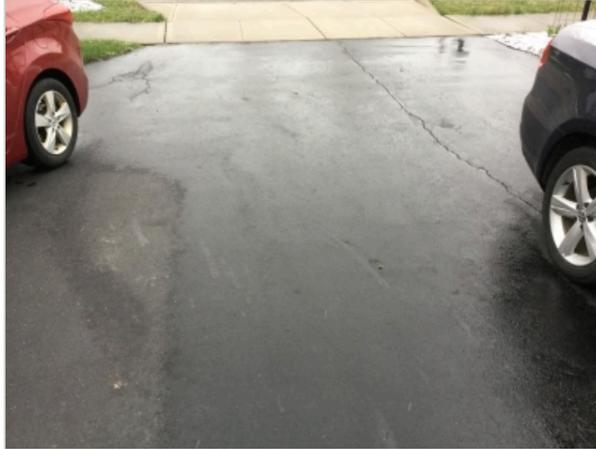
**Photo 17**

An asphalt driveway is present in the front of the structure. Cracks and spalling were observed on the driveway. Surface

defects in driveways develop and progress with age and are considered normal as long as they do not create a safety hazard. Sealing defects may help slow the rate of deterioration.

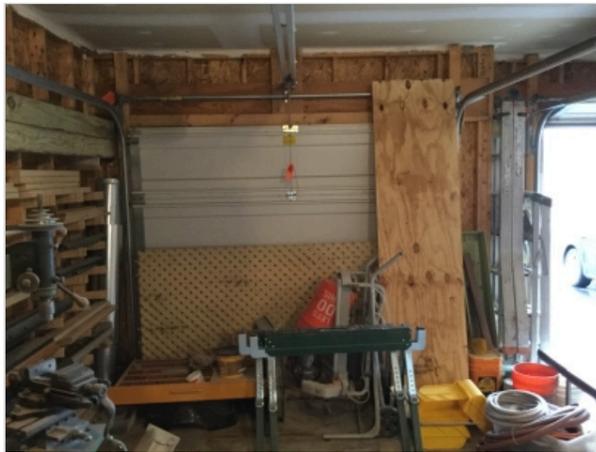
**Photo 18**

**The garage door safety pressure reverse system is not operable.** This means that the door does not stop and reverse when resistance is placed at the base of the door. The opener should be adjusted or repaired.

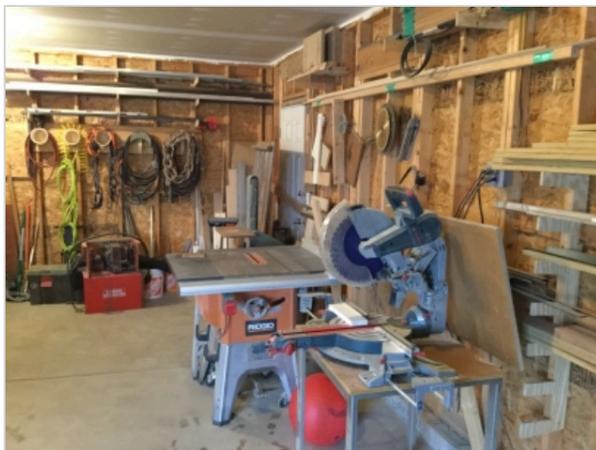
**Photo 19**

The garage was cluttered with many stored items and/or shelves at the time of inspection. The obstructed areas were not able to be visually inspected.

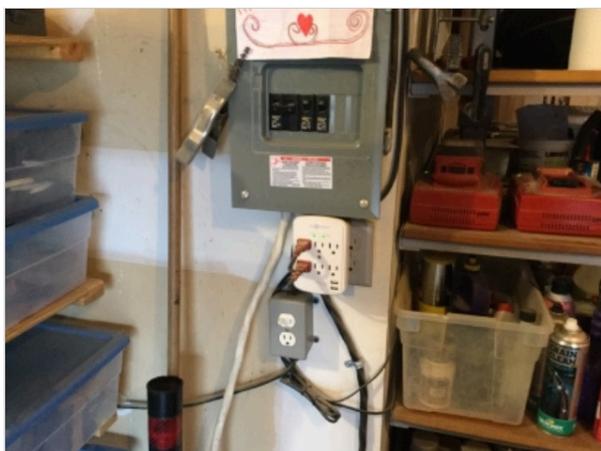
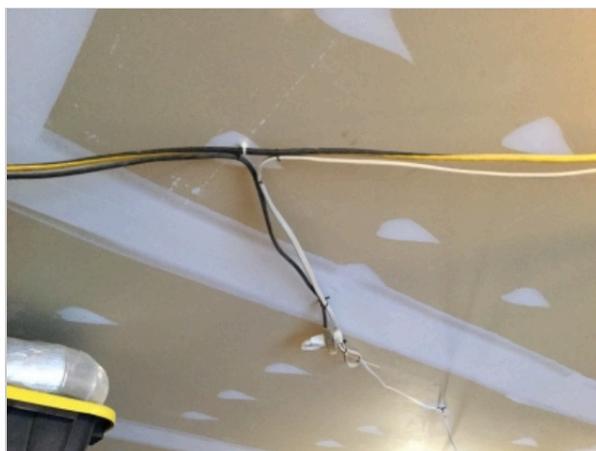
**Evidence of amateur wiring was observed in the garage.** Amateur wiring may not conform to standards methods and could be a safety concern. Consult with a qualified electrician for repairs and further evaluation.

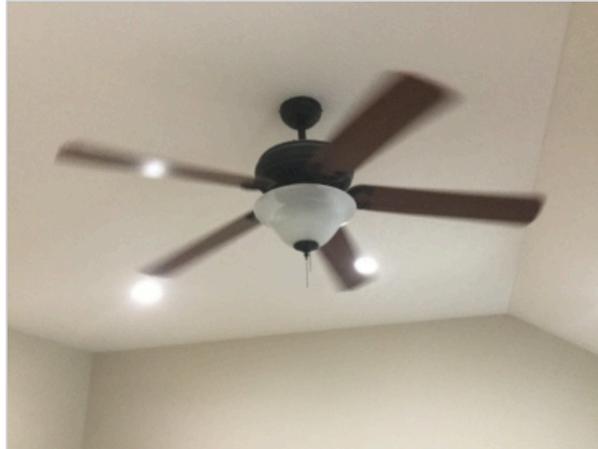
**Photo 26**

The ceiling fan light in the bonus room did not function at the time of inspection.

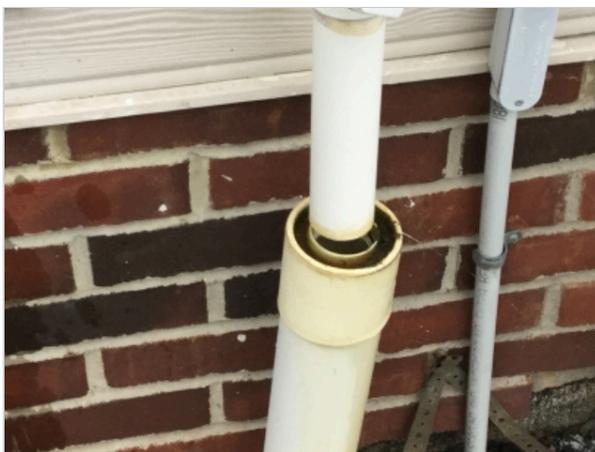
Photo 28

Exterior sump pump discharge line has a gap. Recommend to repair as necessary.

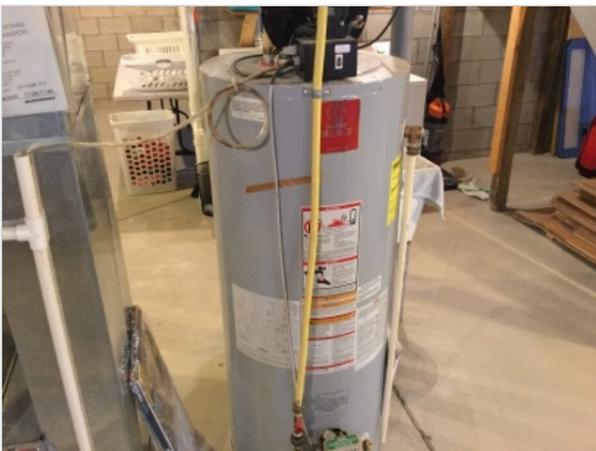
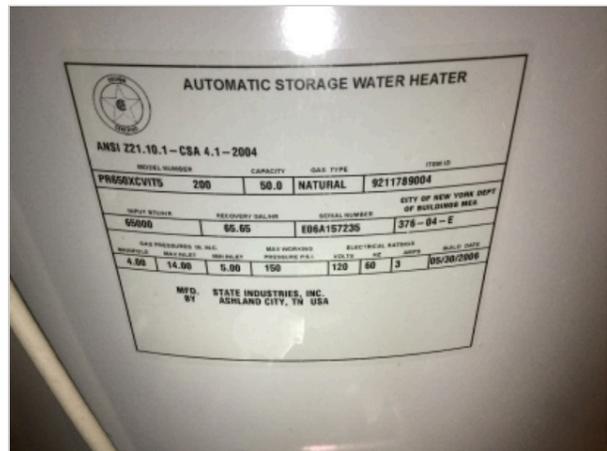
The water heater may be past its design life. This is an informational note only to help give an idea of future budgeting considerations. The unit was functional unless noted otherwise. Please note that since codes change, it is possible the configuration for a water heater's flue and/or discharge may need to be altered at the time of a future replacement.

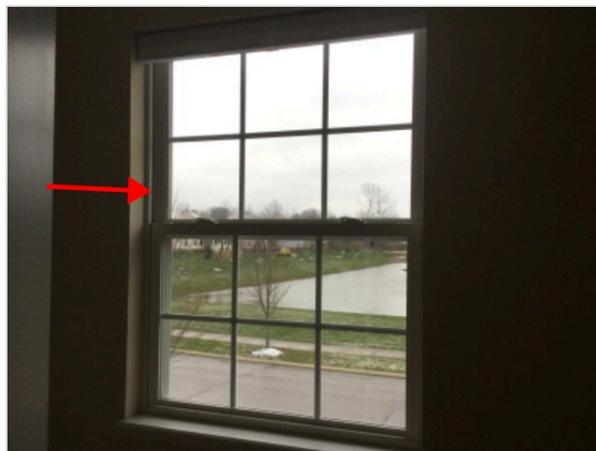
Photo 33

**One of the windows in the structure had a broken thermal seal.** A window with a defective thermal seal will show a slow but gradual "fogging" effect, and the insulation value of the window is marginally reduced. HomeTeam recommends having the affected window(s) repaired or replaced and further assessed.

Hall bathroom

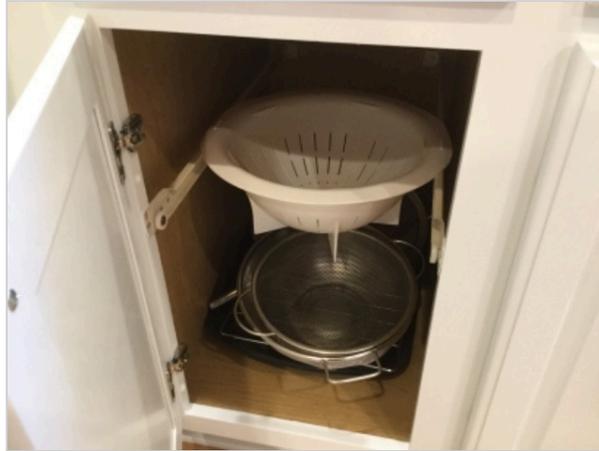
Photo 35

One of the kitchen cabinets was missing a sliding drawer.

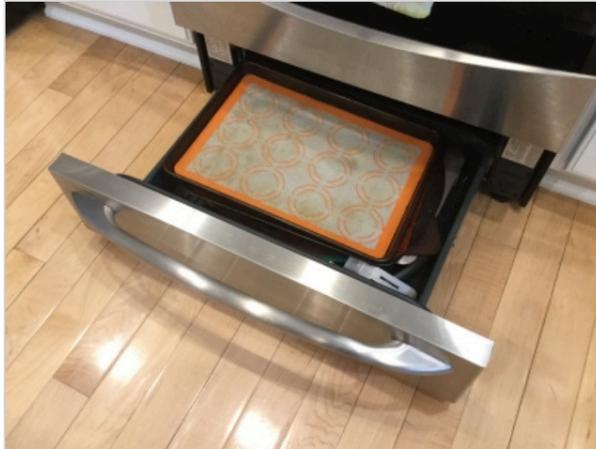
**Photo 38**

The lower oven did not function.
