1234 Sample Report Lane Dallas, TX 75228

I. STRUCTURAL SYSTEMS

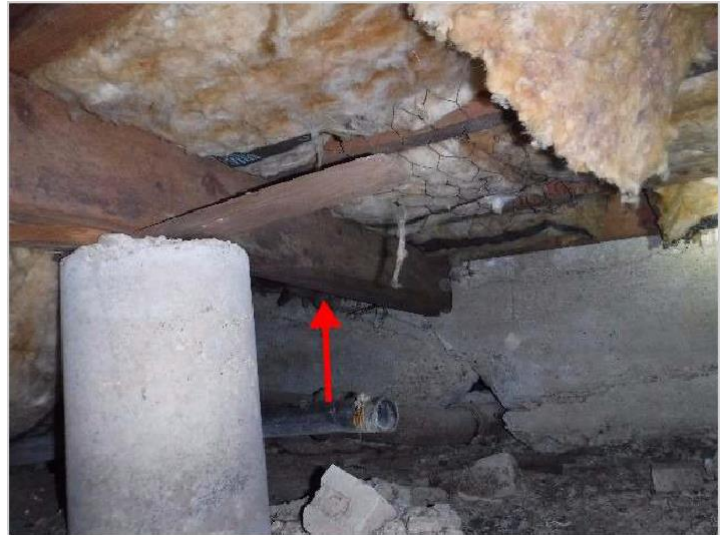
A

The second main beam from the right (PIC A,B) and the second main beam from the left (PIC C,D) in the rear crawl space were unlevel and twisted out of position along the entire lengths. The floor structure appeared to be compromised. Recommend further evaluation by an independent foundation repair specialist.

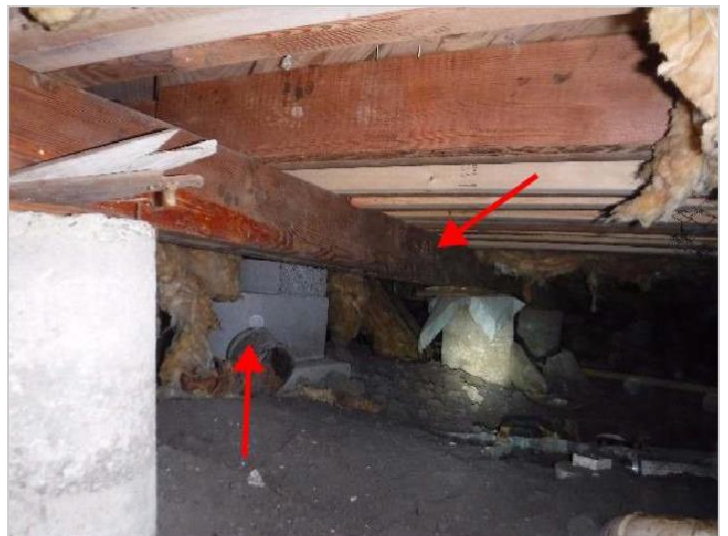
E

Main beam(s) were unlevel in the rear crawl space along the entire front (PIC B,D,E). The floor structure appeared to be compromised. Recommend evaluation by an independent foundation repair specialist.

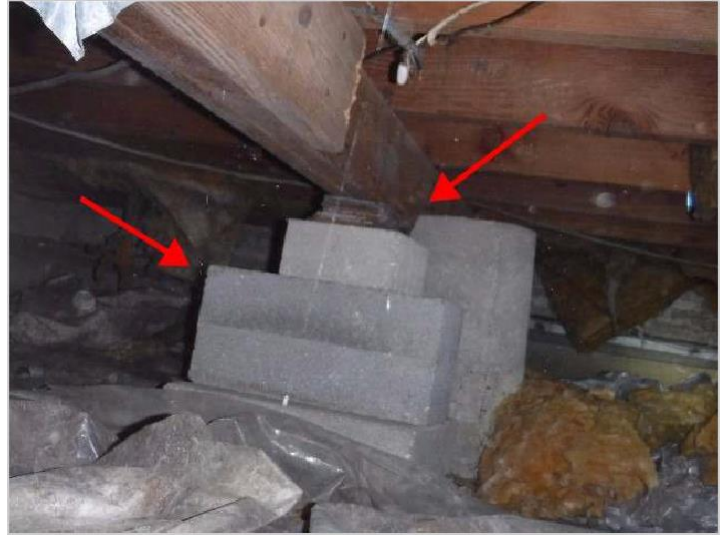
G

The middle main beam in the front crawl space under the kitchen area was twisted out of position (PIC F) and attempts at additional support did not appear to be adequate (PIC F,G). Recommend evaluation and repair as needed by an independent foundation repair specialist.

- The middle main beam in the front crawl space under the kitchen area was twisted out of position (PIC F) and attempts at additional support did not appear to be adequate (PIC F,G). Recommend evaluation and repair as needed by an independent foundation repair specialist.

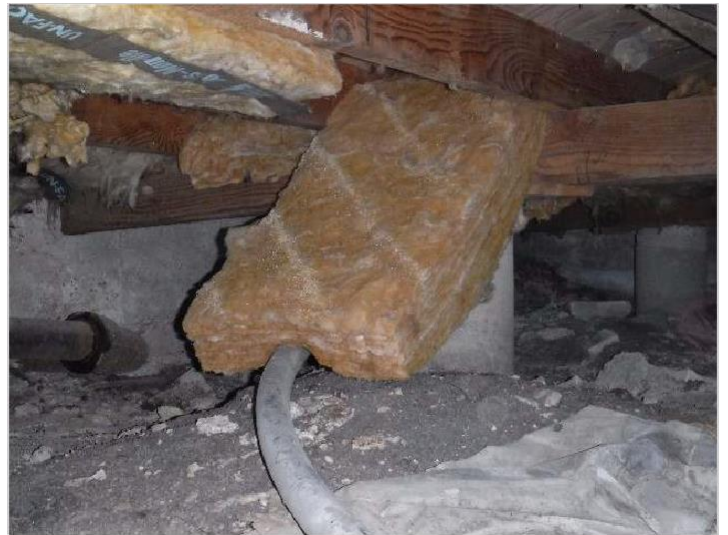
I

The front main beam in the front crawl space was shifted completely off the pier at the left side (PIC H). Attempts at additional support did not appear to be adequate. Recommend evaluation and repair as needed by an independent foundation repair specialist. Insulation under the floor was loose and resting on the ground throughout the front and rear crawl spaces (PIC I,J,K,L).

- Insulation under the floor was loose and resting on the ground throughout the front and rear crawl spaces (PIC I,J,K,L).
- Several hydraulic jacks were used for permanent framing support under the front living room area (PIC M).

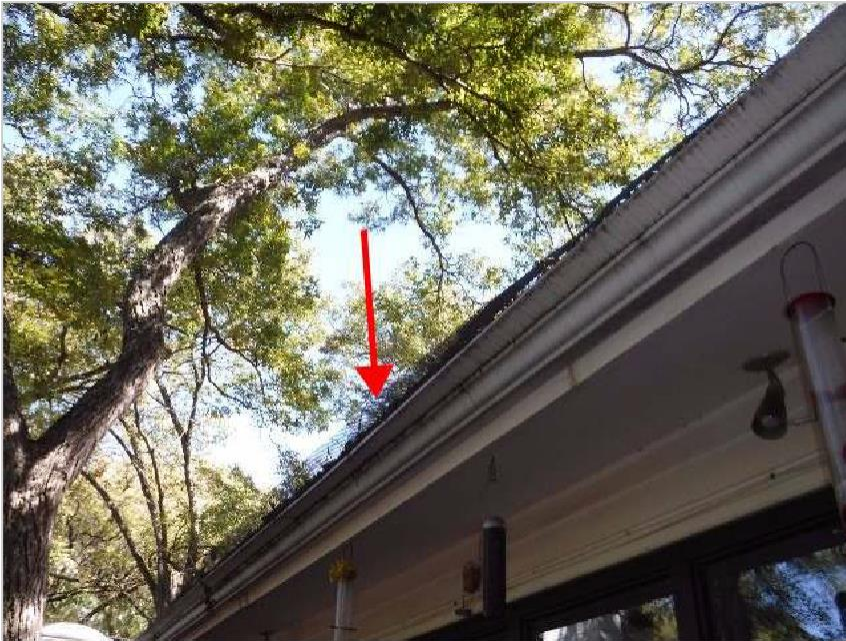
A

The addition of gutter downspout extension(s) are recommended at the front left and the front middle to allow water to drain properly away from the foundation. Gutter(s) were damaged at the rear left area (PIC A).

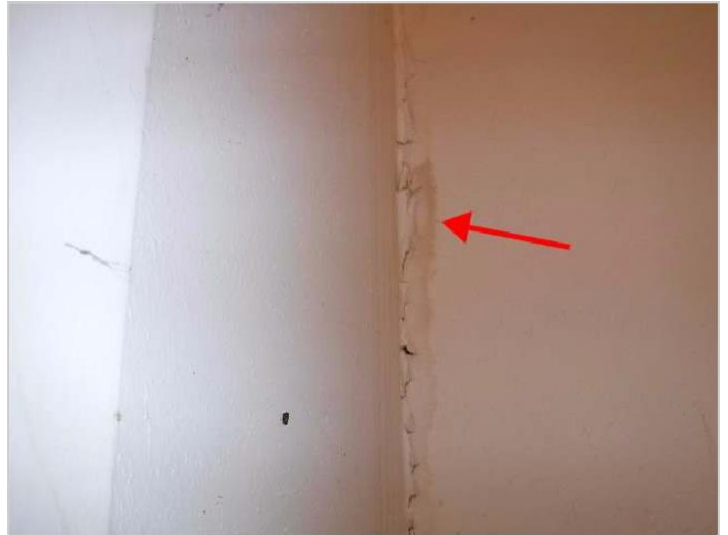
1A

- Water stain(s) were observed at left side in garage water heater closet (PIC 1A) and at multiple locations in front entry closet (PIC 1B).
- Baseboards were missing in front entry closet at left side (PIC 1C).

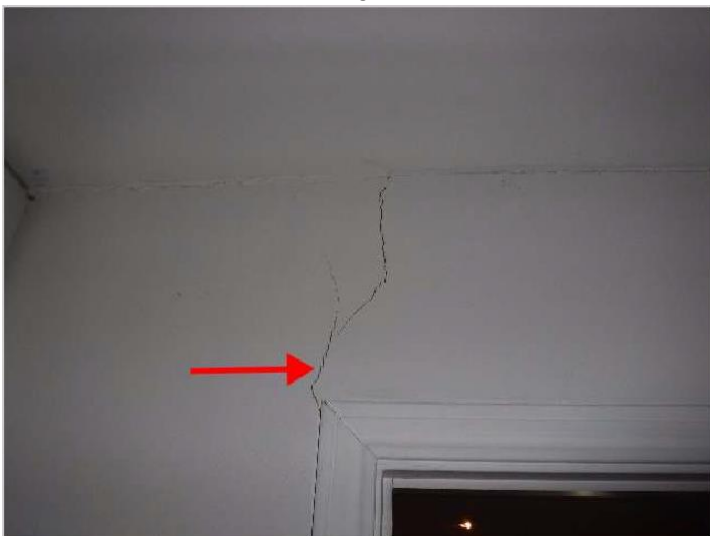
1E

- Door trim was missing in garage at left side exterior entry (PIC 1D).
- Sheetrock crack(s) were observed in utility room above the right side entry (2) (PIC 1E, 1F) and in utility room above exterior entry.

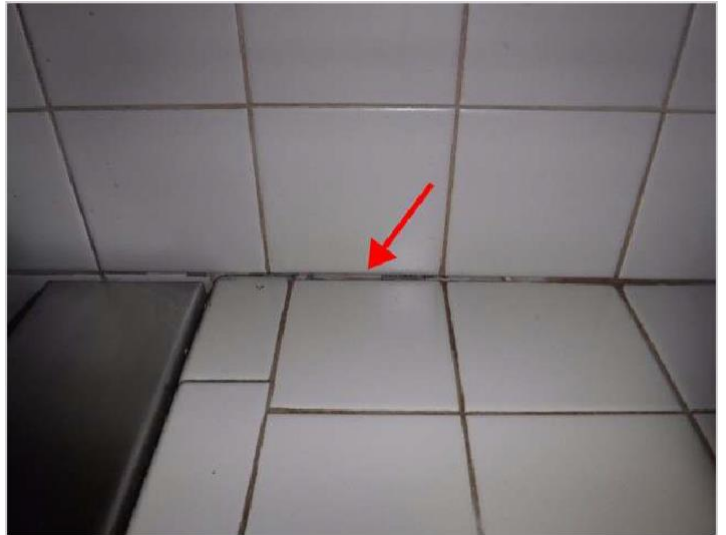
1H

- WDI damage was observed at rear wall in garage bath (PIC 1G). Refer to independent Wood Destroying Insect report if applicable.
- Caulk/seal was needed at backsplash at counter(s) in kitchen (PIC 1H).

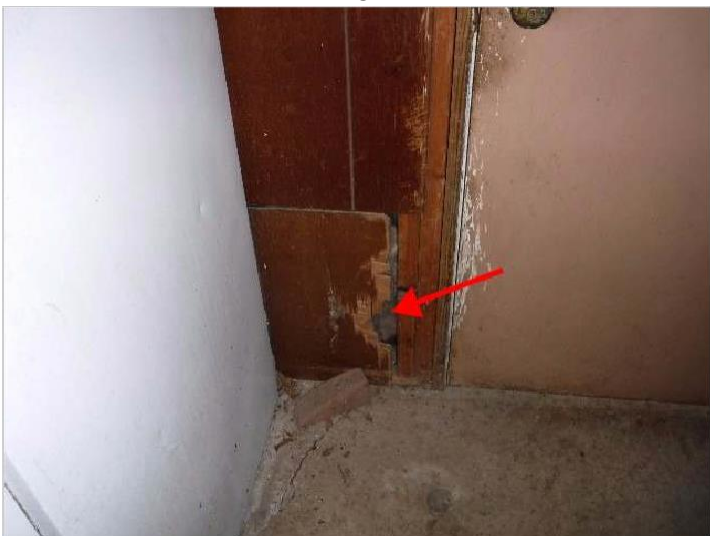
1I

- Damaged panels were observed at left side rear in garage (PIC 1I).
- The rear left kitchen countertop was not properly secured.
- Wood panel was cracked/damaged at right side rear in right hall (PIC 1J).

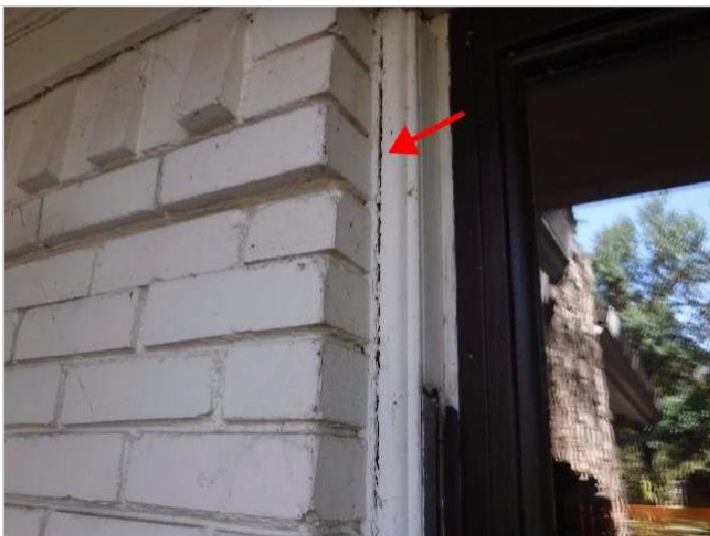
2A

- Caulk/seal was needed at the right side of the rear patio entry doors (PIC 2A).
- Damaged trim was observed at the rear right top corner of the front porch (PIC 2B).

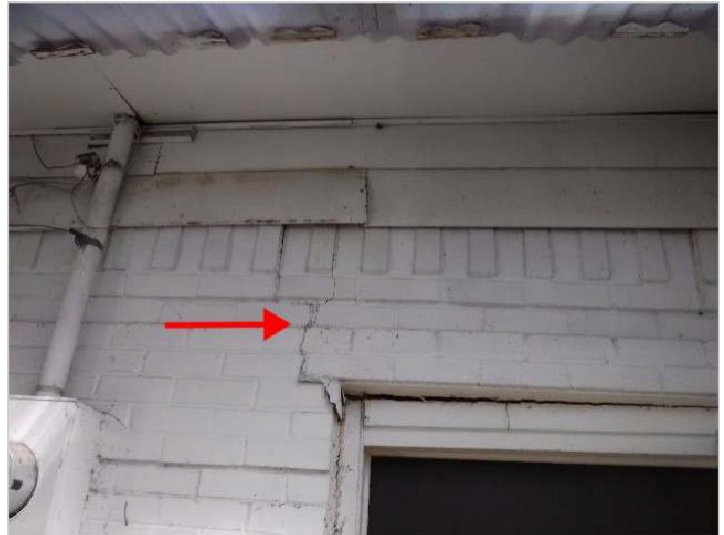
2C

- Vertical/stairstep crack(s) were observed in the brick surface at the right side of the garage (PIC 2C), at the left side above the garage entry door (PIC 2D), at the rear left corner of the rear living room (PIC 2E), at the right side middle (PIC 2F,2G) and at the right side front (PIC 2H).

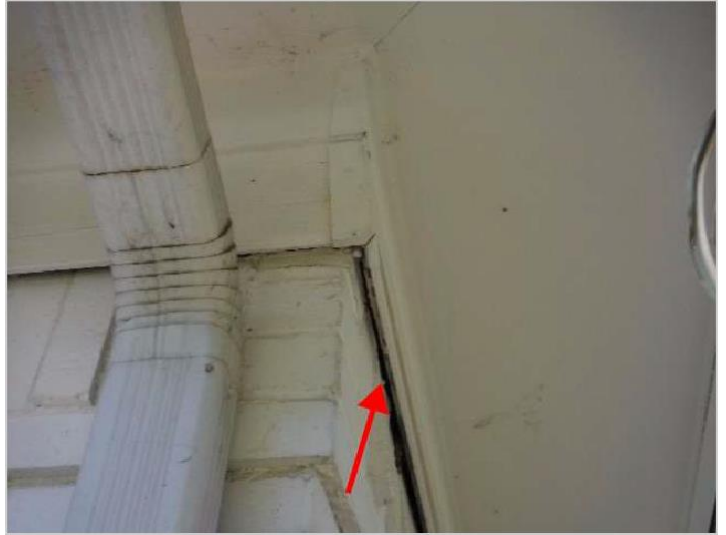
2I

- Crack(s) with deflection were observed in the brick surface at the front right corner (PIC 2I).
- Brick frieze board displacement was observed at the right side of the garage (PIC 2J).

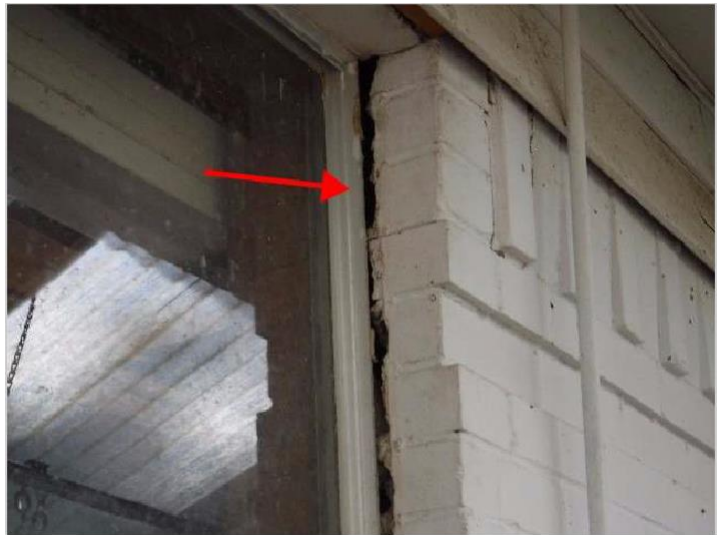
2K

- Separation was observed at both left side garage windows (PIC 2K,2L).
- Loose brick(s) were observed at the soldier row at the left side of the garage (PIC 2M).

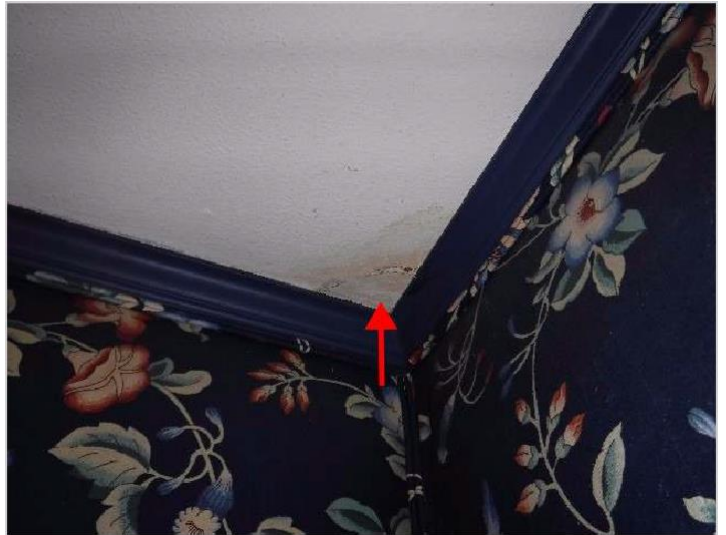
A

Damaged sheetrock was observed at rear middle (PIC A) and front left (PIC B) in front left bedroom.

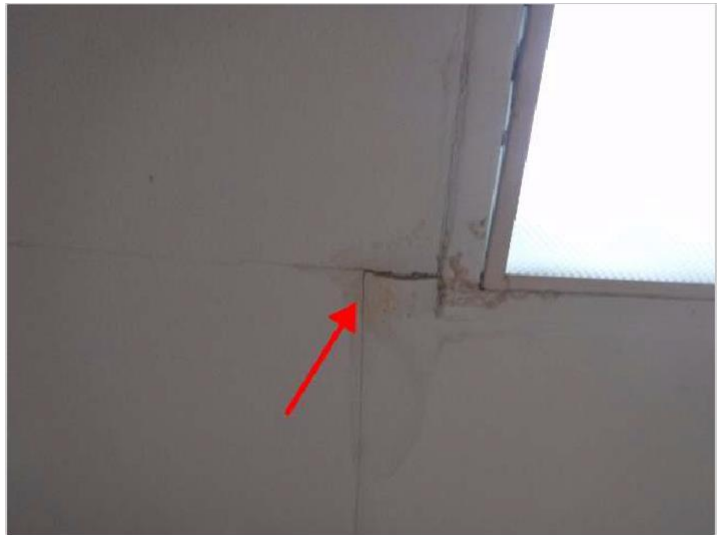
C

Water damage was observed at ceiling above garage water heater (PIC C) and at middle around light/skylight in kitchen (PIC D, E).

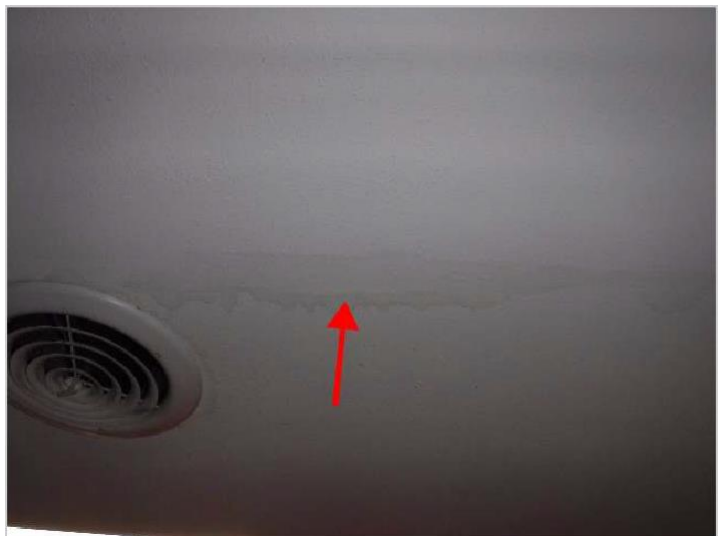
F

Water stain(s) were observed at front right (PIC F) and front left (PIC G) in rear living room, at middle (3) (PIC H, I, J) in rear hall bath and at rear right in front entry closet (PIC K).

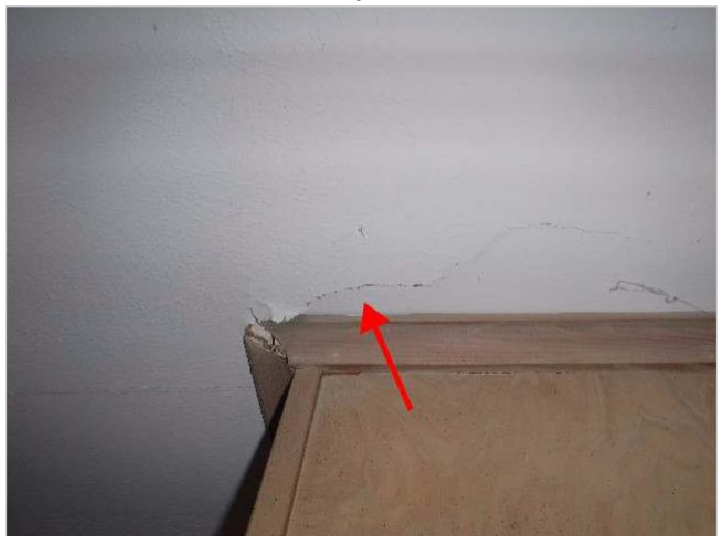
L

Sheetrock crack(s) were observed in front living room at left side hall entry (PIC L) and in rear bedroom at middle (PIC M).

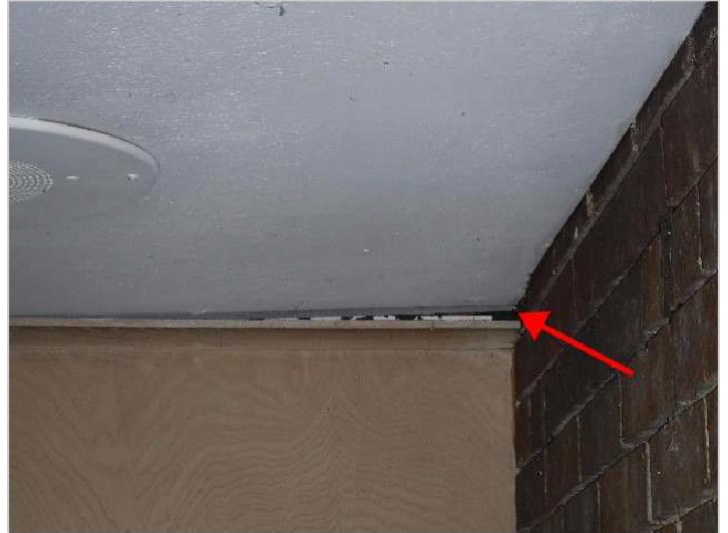
N

Separation was observed between ceiling(s) and wall(s) at front left in front living room (PIC N).

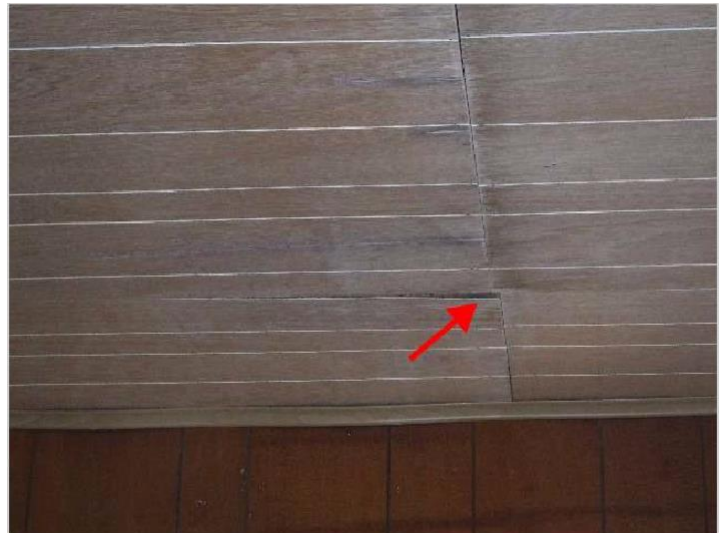
P

Loose/warped panels were observed at multiple locations throughout the garage ceiling (PIC O, P).

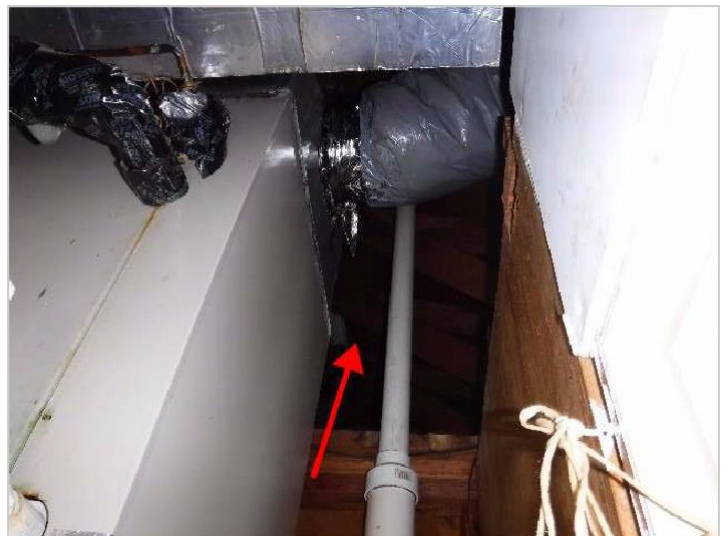
R

- An unidentifiable stain was observed at middle in rear bedroom (PIC Q).
- There was no ceiling in the right side furnace closet, the closet was open to the attic (PIC R).

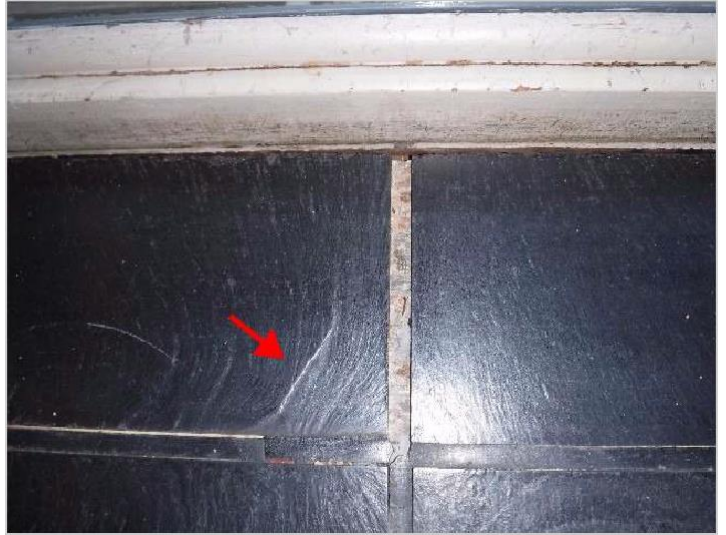
T

Cracked tile(s) were observed in front living room (7) (PIC S, T) and in kitchen (12) (PIC U, V).

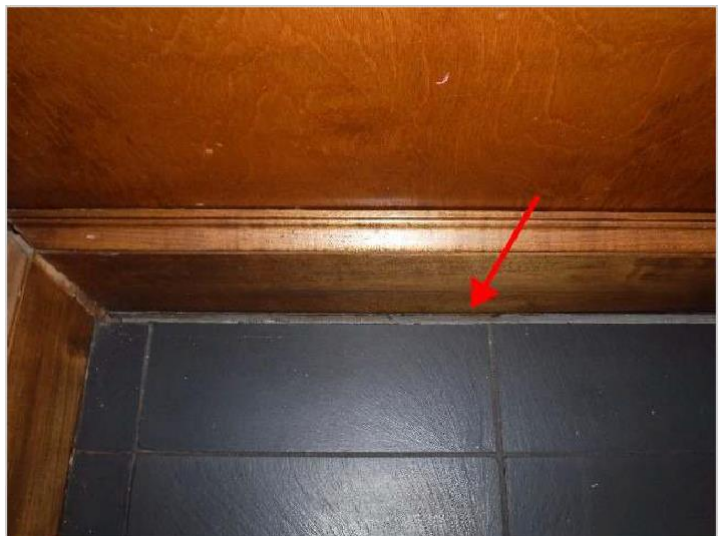
X

Separation between wall and floor was observed at rear in front living room (PIC W) and at front in rear living room (PIC X).

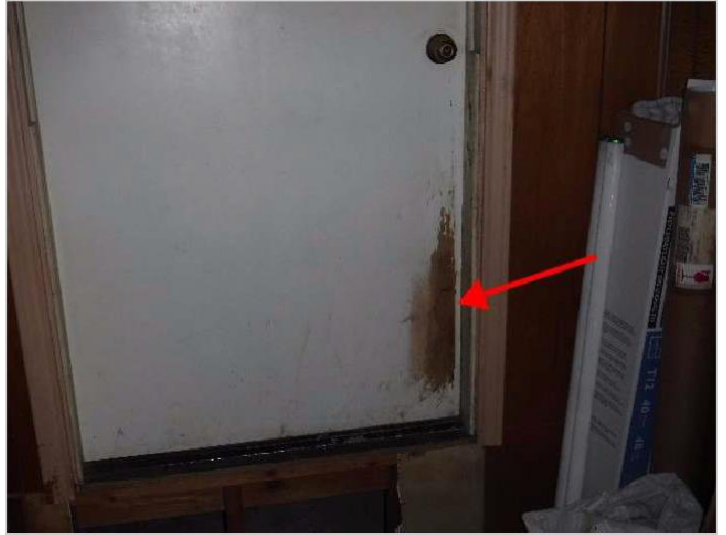
A

Water damage was observed on the door(s) at garage bath entry (PIC A).

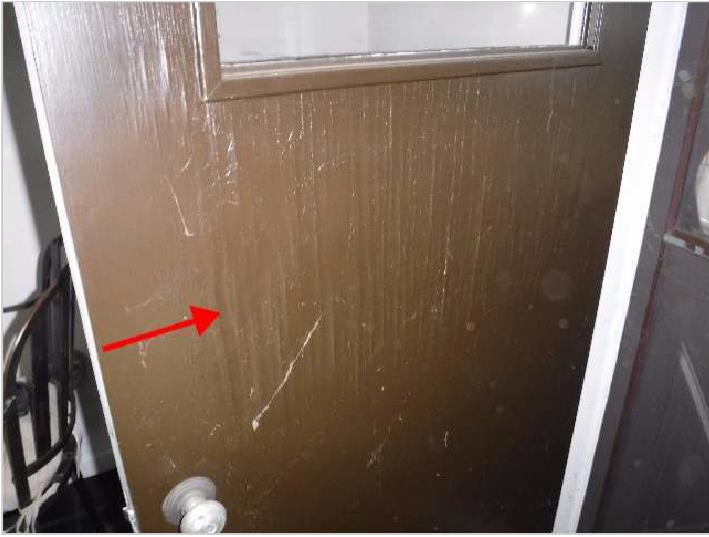
B

The door(s) were damaged at garage entry (PIC B).

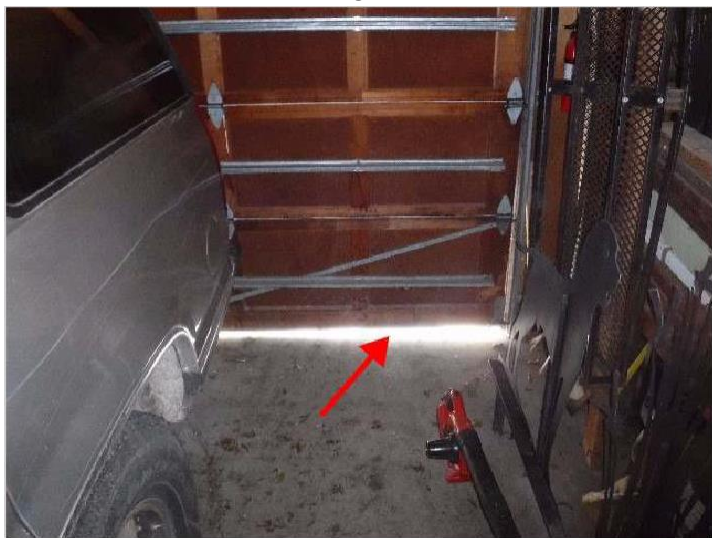
H

The overhead garage door panel(s) were damaged at right side bottom on bottom panel (PIC H).

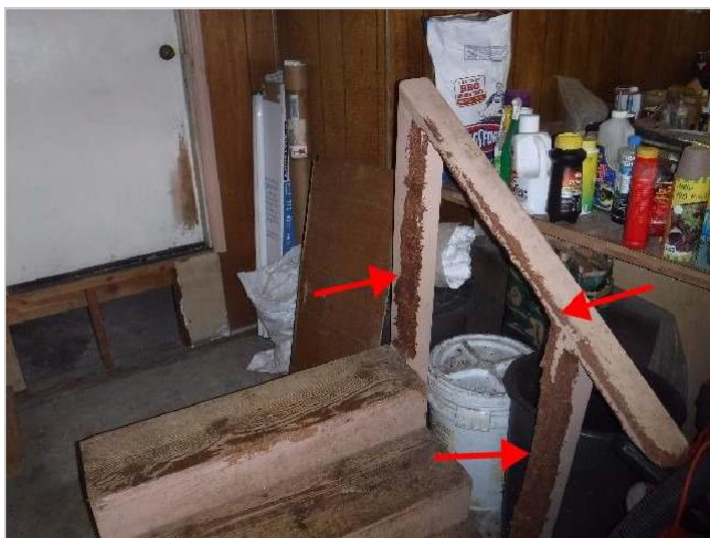
A

The handrail(s) were damaged at garage entry (PIC A).

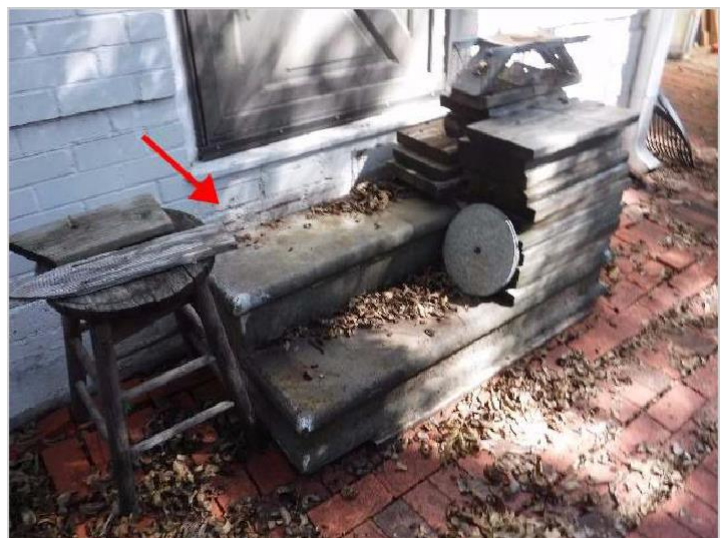
B

An improper riser height was observed at the left side exterior entry steps (PIC B).

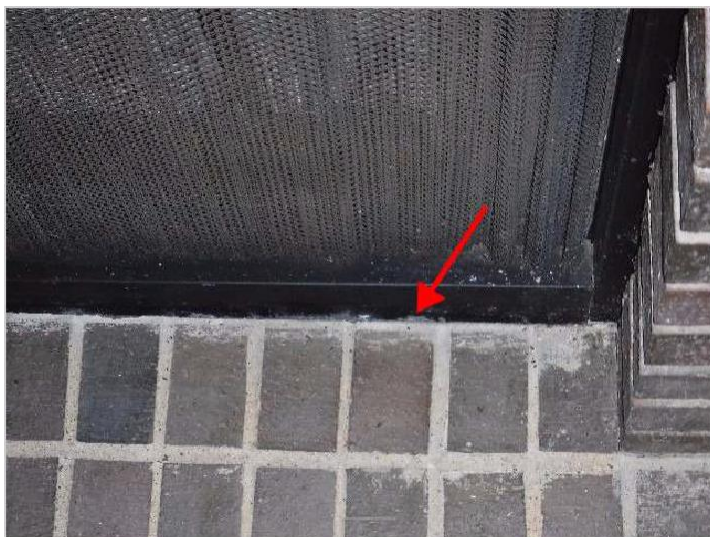
A gap was observed around the front living room fireplace and the brick (PIC A, B).

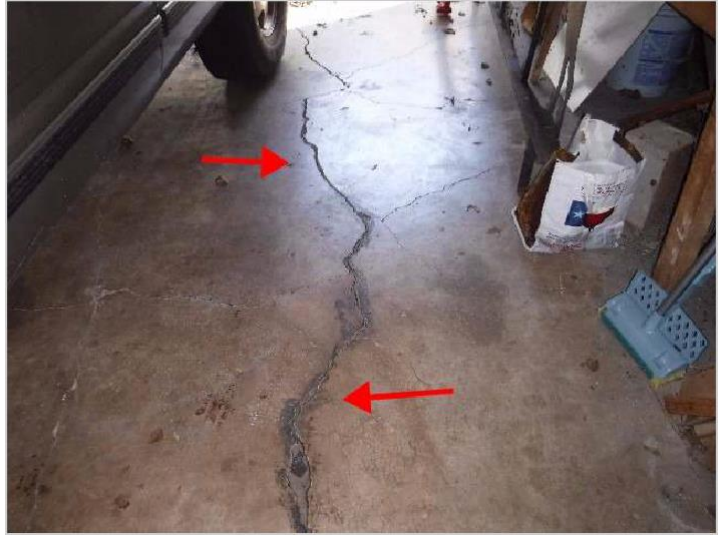
B

The garage floor was cracked/damaged and unlevel (PIC A,B).

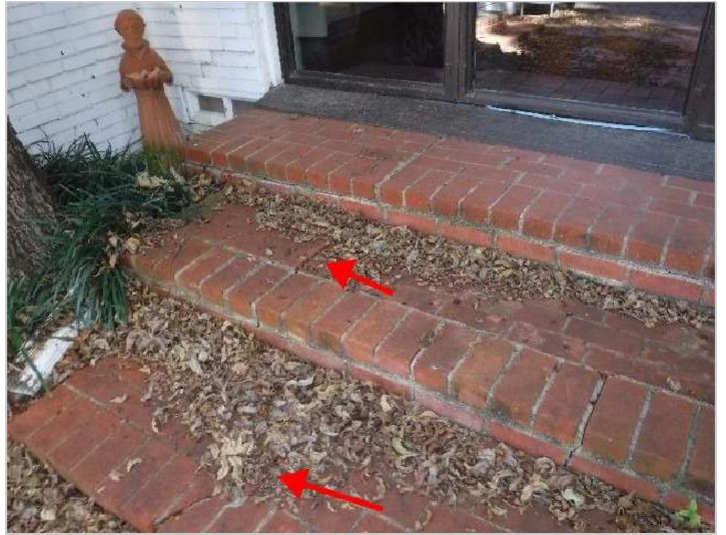
C

The rear brick steps were damaged and shifted throughout (PIC C,D,E,F) and present a considerable trip safety hazard.

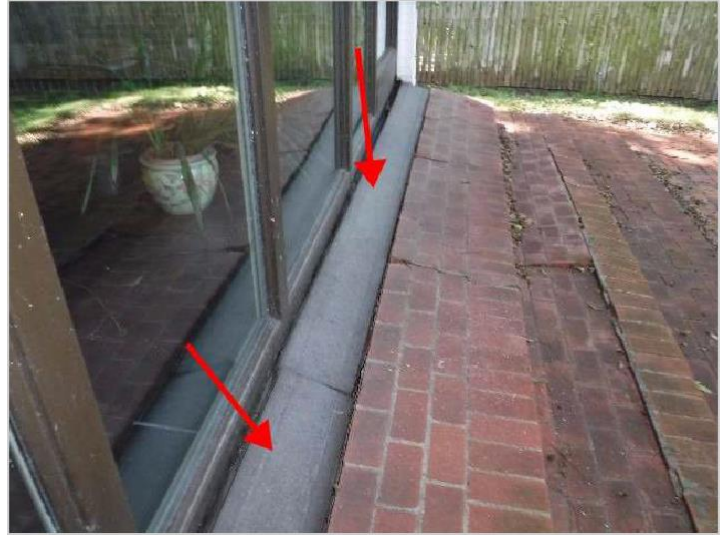
G

The transition between the rear entry and the rear brick steps was loose and unlevel (PIC G,H).

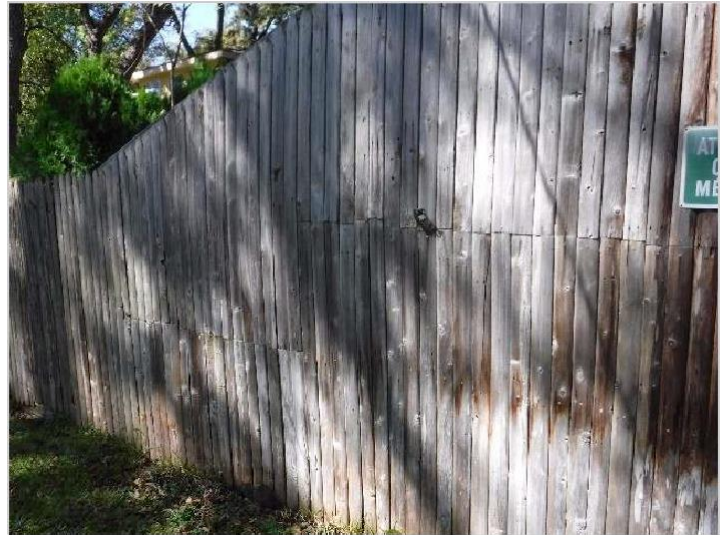
A

The fence was in need of cleaning and seal/stain around rear yard perimeter (PIC A,B).
Loose and damaged fence pickets were observed at the entire rear yard perimeter (PIC C,D).

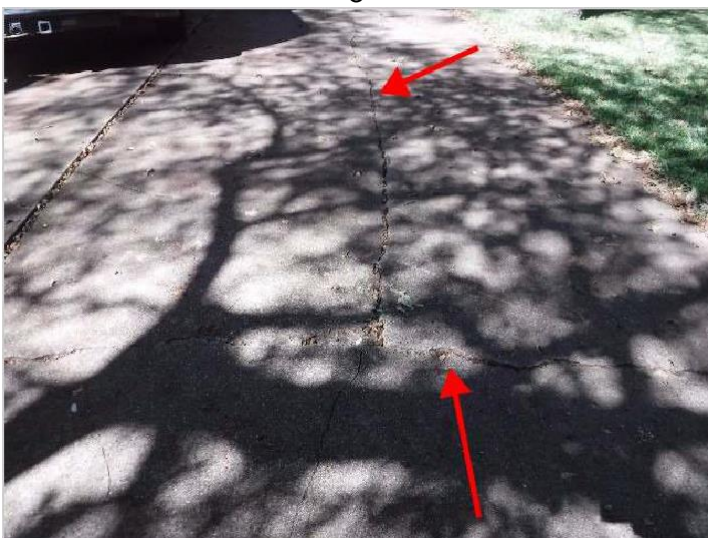
E

The driveway surface was cracked, damaged and unlevel (PIC E,F).

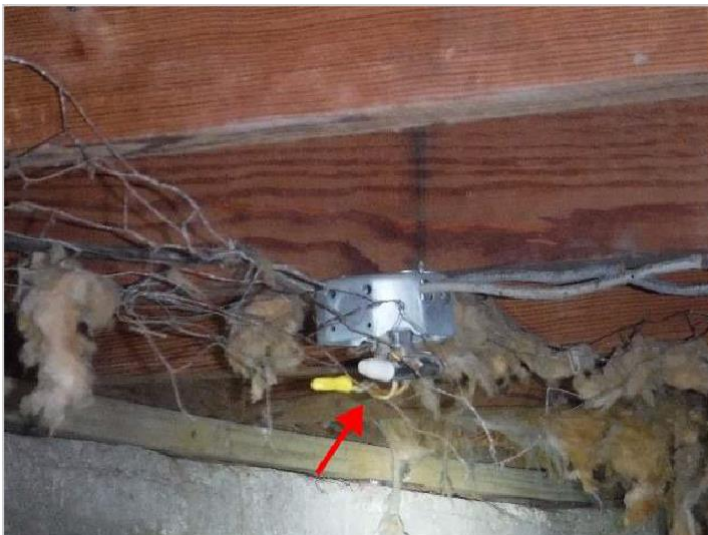
A

Junction box(es) were missing cover plate(s) in the crawl space at the front left (PIC A).

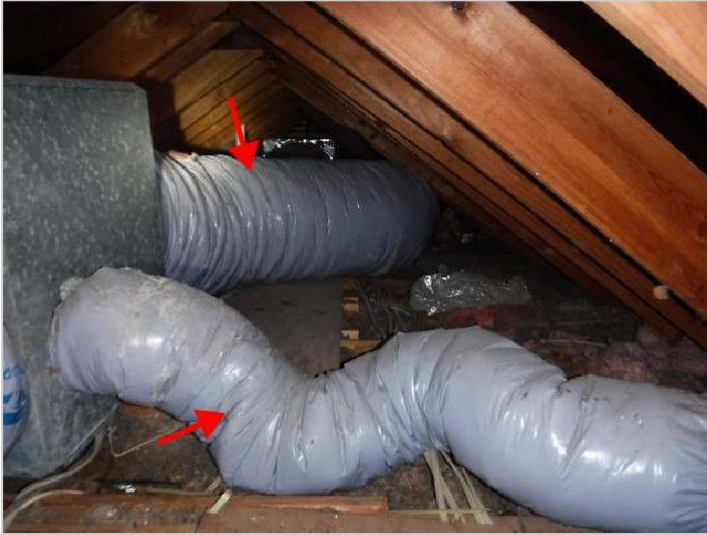
A

Gray vinyl sheathing ducts were observed throughout the attic space (PIC A,B), recommend duct replacement.

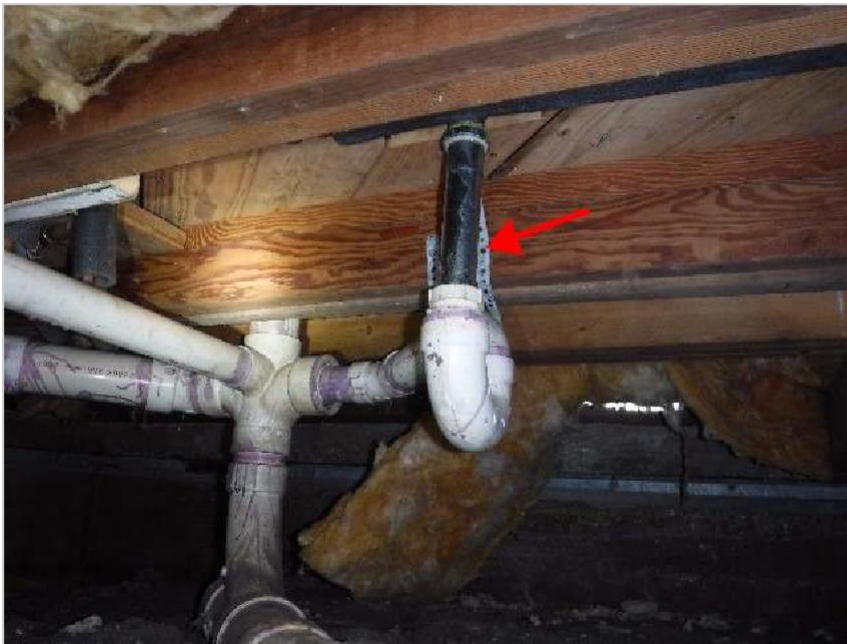
A

The drain line was leaking at the right side front bath tub (PIC A).

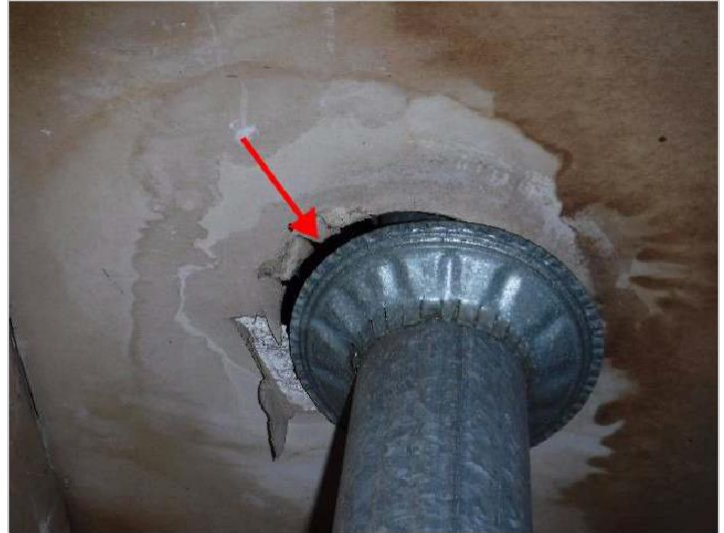
B

The emergency drain pan was damaged under the right side front bath water heater (PIC A). An improper firestop was observed at the garage water heater vent pipe penetration at the ceiling (PIC B), there was a gap at the ceiling.

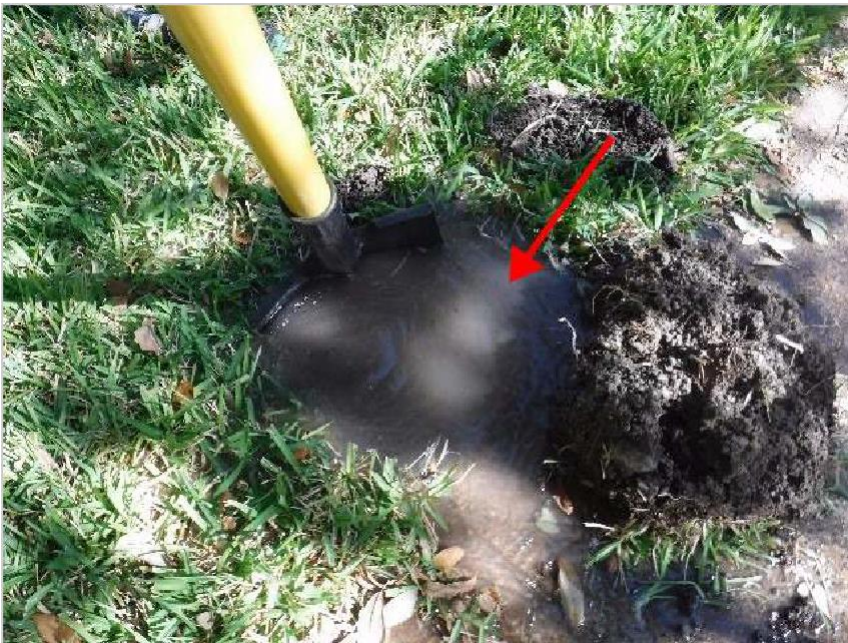
A

Sprinkler system station # 2: underground leak was observed at right side front of driveway (PIC A).
