PROPERTY INSPECTION REPORT

Concerning: 123 Sample Drive, Anytown, TX 12345

By: Jerimy Schiewe (# 21015) Dale Lockamy (# 22446) Bobby McDonald (# 8094) 12-12-2019

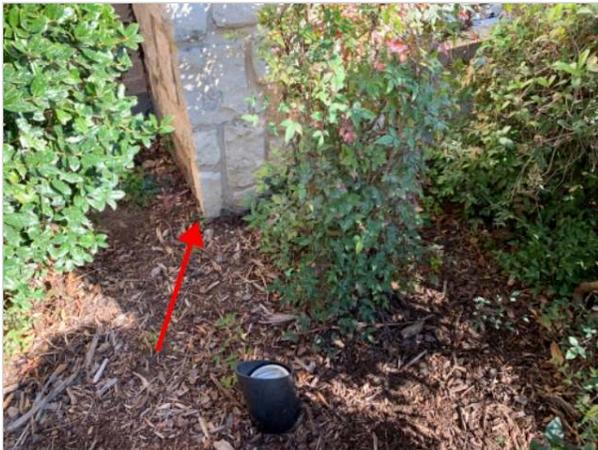
A

The soil level was too high at front (PIC A); the foundation was not fully visible. Recommend a 2"-4" exposure on the foundation below brick and/or siding around the entire perimeter.

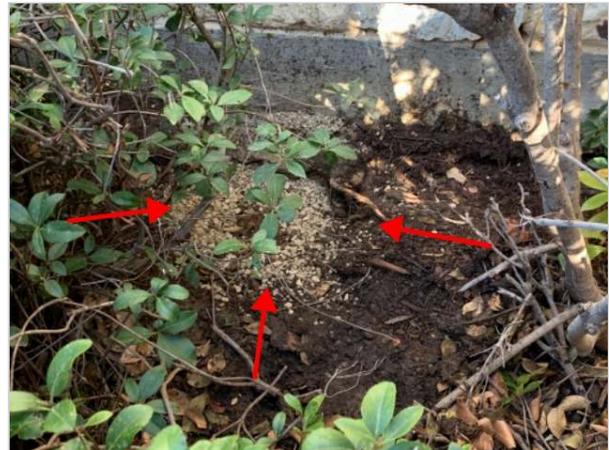
B

The soil was unlevel or too low adjacent to the foundation at front right (PIC B). Add and/or regrade soil as needed to prevent standing water at areas adjacent to the foundation.

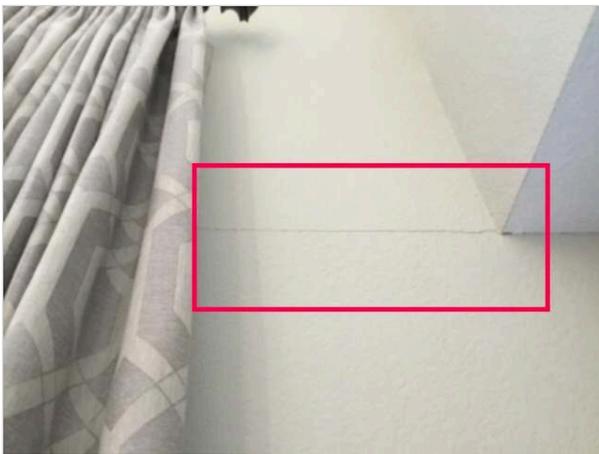
1A

Sheetrock crack(s) were observed on interior wall surfaces at rear right in rear living room (PIC 1A) and front right at door entry in upstairs rear left bedroom (PIC 1B).

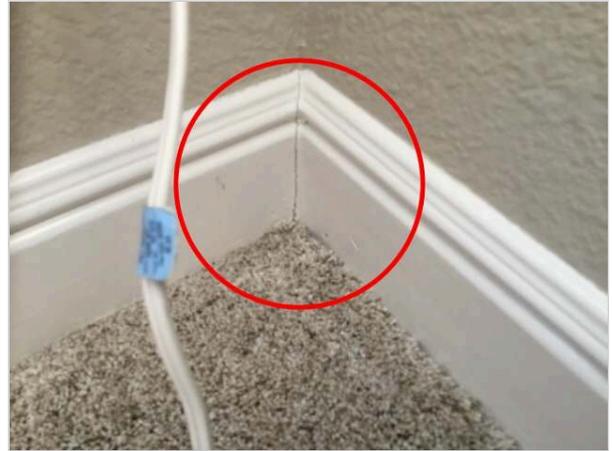
1D

Gaps were observed in baseboard joint(s) at front left corner in front dining room (PIC 1D) and rear left corner in study (PIC 1E).

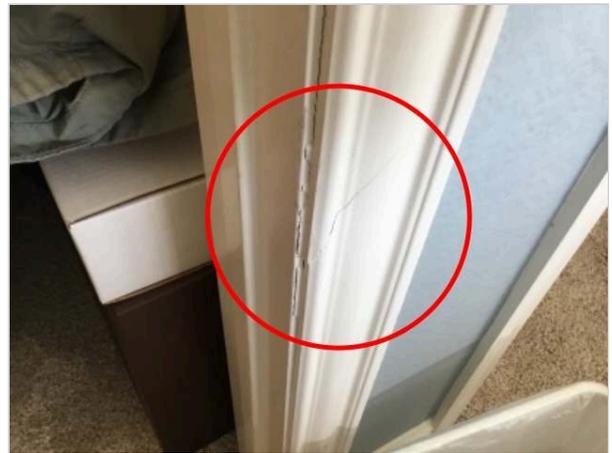
1F

Door trim was damaged at closet entry in upstairs front left bedroom (PIC 1F)

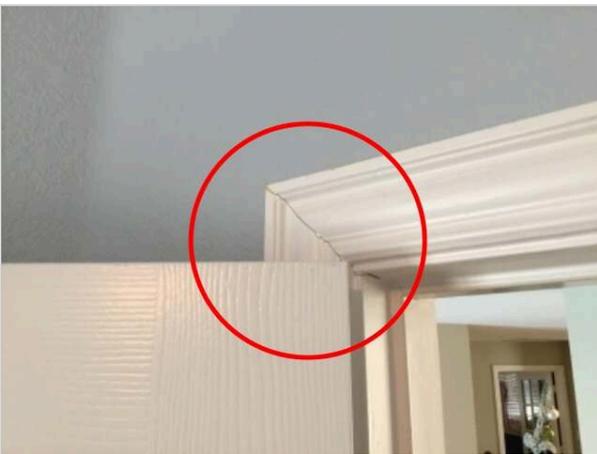
1G

Gap(s) were observed on interior door trim at upstairs rear left bedroom entry (PIC 1G) and upstairs hallway bath entry (PIC 1H).

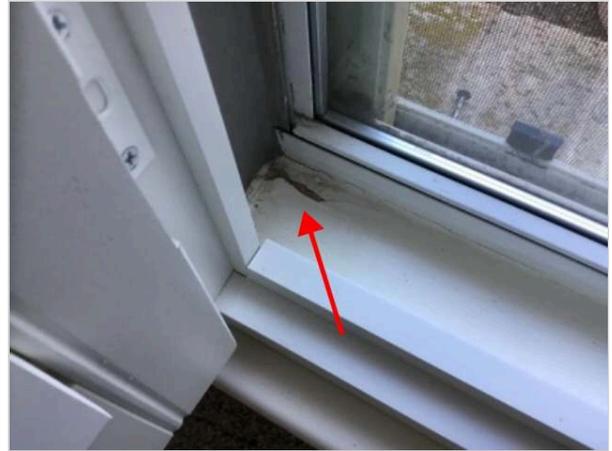
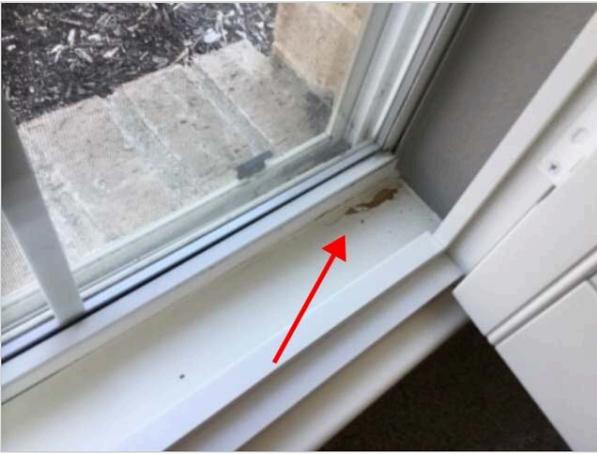
Water damage was observed on window sill(s) at multiple windows at rear in master bedroom (PIC 1I,1J,1K), left window in upstairs front left bedroom (PIC 1L), upstairs rear left bedroom (PIC 1M), upstairs front right bedroom (PIC 1N,1O) and windows in upstairs living room(4) (PIC 1P,1Q).

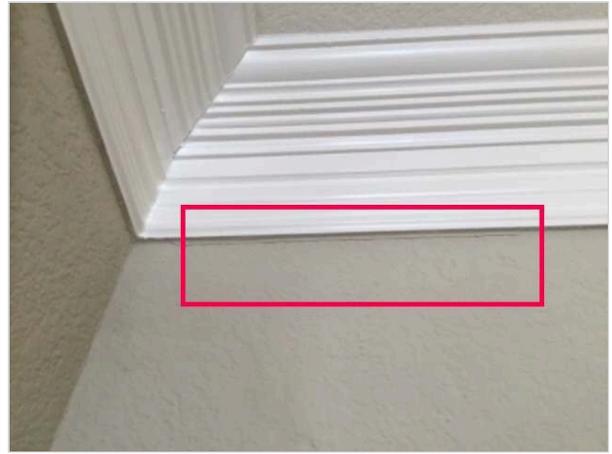
1R

Separation was observed at wall surfaces and bottom of crown molding at rear left and left side rear in front dining room (PIC 1R).

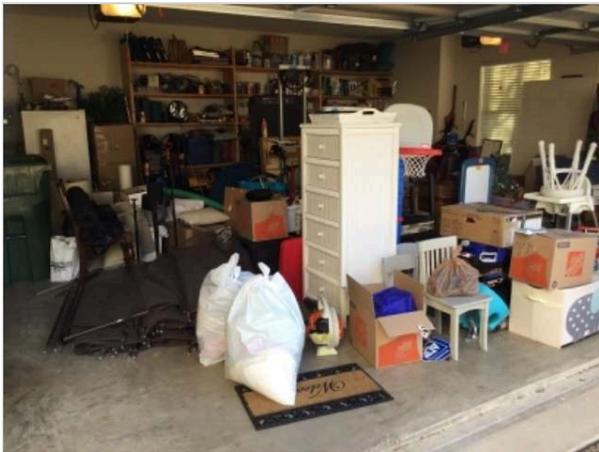
1S

Interior walls were inaccessible throughout garage due to storage and personnel belongings (PIC 1S).

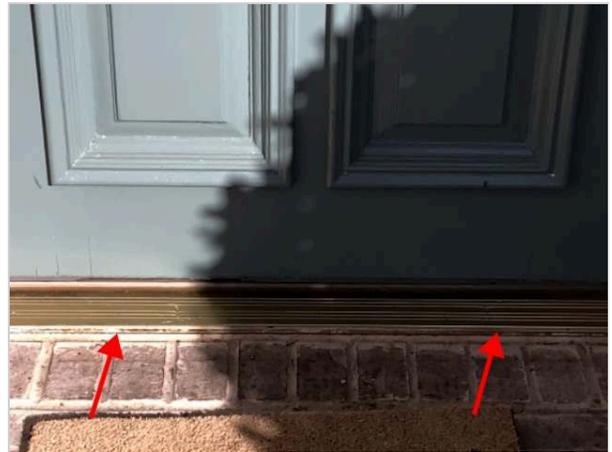
2A

- Separation was observed at wall surfaces and bottom of crown molding at rear left and left side rear in front dining room (PIC 1R).
- Caulk/seal was needed at front entry threshold (PIC 2A), at most exterior windows (PIC 2B, 2C) and at front right corner brick frieze board (PIC 2D).

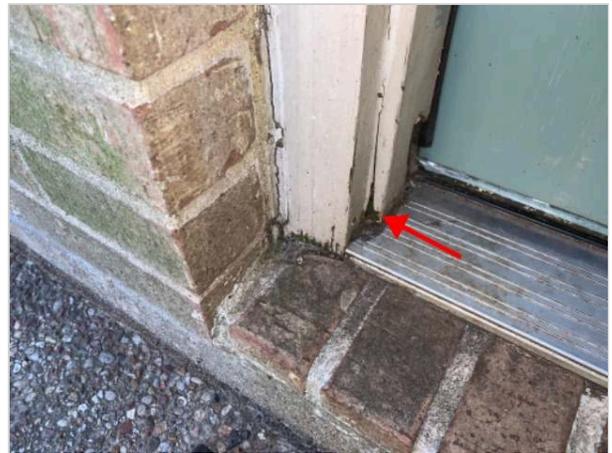
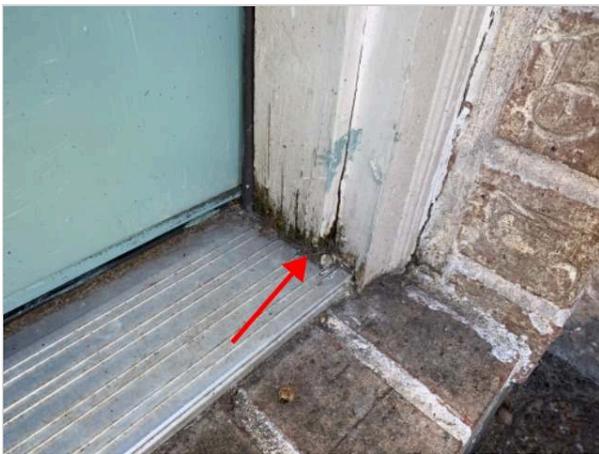
Dry rot was observed at right and left side bottom (PIC 2E, 2F) of rear entry.

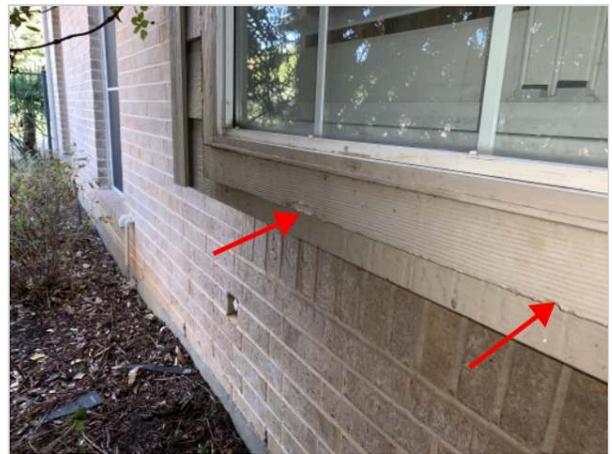
2G

Damaged trim was observed at left side front window (PIC 2G).

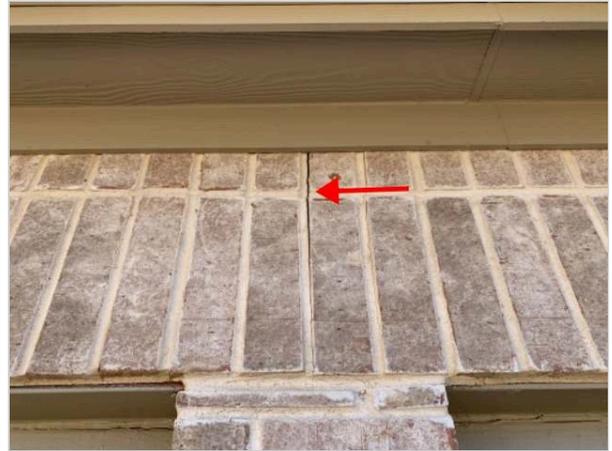
2I

Separation was observed at front right between garage doors (PIC 2I).

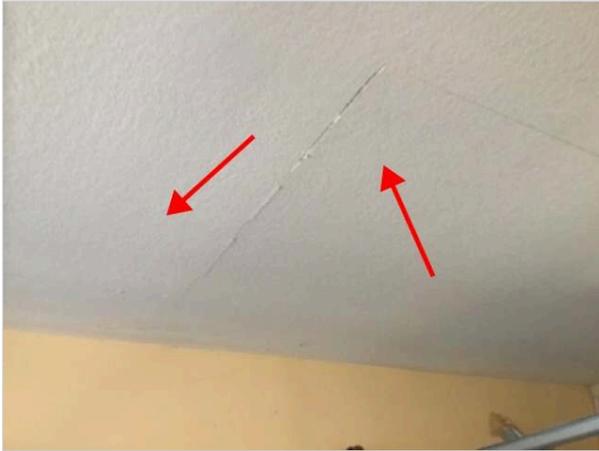
A

Sheetrock crack(s) were observed at ceiling surfaces at rear left in garage (PIC A).

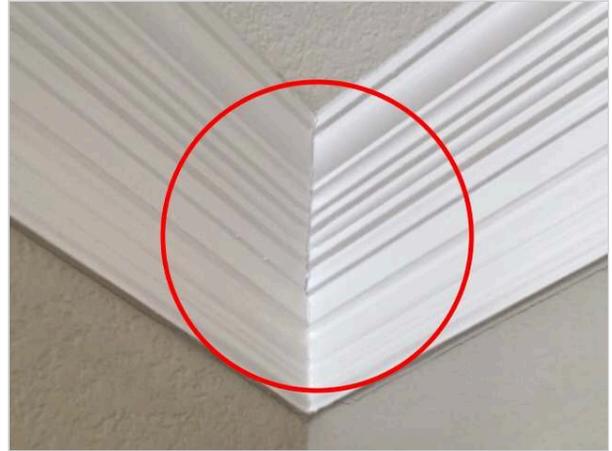
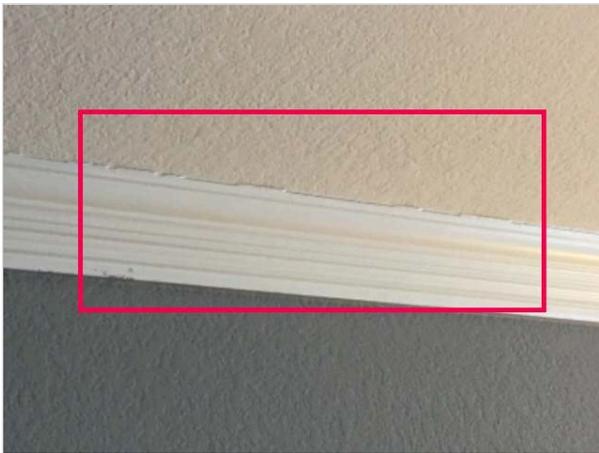
Separation was observed between ceiling(s) and crown molding at multiple locations in master bedroom (PIC B,C).

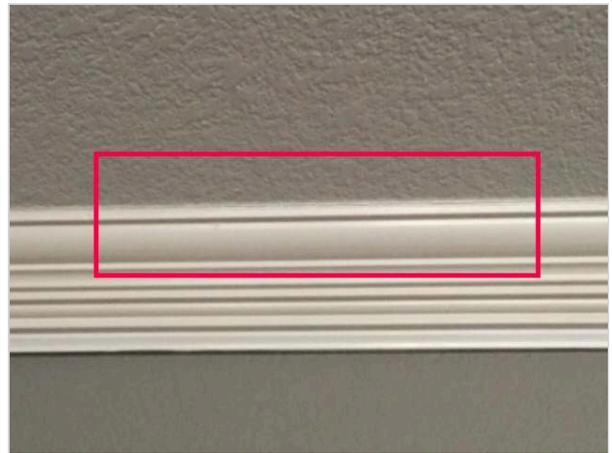
D

Gaps were observed in crown molding joints at rear left and right corners in front dining room (PIC D).

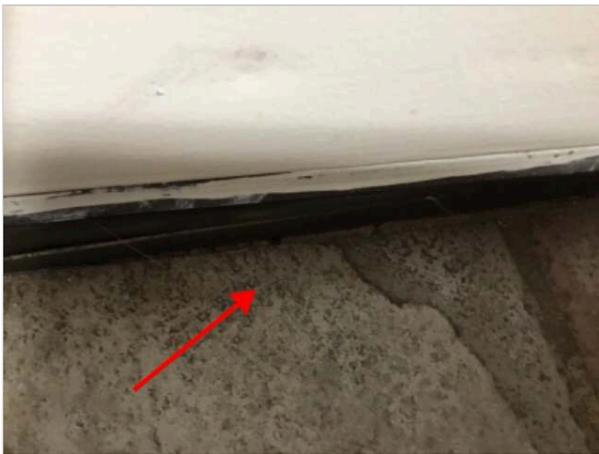
E

Cracked/missing grout was observed at threshold at garage entry (PIC E).

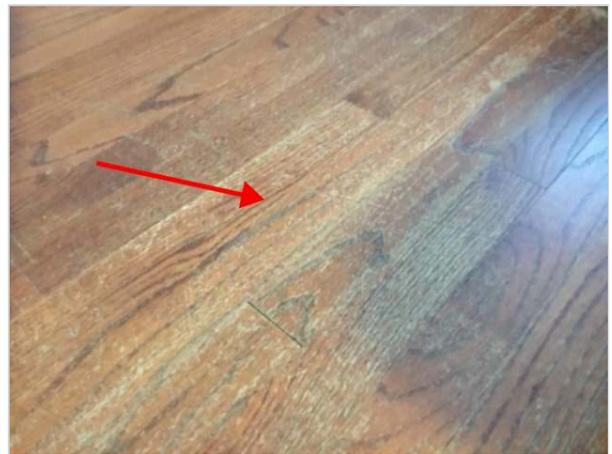
F

Significant wear was observed on wood flooring at multiple locations in study (PIC F,G).

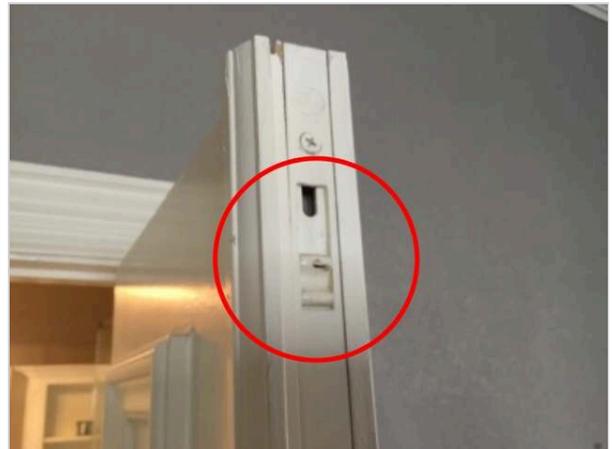
B

The interior door frame(s) were damaged at upstairs rear left bedroom entry (PIC B).

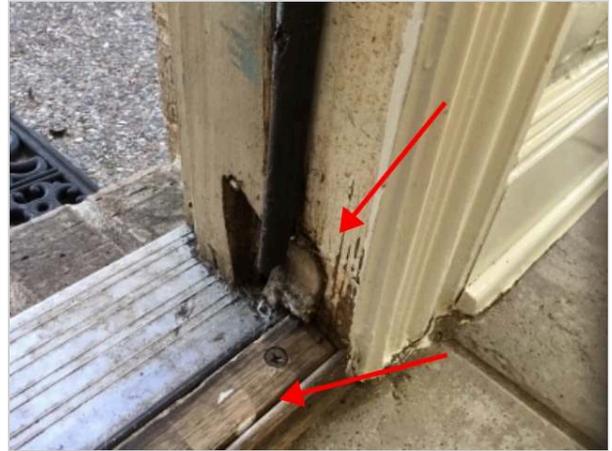
D

Water damage was observed at the base of door framing and/or threshold at rear entry (PIC C,D).

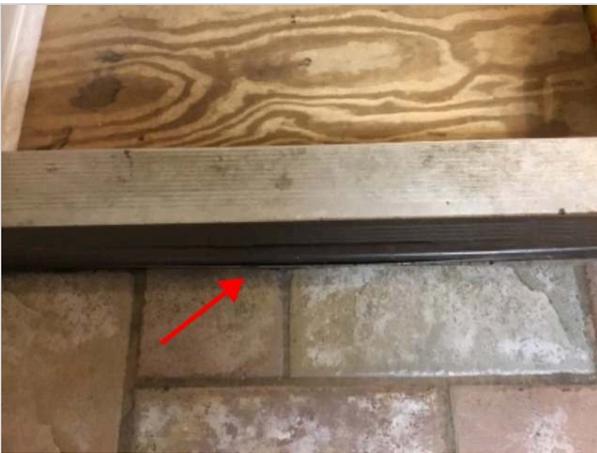
E

The door(s) rubbed at the exterior door framing during operation at rear entry in rear dining room. The threshold(s) were damaged at base of door(s) at rear entry (PIC E).

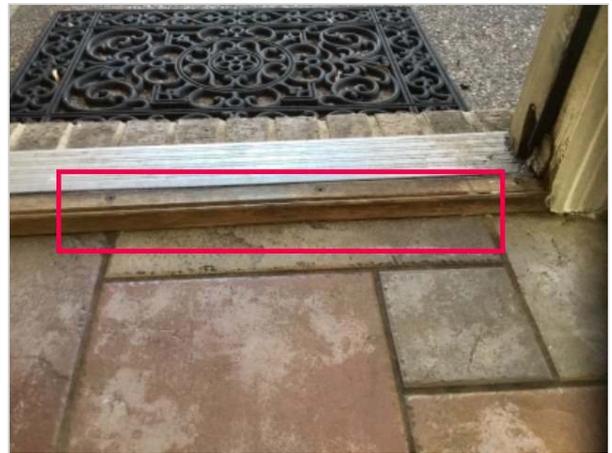
F

The threshold(s) were loose at base of door(s) at rear entry in rear dining room (PIC F).

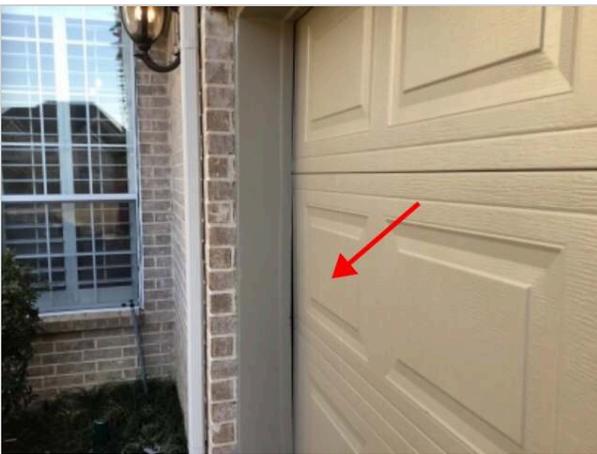
G

- The threshold(s) were loose at base of door(s) at rear entry in rear dining room (PIC F).
- The rear overhead garage door did not seal properly at the panel(s) and the door framing (PIC G).

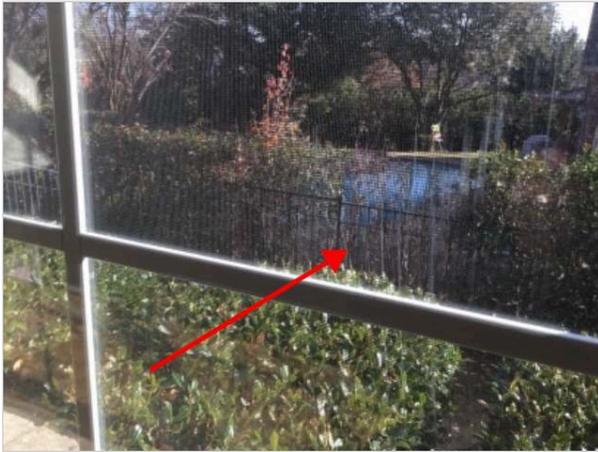
A

Window glass was scratched/damaged at lower panel at rear in kitchen (PIC A).

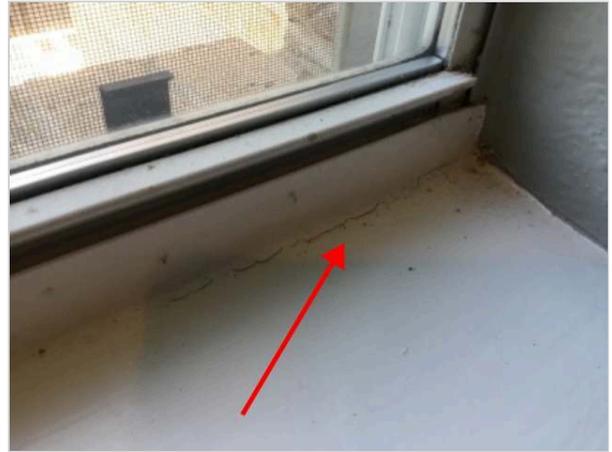
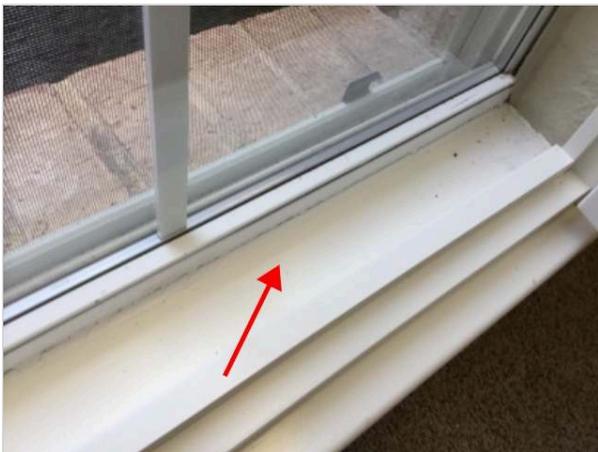
Gaps at interior window framing were observed at multiple interior window locations, caulk/seal as needed (PIC B,C).

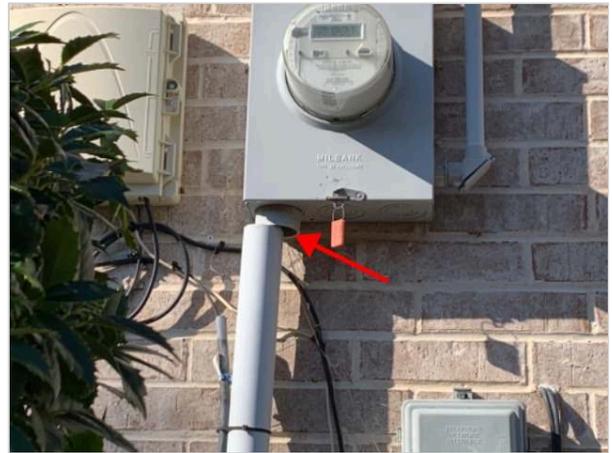
Arc-fault circuit protection has been required in some form in most cities since approximately 2002. Standards for which circuits require protection have changed over the years. There was no arc-fault circuit protection observed in the service panel at the time of the inspection. A gap was observed between conduit and meter box at right side exterior (PIC A).

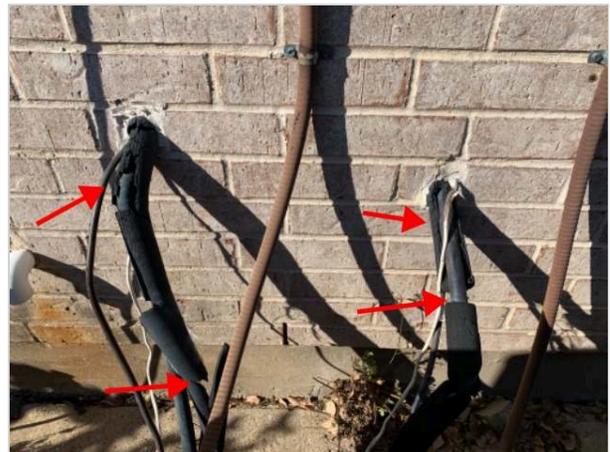
A

Insulation was damaged and/or missing on the refrigerant line(s) at right side exterior (PIC A).

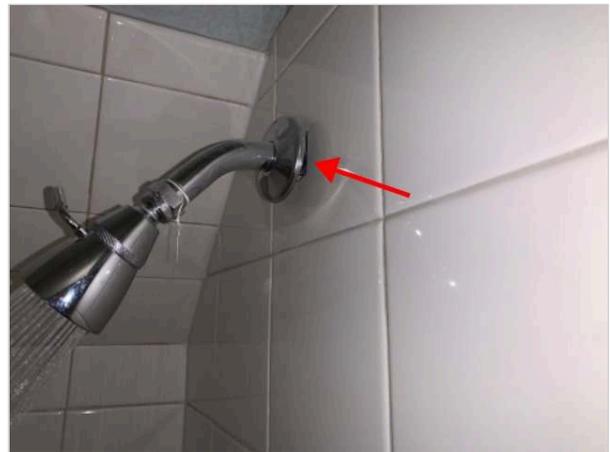
A

The collar was loose around the upstairs right side hall bath shower pipe at the wall (PIC A).

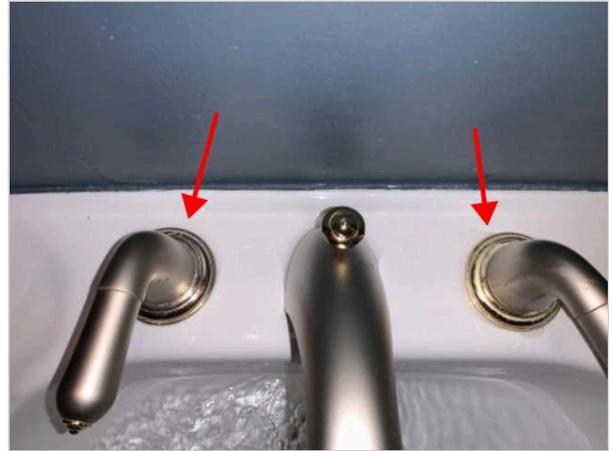
C

The hot and cold water valves leaked at the hall bath sink (PIC C).

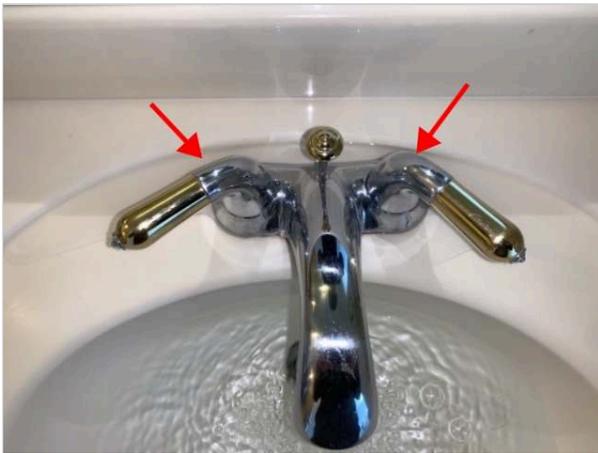
D

The hot and cold water valve leaked at right sink in upstairs left side bath (PIC D).

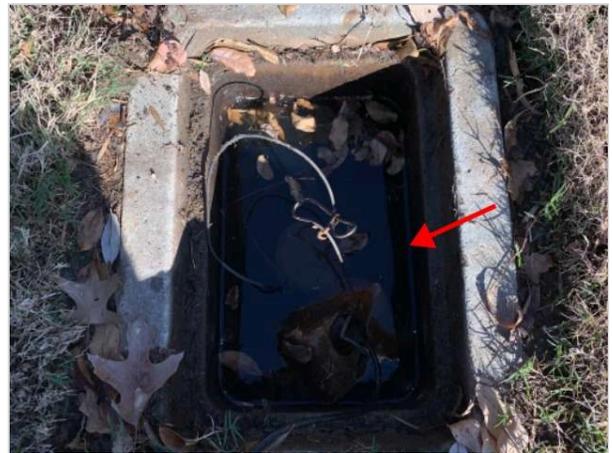
E

Meter box was full of water at the time of the inspection (PIC E), unable to determine the source of water; recommend evaluation by service provider and/or licensed plumbing professional.

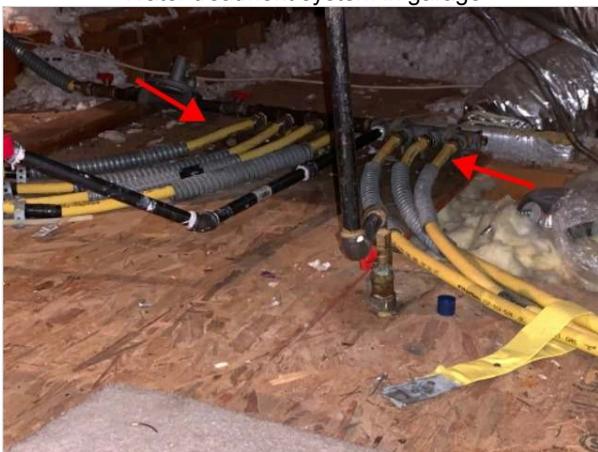
A

CSST gas lines were used for natural gas distribution; the CSST gas supply system was not inspected for proper bonding (PIC A).
