# HomeTeam<sup>®</sup>

### *HOME INSPECTION REPORT*

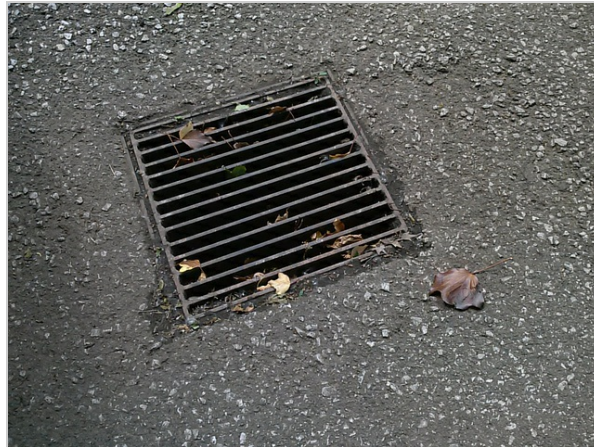
***NOTE: Some cracking of the asphalt driveway material was observed. This is not uncommon with older asphalt. The driveway was serviceable at this time. We recommend sealing this driveway with the appropriate material as part of a continuous maintenance program.***

***NOTE: A drain was present at the driveway, but appeared to be clogged. We recommend removal of debris so the drain can function.***

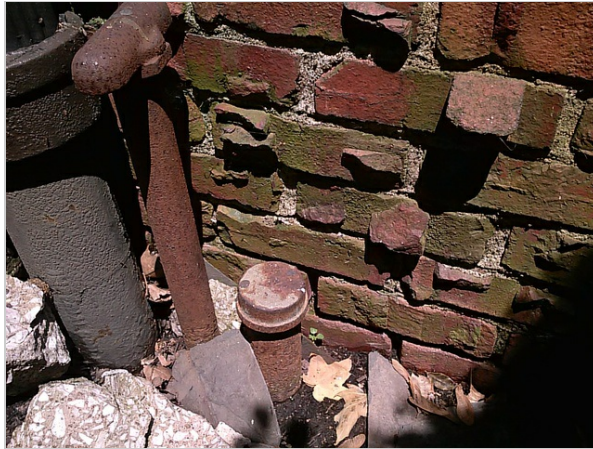
***NOTE: A 1 1/2" metal pipe, used for heating oil, was capped off and visible at the front exterior ground level.***

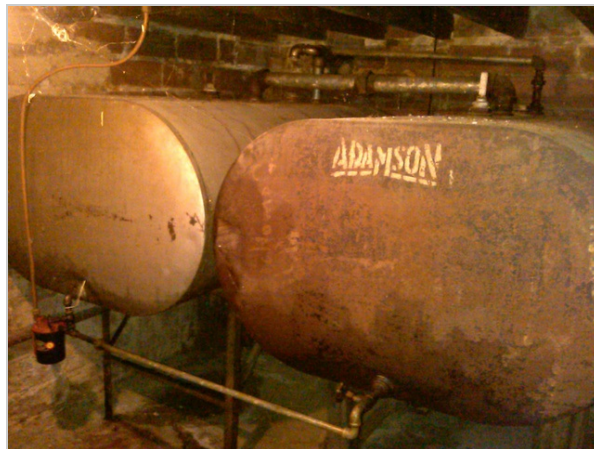
***NOTE: Two fuel oil tanks were present in the basement. The fuel oil tanks were not connected to the current heating system for the property. Evidence of significant corrosion / rusting on the tank was not visible. Evidence of past or active leaking from the tank was not visible. The amount of heating oil in the tank is unknown. If this fuel oil tank is NOT in use then you should explore options for removal of it.***

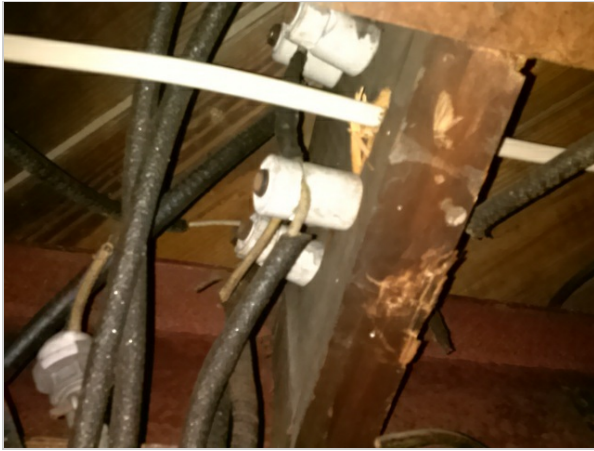
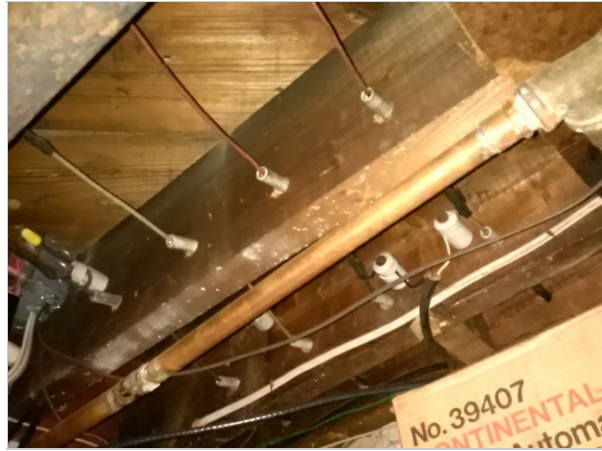
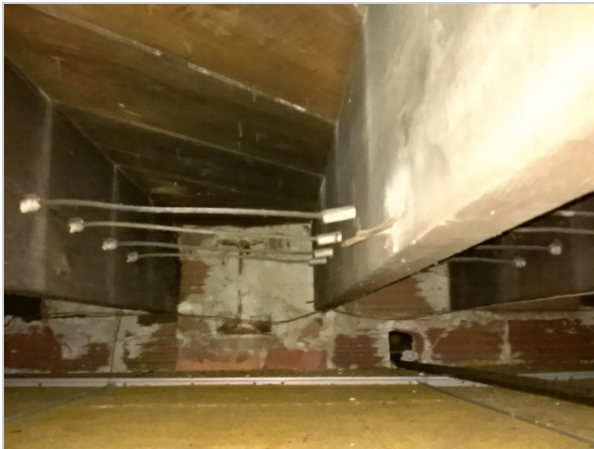
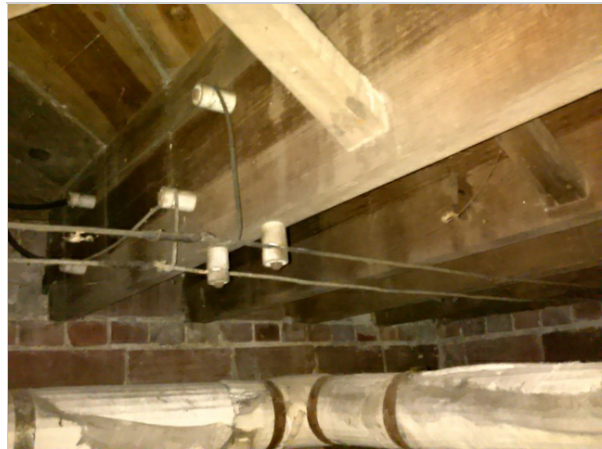
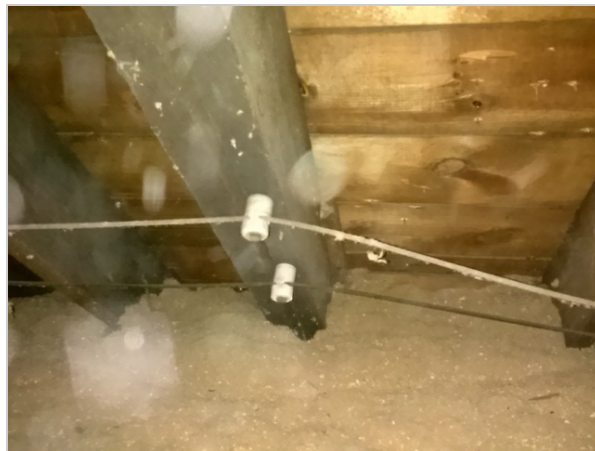
***NOTE: Active knob & tube wiring was observed at the attic, basement and crawl space. Due to its advanced age, wear and tear - alterations- mechanical damage - damaged insulation, etc etc are likely. For these reasons it is considered a potential safety issue. It is recommended to have any active knob & tube wiring further evaluated by an electrical contractor. Knob-and-tube wiring was common in wiring systems installed before 1940. The insulation is often dry and brittle, and chips easily. Exposed areas should be insulated/repaired by a licensed electrician, and any modifications to the wiring must be made by a licensed electrician. Knob & tube wiring was designed as an "open-air" system, not to be covered with attic insulation. In addition, the outlet receptacles of a knob-and-tube-wired system are not grounded.***

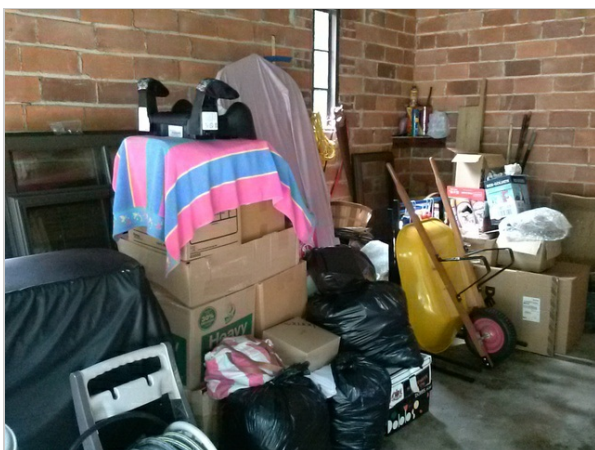
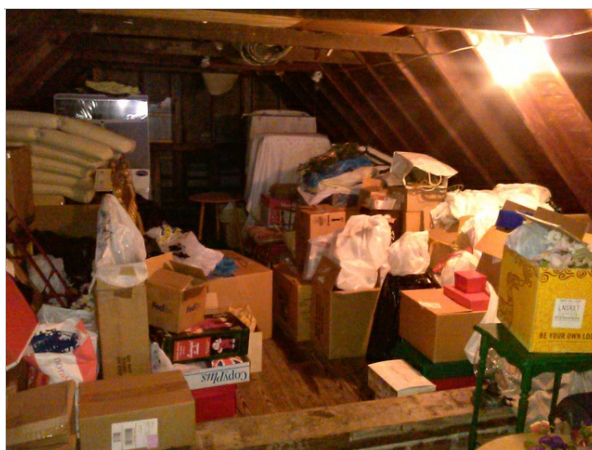
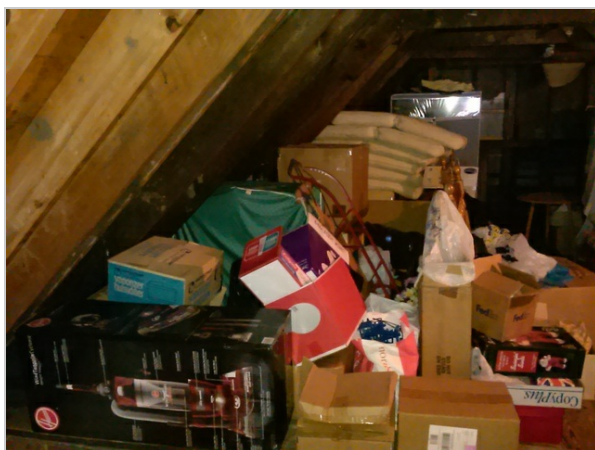
***NOTE: The presence of many stored items and/or a cluttered condition in the garage attic area and parking area blocked much of the visual inspection, mostly at floor and along the walls.***

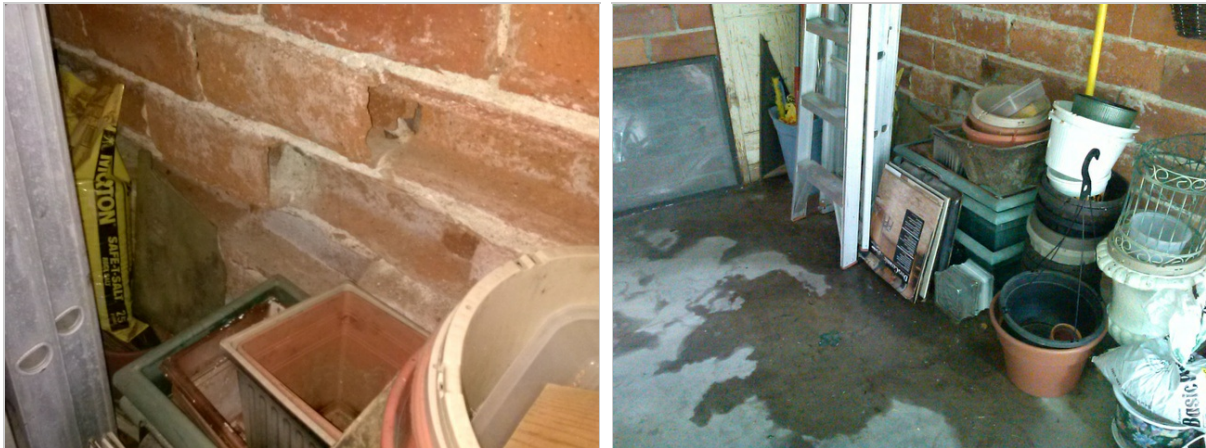
***NOTE: Some minor cracking garage floor was observed. This is not uncommon with older concrete. The garage floor was serviceable at this time.***

***NOTE: There were some missing blocks at the right side block wall(s) of the garage. Moisture intrusion was present at the garage floor by this area. We recommend further evaluation by a masonry contractor to***

***determine what type of repair, if any, is necessary to ensure future structural integrity of the wall(s).***

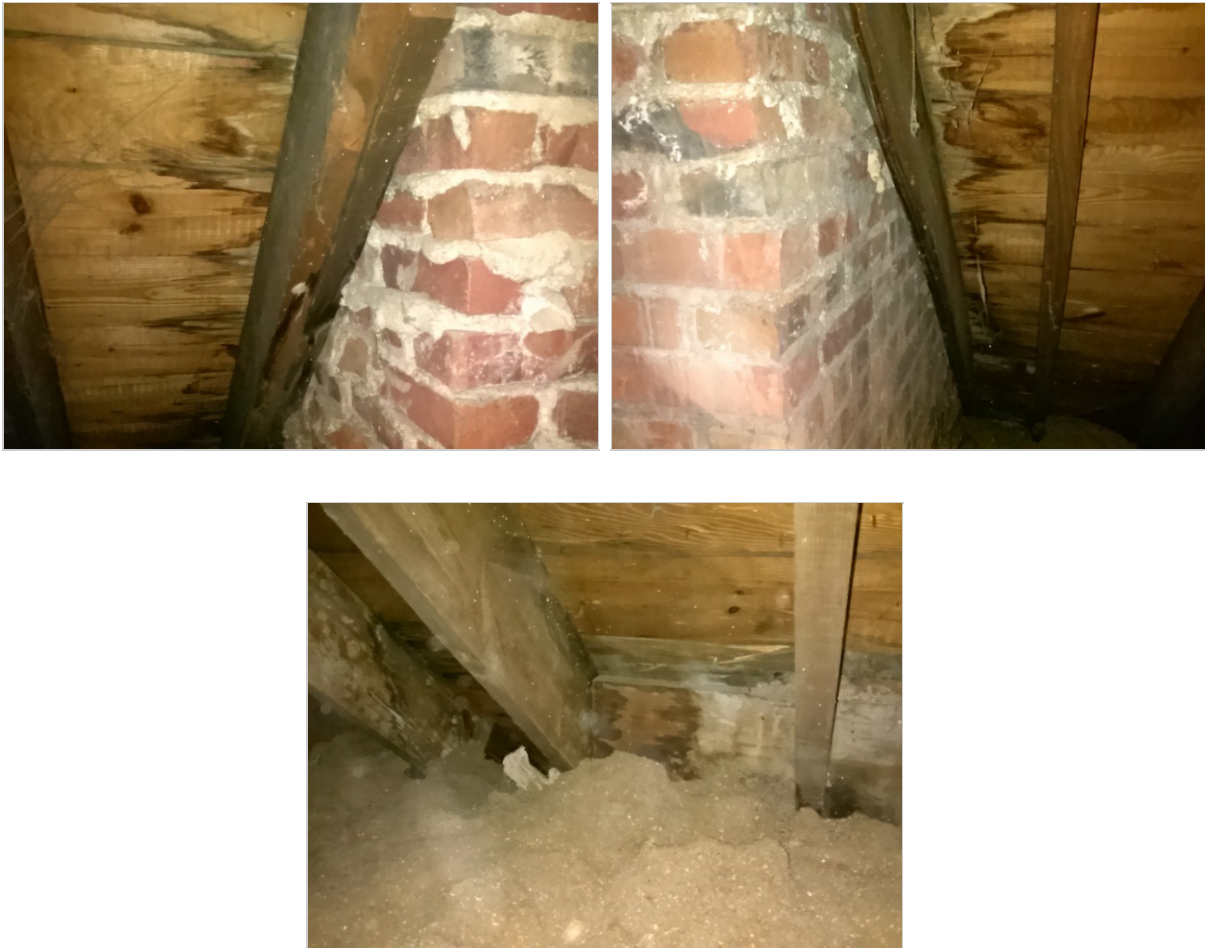
***NOTE: Water staining on the wooden roof structure at the chimneys was observed in the attic. These stains were not damp to the touch at the time of inspection. They are an indication of past moisture intrusion. Without inspecting this area during a prolonged period of rain we cannot determine if the leaking is still active or not. If we also noted any issues at the exterior re; caulking, roof shingles, flashing, spalling, chimney, etc then we recommend that you seek further evaluation by a roofing contractor.***

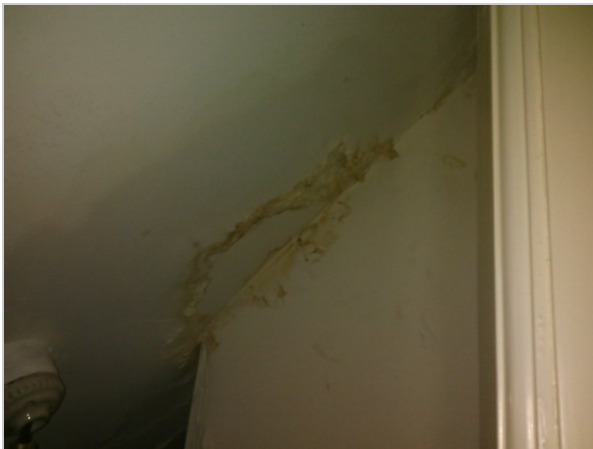
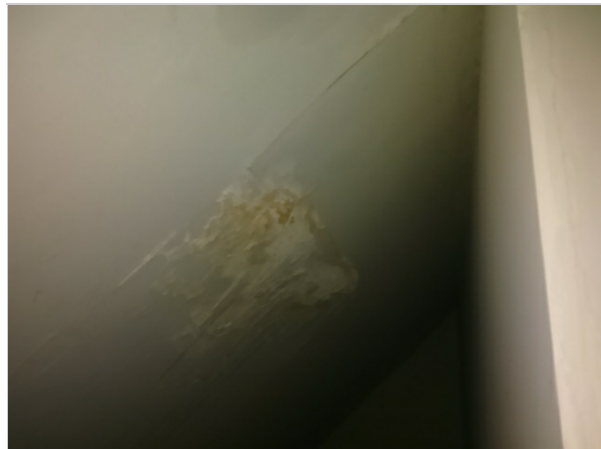
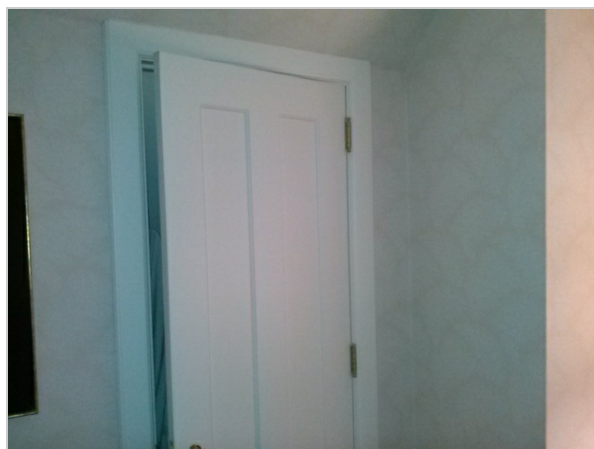
***NOTE: Water stains were observed at the 2nd floor closet ceiling(s). These stains were not damp to the touch at the time of inspection. Stains do indicate past moisture intrusion. It is unknown as to whether the moisture intrusion is still active or not. We recommend that you ask the seller for information on age and source of stain(s). If the stain is on a ceiling below a bathroom, we recommend that you seek further evaluation by a plumbing contractor.***

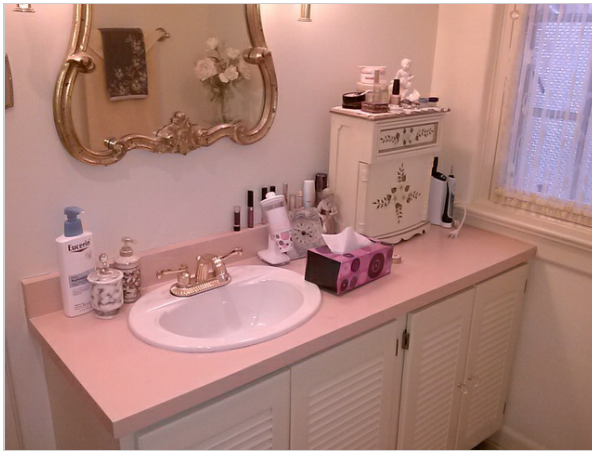
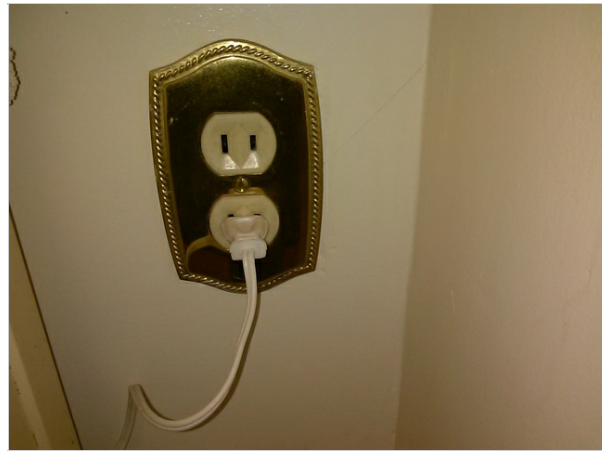
**NOTE:** Two prong receptacles were present throughout the property. At the time this property was constructed, two-prong receptacles were the standard construction. However, the two-pronged receptacles are not grounded (also called "open-ground"), and are not considered to meet the safety standards of modern wiring. They are more likely to be a shock hazard. The installation of GFCI receptacles in kitchens, baths, garages, basements, outdoor receptacles, and any other high-risk areas, will increase the overall safety of the electrical system. 2 prong outlets were present near water at the 2nd floor bathroom. If so, we recommend the installation of GFCI outlets where present. We also recommend upgrading to grounded circuits for any appliance that requires proper grounding, such as: refrigerators, ranges, air conditioning units.

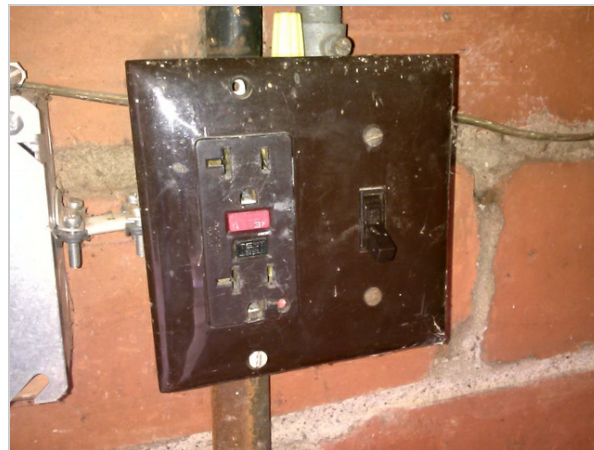
**NOTE:** The GFCI receptacle at the detached garage was not fully functional. This is a safety concern. Typically, this means that either the "test" and "re-set" buttons were not working OR that the outlet still had electrical power even after it was tripped. In some cases a GFCI receptacle can be tripped, but cannot be re-set. All of these are common problems with older GFCI receptacles. We recommend replacement with a new one by an electrical contractor.

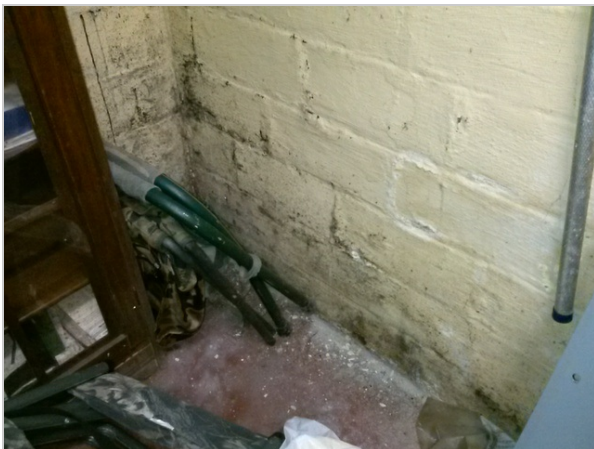
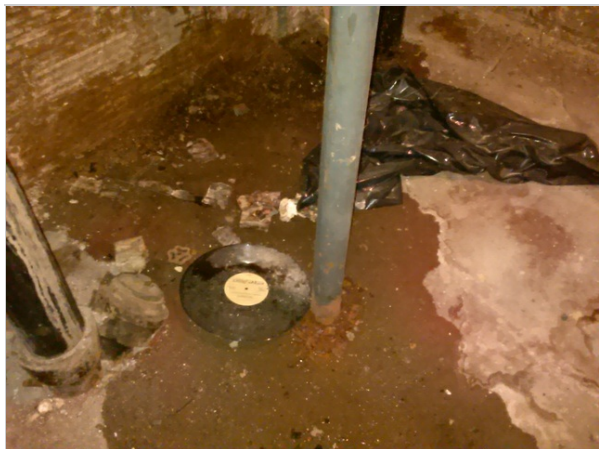
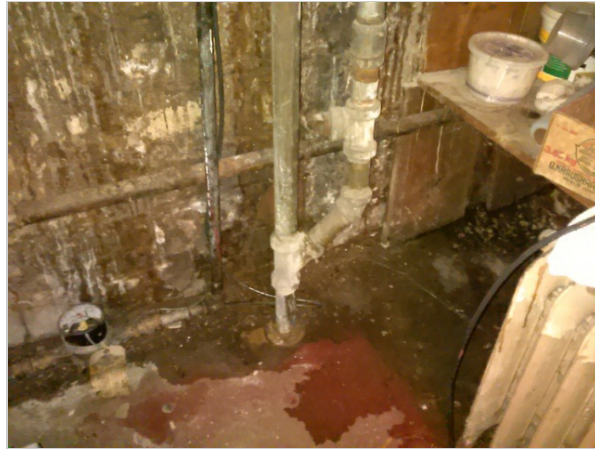
The basement was not completely dry at the time of the inspection. Some water stains were visible on the walls. Indications of present moisture were visible on the floor by the oil tanks, the water heater and water meter ( see photos ). Some cracking of the concrete floor with water staining at the cracks was not present. A musty odor was present. Efflorescence ( a crusty white-ish residue on masonry walls ) was not visible on the walls. No signs of past flooding were visible on the floor at this time. An inspection cannot be conclusive on Basement/foundation walls that have interior finishing (paint, sealant, paneling, drywall, etc). A waterproofing paint or sealant was not present on the foundation walls.

**It is not within the scope of this one-time property inspection to determine or predict the severity or frequency of past or future water intrusion into the basement. We recommend that you consult with a company specializing in water proofing of basements if you require a guarantee of a 100 percent dry basement.**

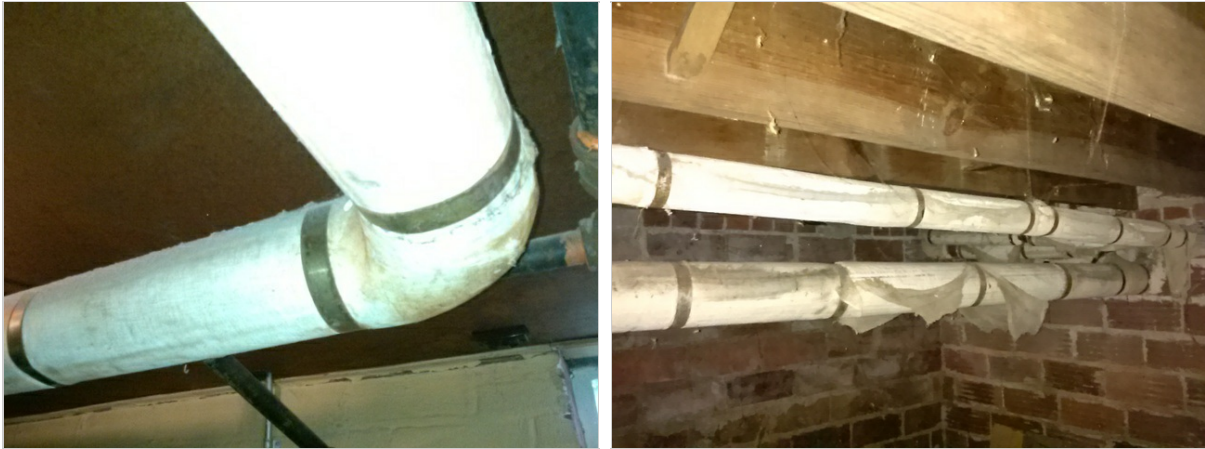
***NOTE: Some asbestos-like material was observed on the boiler piping in the crawl space and basement. The positive identification of this material is beyond the scope of the home inspection. If you are concerned about the possibility of having asbestos type materials present, you can have the material sampled and tested by a reputable environmental company. ASBESTOS PIPE - A common method of insulating pipes in many homes built in the early twentieth century involved the use of asbestos pipe insulation. Asbestos pipe insulation, also called "asbestos pipe wrap", is one of the more hazardous uses of asbestos because it is less stable than other forms of asbestos materials. Generally it is safe to assume that insulated pipes contain some sort of asbestos pipe insulation material. Asbestos pipe insulation is prone to deterioration and is considered a friable asbestos material. The particles released when asbestos pipe insulation deteriorates are a health hazard and should not be taken lightly.***
