HOME INSPECTION REPORT

SAMPLE REPORT

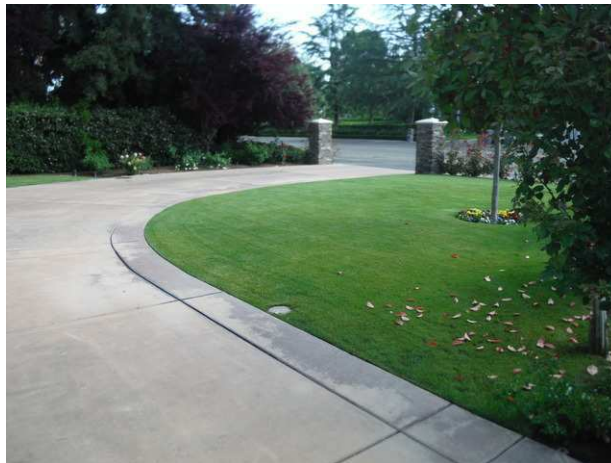
- The large tree roots located in the right side should be evaluated and if possible have the roots (or tree) removed by a licensed tree removal company.

1. There is a leak at the impeller at the pool pump motor.
2. The large tree roots located in the right side should be evaluated and if possible have the roots (or tree) removed by a licensed tree removal company.

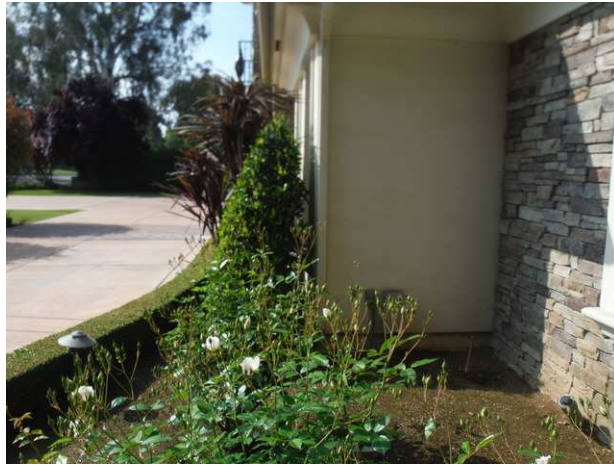
- There were tree branches / shrubs in contact with the home and roof on the front back and sides of the home. There were no debris on the roof. Debris from trees & shrubs can hold moisture and can prematurely wear out the siding and roof covering.

Trees and shrubs should be trimmed back/cut away from the home and roof. Debris from trees and shrubs hold moisture and can prematurely wear out the siding and roof covering.

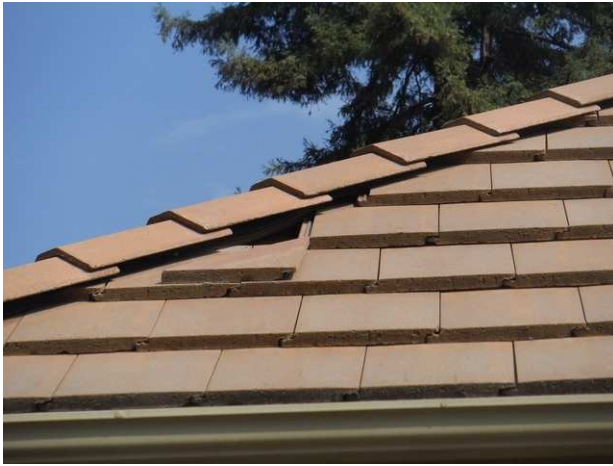
- There are a few loose tiles observed on the front left and rear of the roof at the time of the inspection

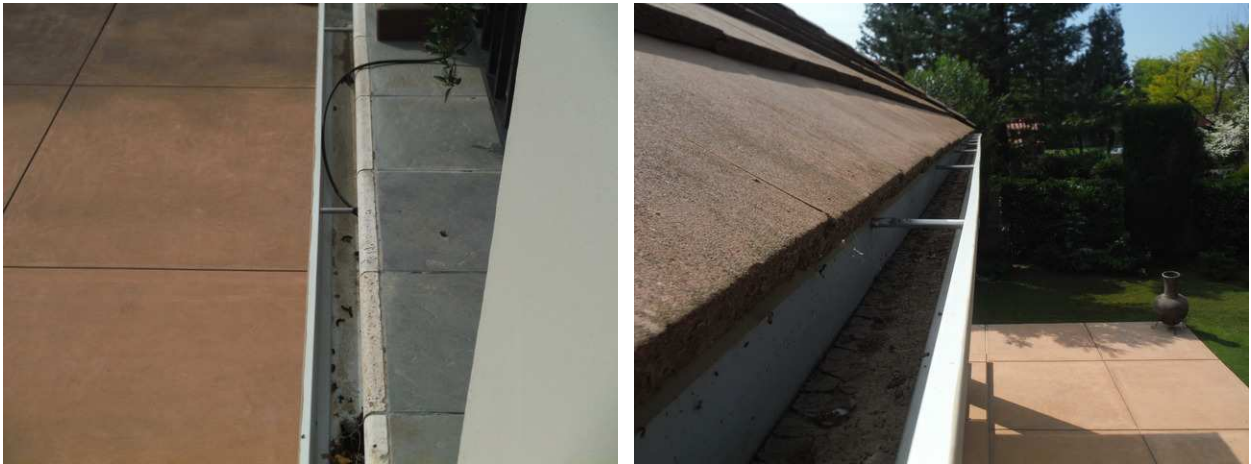
- The rain gutters were in need of cleaning in the rear right at the time of the inspection.

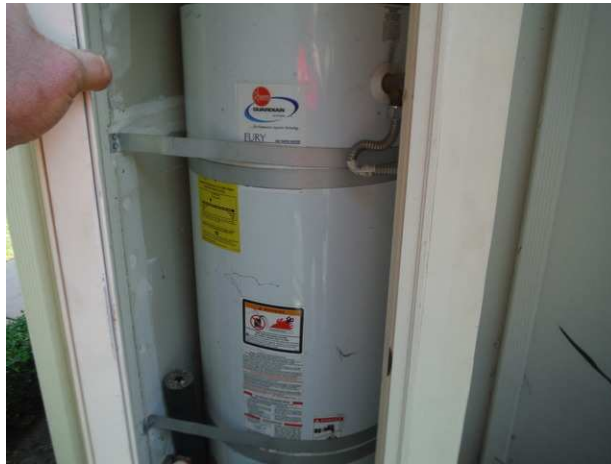
- Noted: The pilot light at the water heater was not lit at the time of the inspection. The pilot light was lit and did appear to be operational. The control setting for the water heater was set back to the pilot position. The water heater will need to be turned to the on position and the temperature control will need to be set.
- The pool house water heater closet has a build up of dust and debris below the tank and burner. Recommend cleaning of the closet area.

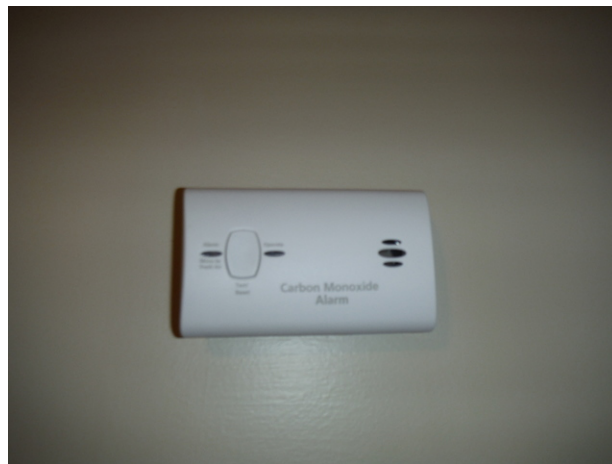
- The detached upper level bedroom will need a carbon monoxide detector installed.

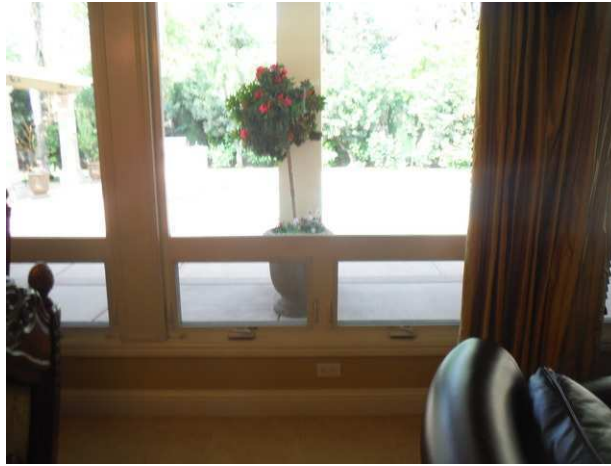
- The seals on the front right bedroom window in the home had failed causing a loss of vacuum between the panes and a resulting loss of insulation value. The most noticeable result of this failure is condensation and fogging between the panes of glass.

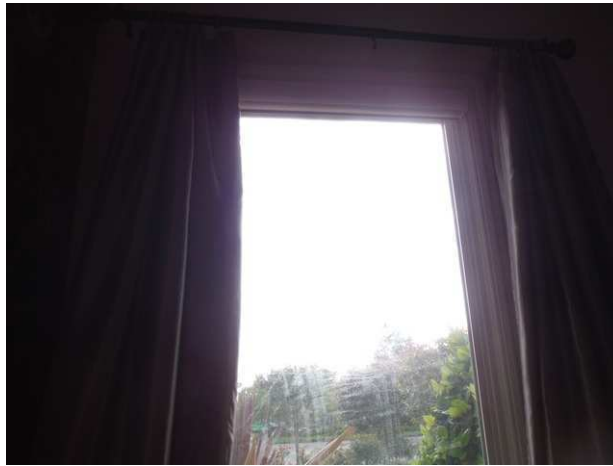
- The rear window in the detached upper level bedroom has a detached or broken tension spring, that should be repaired or replaced. The tension spring, is a safety device that holds the window in the open position.

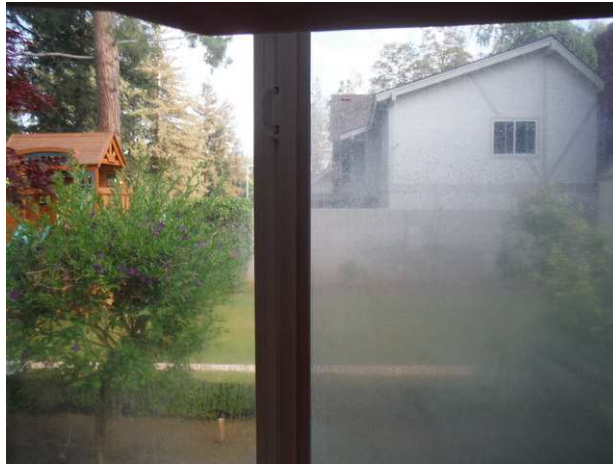
- The "Low e factor" in the two windows in the upper level detached bedroom may have lost some of its effectiveness. The "e" in low "e" stands for emissivity-the ability to to emit radiant energy. This coating layer allows light to penetrate the glass, but blocks most ultraviolet (UV) long wave energy, which we feel as heat during the summer months. During the winter months, heat from the room interior is reflected back into the room.

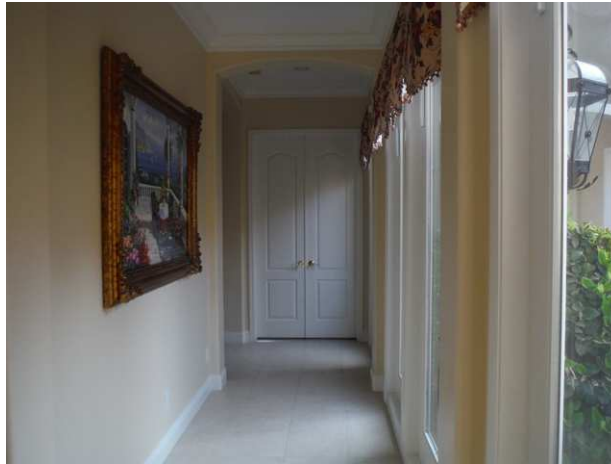
- The rear family room door needs adjustment to open and close easily.

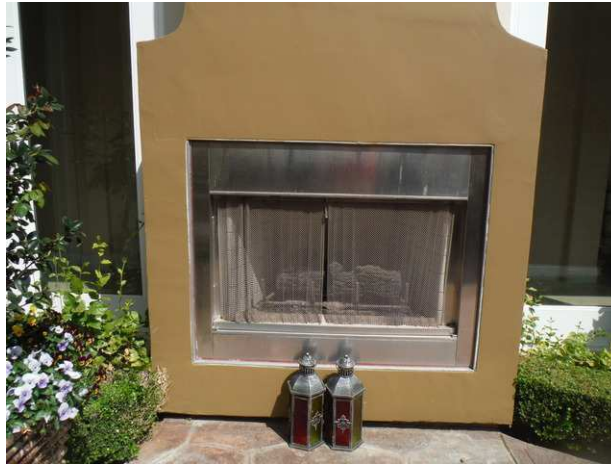
- The glass doors to the courtyard fireplace are missing.

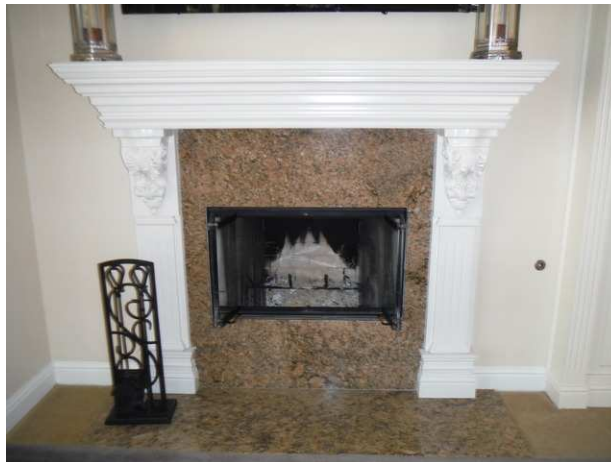
- There was a hairline crack observed at the rear refractory panel in the firebox .The panel felt secure. It is recommended that the firebox be monitored.

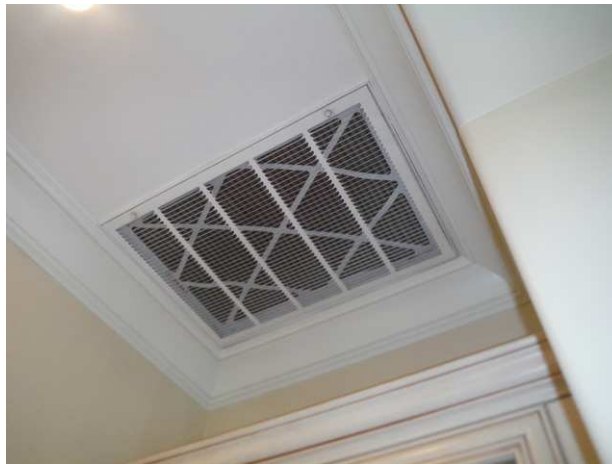
- The HVAC disposable return air filters need to be replaced.

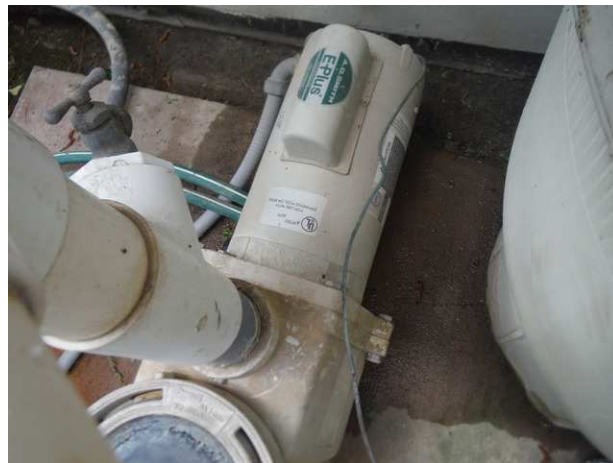
- There is a leak at the impeller at the pool pump motor.
