HomeTeam[®]

HOME INSPECTION REPORT

SAMPLE INSPECTION

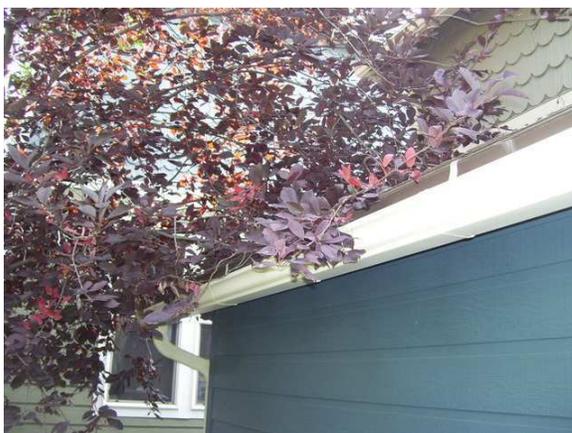
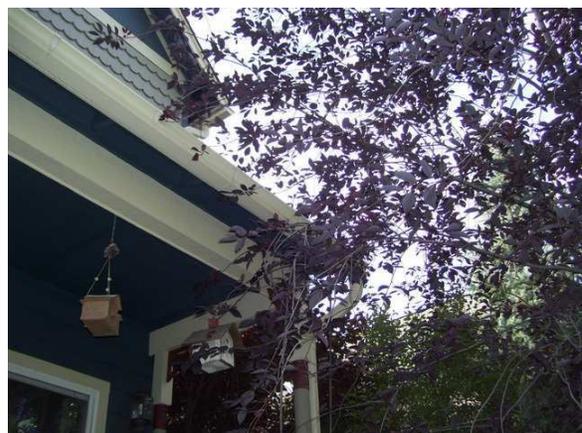
- Trees were observed to be growing against the home; the trees should be monitored and/or trimmed to prevent possible damage to the home.

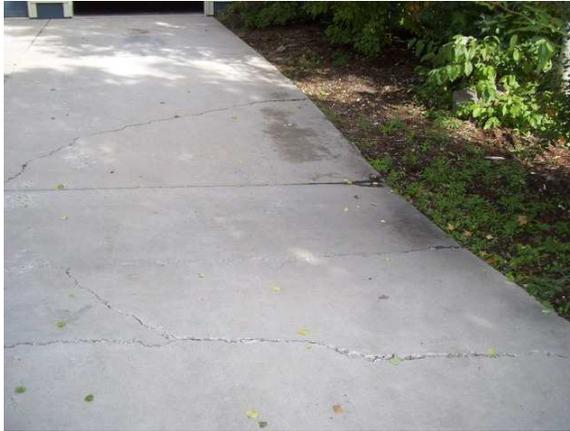
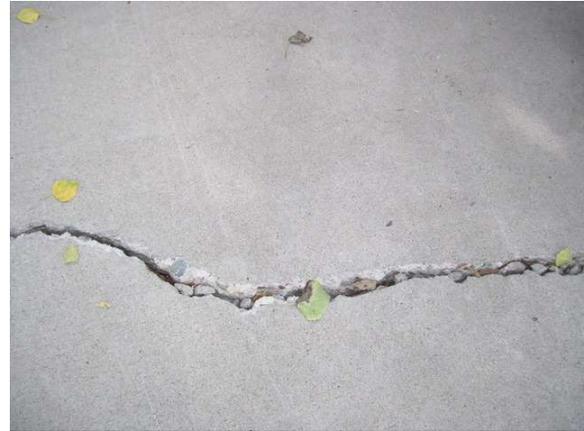
- There was significant cracking and settling observed at the driveway. The driveway should be further reviewed and repaired by a qualified concrete contractor.

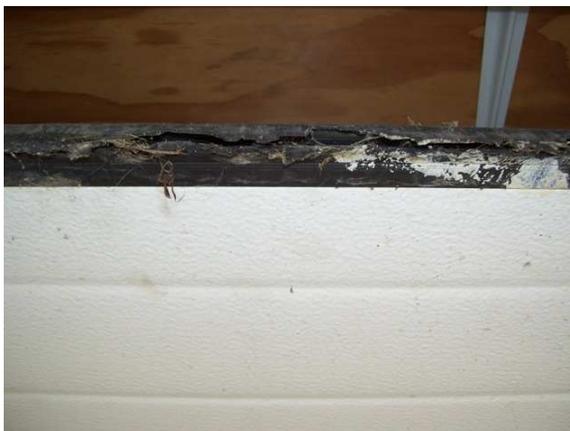
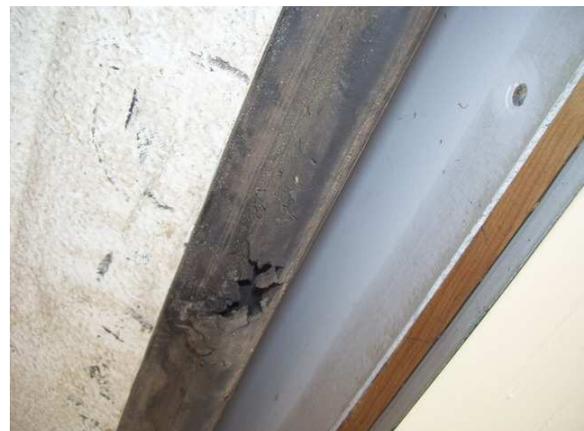
- The base weather strips at the garage doors were damaged.

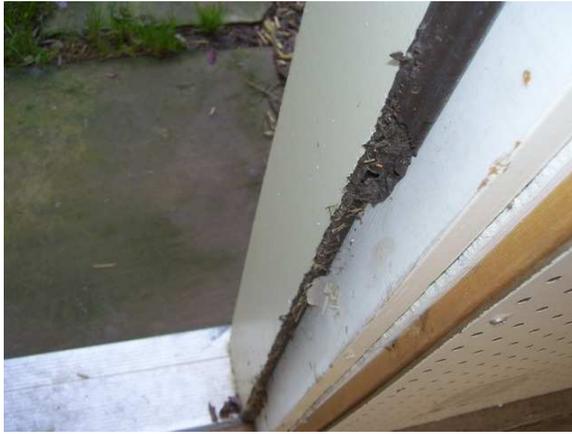
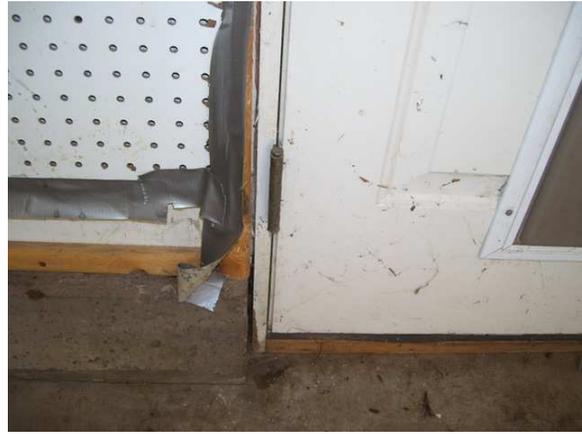
- Air gaps were observed at the rear exterior "man" door and the weather strip was damaged at this door.

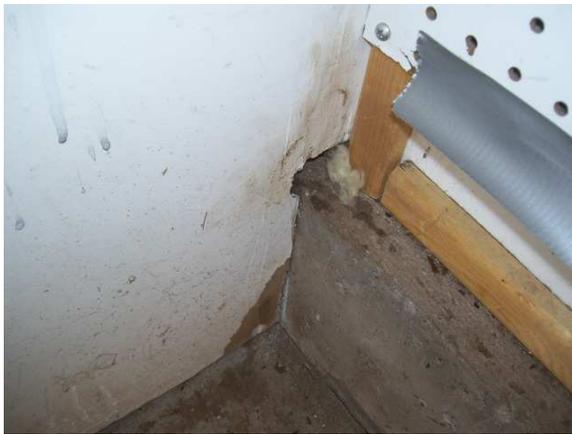
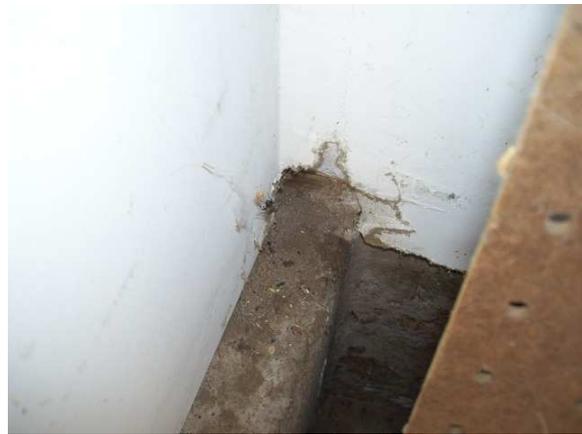
- There was some evidence of pest infiltration; if this is a concern, this should be further reviewed by a qualified pest professional.

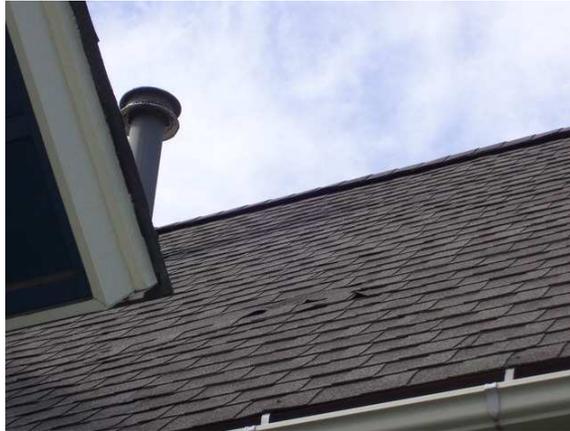
- At least one of the shingles at the right rear of the roof has slipped and it should be repaired by a qualified roofer.

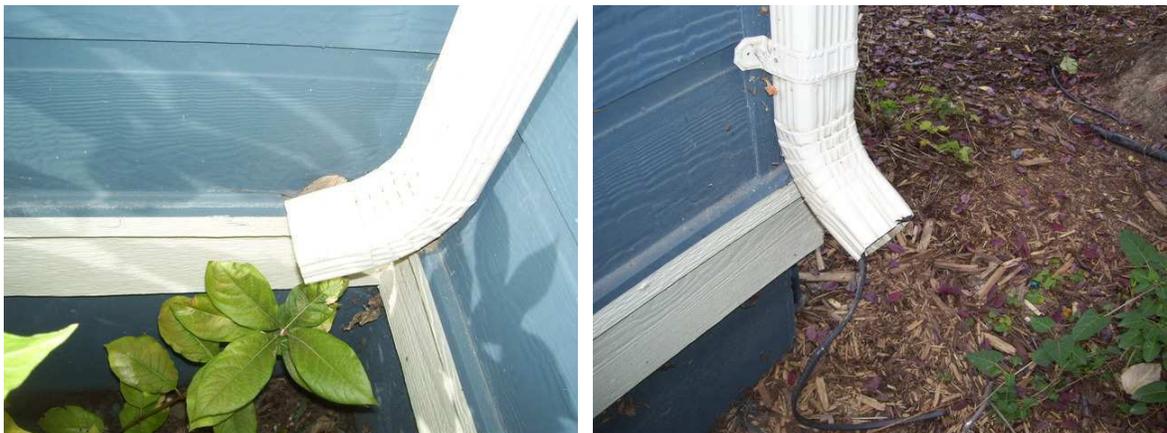
- The downspouts should be extended further away from the home to direct water away from the home.

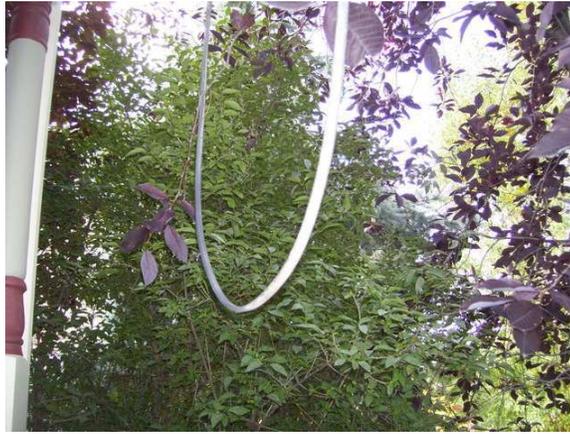
- Some of the heat tape at the back of the home was not installed in the gutter.

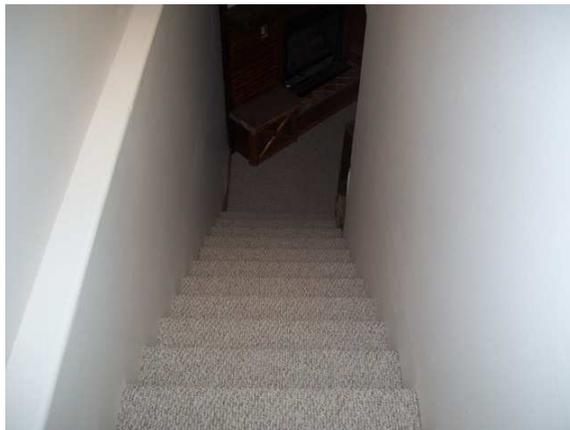
- There was not a handrail at the basement stairwell; a handrail should be installed for safety reasons.

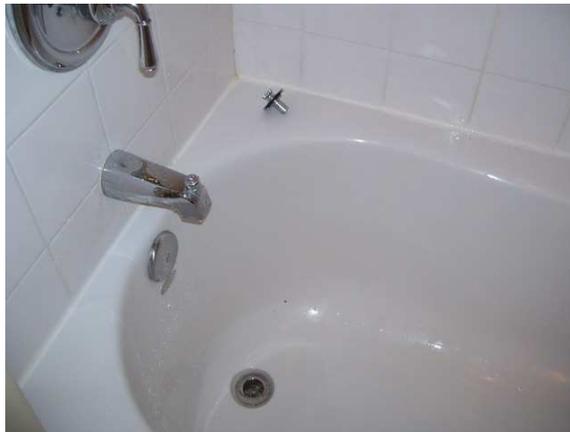
- The tub stopper in the basement bathroom was not functional. The sink stopper in the second level hall bathroom did not stay closed and the tub stopper was not attached in this bathroom.

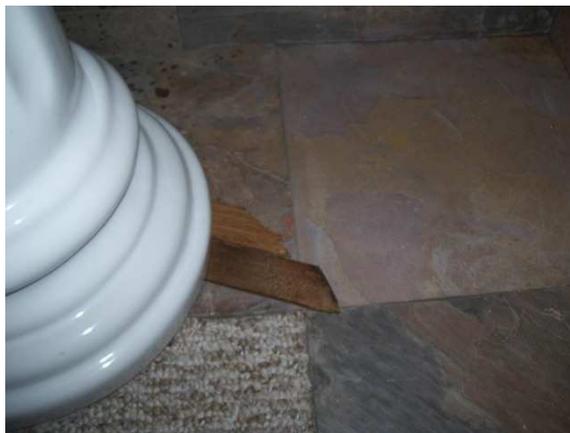
- There were wood shims observed at the base of the sink in the basement bathroom.

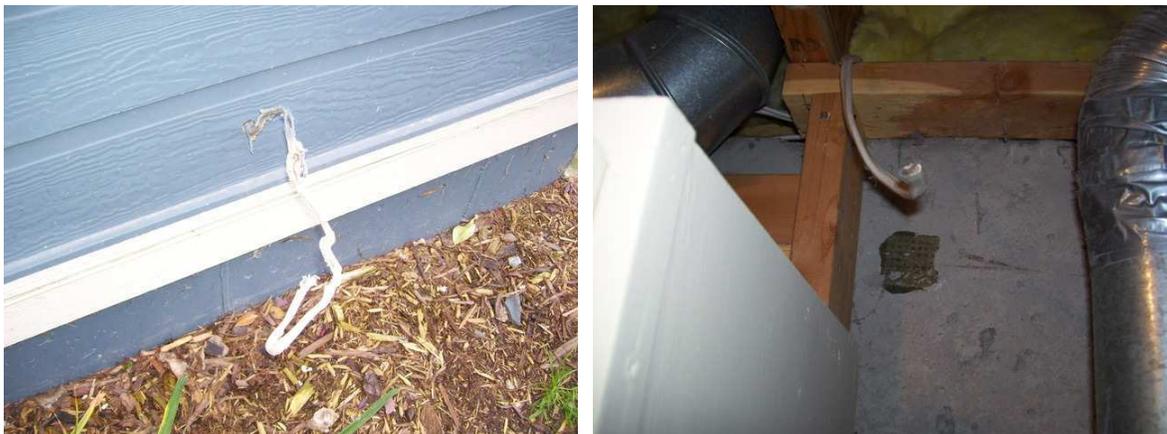
- There were abandoned wires observed at the rear exterior of the home and in the utility room. These should be further reviewed by a licensed electrician.

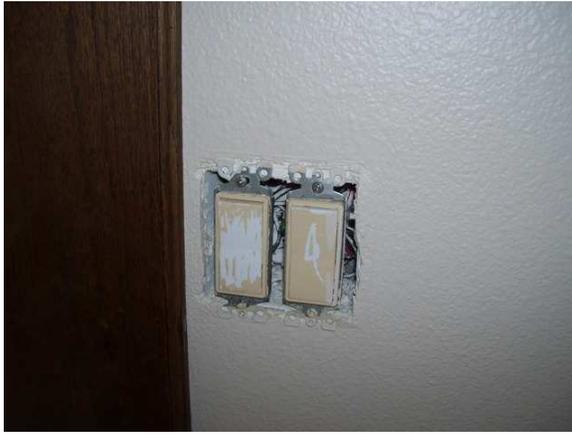
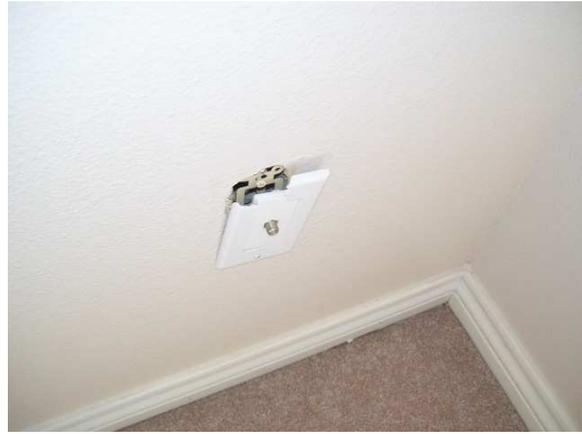
- The over plate was missing from the light switch in the first level family room. The cover plate for the CATV receptacle in the front bedroom was cracked.

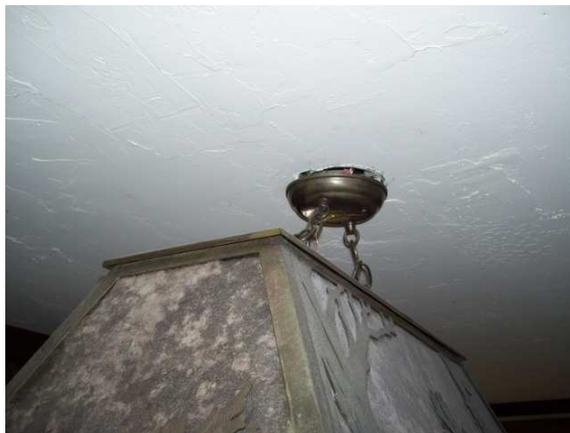
- The ceiling light in the basement family room was not secure; this should be corrected.

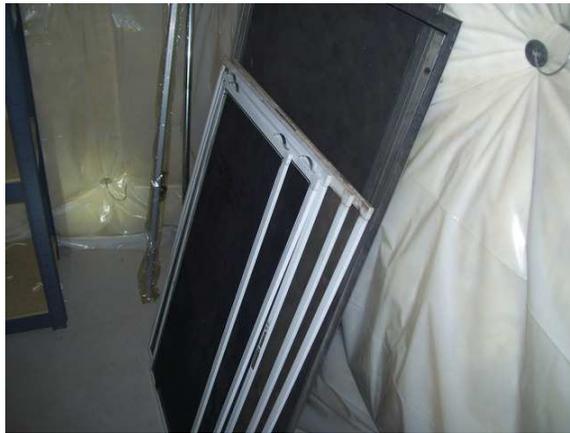
- Window screens were missing in the basement, the first level family room and the living room. However, screens were being stored in the area of the basement behind the TV.

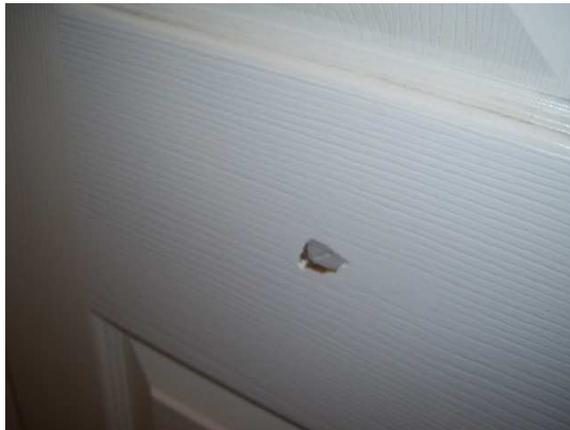
- One interior door was damaged.

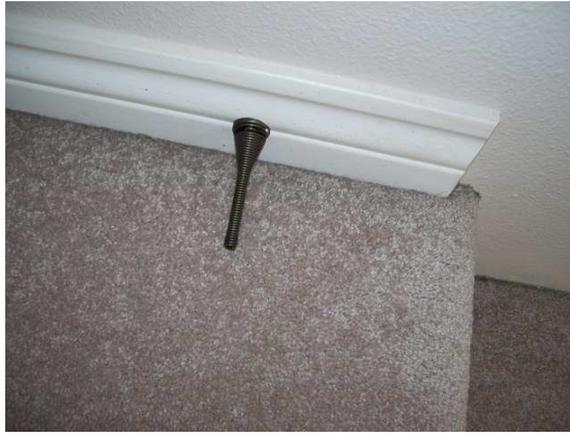
- There were no door stops or the door stops were damaged at many of the doors. Door stops should be installed and/or repaired to help prevent possible blemishing of the walls that could be caused by door handles.

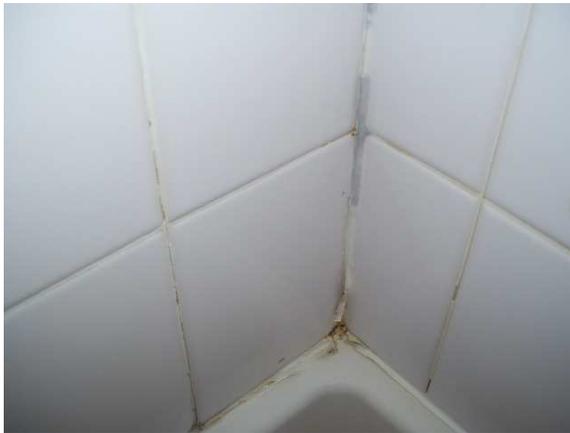
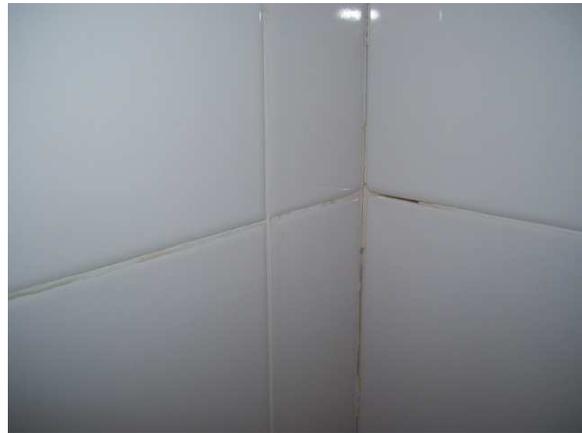
- Sometimes the failure to keep walls sealed can cause deterioration and moisture damage to the interior walls which is not always visible at the time of the inspection. Some of the grout and/or caulk was cracked/missing from around the tub and shower surrounds in the home. These areas should be re-grouted and/or re-caulked to prevent moisture penetration.

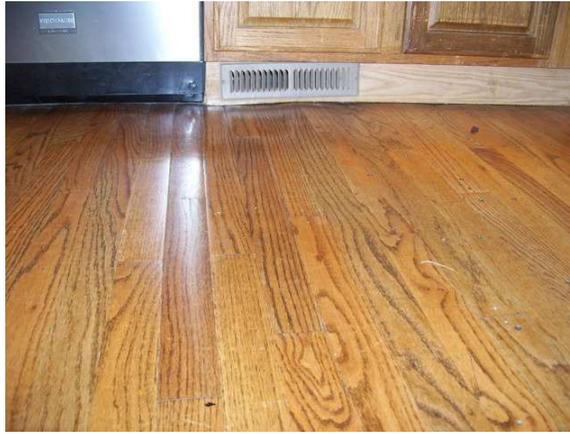
- Some of the wood flooring in the kitchen was warped.

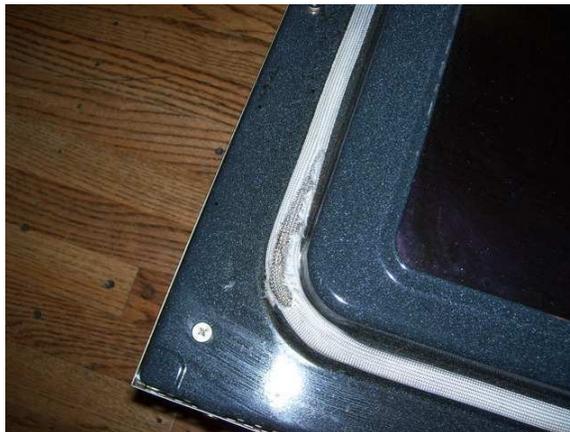
- The seal at the oven door was damaged.

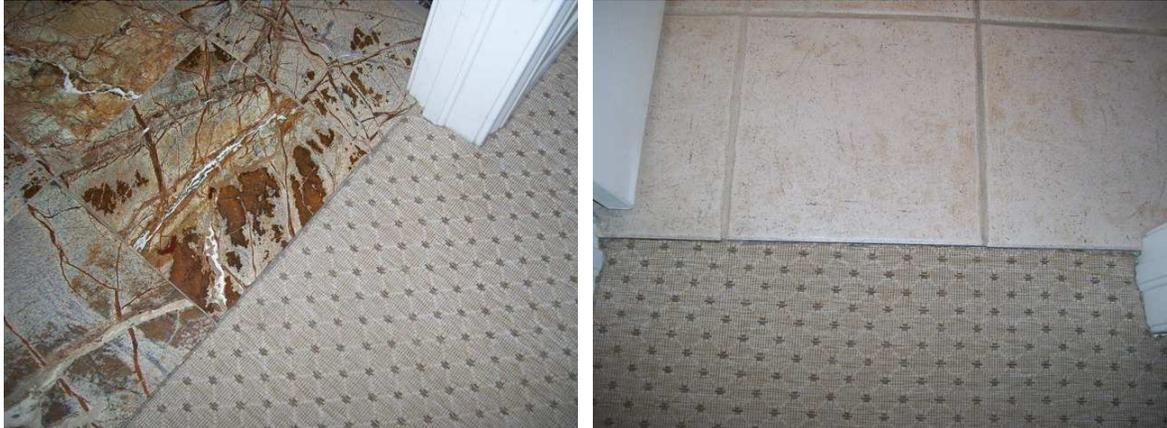
- There were no thresholds observed between the carpeting and the floor tiles.

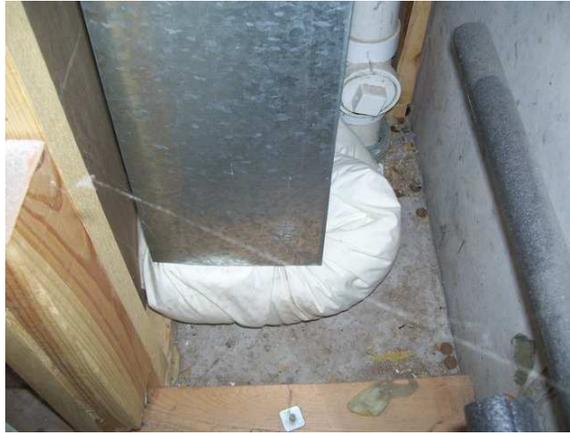
- Insulation was observed in the combustion air duct; this should be further reviewed by a licensed HVAC contractor.

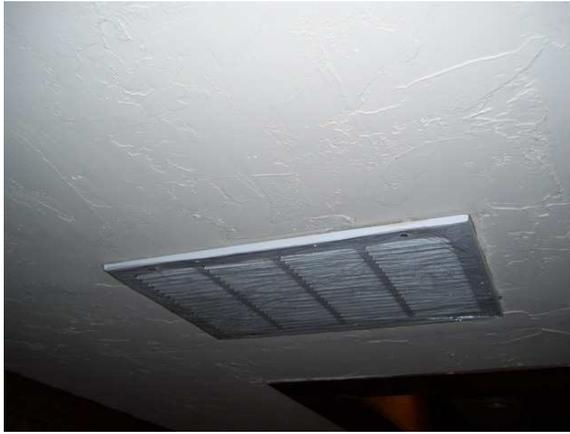
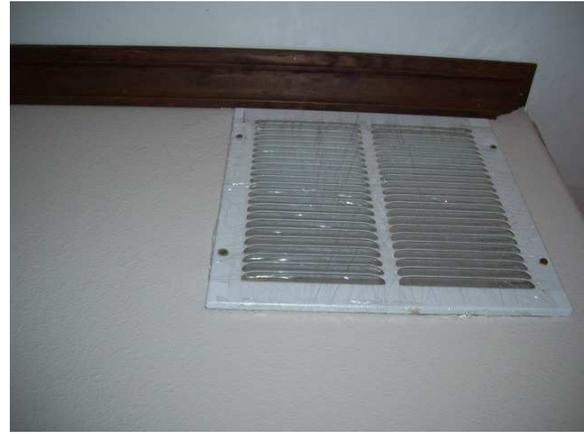
- Plastic was covering some of the registers in the home; this should be reviewed by a licensed HVAC contractor.
