**123 Main St  
Anywhere, NC**

### *HOME INSPECTION REPORT*

File Number: **655439**

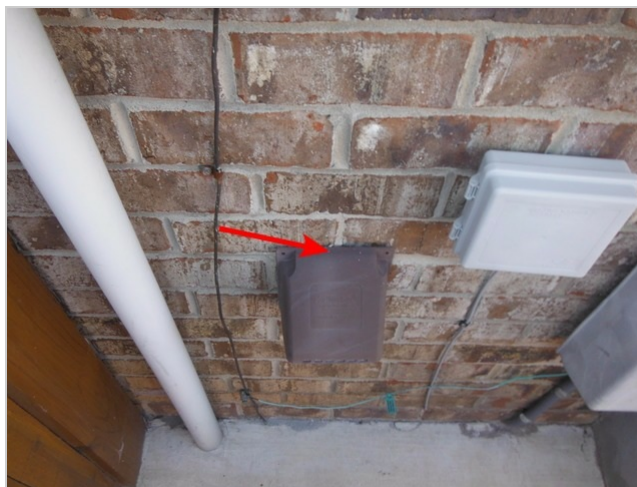
Unsealed-Right

***Unsealed penetrations through brickwork in areas at but not limited to right side around dryer vent, and left side around HVAC piping and water spigot. This is a water penetration concern. Recommend repairs as necessary.***

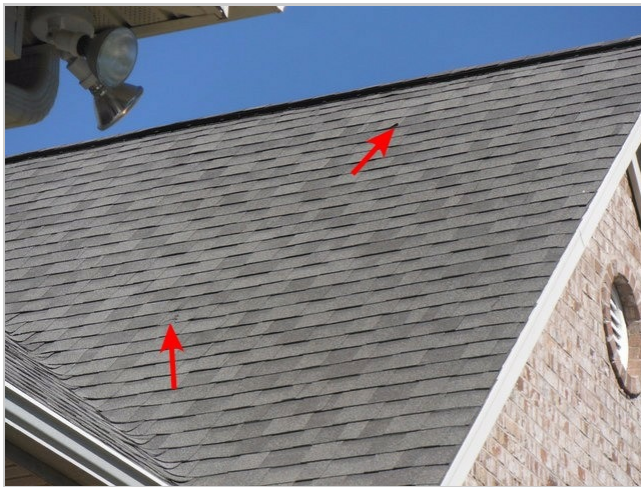
1. ***Raised shingles at but not limited to the front and rear roof of the house. This is a water penetration/wind lift/nail wear through concern.***
2. ***Damaged shingles observed on areas at but not limited to the front, rear right, and rear roof. This is a water penetration/substrate damage concern.***

Damage-Front

Damage-Rear

Damage-Front right

***Recommend review and repairs as directed by qualified contractor.***

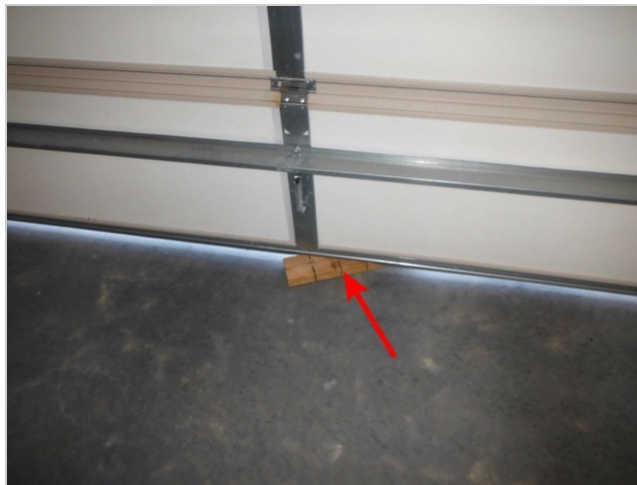
***The rear most garage door did not reverse when met with reasonable resistance (as tested with a 2x4 block). This is a safety concern. Recommend repairs/adjustments by qualified person and verifying proper operation prior to closing.***

Did not reverse

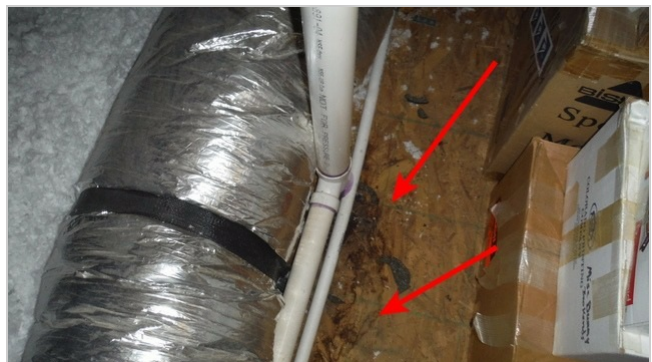
***Exhaust vent stack in the right rear attic space had light visible around boot area and stained OSB decking below indicating possible leak. This is a possible leakage/damage concern. Recommend review and repairs as directed by qualified contractor.***

Penetrating daylight-attic

Deck staining below exhaust vent-attic

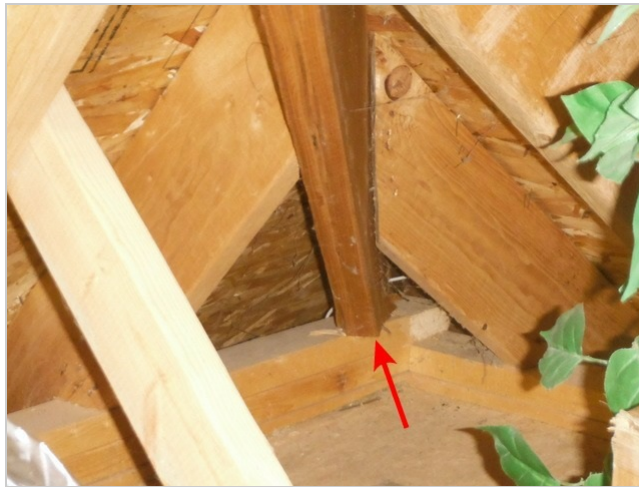
***LVL framing at the front right of house is not fully bearing at the heel cut. This is a***

***support/installation/damage concern. Recommend repairs as directed by qualified contractor.***

Not fully bearing

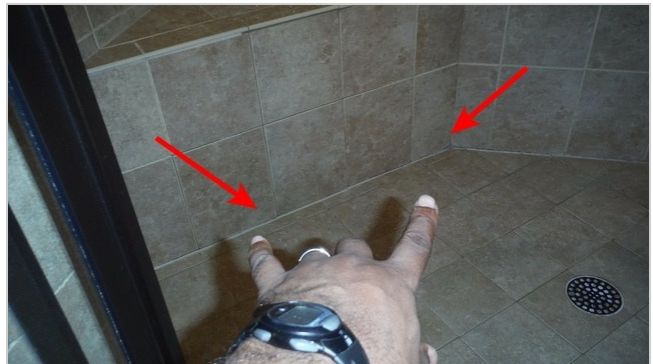
***Unsealed areas at bath surrounds in the master and upstairs bathrooms. This is a water penetration/substrate damage concern. Recommend repairs by qualified person.***

Upstairs bathroom surrounds

Master bathroom shower surrounds

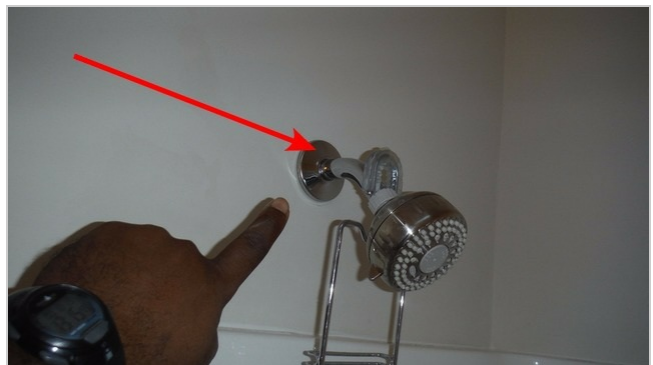
***Observed loose shower stems in the upstairs and downstairs hallway bathrooms. This is a movement concern. Recommend repairs by a qualified person.***

Downstairs hallway bathroom shower stem

Upstairs bathroom shower stem
