# HomeTeam<sup>®</sup>

### HOME INSPECTION REPORT

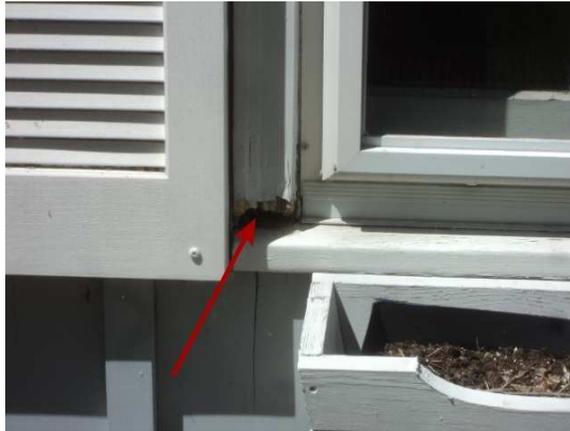
- We observed wood deterioration of a window sill in the front of the home. We observed wood deterioration of a window casing in the front of the home. We also observed wood deterioration of window sills on the right side of the home. We recommend replacing the deteriorated wood.

WOOD DETERIORATION TRIM FRONT WINDOW

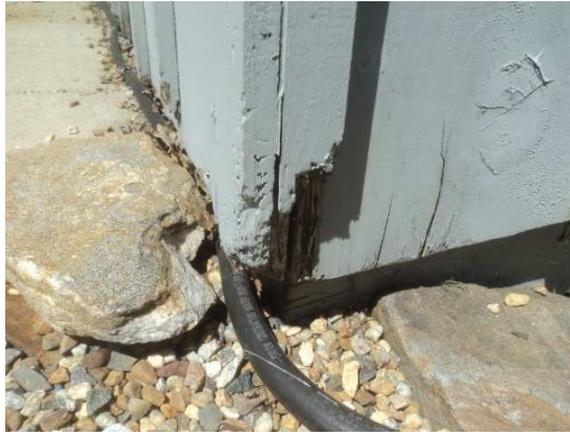
- We did note that there was wood deterioration of the siding on the left side of the home. We recommend replacing the deteriorated siding.
- We noted that we observed wood deterioration of the trim on the left side of the home. We recommend replacing the deteriorated trim.

WOOD DETERIORATION TRIM LEFT EXTERIOR

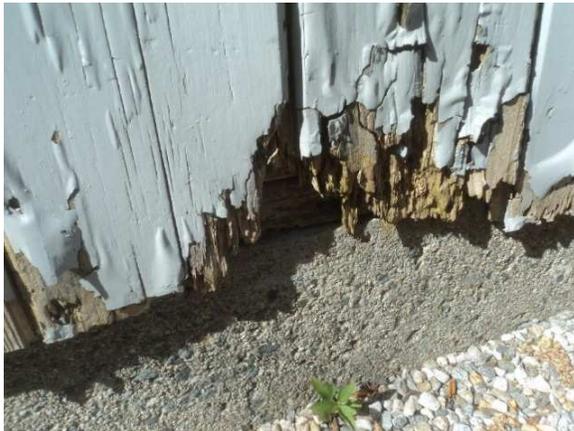
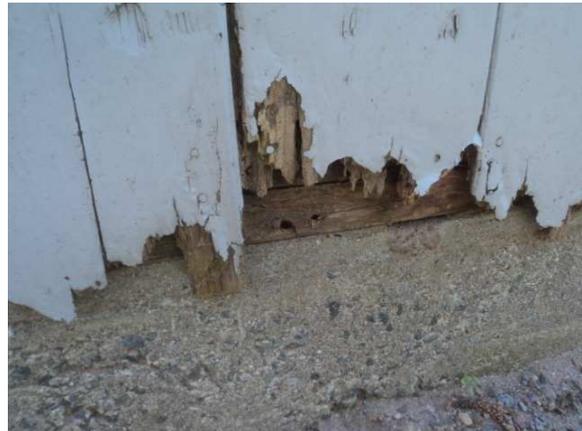
- We did note that we observed wood deterioration of the siding on the right side and left side of the garage. We recommend replacing the deteriorated siding.

WOOD DETERIORATION SIDING AND SILL GARAGE

- We recommend further evaluation by a licensed carpenter regarding the damaged wood.

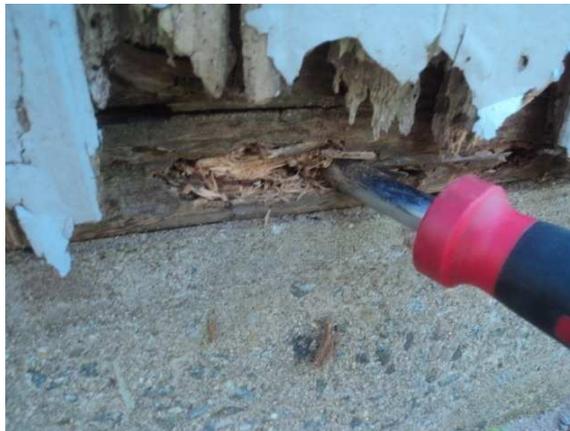
WOOD DETERIORATION SILL GARAGE

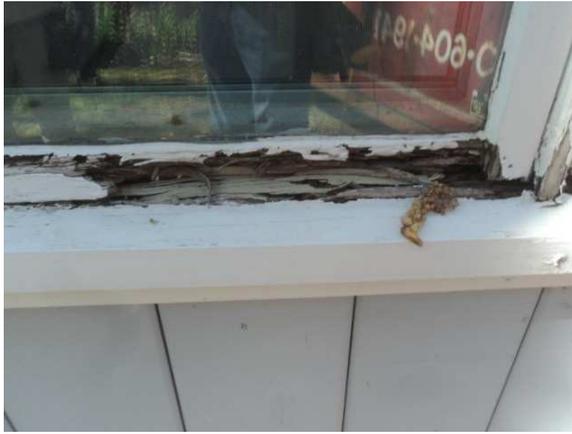
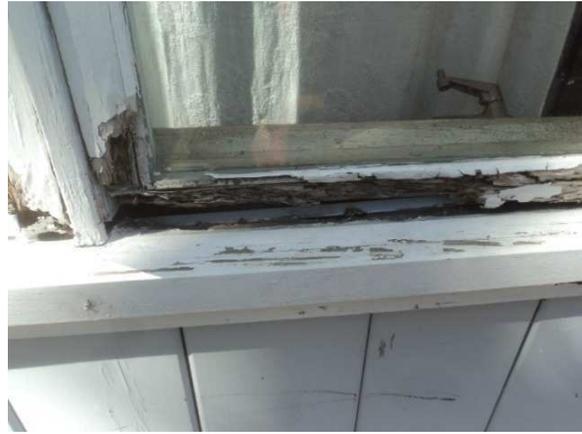
- We observed significant wood deterioration of the windows on the left side and in the rear of the garage.

DETERIORATED WINDOW GARAGE

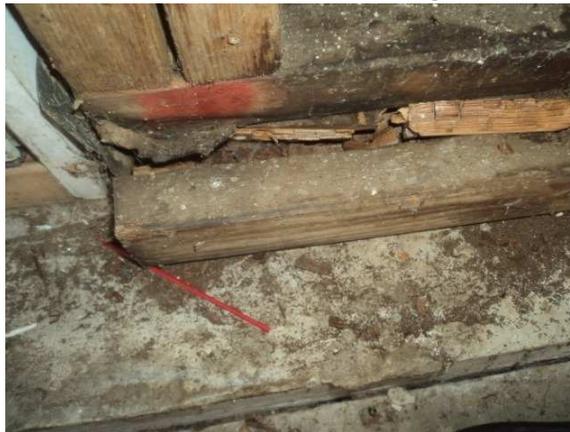
- We observed wood deterioration of the sill on the left side and right side of the garage.

WOOD DETERIORATION SILL LEFT SIDE  
GARAGE

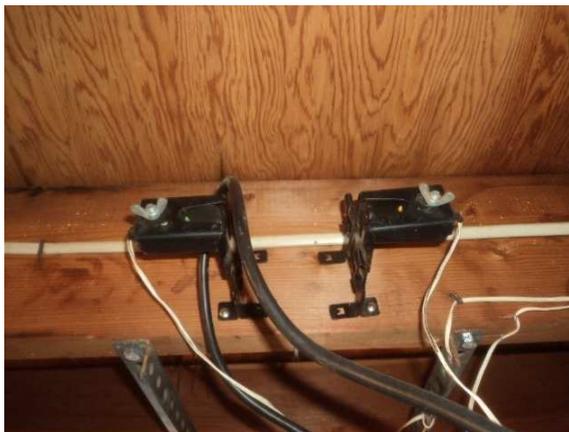
- We did note that we observed wood deterioration of the fascia board on the right side of the garage.
- We observed wood deterioration of the window sill on the right side of the garage.
- We noted that the membrane roofing in the rear of the garage was not installed in a professional manner (buckled).
- We did note that there were several household items in the garage at the time of the inspection which inhibited our visual inspection of the garage (cluttered conditions-the sill was mostly inaccessible).
- We observed wood deterioration of the sill in the garage (left side). We recommend replacing the damaged sections of the sill.
- We observed dry water marks on the rafters and sheathing in the garage.
- We noted that the safety reverse sensors were installed above the garage door opener. The sensors should be installed on each side of the garage doors within 6" of the floor.

REVERSE SENSOR INSTALLED ABOVE  
DOOR OPENER

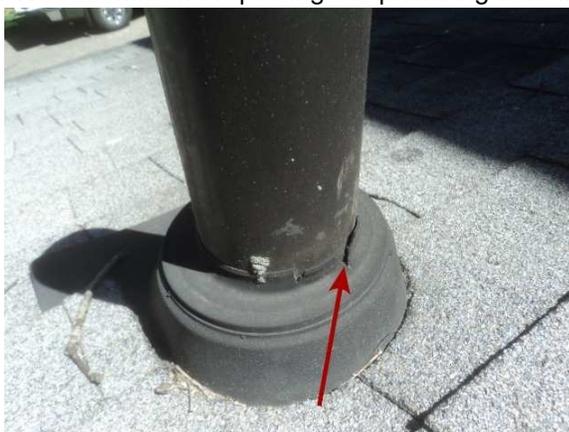
- We did observe several roof shingles to the home with missing granules. When the granules wear away the shingles are more susceptible to the elements. When the granules are absent from the shingles, the sun is able to dry out the asphalt coating.
- We observed a crack in the rubber flange to the rear plumbing vent which will allow moisture penetration into the surface areas below. We recommend replacing the plumbing vent flashing.

CRACK IN PLUMBING VENT FLASHING

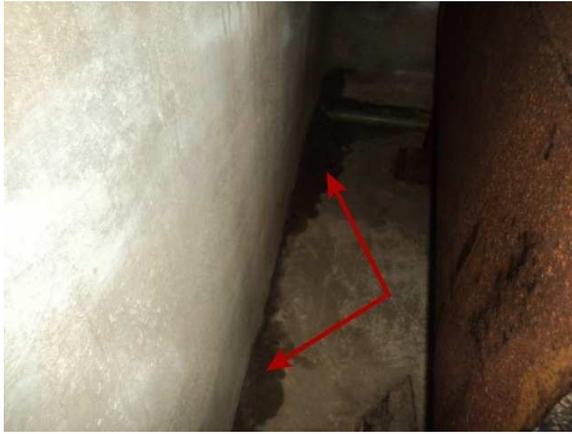
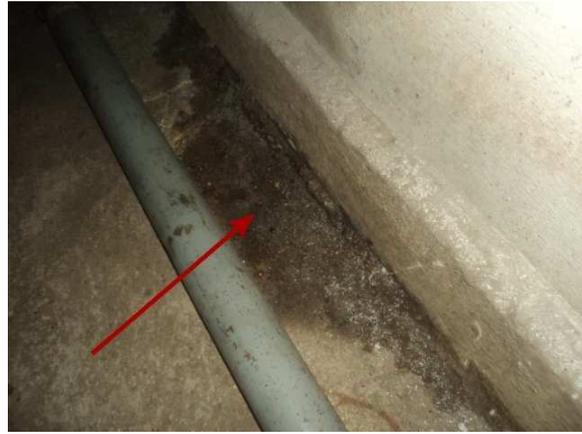
- We would like to note that stone foundations are more susceptible to moisture penetration than other types of foundations.
- We noted that the floor was damp in the left rear area the basement at the time of the inspection.

MOISTURE BASEMENT FLOOR

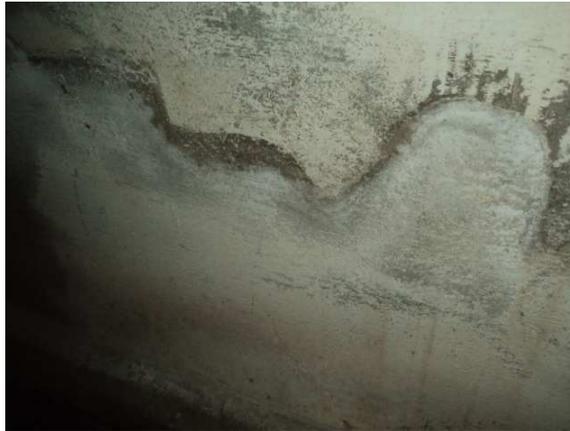
- We did observe efflorescence on the foundation walls in the basement. Efflorescence is the white powdery mineral deposits often found on masonry foundation walls when water seepage has occurred. A single inspection cannot determine the amount or frequency of water seepage into the basement. We recommend obtaining further information from the current home owner. For further evaluation, we recommend consulting a licensed water proofing contractor.

EFFLORESCENCE

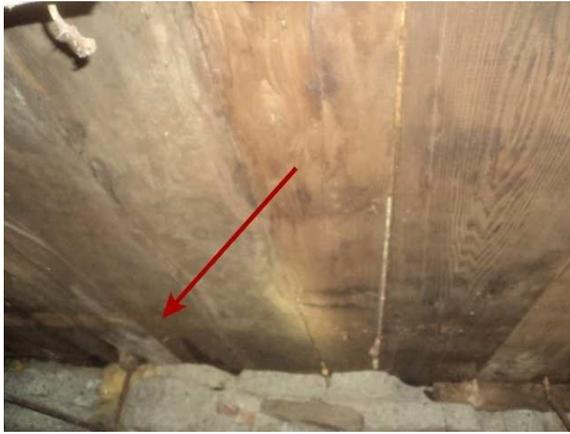
- We noted that there was batted insulation installed between the floor joists which inhibited our visual inspection of the floor structure.
- We did note that we observed termite damage to the floor in the crawl space. We also observed powder post beetles damage to the beams in the basement and crawl space.
- We noted that it appears that joists had been removed from the right side of the crawlspace. We also observe significant deterioration of the beam in the crawlspace.

NO JOISTS RIGHT SIDE CRAWL SPACE

- We recommend further evaluation by a licensed carpenter.

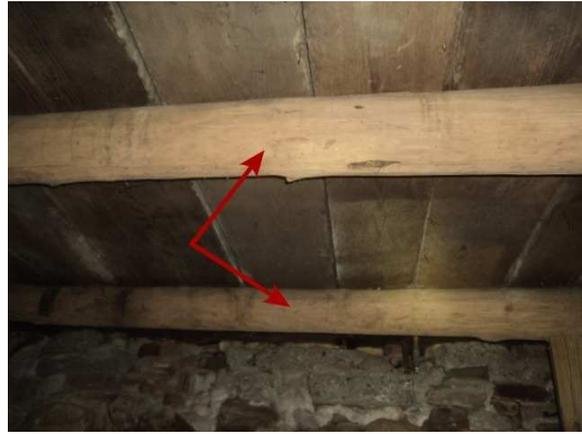
JOISTS LEFT SIDE CRAWL SPACE

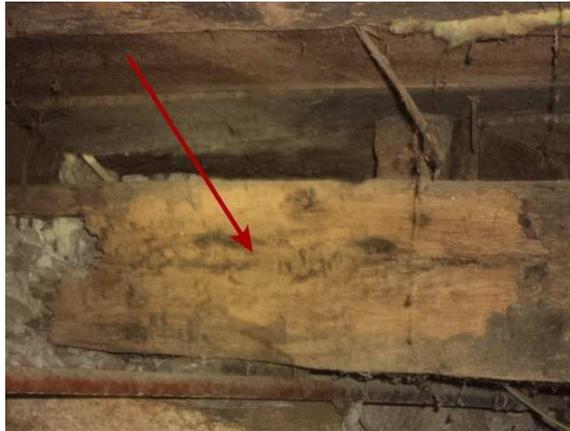
DETERIORATED BEAM IN CRAWL SPACE

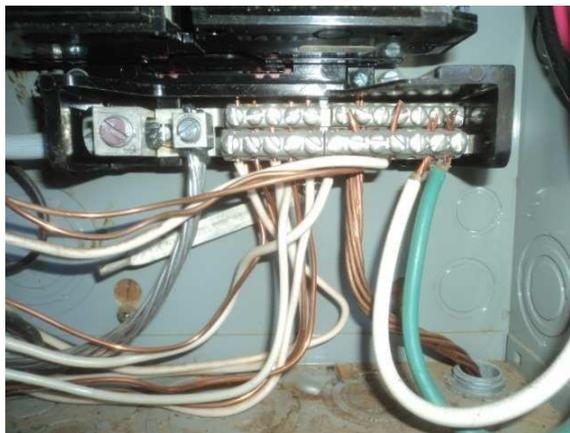
- We noted that we observed a General Electric sub-panel in the garage. The sub-panel was serviced by a 100 amp breaker in the main service panel. We noted that the grounds and the neutrals were attached to the same buss bar in the sub-panel (potential hazard). Grounds and neutrals should be isolated from one another in a sub-panel.

GROUND AND NEUTRALS SAME BUSS BAR  
GARAGE SUB-PANEL

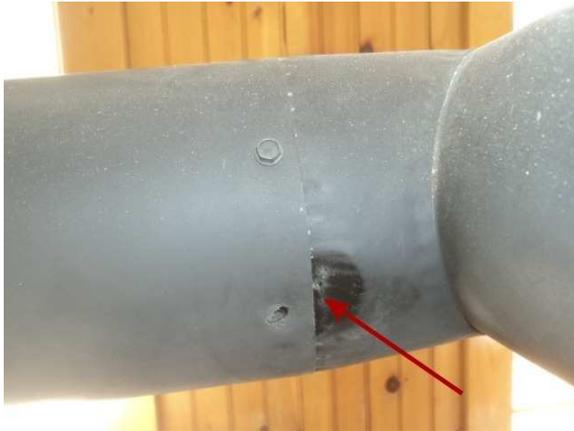
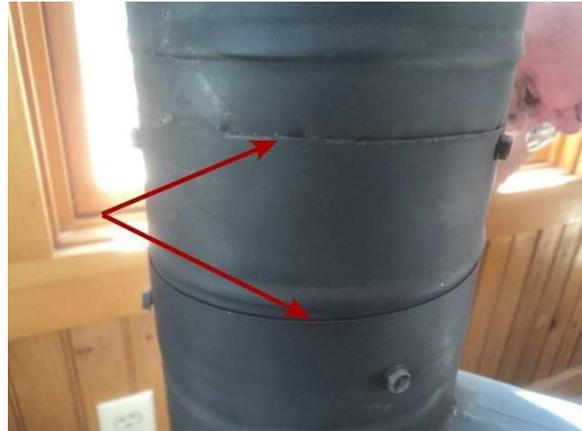
- We noted that the flue to the wood stove was not installed properly. The lower section of the pipe should be inserted into the upper section of the pipe.

WOOD STOVE FLUE

- We recommend further evaluation by a qualified contractor.

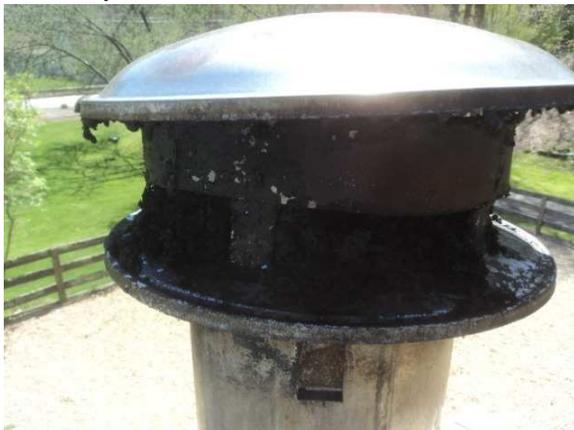
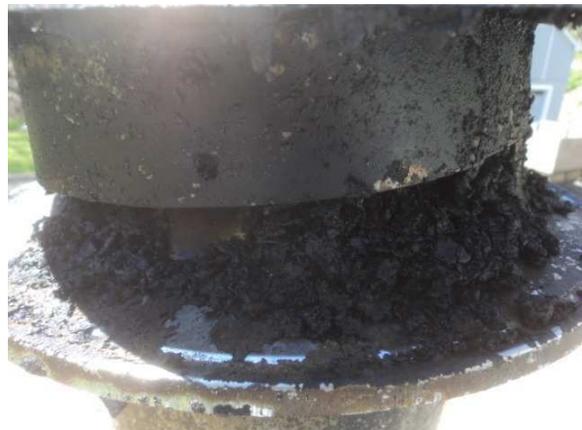
- We noted that the wood stove appeared to have inadequate clearance from the combustible walls in the porch.
- We observed creosote build up in the flue to the wood stove. We recommend having the flue professionally cleaned.

CREOSOTE BUILD-UP STOVE FLUE

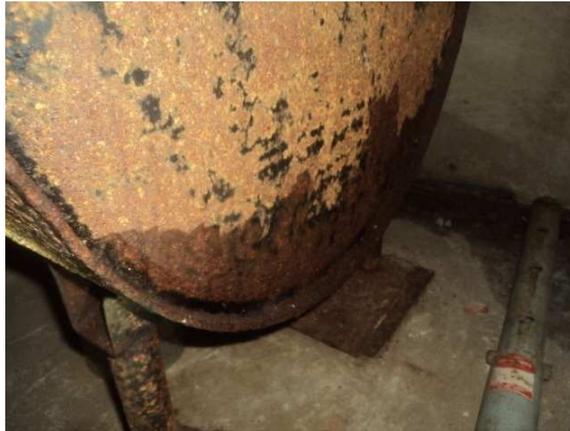
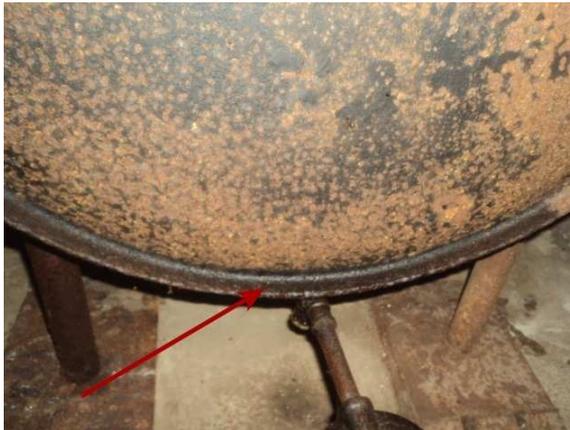
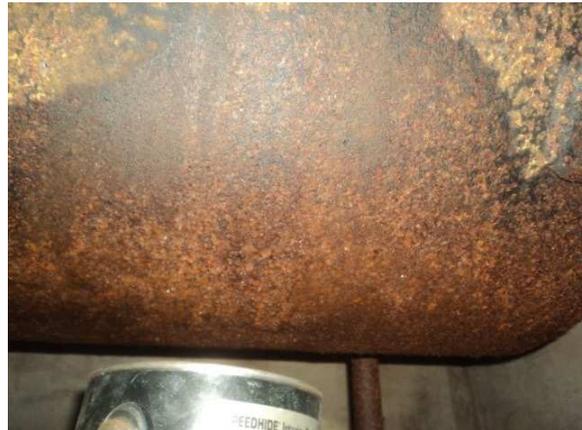
OIL TANK WET AND RUSTED ON SIDE

- We noted that the oil tank is in poor condition. The oil tank is wet on the sides and on the underside of the tank. We also noted that the oil tank is significantly rusted. We recommend replacing the oil tank.

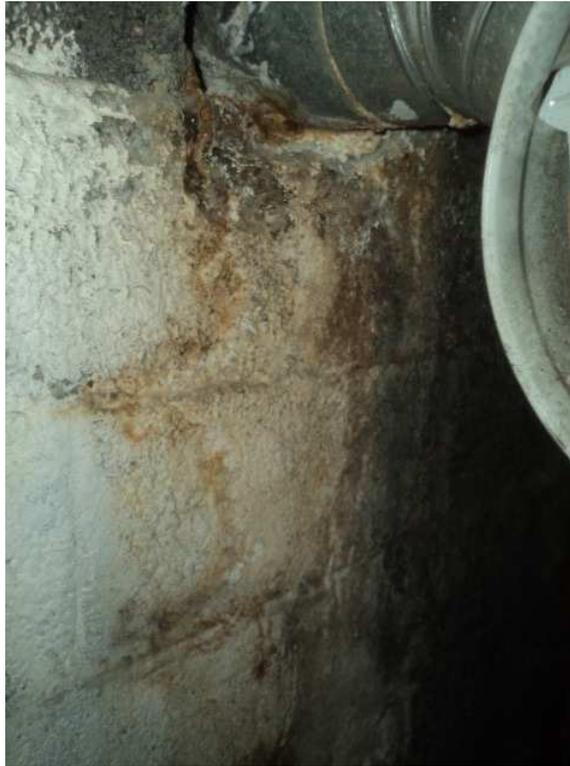
- We observed a leak in the fill pipe to the oil tank.
- We observed efflorescence under the flue to the boiler. This may indicate that the boiler does not draft properly. We recommend further evaluation by a licensed chimney professional.

EFFLORESCENCE UNDER BOILER FLUE

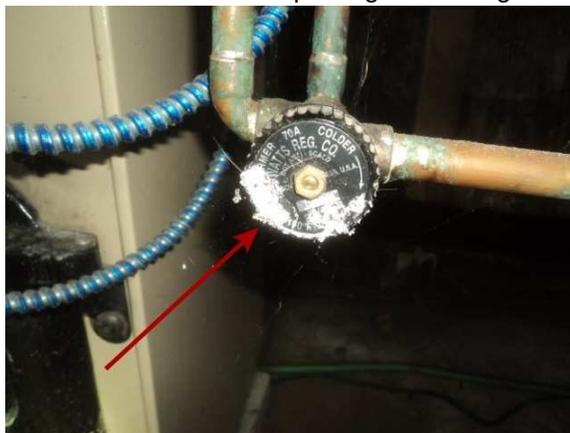
- We noted that the boiler pressure was 30 psi according to the gauge. The normal operating pressure of a boiler is 16-22 psi. The boiler should release pressure at 30 psi. We recommend further evaluation by a licensed heating technician.
- We noted that the mixing valve to the tankless coil was inoperable. This means you will not be able to adjust the hot water temperature. We recommend replacing the mixing valve.

MIXING VALVE
