HOME INSPECTION REPORT

File Number: 1132 - 100000

Address of Inspection: 123 Sample Drive

RE: 123 Sample Drive
Leawood, KS 66206
Inspection #: 1132 - 100000

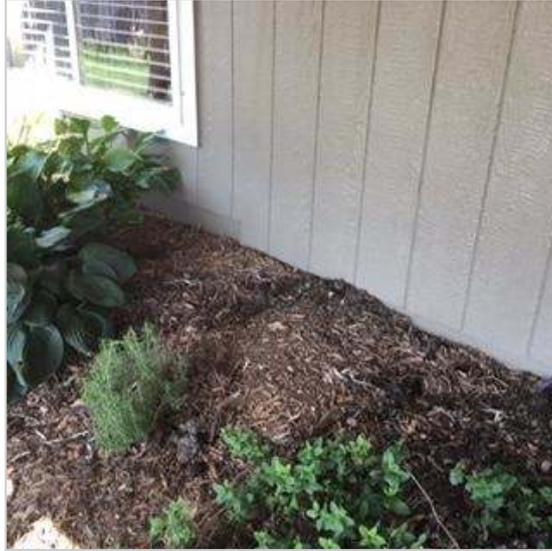
Figure Number 2

landscaping material in contact with siding underneath deck

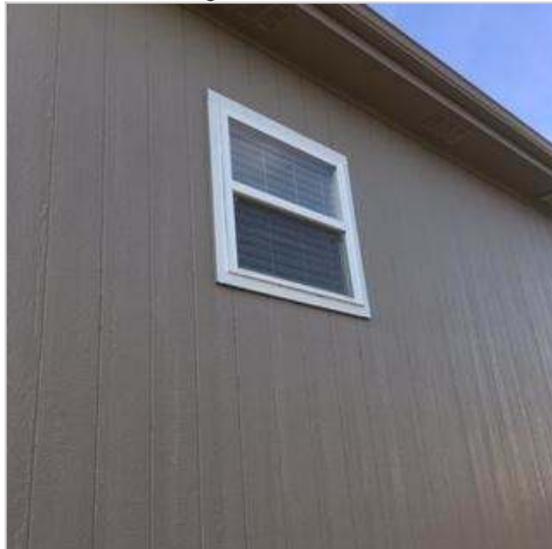
Figure Number 3

flashing missing over top exterior of left front window

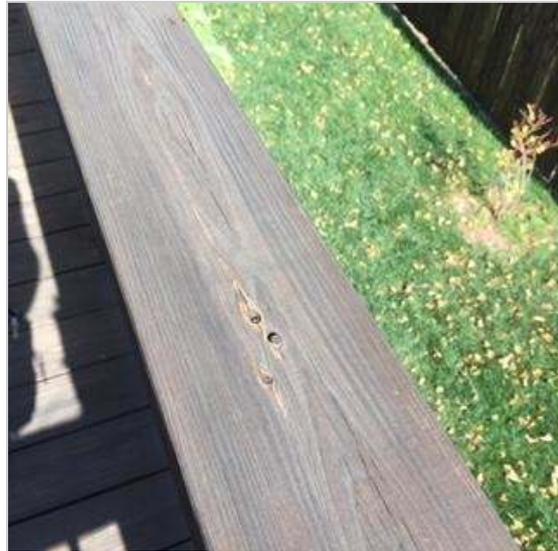
Figure Number 11

deck support post for in contact with soil and did not have proper mechanical fasteners; raised nailheads on handrail for steps and guard rail around deck

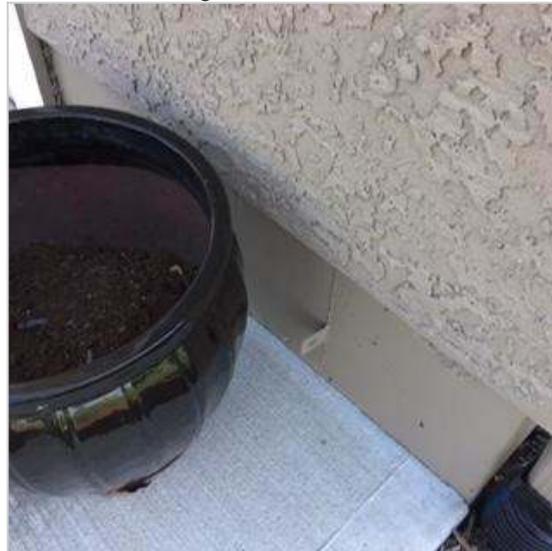
Figure Number 13

Intact foundation form tie on front right corner of home

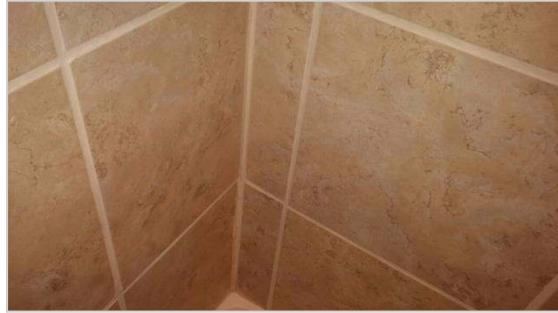
Figure Number 17

lower-level bathroom tank is loose on the toilet. Grout cracks in the corners of the shower.

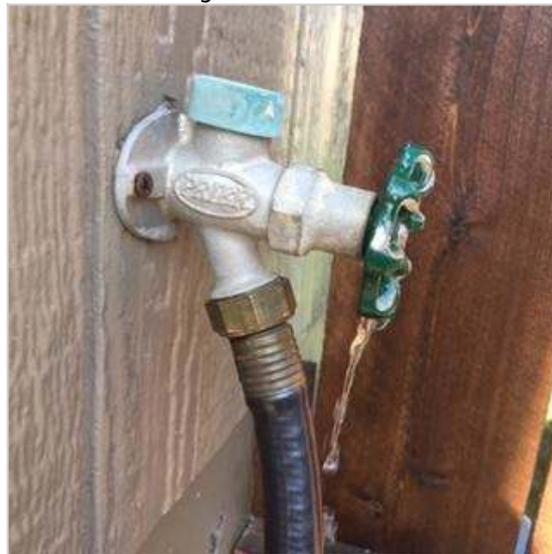
Figure Number 18

hose bib on left front of home leaks at faucet knob

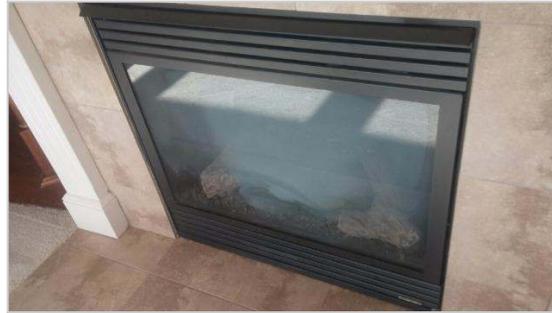
Figure Number 22

Direct vent gas fireplace glass front is cloudy.

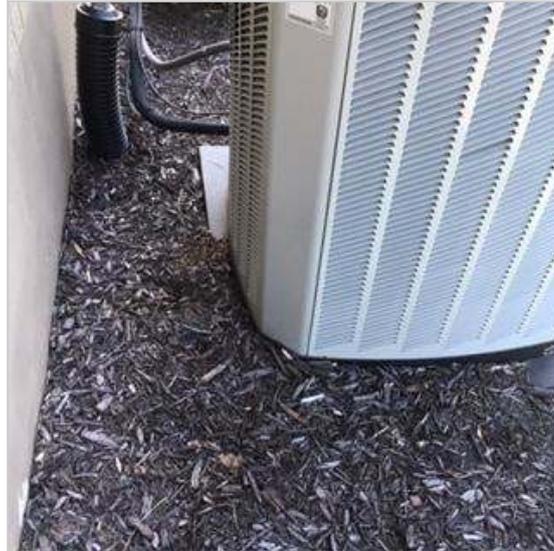
Figure Number 26

landscaping material in contact with heat pump/AC condensing unit
