HOME INSPECTION REPORT

**123 Sample Drive
Anytown, IL 60000
Inspection #: XXXX**

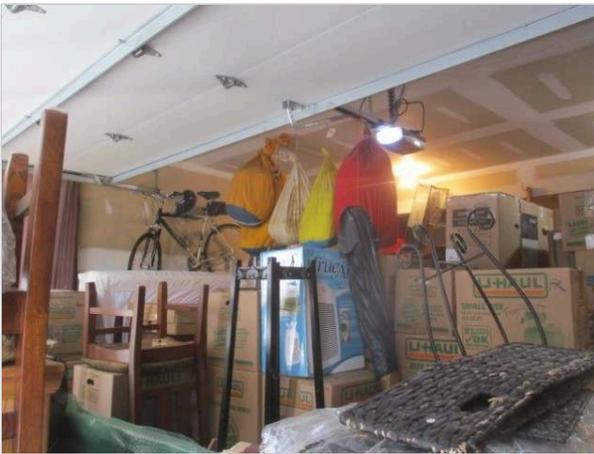
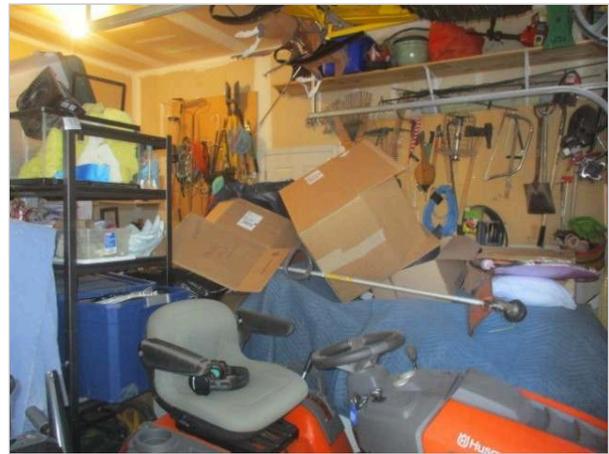
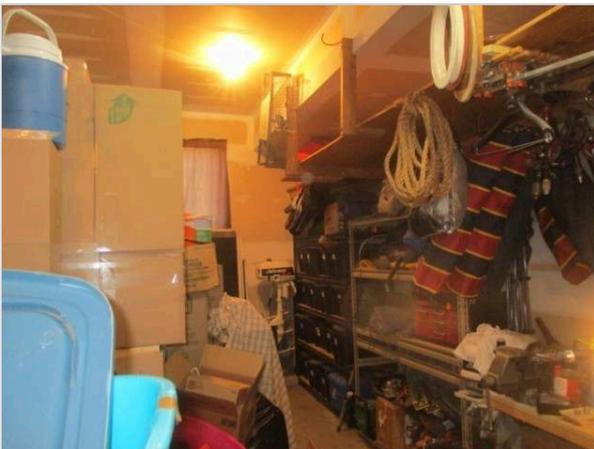
- ***There was storage in the garage that obscured some areas from visual inspection.***

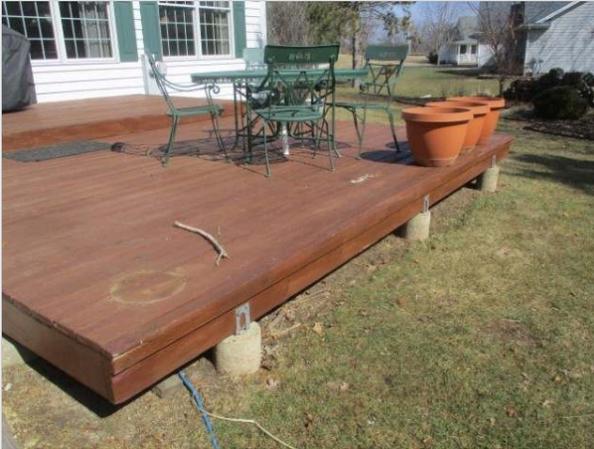
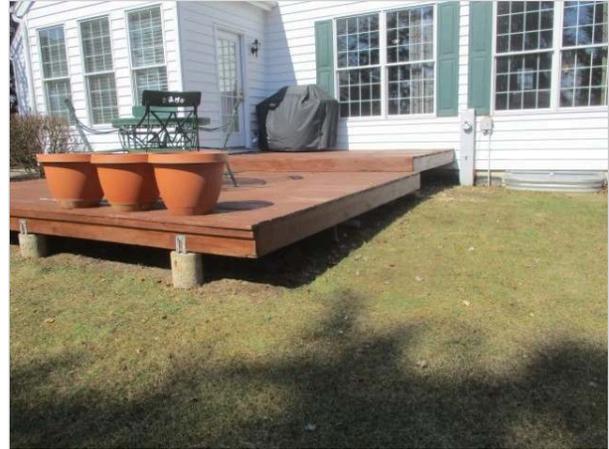
- ***The deck guardrail was missing and should be corrected as this is a safety concern.***

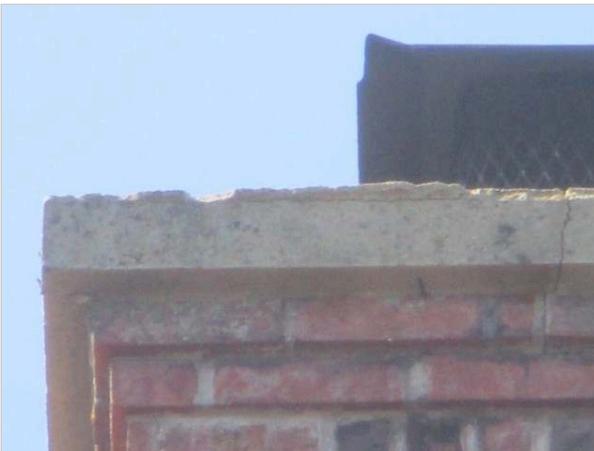
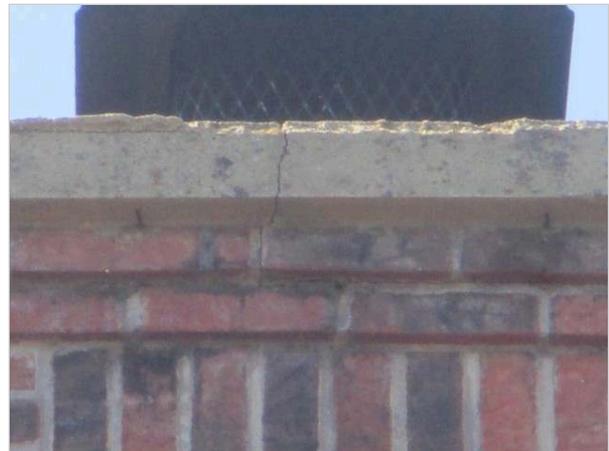
- ***The concrete chimney cap was cracking and should be repaired.***

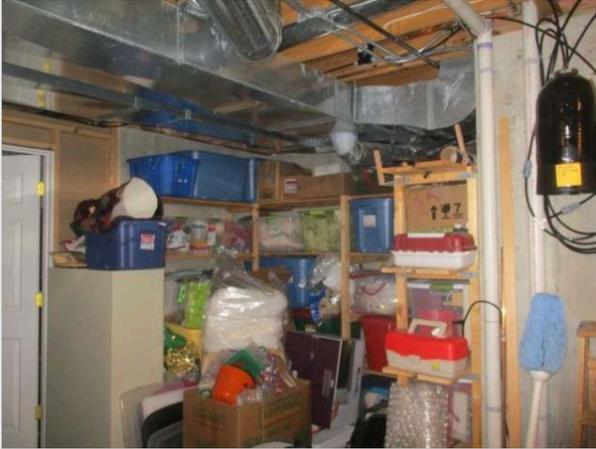
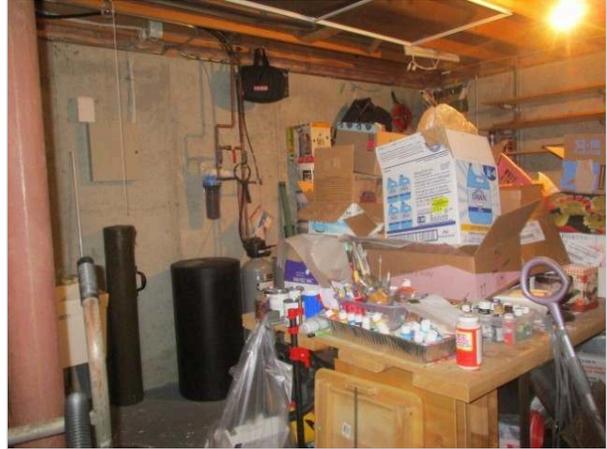
- ***There was storage in the basement that obscured some areas from visual inspection.***

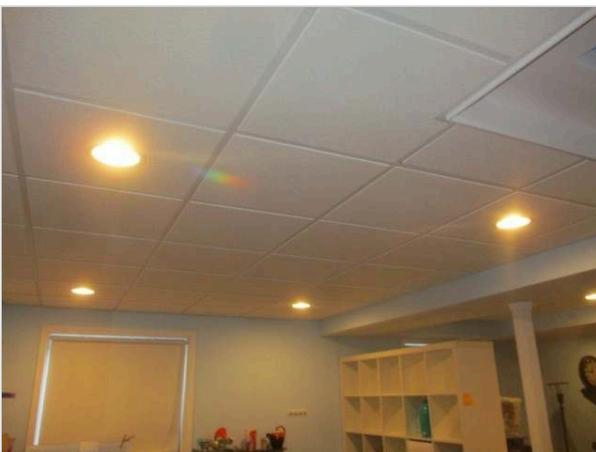
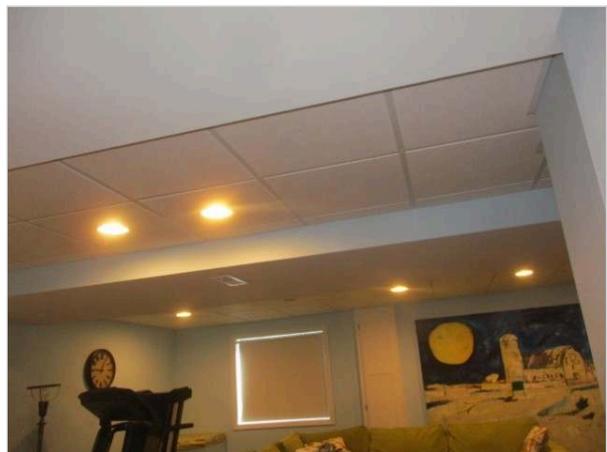
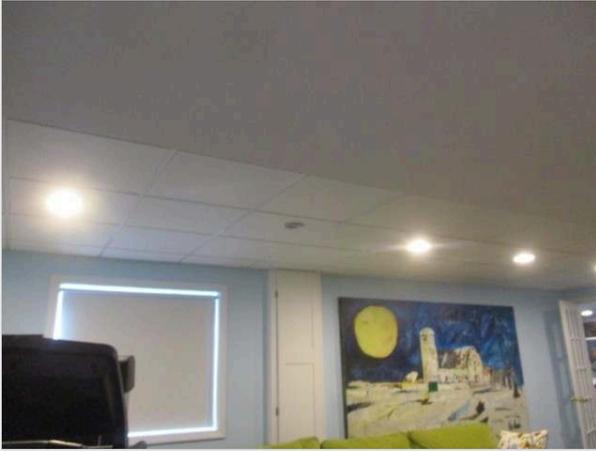
- ***Part of the basement ceiling was finished, which restricts a clear view of the floor joists. As a result, we were not able to see the entire floor structure during the inspection.***

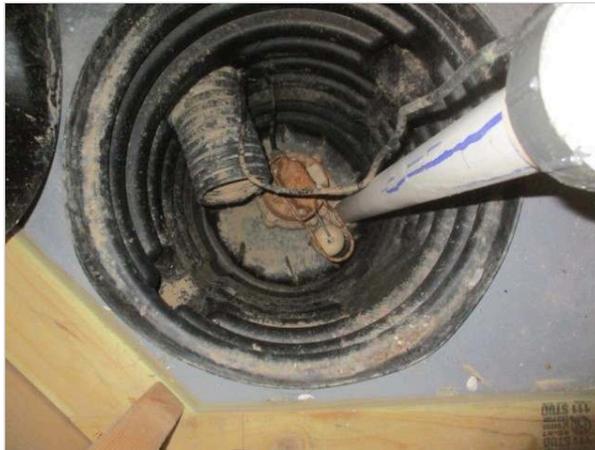
- ***The sump pump pit was dry and should be monitored during heavy rain.***

- ***We recommend installing a battery back up for the sump pump as necessary.***

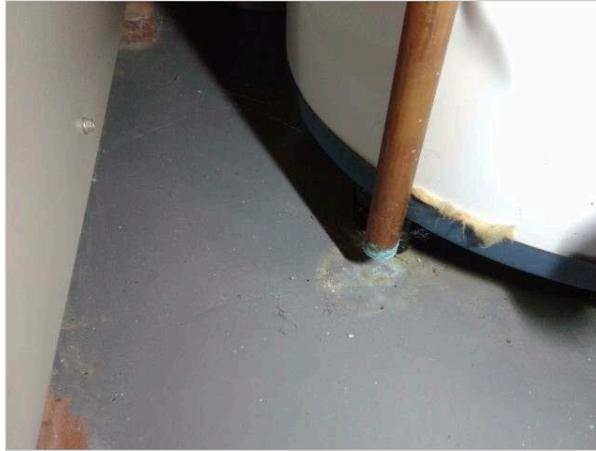
- *There was corrosion at the bottom of the T&P pipe and should be monitored for action.*

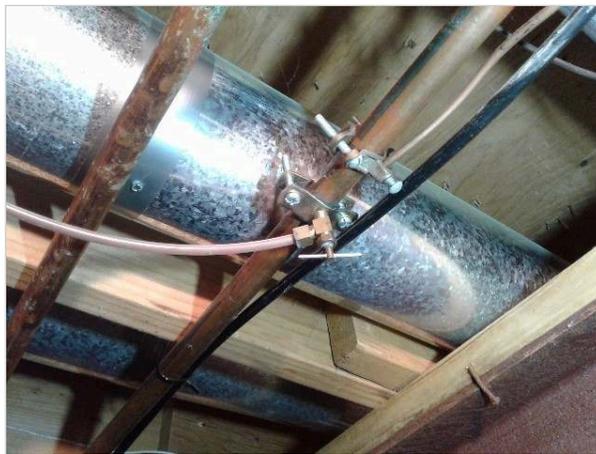
- *There was a saddle valve over the hot water heater that should be replaced with a positive shut off valve.*

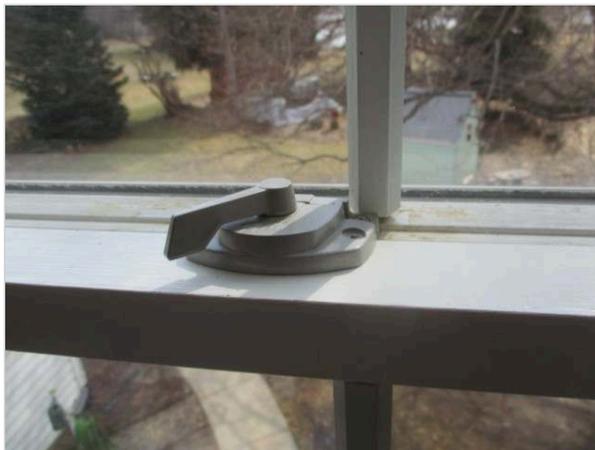
- ***The right rear bedroom right window lock would not latch and should be repaired or replaced.***

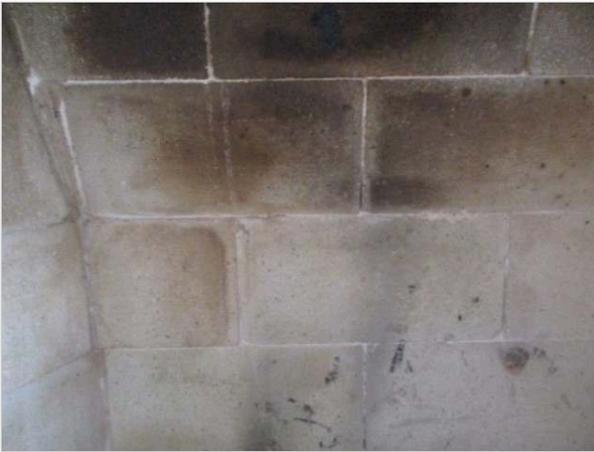
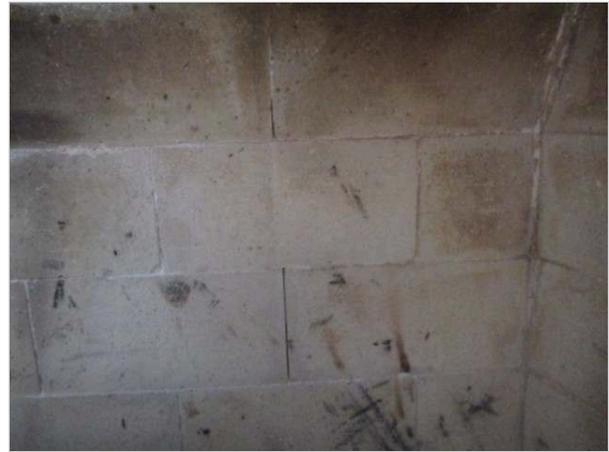
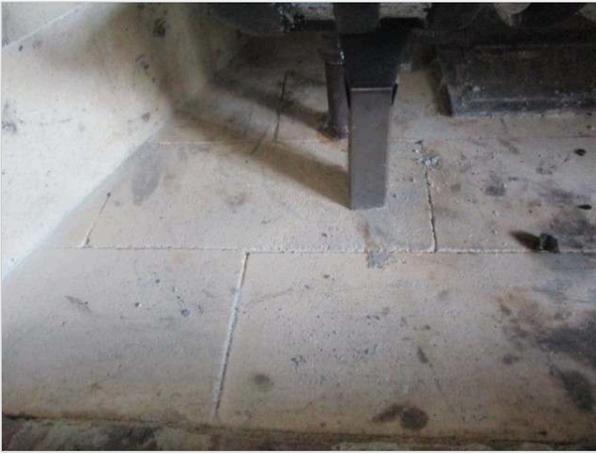
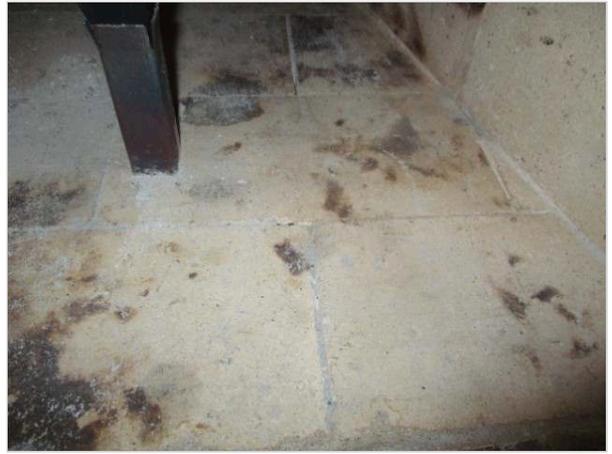
- ***There was mortar missing from the firebox of the fireplace located in the family room. The bricks and mortar inside the firebox are designed to act as a heat and spark shield and should be free of any voids. The fireplace should be serviced and repaired by a chimney sweep prior to use.***
