# HomeTeam<sup>®</sup>

### HOME INSPECTION REPORT

Address of Inspection: 123 SAMPLE DRIVE

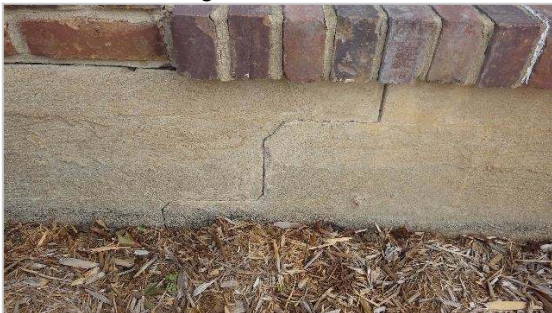
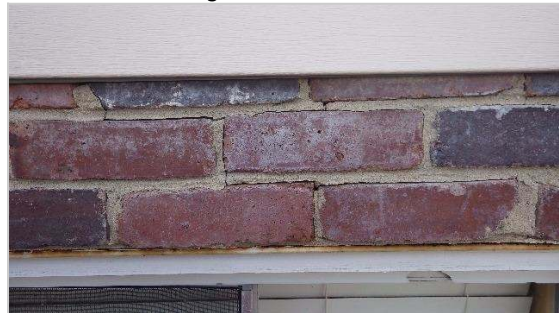
There were brick and block and mortar separation-type cracks observed at the foundation wall. All cracks in the masonry should be sealed to help prevent further cracking from the freezing and thawing effects of ice.

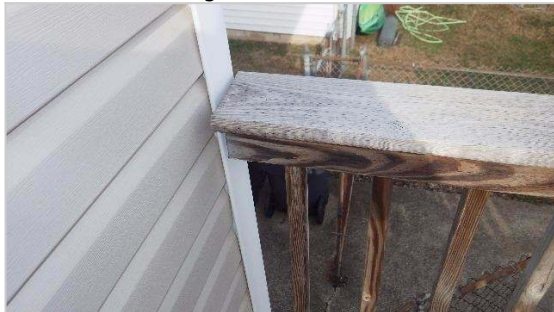
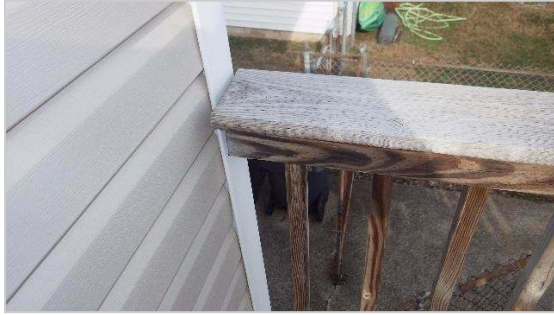
Figure Number 7

The safety railing at the deck was not securely attached where the railing contacted the wall of the structure. Also, the load bearing support did not appear to be adequate at the corner post. Repair is recommended to maintain the safety of the railing.

1. The safety railing at the deck was not securely attached where the railing contacted the wall of the structure. Also, the load bearing support did not appear to be adequate at the corner post. Repair is recommended to maintain the safety of the railing.

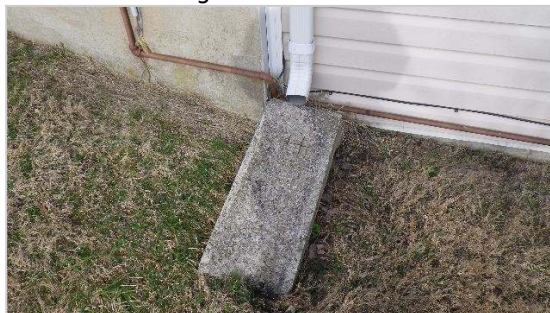
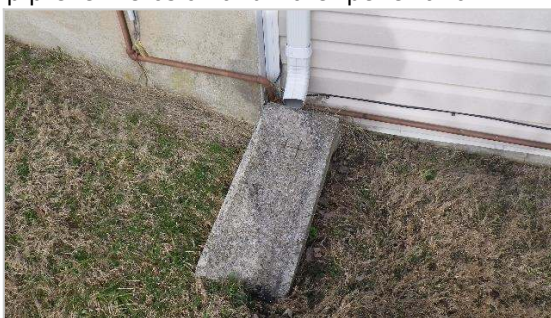
Figure Number 11

The downspouts were directing roof surface water toward the foundation. They should be extended farther away to help prevent erosion and water penetration.

1. The downspouts were directing roof surface water toward the foundation. They should be extended farther away to help prevent erosion and water penetration.

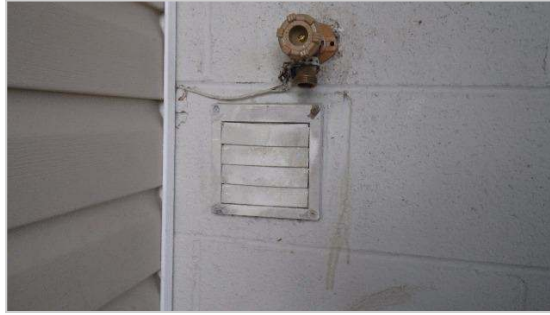
Figure Number 14

The visible sections of the clothes dryer exhaust vent piping and exterior cover were inspected and it was functional and adequate, however, it did not have a protective screen (or cage installed at the exterior cover to help prevent pest entry.

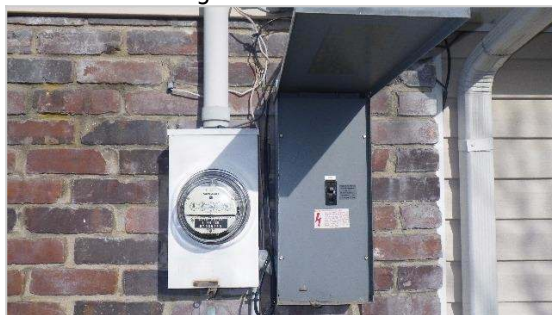
Figure Number 17

The main circuit breaker for the electrical service was not located in the service panel, but was located next to the meter base at the exterior of the structure.

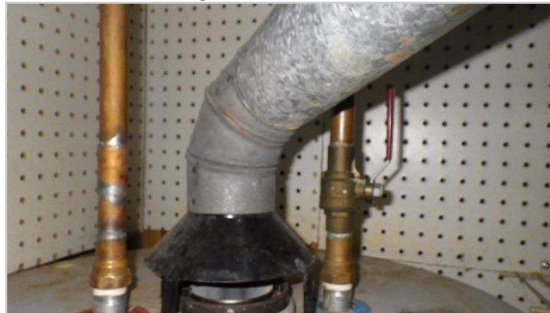
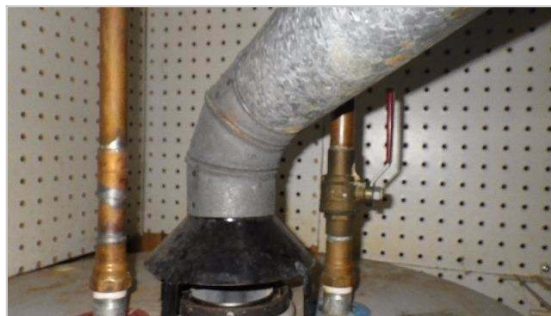
Figure Number 19

The gas-fueled water heater exhaust pipe was not secured with retaining screws at each joint in the pipe sections. Retaining screws should be installed to help prevent the exhaust vent pipe from being moved away from the vent opening which could allow combustion gases to seep into the living areas of the structure.

3. The gas-fueled water heater exhaust pipe was not secured with retaining screws at each joint in the pipe sections.

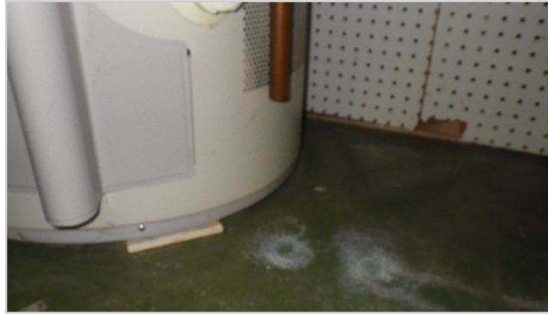
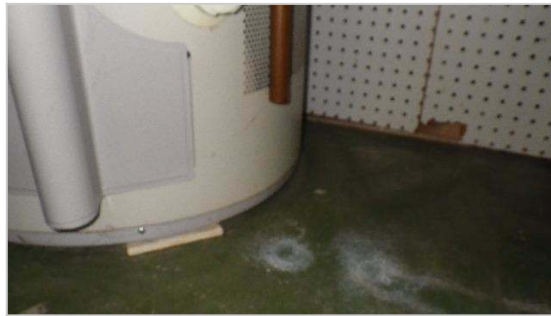
Figure Number 20

The overflow pipe for the water heater was not within 2-inches of the floor for safety and should be extended.

2. The overflow pipe for the water heater was not within 2-inches of the floor for safety and should be extended.

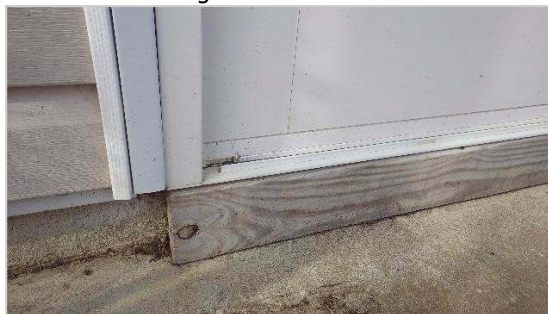
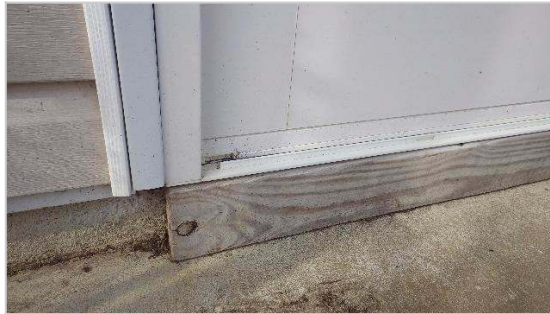
Figure Number 21

The exterior door sills at the back patio were not adequately caulked. Additional caulk should be installed to help prevent water penetration into the structure.

1. The exterior door sills at the back patio were not adequately caulked. Additional caulk should be installed to help prevent water penetration into the structure.

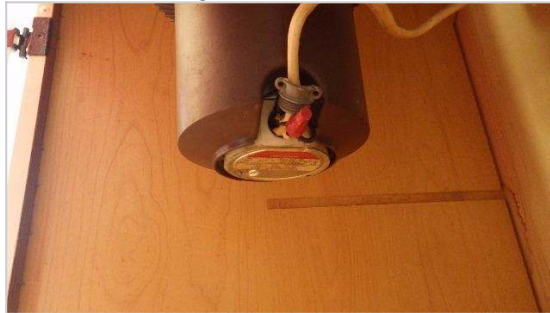
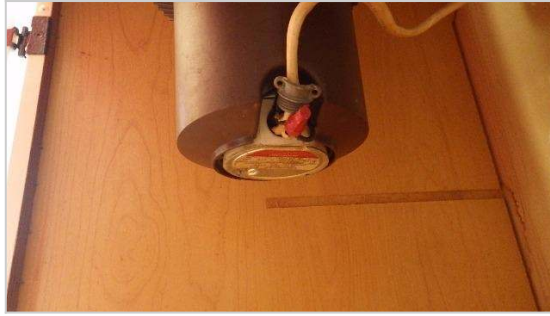
Figure Number 25

The electrical wire at the disposer was not adequately secured with tape. The electrical wiring should be properly secured to help prevent accidental entry or shock.

2. The electrical wire at the disposer was not adequately secured with tape. The electrical wiring should be properly secured to help prevent accidental entry or shock.

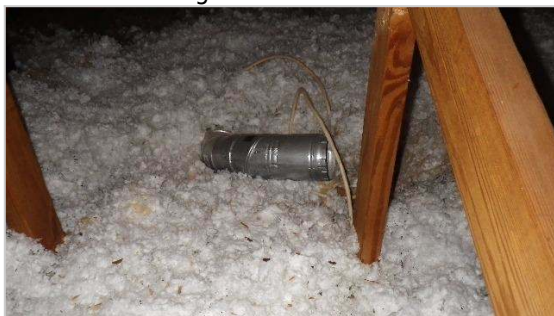
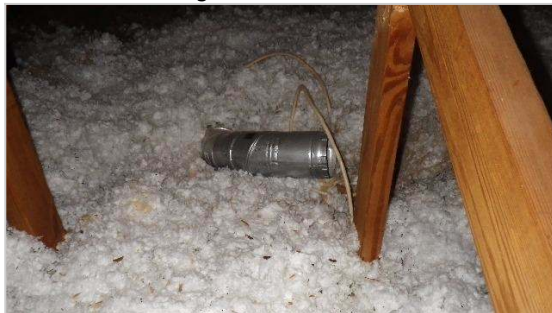
Figure Number 29

The hallway bathroom exhaust pipe and the microwave vent pipe were vented to the attic space. They should be properly vented to the exterior of the structure, which will help prevent moisture from accumulating in the attic space.

1. The hallway bathroom exhaust pipe and the microwave vent pipe were vented to the attic space. They should be properly vented to the exterior of the structure, which will help prevent moisture from accumulating in the attic space.

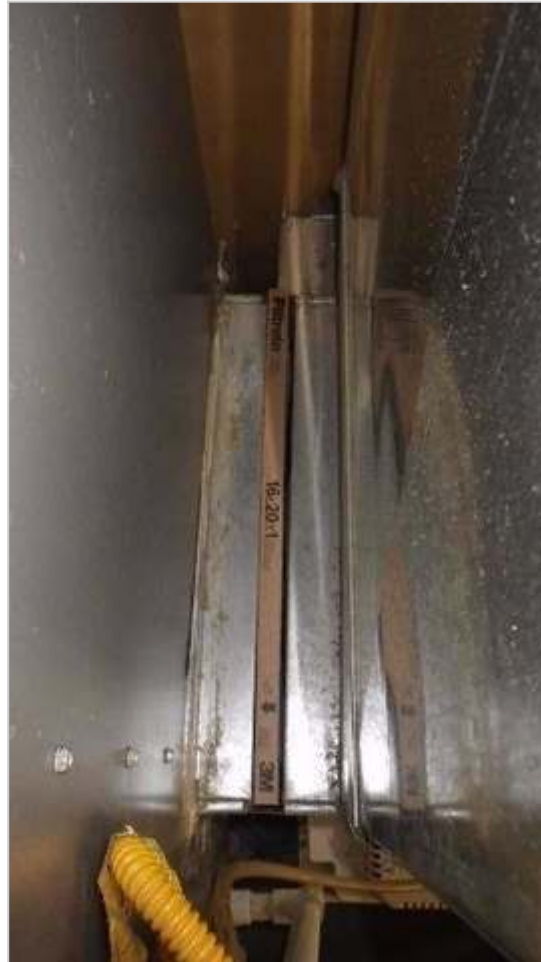
Figure Number 33

The filter compartment door at the HVAC coil/air-handler unit in the basement was not installed. A roll of duct tape should be kept near the unit and used to seal the compartment to help prevent un-filtered air from being distributed throughout the structure.
