# HomeTeam<sup>®</sup>

### HOME INSPECTION REPORT

Thursday, December 5, 2019

**Bill Sample**  
**123 Sample Dr**  
**Anytown, KY 12345**  
**Reference Number: XX-XX-XX**

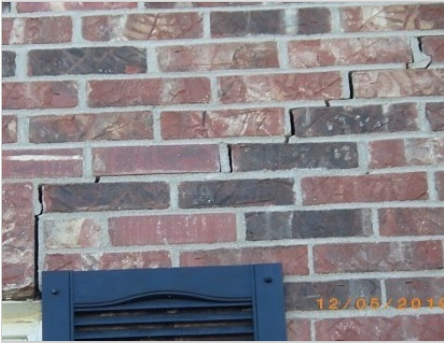
**Photo# 9**

There were brick and mortar separation-type cracks observed at the brick veneer. All cracks in the masonry should be sealed to help prevent further cracking from the freezing and thawing effects of ice.

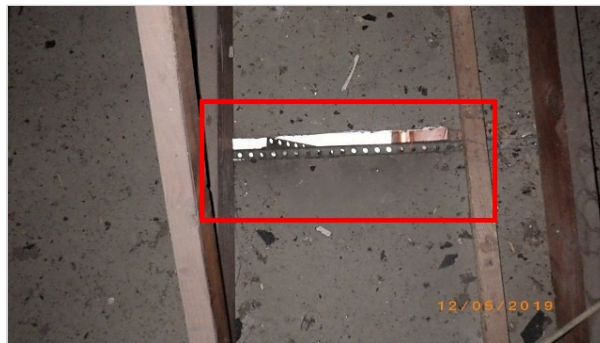
**Photo# 16**

The fire separation components of the walls, doors, and ceiling at the interior of the garage were inspected and had a small opening in the ceiling. Which could allow a potential fire to spread to other parts of the structure. It should be repaired with a fire rated product.

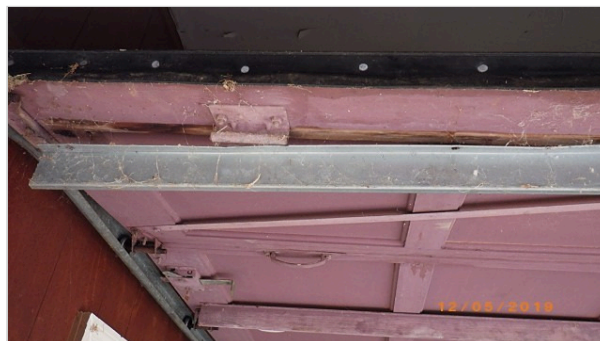
**Photo# 17**

The garage door was functional at the time of the inspection, however, a support on the bottom panel was damaged. Please repair or replace as necessary.

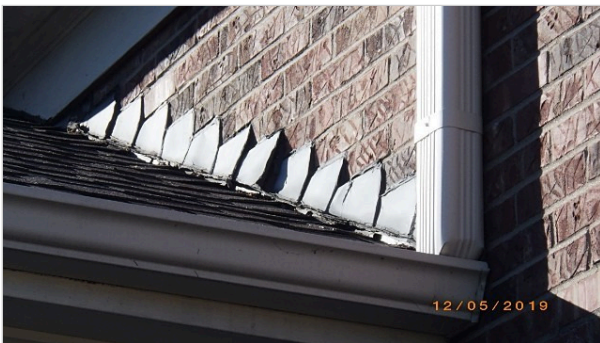
**Photo# 26**

The metal step and counter flashing components (all around the roof surface) where the shingles contacted the vertical walls were not adequately sealed. The flashing had open gaps in the caulking or had pulled away from the wall. Repair or replacement should be made to help prevent water penetration into the structure.

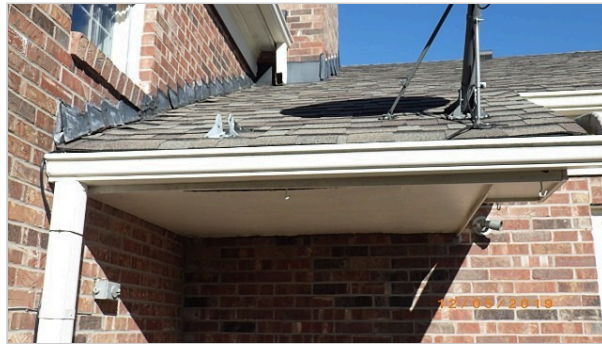
**Photo# 28**

The gutters and downspouts were primarily painted metal components that were functional, however, several of the downspouts were directing water toward the foundation and should be extended at least 10 feet away from the foundation wall.

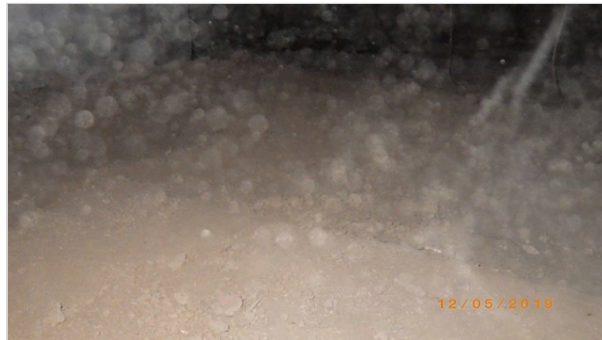
**Photo# 47**

The crawl space did not have a vapor barrier (usually a 6-mil plastic material) covering the majority of the ground in the crawl space. Vapor barrier helps prevent ground moisture from penetrating the insulation and floor structure and causing possible damage to the wooden framing components and decreasing the efficiency of the insulation.

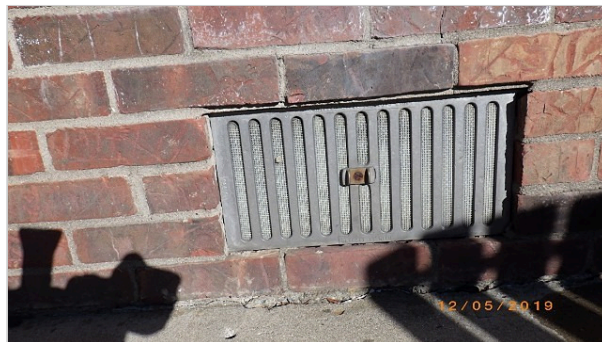
**Photo# 48**

Some of the crawl space ventilators were closed or blocked closed. Crawl space ventilators should remain fully open at all times.

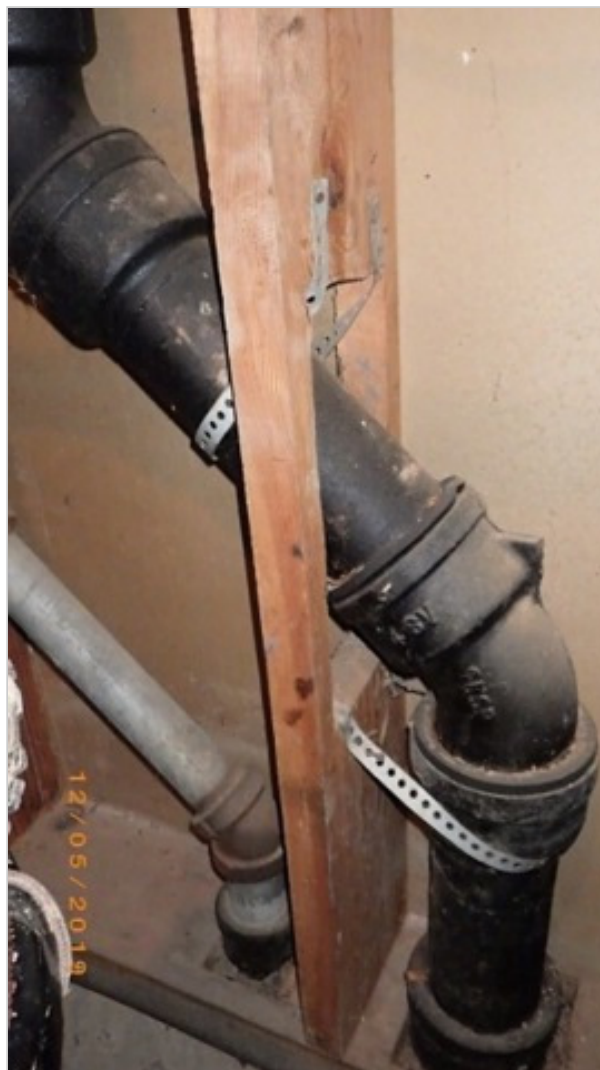
**Photo# 60**

Galvanized plumbing pipes will corrode, rust and clog with calcium over time. The water pressure may vary at certain faucets due to the age and condition and number of supply pipes in use simultaneously. Repair or replacement should be made as necessary to maintain adequate water supply pressure.

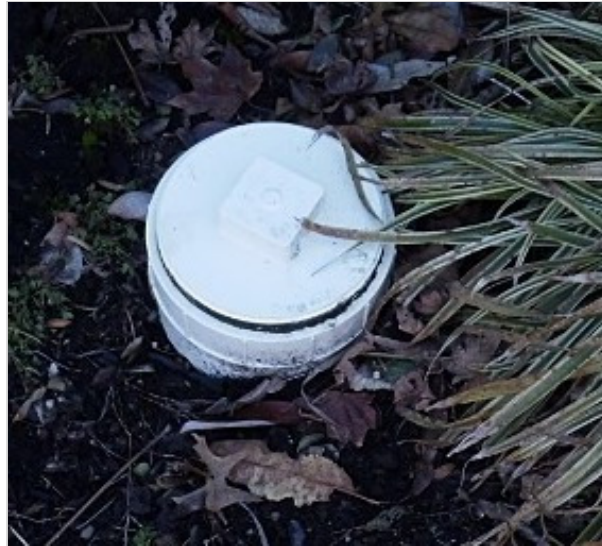
**Photo# 61**

Main sewer line clean out at the front yard. Check with the sellers or a licensed plumber on information on the age and/or condition of the main sewer line.

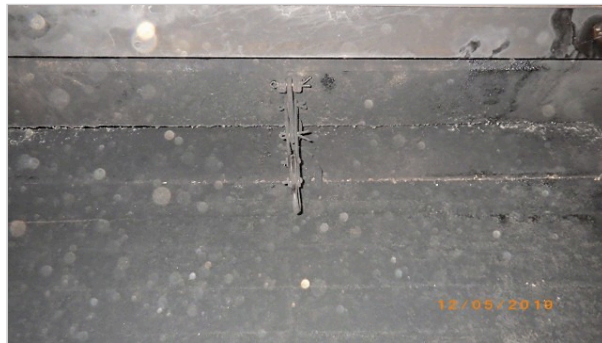
**Photo# 83**

The masonry fireplace damper was not fully operable and there was an excessive amount of creosote in the firebox and flue. The masonry fireplace should be inspected by a qualified chimney sweep and make any necessary repairs.

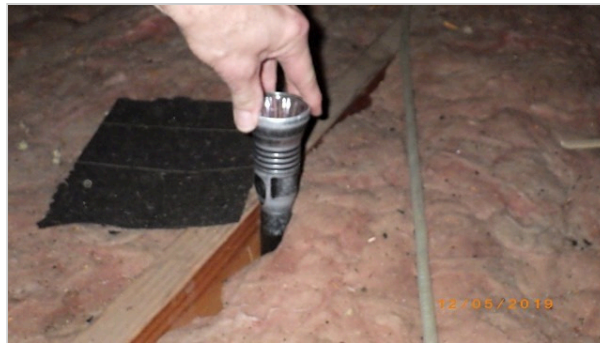
**Photo# 101**

The insulation above the living areas appeared to be inadequate (the thickness was less than six inches in depth) which appeared to be significantly deficient. An evaluation should be made by a qualified energy specialist and additional insulation should be installed as necessary.

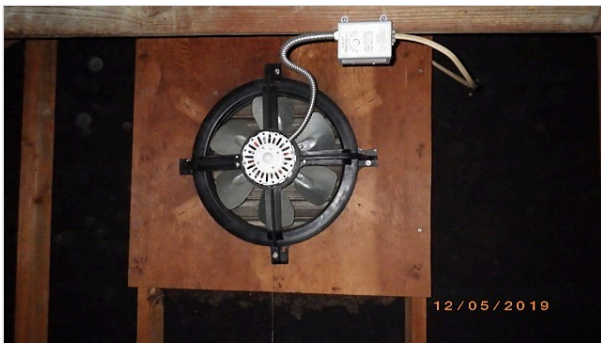
**Photo# 102**

The 2 electric powered attic ventilation fans in the attic space were not functional and should be repaired or replaced.

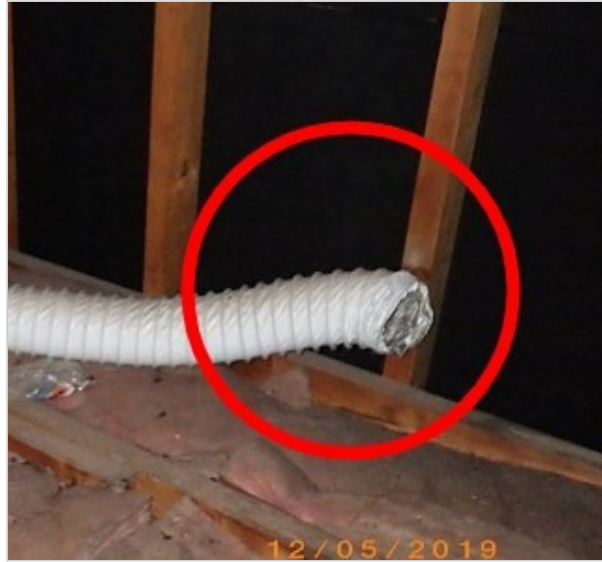
**Photo# 104**

The bathroom exhaust vent pipe(s) were vented to the attic space. They should be properly vented to the exterior of the structure, which will help prevent moisture from accumulating in the attic space and reducing the effectiveness of the insulation.

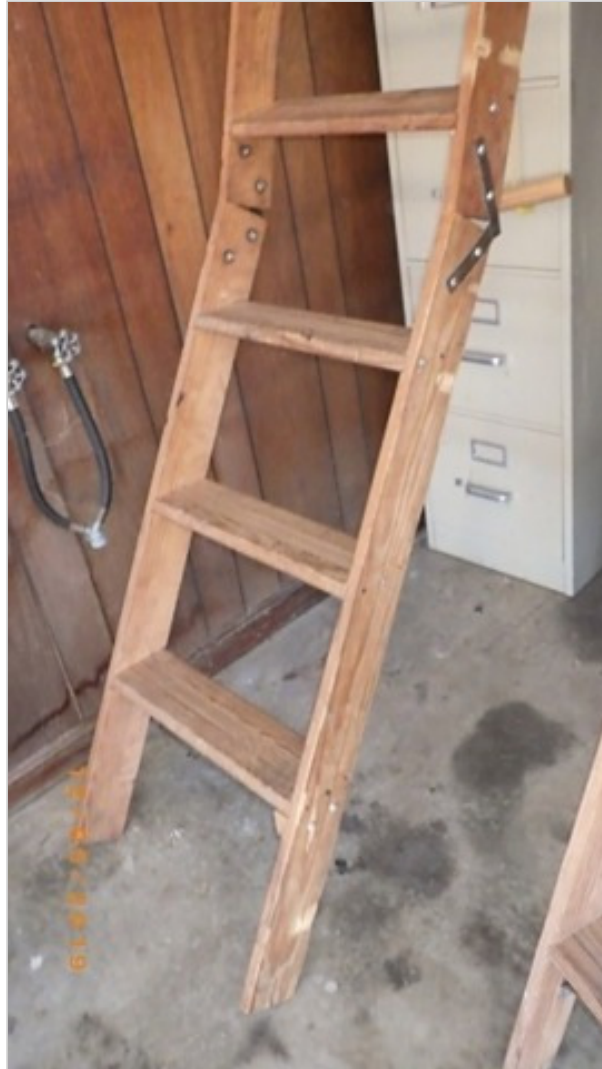
**Photo# 105**

The attic folding stairway bottom legs were not cut at the proper angle for safety. It should be repaired or replaced as necessary.

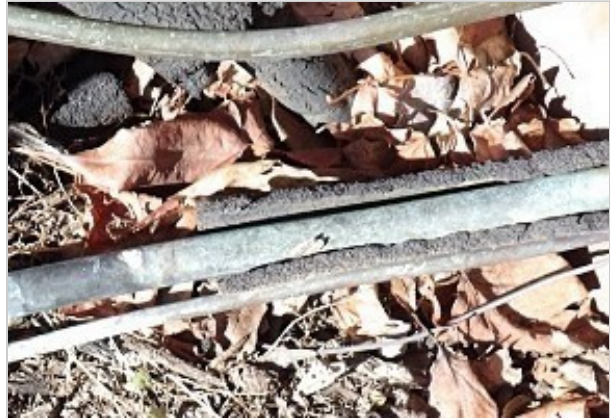
**Photo# 107**

The exterior HVAC unit appeared to have an inadequate airflow due to the vegetation surrounding the unit, which could reduce the efficiency of the system.

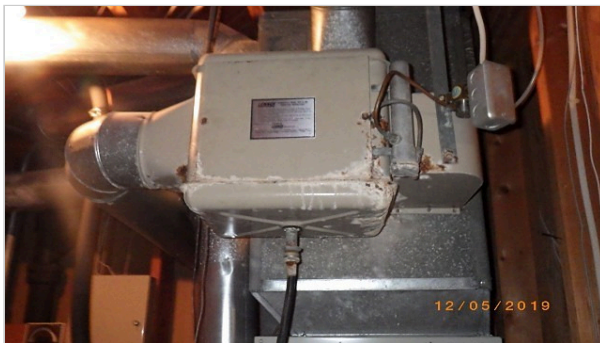
**Photo# 112**

The second level heating system contained a humidification component that adds moisture to the supply air in the ductwork. The operation and functionality of the humidification component was not within the scope of the inspection. A reliable, licensed HVAC technician should be consulted for concerns or for further consultation.

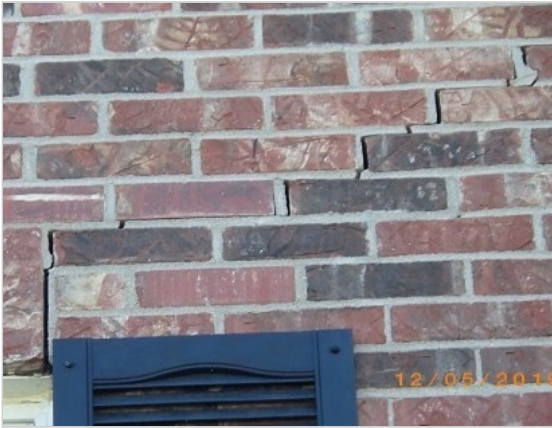
Photo# 9

1. There were brick and mortar separation-type cracks observed at the brick veneer.

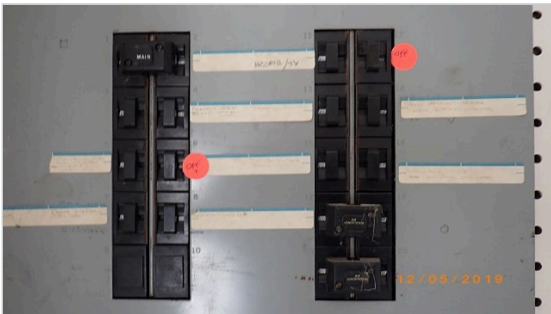
- 1. There were circuit breakers in the main electrical service panel that had two attached circuits (double wired)  
Photo# 68

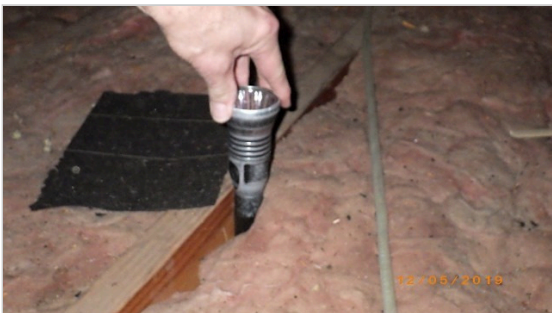
Photo# 101

- 4. The insulation above the living areas appeared to be inadequate (the thickness was less than six inches in depth) which appeared to be significantly deficient. An evaluation should be made by a qualified energy specialist and additional insulation should be installed as necessary.

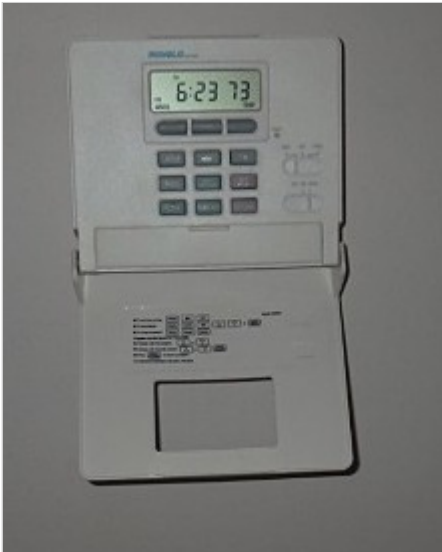
Photo# 117

4. The second level HVAC thermostat display would dim when using the controls. Repair or replace.

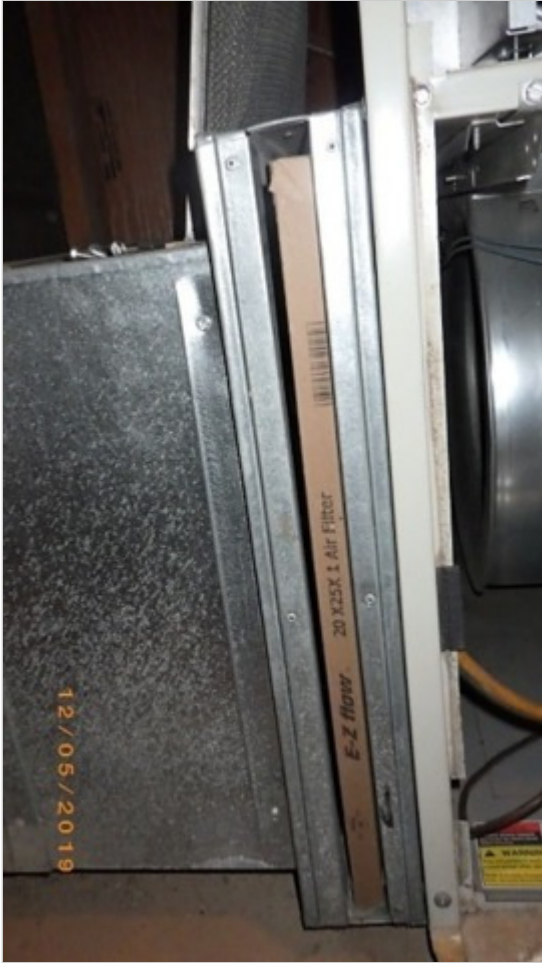
Photo# 116

5. The second level filter compartment door at the HVAC coil/air-handler unit in the basement was not installed. A roll of duct tape should be kept near the unit and used to seal the compartment to help prevent un-filtered air from being distributed throughout the structure.

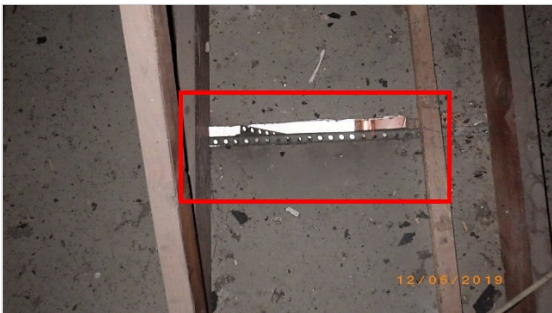
Photo# 16

6. The fire separation components of the walls, doors, and ceiling at the interior of the garage were inspected and had a small opening in the ceiling. Which could allow a potential fire to spread to other parts of the structure. It should be repaired with a fire rated product.

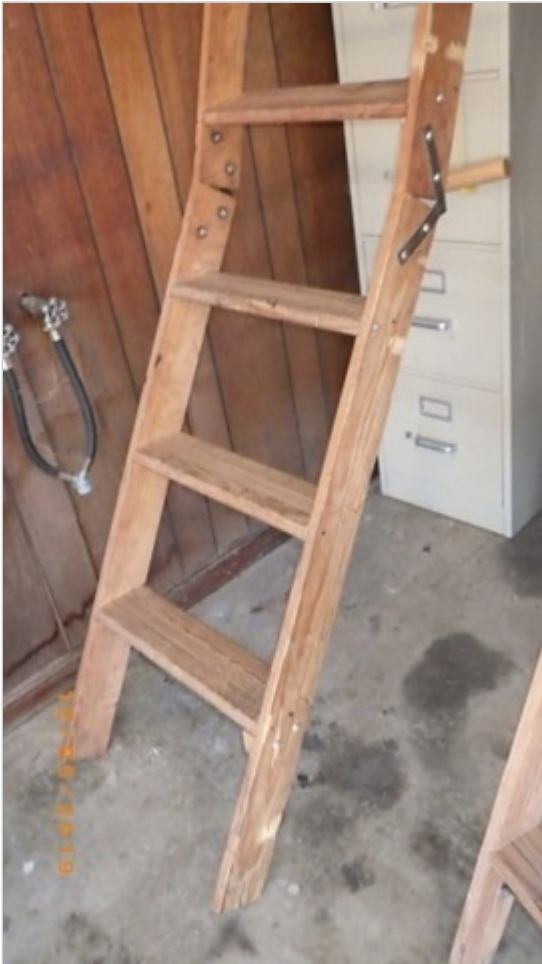
Photo# 105

7. The attic folding stairway bottom legs were not cut at the proper angle for safety. It should be repaired or replaced as necessary.
