HOME INSPECTION REPORT

On Sunday, August 28, 2022 The HomeTeam Inspection Service made a visual inspection of 123 Sample Street, City, ST 12345. On the following pages please find a written, narrative report of our findings in accordance with the terms of our Inspection Agreement.

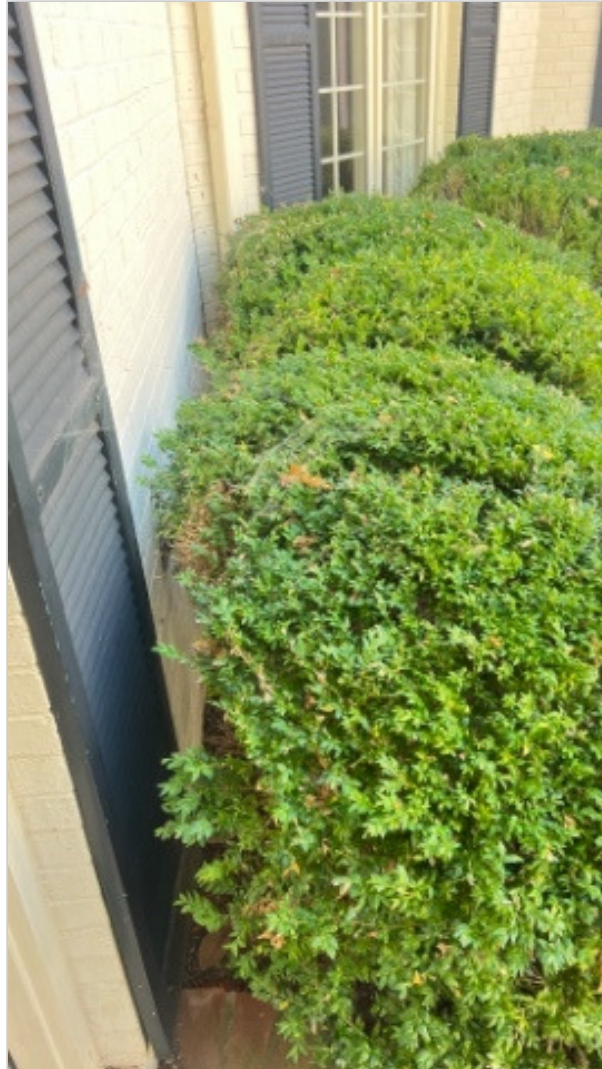
Photo# 11

Excessive vegetation was contacting and/or close to the structure. The vegetation may damage the structure and cause water retention at the foundation and should be trimmed or removed.

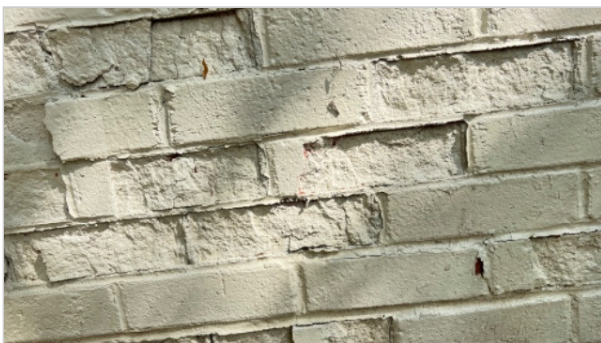
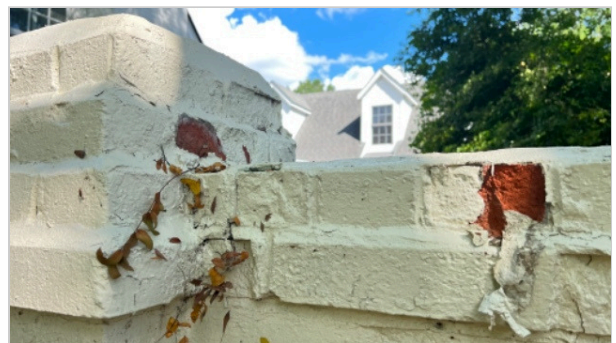
Photo# 12

The retaining wall brick was spalling.

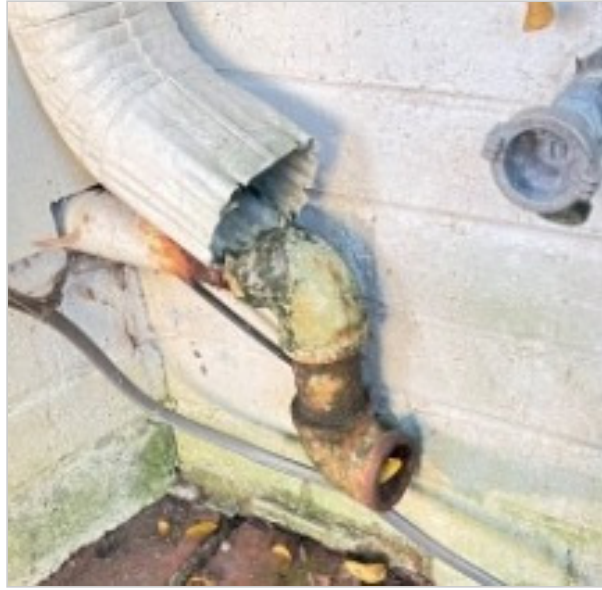
Photo# 27

Some sections of the gutters were slightly damaged and/or not securely attached to the structure. The damaged components should be repaired or replaced as necessary to help provide adequate drainage of the roof surface water away from the structure.

The downspouts were directing roof surface water toward the foundation and the walkway. They should be extended farther away to help prevent erosion and water penetration.

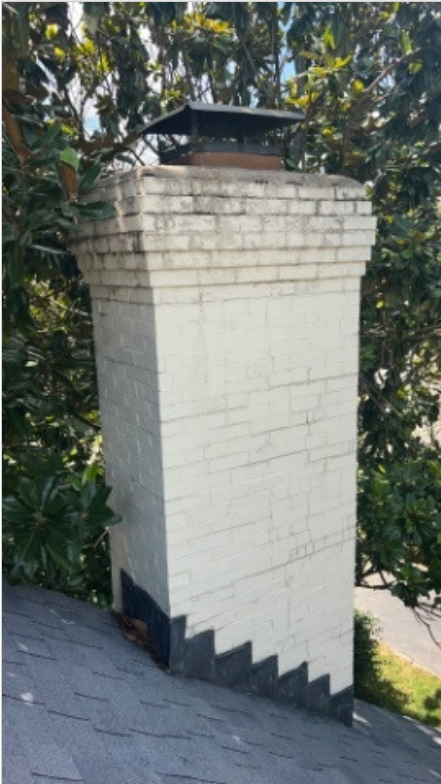
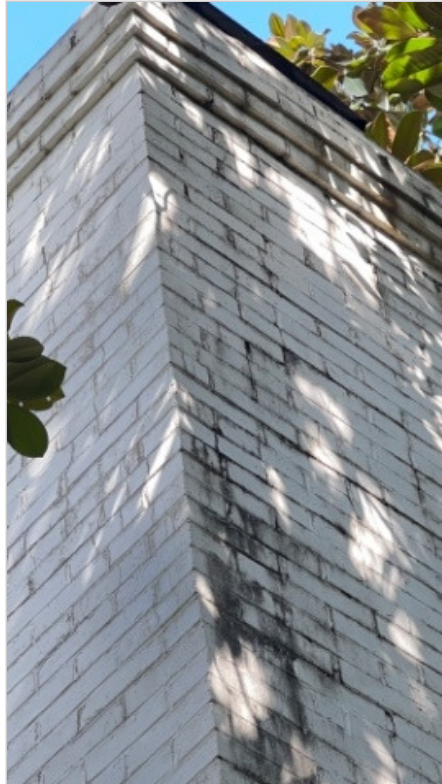
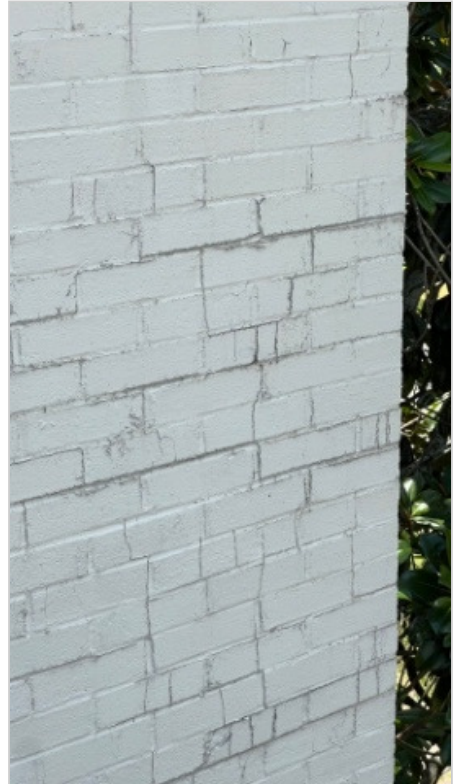
There were cracks in the bricks.

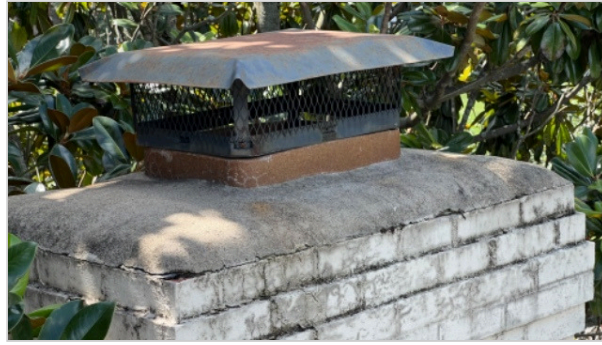
Photo# 31

The unsealed concrete at the top of the masonry chimney could absorb water that may seep into the interior of the chimney structure. Moisture present in the interior of a chimney structure may increase the possibility of mortar deterioration and brick/stone spalling (the face of the brick/stone surface falling away). The concrete crown should be sealed with a brush-able tar-based product to help prevent water absorption into the concrete crown and the interior of the chimney structure.

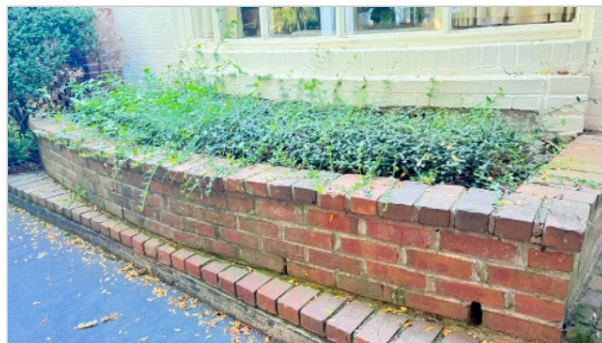
Photo# 32

There was a negative grade of the soil around the perimeter of the structure. It appeared to be significantly deficient. It should be graded to a gentle slope, falling away from the foundation, in order to properly drain the ground surface water away from the structure. The slope should be approximately six-inches of vertical fall for every ten-feet of horizontal distance.

There was a planter at the back by window area. It should be removed to help prevent water penetration at the wall.

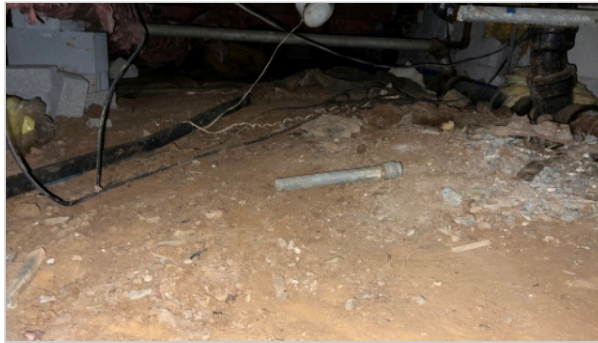
Photo# 40

The crawl space did not have a vapor barrier (usually a 6-mil plastic material) covering the majority of the ground in the crawl space. Vapor barrier helps prevent ground moisture from penetrating the insulation and floor structure and causing possible damage to the wooden framing components and decreasing the efficiency of the insulation.

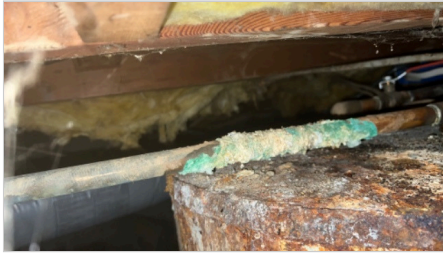
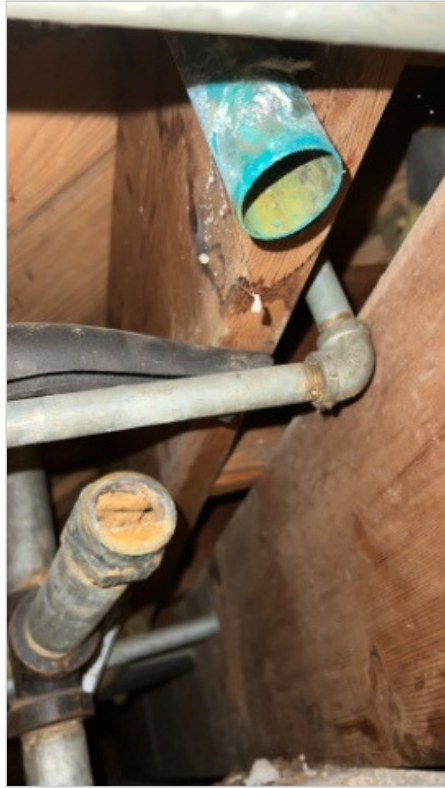
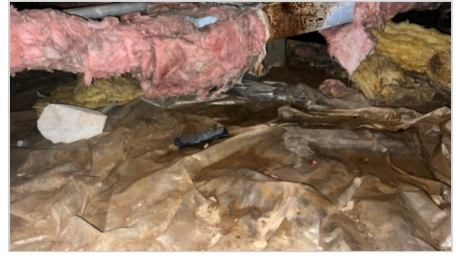
The second level bathroom sink drain was leaking and the tub and sink drains were clogged.

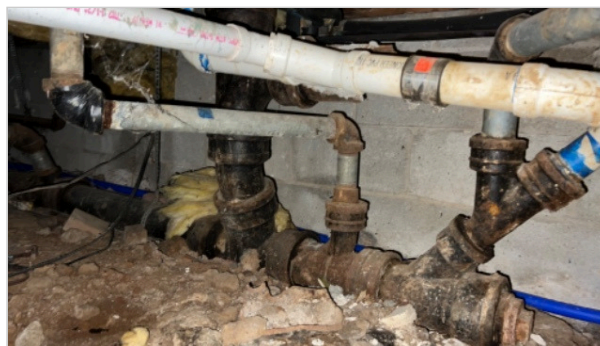
Photo# 49

Cast iron plumbing was installed in the structure. It has a tendency to crack after it ages and these cracks are not usually visually observable. It is suggested that a licensed plumber be consulted before closing to fully inspect and electronically scope the plumbing system for damage, clogs leakage, ect.

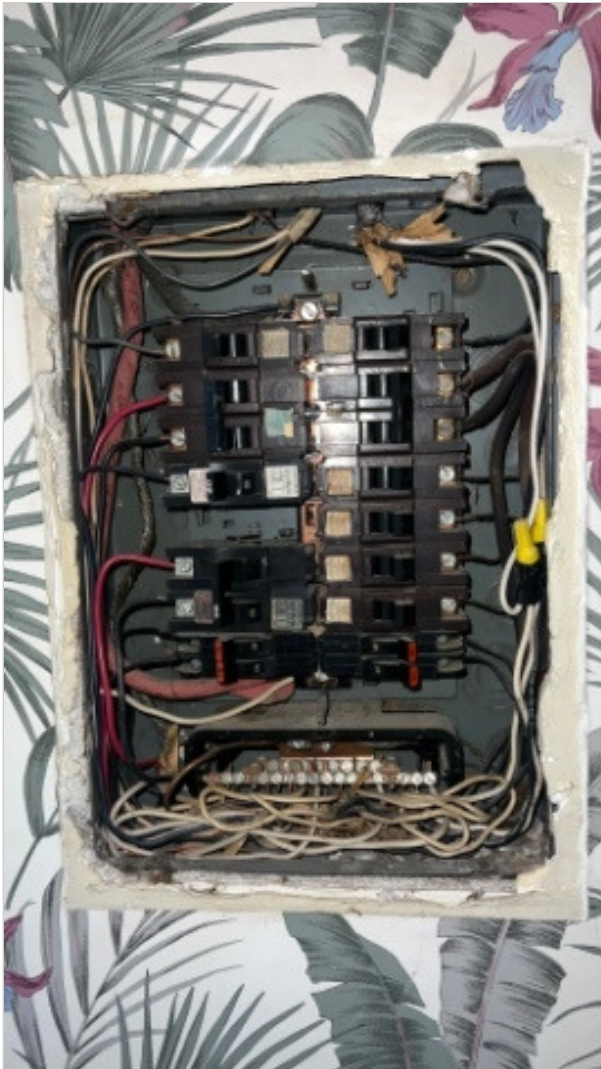
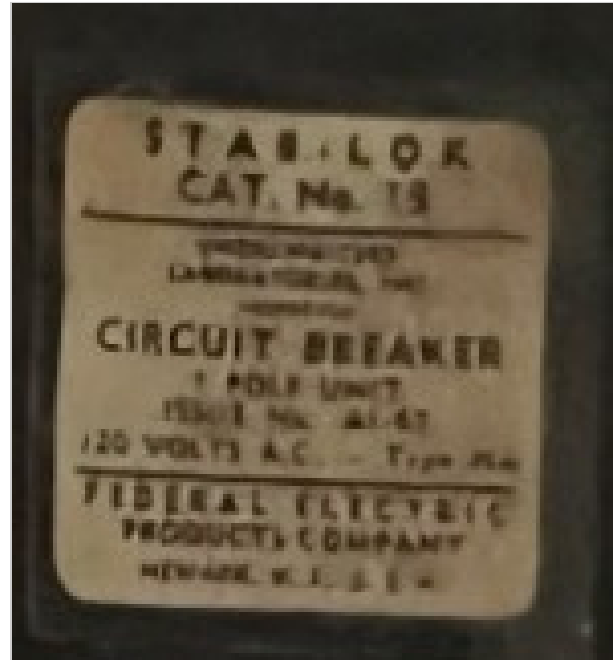
The breakfast room electrical panel was an FPE (Federal Electric Pacific) brand electrical service panel and the Stab-Lok circuit breakers located in the structure should be considered a safety defect and the service panel and breakers should be replaced. Based on reported incidents involving Stab-Lok panels, the panel is considered a latent fire hazard. This means that the circuit breakers may not trip in response to an overload or a short circuit. The presence of this type of panel alone does not initiate an unsafe condition. The unsafe condition occurs when a short circuit or overload occurs; and the equipment may or may not provide the expected protection. The end result can be an overheated wire, which could lead to an electrical fire and/or personal injury. A licensed electrician should be consulted to evaluate the safety of this system.

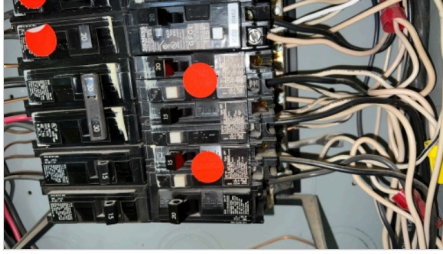
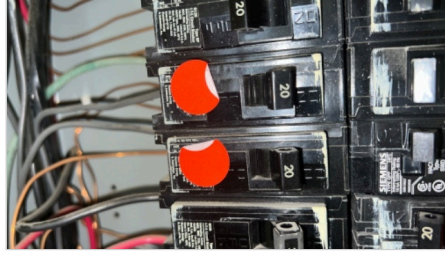
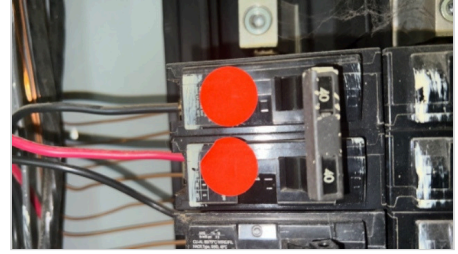
1. The electric panel in the game room evidently was an active panel. It was not inspected.
2. In the 125 amp ITE electrical panel in the master bedroom, there were two 20 amp circuits breakers that over-rated and two GFCI circuit breakers that would not reset after testing.
3. There was NO MAIN CIRCUIT BREAKER for the electrical system.

1. The electrical power line to the carport is mounted too loose. It should be 12-ft of of the ground.
2. The front entry door bell was not functional.

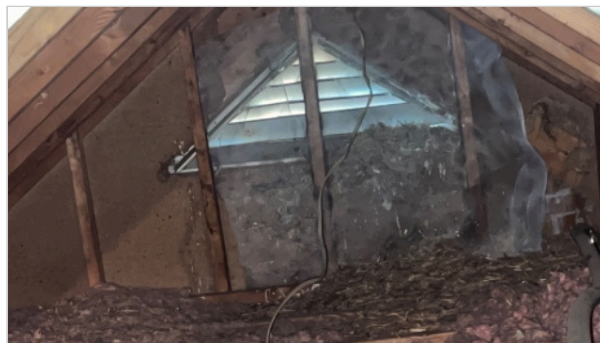
Photo# 63

There did not appear to be adequate ventilation at the attic space, which may be significantly deficient. The back gable vent was blocked and there were no soffit vents. It is recommended to provide ventilation to the attic space to help maintain the longevity of the roofing structure and roofing shingles. 3- electric powered attic vents should be installed with a thermostat and a humidistat. (approx cost \$500 each installed).

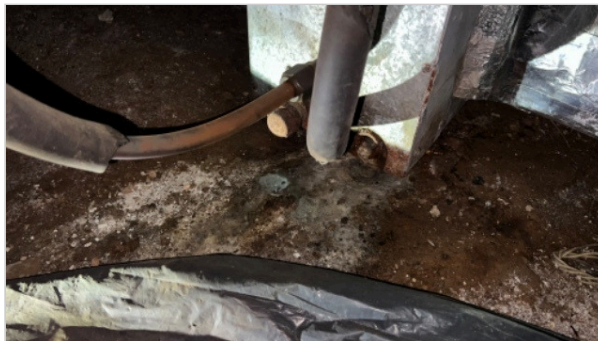
Photo# 64

1. The second level HVAC system was about 2-3 years in age and was functional.
2. The main area and master area HVAC systems were 23 and 33 years in age and had exceeded their normal useful operating life. Plus, the main area cooling system was not functional.
3. Both HVAC condensate lines were draining to the crawl space. An electric condensate pump should be installed.
4. The main structure HVAC coil appeared to be leaking.

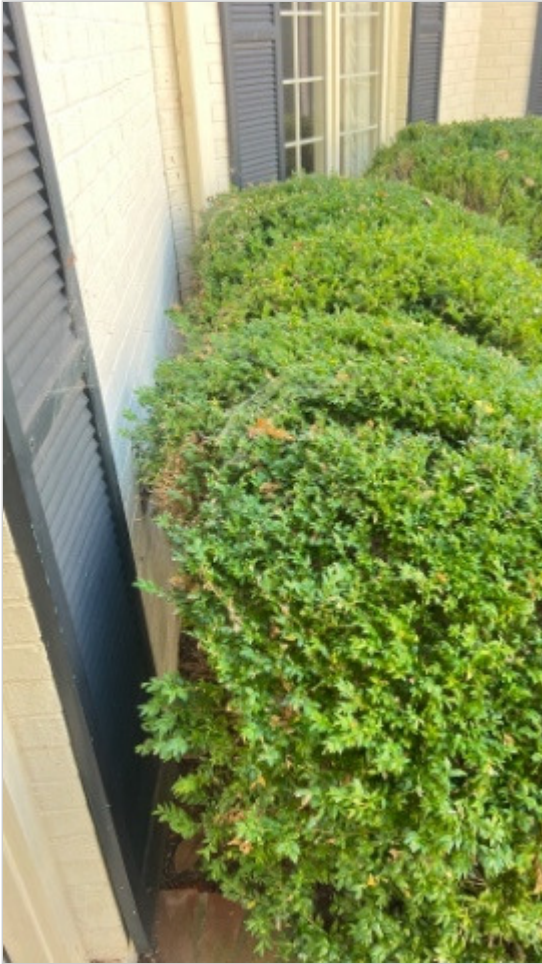
Photo# 11

1. Excessive vegetation was contacting the structure.

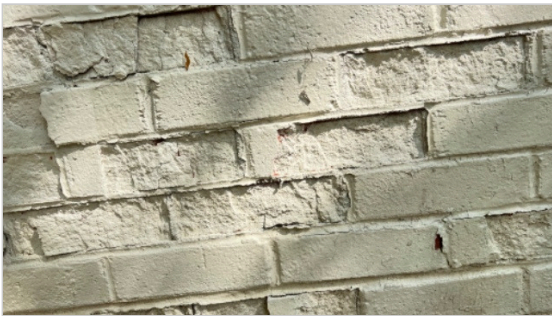
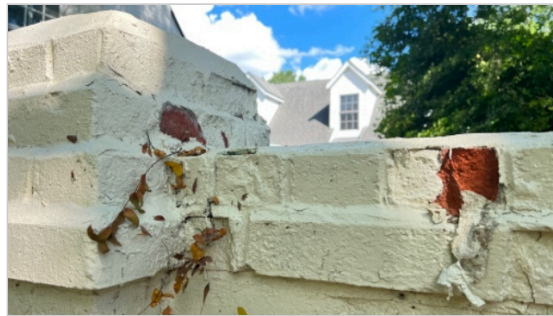
2. The retaining wall brick was spalling.

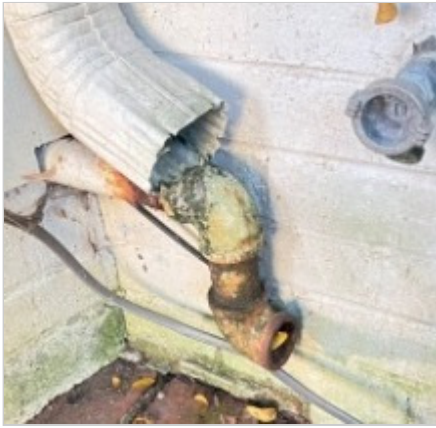
Photo# 27

1. Some sections of the gutters were slightly damaged and/or not securely attached to the structure. The damaged components should be repaired or replaced as necessary to help provide adequate drainage of the roof surface water away from the structure.
2. The downspouts were directing roof surface water toward the foundation and the walkway.

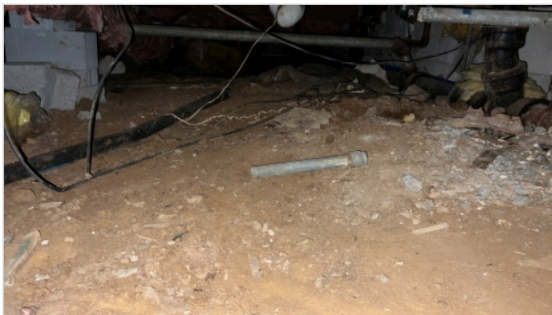
Photo# 40

1. The crawl space did not have a vapor barrier (usually a 6-mil plastic material) covering the majority of the ground in the crawl space.

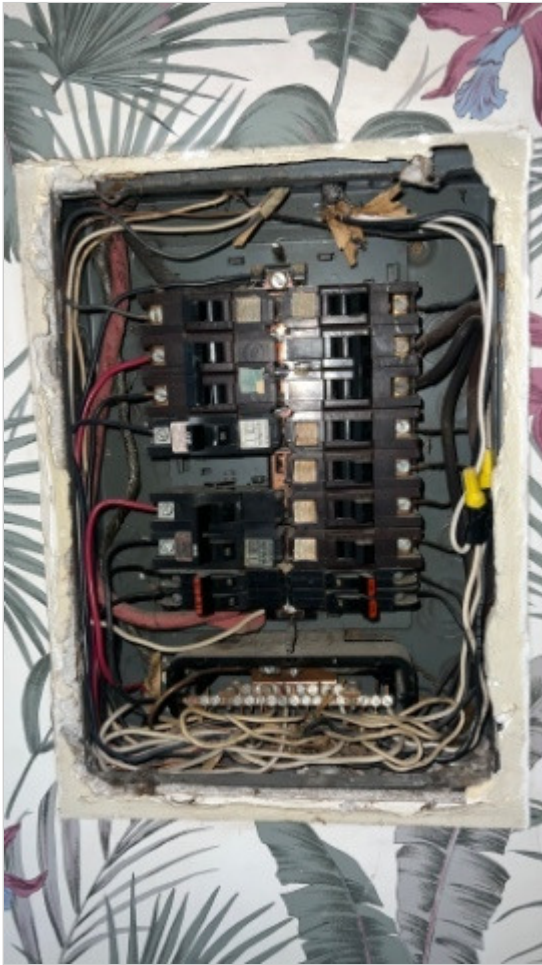
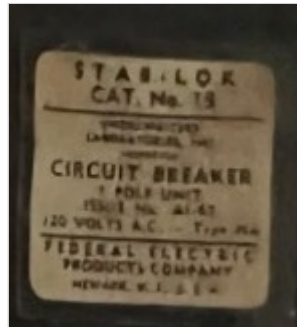
2. The electric panel in the game room evidently was an active panel. It was not inspected. In the 125 amp ITE electrical panel in the master bedroom, there were two 20 amp circuits breakers that over-rated and two GFCI circuit breakers that would not reset after testing. There was NO MAIN CIRCUIT BREAKER for the electrical system.

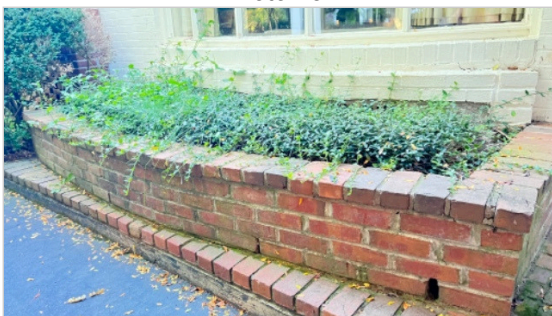
Photo# 32

2. There was a negative grade of the soil around the perimeter of the structure. It appeared to be significantly deficient. It should be graded to a gentle slope, falling away from the foundation, in order to properly drain the ground surface water away from the structure. The slope should be approximately six-inches of vertical fall for every ten-feet of horizontal distance.
