### *HOME INSPECTION REPORT*

The inspected property consisted of a ranch wood-framed structure with plywood siding / cladding that was occupied at the time of the inspection. Minor, exterior type caulking and maintenance, painting are common on most homes and may be present but may or may not be specifically identified in this report. The approximate temperature at the time of the inspection was 70-75 degrees Fahrenheit, and the weather was sunny and clear. The utilities were on at the time of the inspection. The buyer was present during the inspection. The home was situated on a lightly sloped lot. The general grade around the home appeared to be mostly adequate to direct rain water away from the foundation. The age of the home, as reported by the building permits was said to be 37 years old.

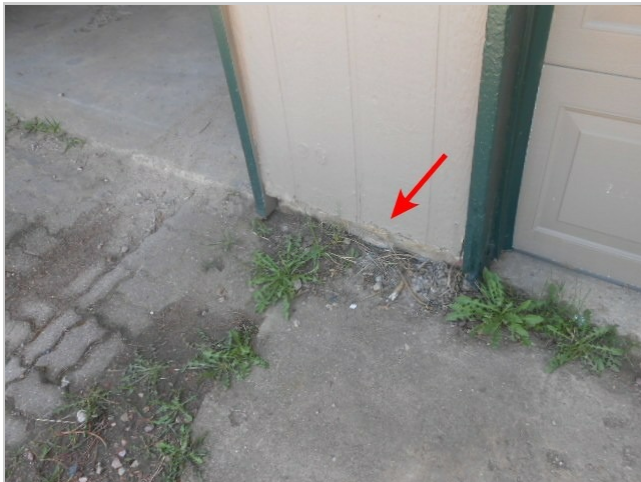
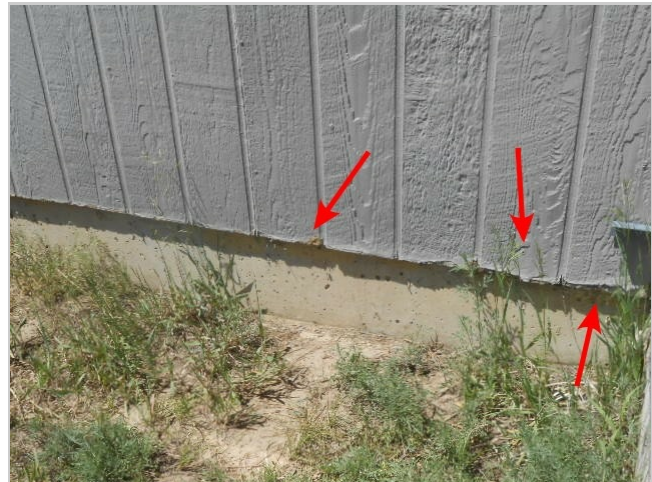
The siding and trim throughout the exterior of the home were in overall marginal condition. There were several areas throughout the exterior where the siding and trim was deteriorating and scraping, repairs, caulking and paint to match are needed. We recommend that a reputable contractor further evaluate the homes exterior and any recommendations for repairs and maintenance be completed prior to closing to prevent any further decay and to prevent possible water intrusion into the home or the homes structure.

- The siding and trim throughout the exterior of the home were in overall marginal condition. There were several areas throughout the exterior where the siding and trim was deteriorating and scraping, repairs, caulking and paint to match are needed. We recommend that a reputable contractor further evaluate the homes exterior and any recommendations for repairs and maintenance be completed prior to closing to prevent any further decay and to prevent possible water intrusion into the home or the homes structure.

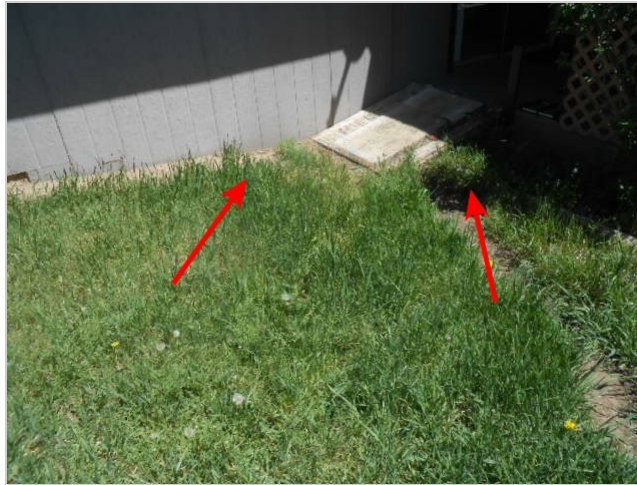
The exterior grading on the rear of the home was noted to be sloping towards the home and foundation. The grading in this area should be corrected to allow for proper drainage and to prevent water accumulation along the home and foundation.

This area of exterior grading on the rear of the home is sloping towards the home.

- The exterior grading on the rear of the home was noted to be sloping towards the home and foundation. The grading in this area should be corrected to allow for proper drainage and to prevent water accumulation along the home and foundation, basement.

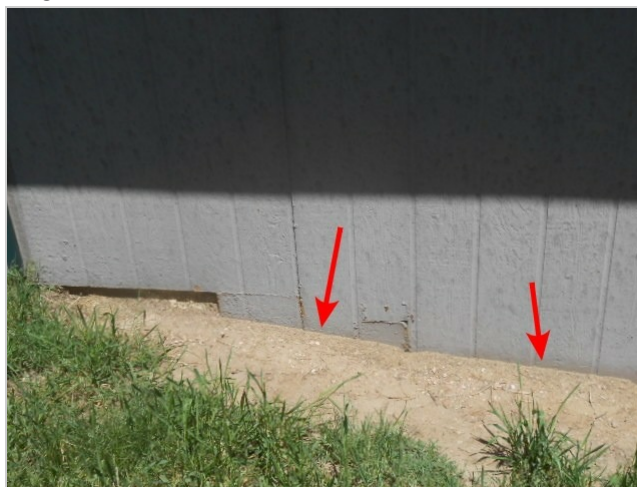
Some of the exterior siding on the rear of the home is in contact or is under the ground or earth. This condition can lead to wood rot or insect intrusion if not corrected. Further evaluation is recommended by a qualified contractor, prior to closing.

This section of siding on the rear of the home is in contact with the ground or earth.

- Some of the exterior siding on the rear of the home is in contact or is under the ground or earth. This condition can lead to wood rot or insect intrusion if not corrected. Further evaluation is recommended by a qualified contractor, prior to closing.

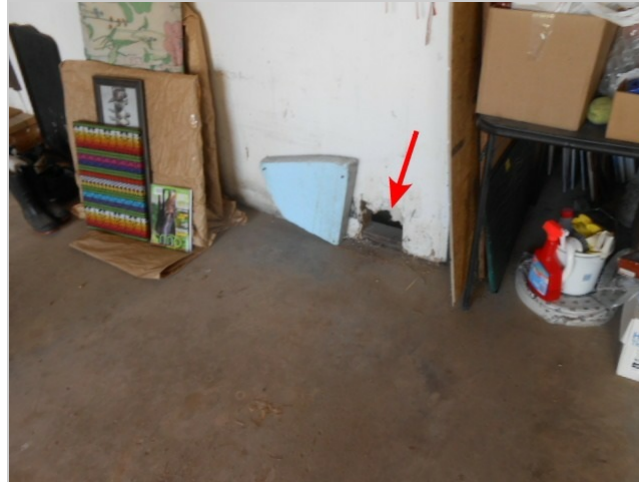
There was one firewall breach observed in the garage ( on the rear garage wall ) at the time of inspection. Firewall breaches are safety concerns which include holes or voids in the firewall separation between the

garage and home which should be sealed to prevent a garage fire from spreading easily into the home.

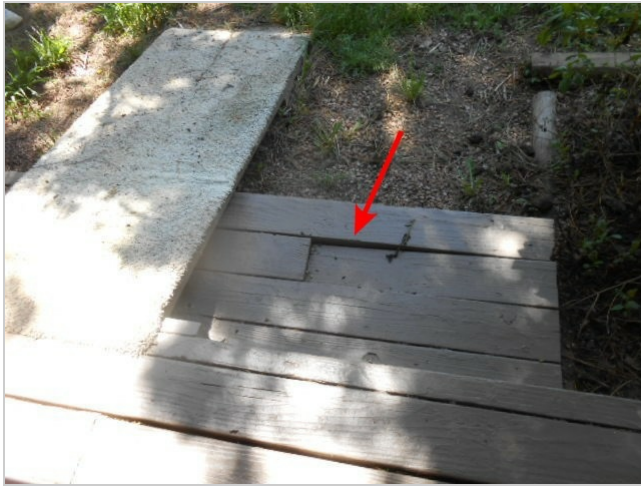
The underside of the deck was unable to be fully inspected due to the deck being very close to the ground or earth below. There were however several deck boards that were loose or were deteriorated indicating the need for further evaluation and repairs to the deck ( as needed ) by a qualified contractor, prior to closing.

Loose or deteriorated deck board on the rear deck.

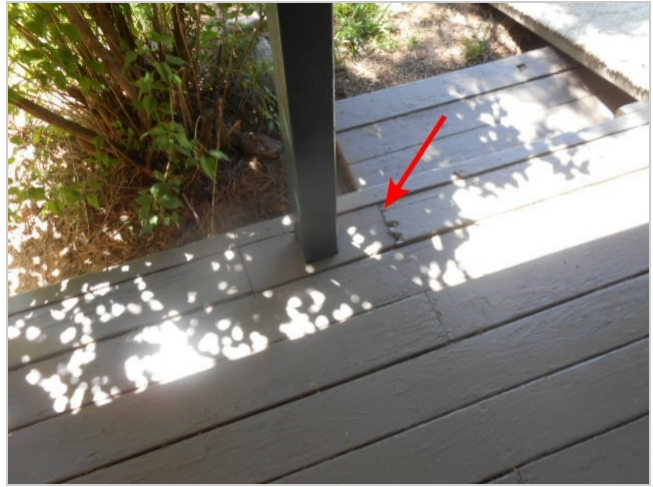
Loose or deteriorated deck boards on the rear deck.

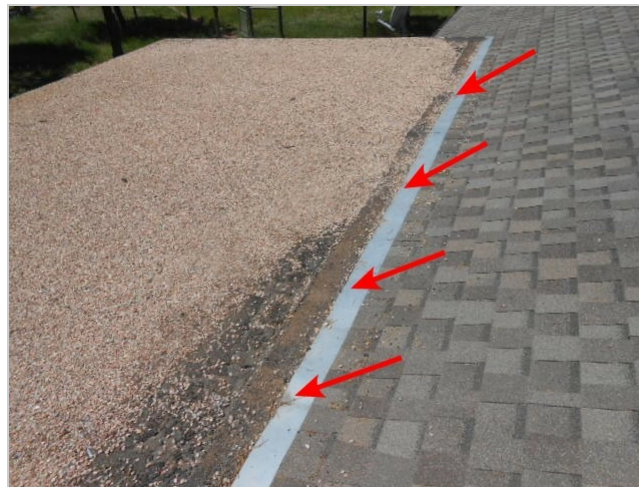
The transition roof flashing ( where the house roof meets the patio roof ) is loose or is unsecured indicating the need for further evaluation and repairs by a qualified roofer, prior to closing.

This transition roof flashing is loose or is not secured which can lead to roof leakage if not repaired.

- The transition roof flashing ( where the house roof meets the patio roof ) is loose or is unsecured indicating the need for further evaluation and repairs by a qualified roofer, prior to closing.

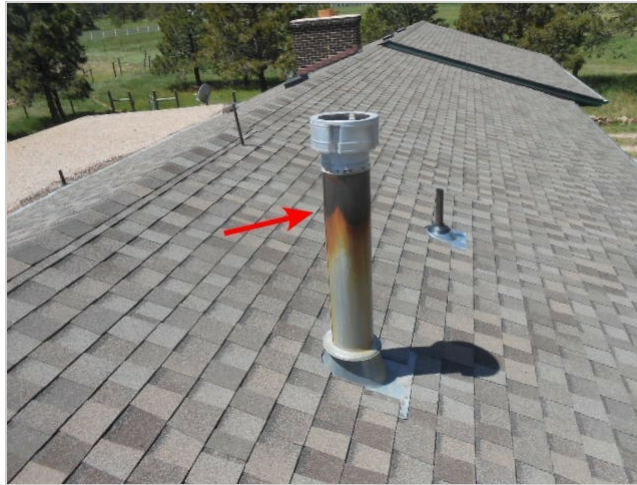
The furnace vent pipe ( which penetrates the roof line ) is rusted or deteriorated and is recommended to be replaced by a qualified HVAC contractor or roofer, prior to closing.

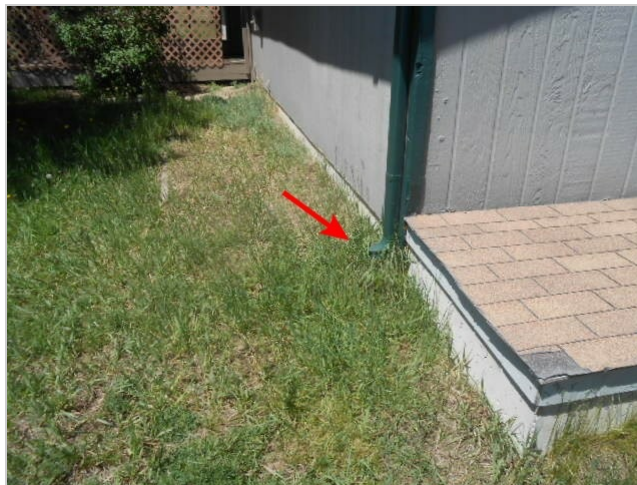
One of the downspouts on the left, rear of the home was missing the extension. This condition can allow for rain water to accumulate along the home and the possibility of water in the crawlspace if not repaired.

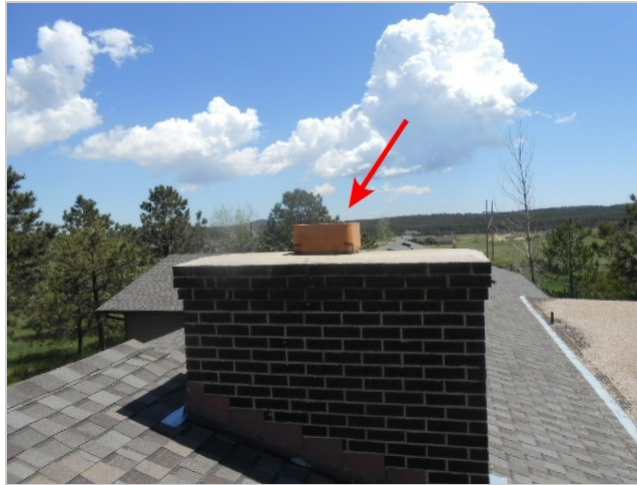
There was no rain hat on the chimney. This device is recommended to be installed by the seller ( prior to closing ) to prevent animals or rain water from entering the chimney and fireplace flue and causing damage to the home or to the metal flue damper inside the chimney.

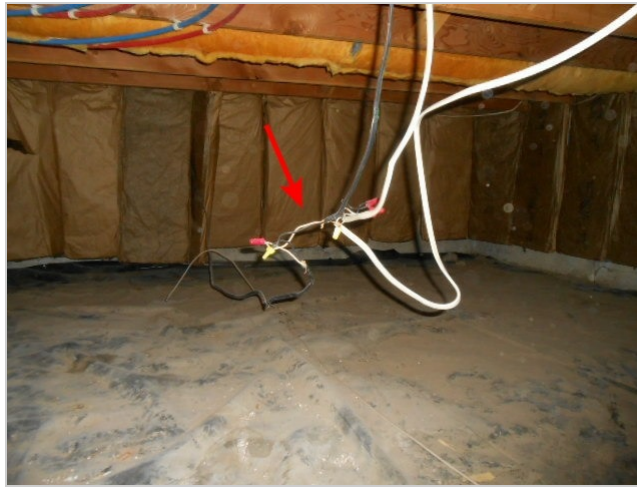
There were a few open splices noted throughout the crawlspace at the time of inspection. Open splices consist of wires joined together outside of a junction box or loose wiring. This is a safety concern which should be corrected by a qualified electrician prior to closing.

Open spliced wiring in the crawlspace.

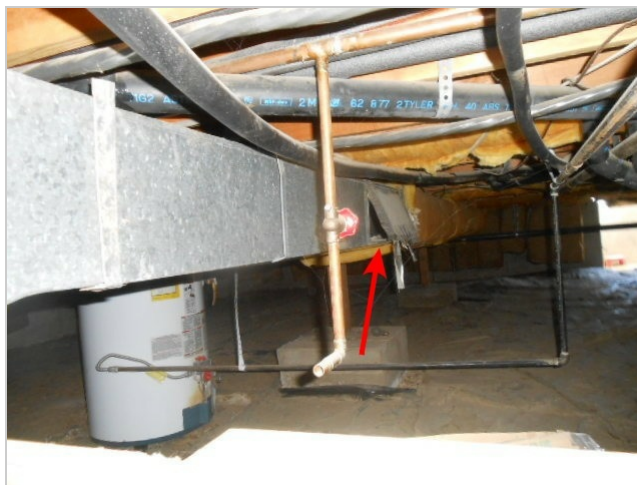
One of the heating supply or return ducts ( in the crawlspace ) has an opening which is recommended to be properly sealed to prevent heat loss into the crawlspace when the heating system for the home is in use.
