HOME INSPECTION REPORT

Address of Inspection: **123 Sample Drive, Louisville, KY**

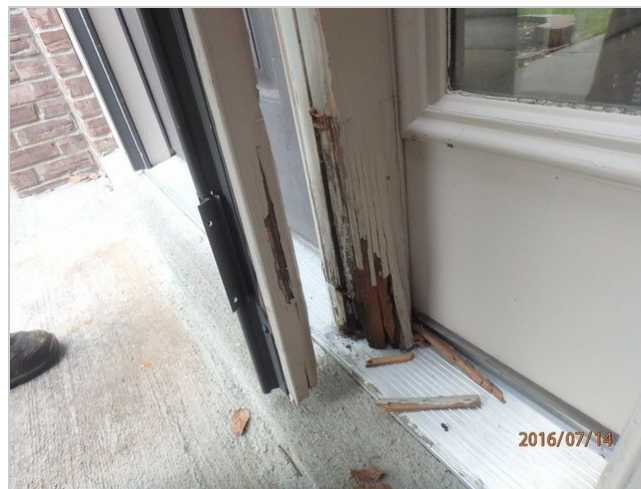
Photo 1

Rotted wood was present on the front door . The areas should be repaired and further evaluated at the time of repair.

example of rotted wood around the front door

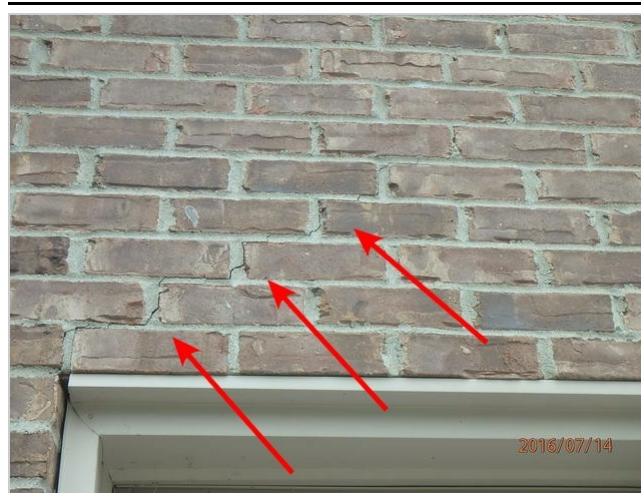
Photo 2

Cracks were present on the brick veneer of the home. The cracks were located on the front. The cracks are common and do not usually have any structural significance. No structural concern on the brick veneer was noted. All cracks should be monitored for significant changes in characteristics. The cracks should be sealed to prevent water intrusion behind the brick.

mortar crack

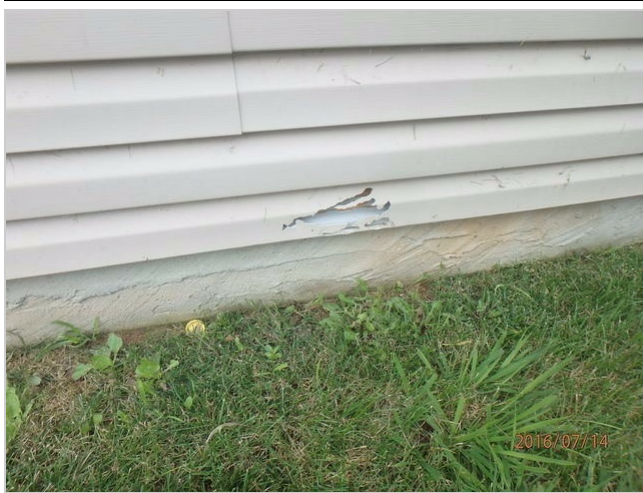
Photo 3

Holes were noted on the right and back sides of the home's exterior. This condition does not have any effect on the structural integrity of the building. The areas should be repaired to prevent water intrusion.

example of damaged siding

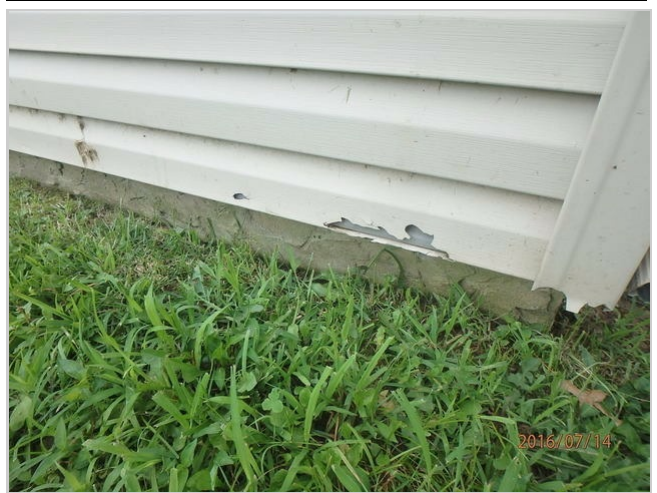
Photo 4

example of damaged siding

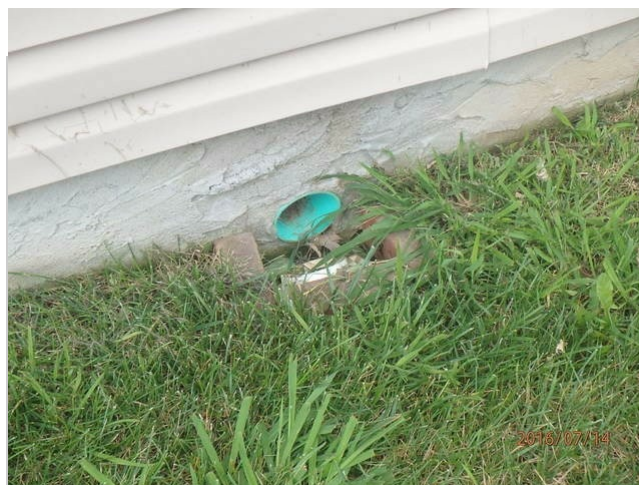
Photo 5

The dryer vent cover is missing. The vent cover should be repaired or replaced to prevent birds or other small animals from entering the home.

missing dryer vent cover

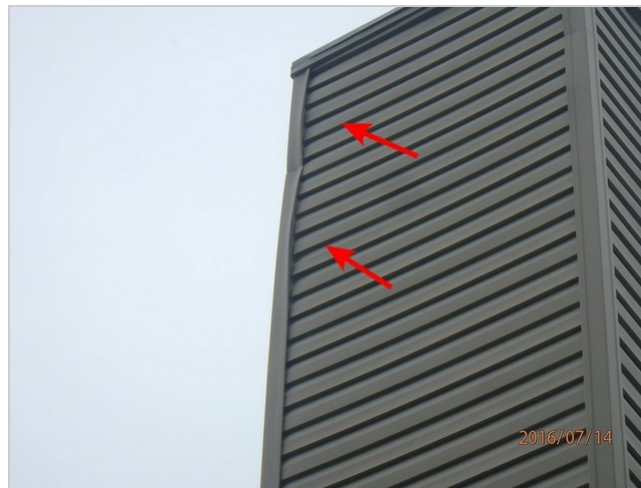
Photo 6

NOTE- Although the vinyl on the flue chase is not loose there are areas that appear to be buckled. These areas should be monitored for any needed repairs and repaired as necessary

buckled vinyl

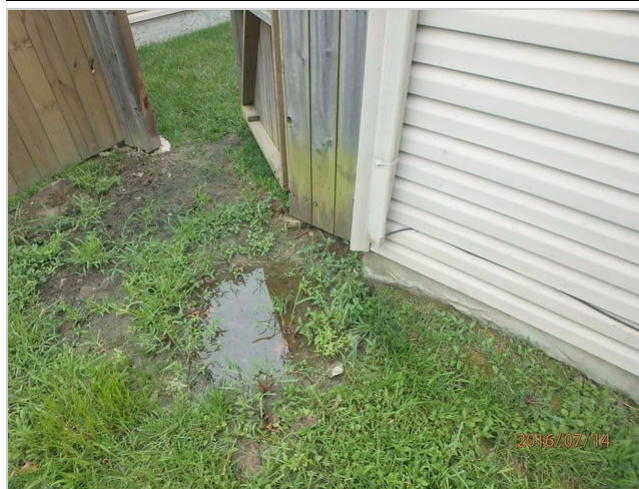
Photo 8

Several downspouts were draining at or too close to the base of the foundation. To reduce the likelihood of water problems at the base of the home, all roof drainage should be directed at least six feet from the base of the foundation.

several downspouts are draining adjacent to the foundation

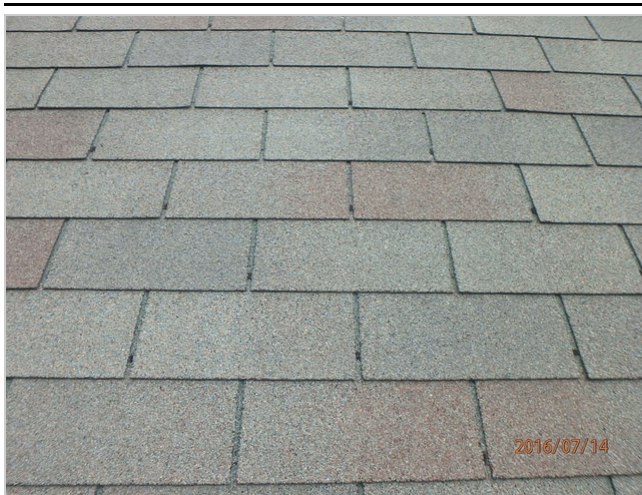
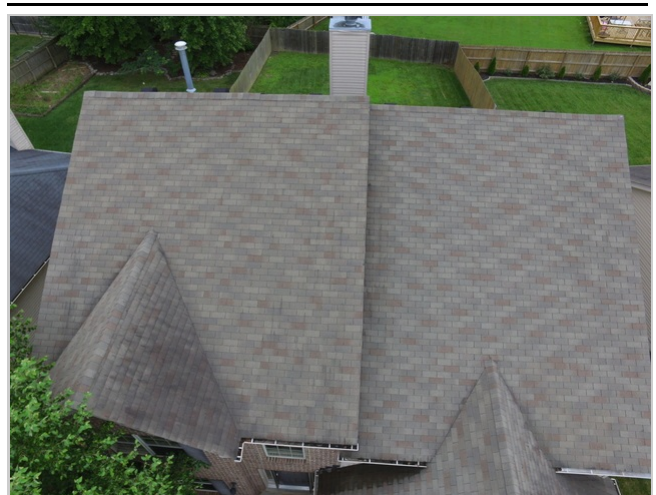
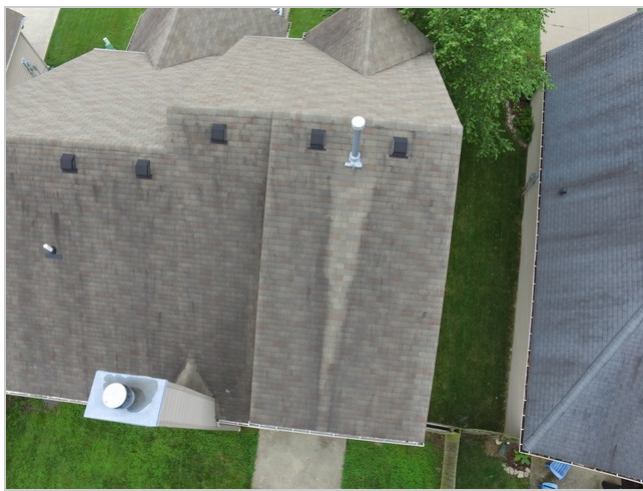
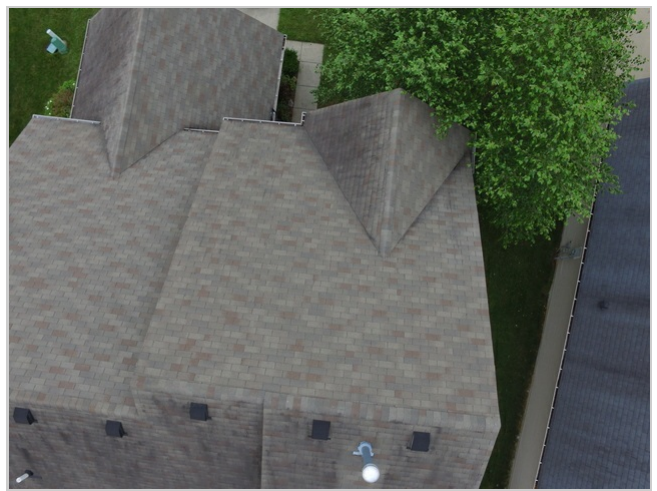
The roof shingles exhibited light curling and moderate surface wear. Several areas were tested for lifted edges, and lifted edges were not observed. Nail pops were observed. Evidence of a hail event was not observed.

These conditions indicate the roof shingles were in the second half of their useful life.

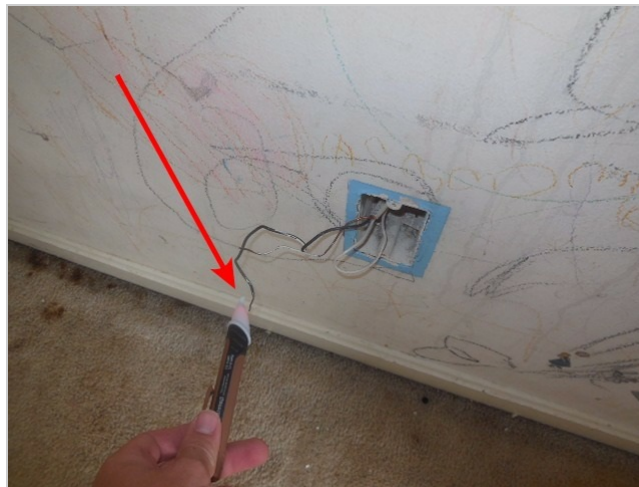
Photo 18

Exposed live wires were observed in the upstairs right bedroom. The wires should either be disconnected at the source or properly terminated in an approved, covered electrical box. Consult with a qualified electrician for repair and further assessment.

Exposed live wires.

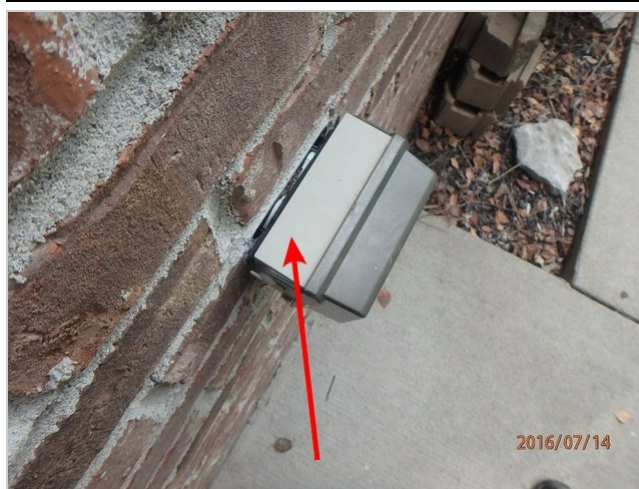
Photo 19

One exterior outlets were not properly covered, potentially allowing rainwater to enter the circuit. Outlet covers designed for use in wet locations should be installed on all exterior outlets.

outlet is not properly covered

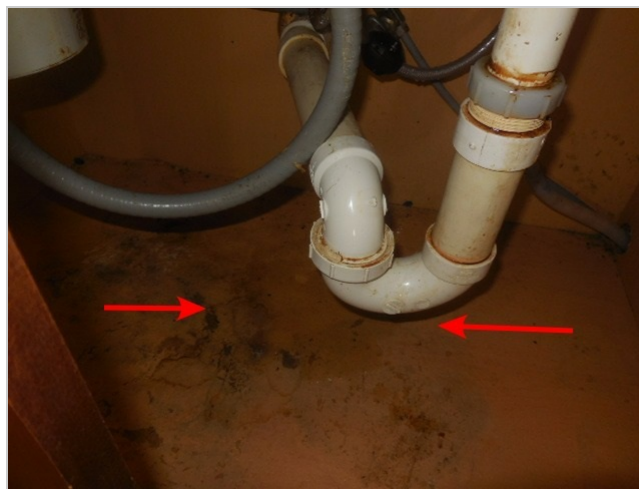
Photo 20

The drain line under the kitchen sink leaks and should be repaired to prevent further water intrusion. At

Drain line leaks under the kitchen sink.

the time of repair, all drain lines should be further assessed.

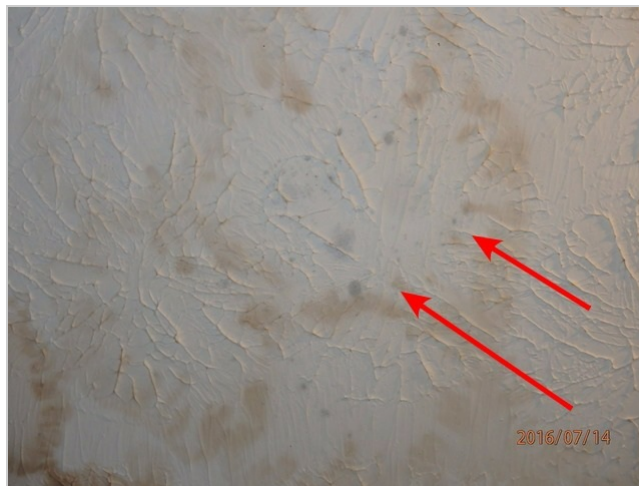
Photo 23

Mold-like growth is visible in the structure (garage). The EPA has helpful information that may assist the buyer (<http://www.epa.gov/mold/moldresources.html>). HomeTeam recommends having the areas tested to determine presence, type and relative concentration of mold spores, and professionally remediated by a reputable mold remediation company, which may include removing and replacing affected segments. A mold remediation company may uncover additional areas or issues requiring repair or remediation.

mold like growth in the garage

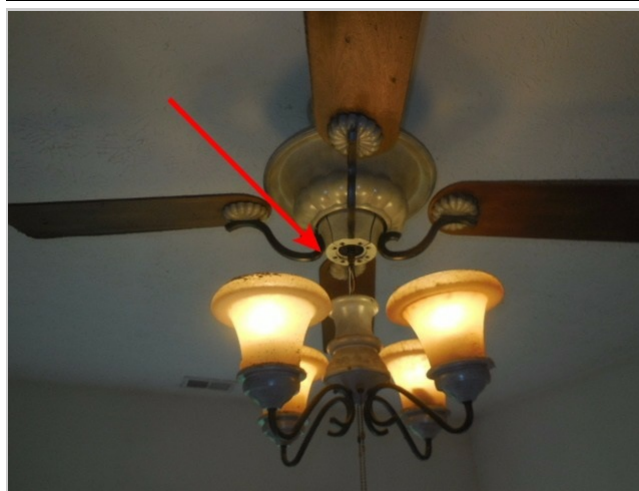
Photo 24

A light fixture in the master bedroom is loose and should be secured.

Loose light fixture.

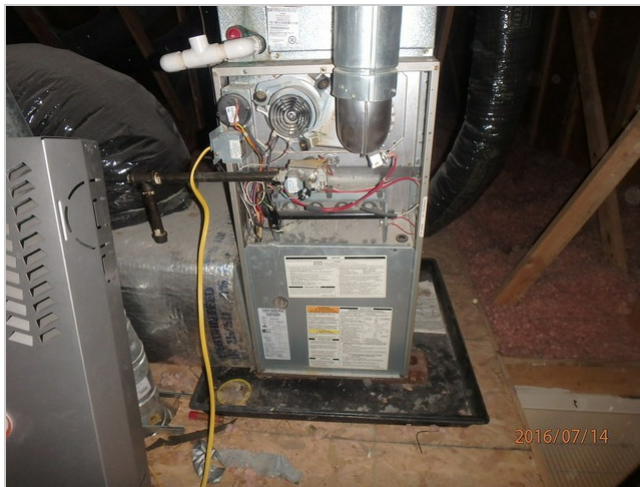
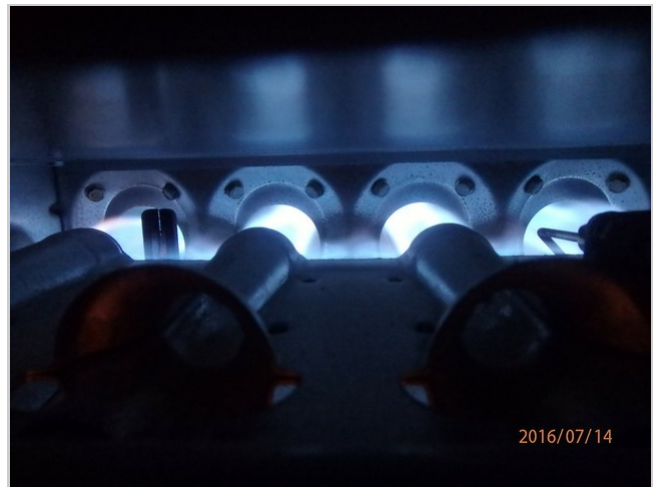
Because of its condition and performance at the time of the inspection, **the furnace requires cleaning and servicing by a professional HVAC technician.** At that time, the technician will test refrigerant levels, service the equipment to improve its performance, and perform other tests beyond the scope of the home inspection to assess and identify any additional areas that may require attention.
