HOME INSPECTION REPORT

SAMPLE REPORT

Address of Inspection: **1234 Fifth Street**

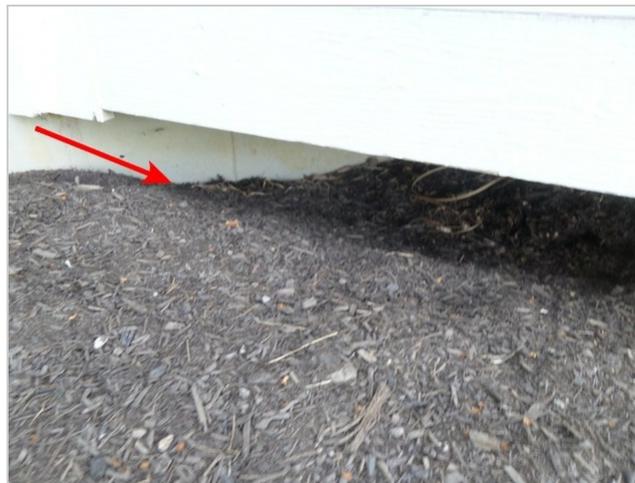
REVERSE GRADE: A reverse grade condition exists in the rear of the home under the bay window. Reverse grade is a condition where the grade is lower at the foundation than in adjacent areas. This condition will cause rain water to be directed toward the foundation which can, over time cause damage to the foundation and structure. Recommend the grading be corrected so that rainwater is directed away from the foundation.

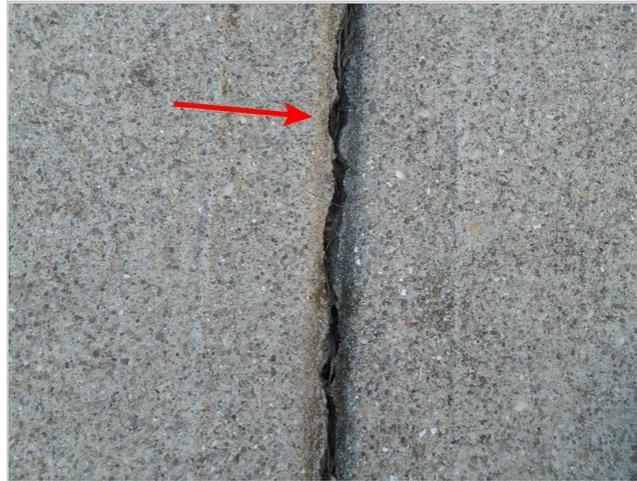
Control joints in walkway need to be sealed.

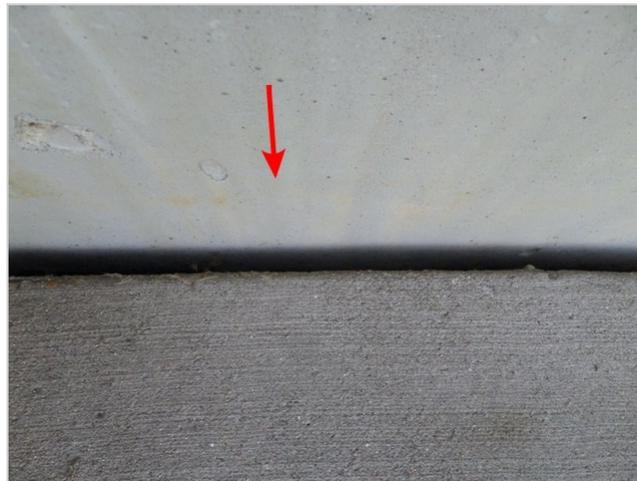
The patio needs to be sealed where it meets the foundation.

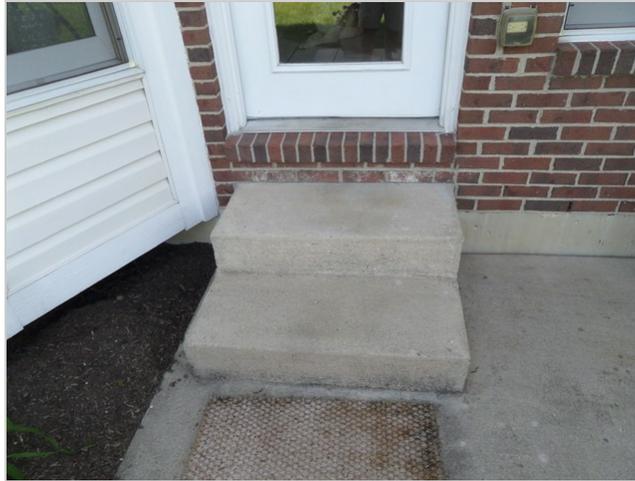
The steps on the patio to the house needs a handrail for safety.

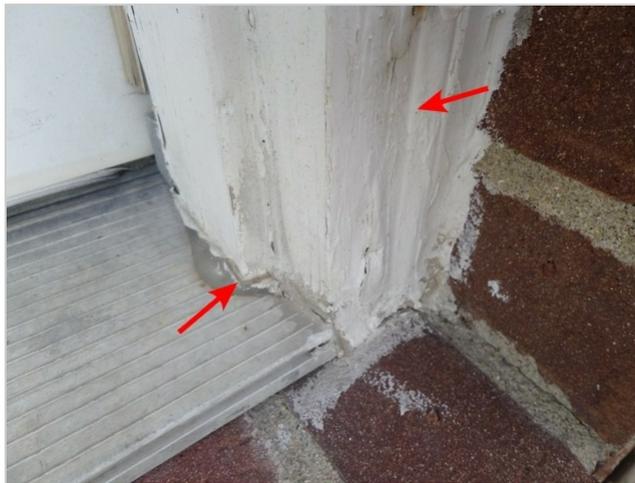
The door to the patio has wood rot on the framing around the bottom that needs to be repaired.

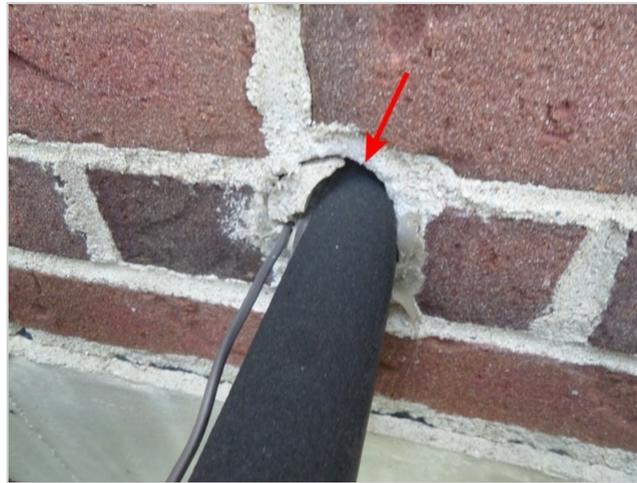
The area of the siding where the A/C lines enter the home need to be sealed to prevent water intrusion.

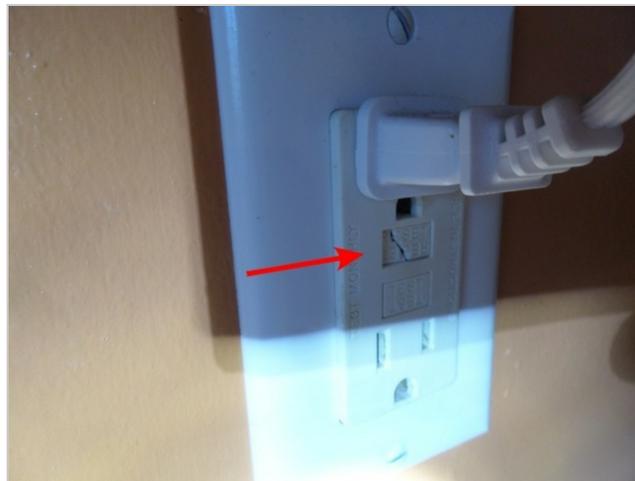
HOT NEUTRAL REVERSE: There were one receptacle in the second floor hallway bathroom where the presence of hot and neutral wires were reversed. This is a safety concern and should be repaired by a licensed electrician.

The receptacle right of the living room door is loose in the wall and needs to be properly secured for safety.

The GFCI reset button in the receptacle right of the kitchen stove is broken and receptacle needs to be replaced.

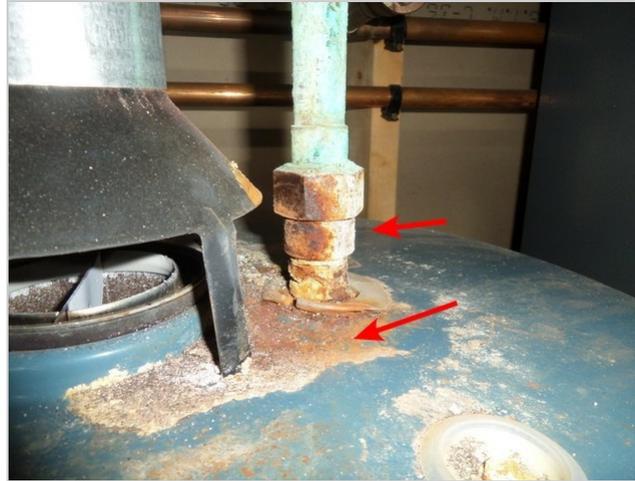
There was a lot of corrosion on the cold water supply line to the water heater. Recommend further evaluation by a qualified plumber.
