### HOME INSPECTION REPORT

Address of Inspection: **2113 Bates Way**

**2113 Bates Way  
Norman, OK 73071  
Inspection #: 01174098**

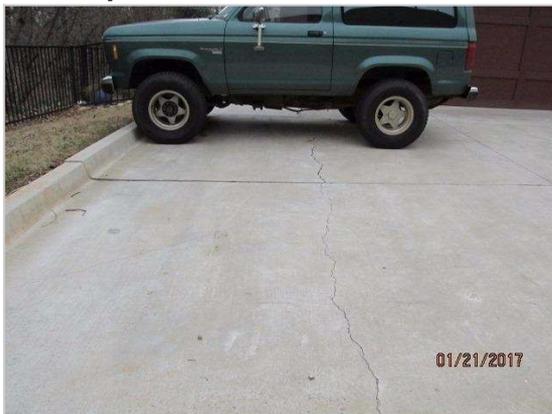
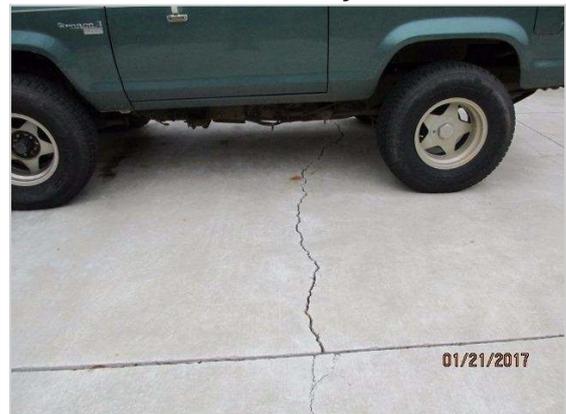
- **The driveway appears to be settling significantly at the north end where the retaining wall is. Without repair it may continue to sink. We recommend it is repaired as needed by a qualified concrete repair contractor. Get estimates from qualified contractors. Likely around \$750**

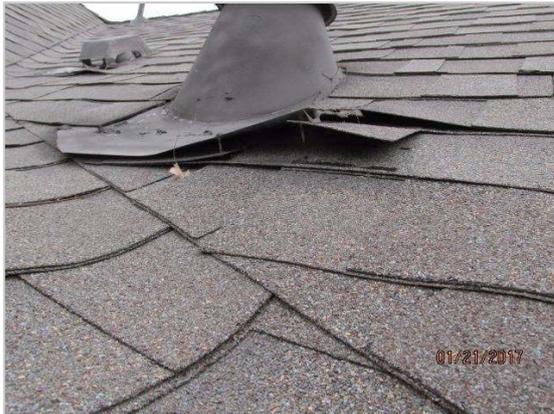
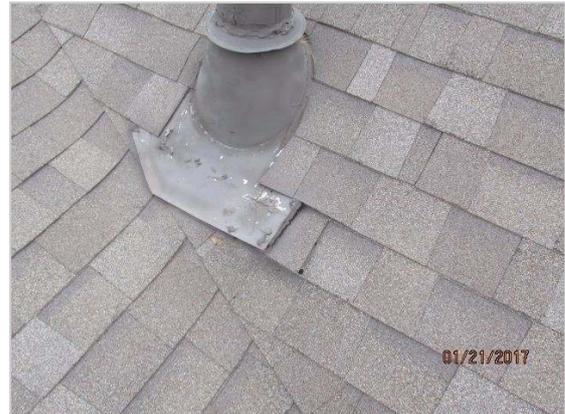
- **The flashing around the vent on the rear side of the roof was lifting and should be sealed back down to prevent leakage. \$150**

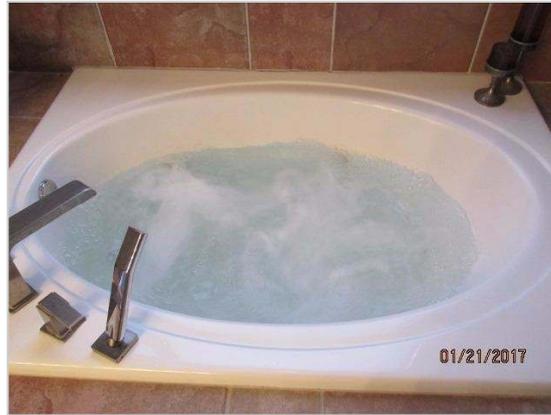
- **There was a crack in the grout around the jetted tub that we recommend sealing. It was caused by minor settlement of the tub and not from foundation movement. \$25**

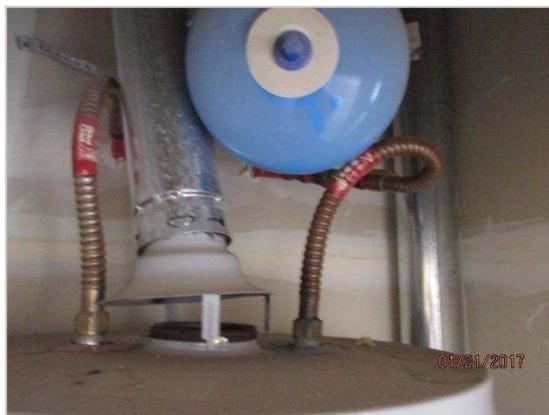
- **The expansion tank for the water heater appeared to be defective as it was full of water and it was also lying on the water heater vent. We recommend this is repaired as needed by a qualified plumber. \$200**

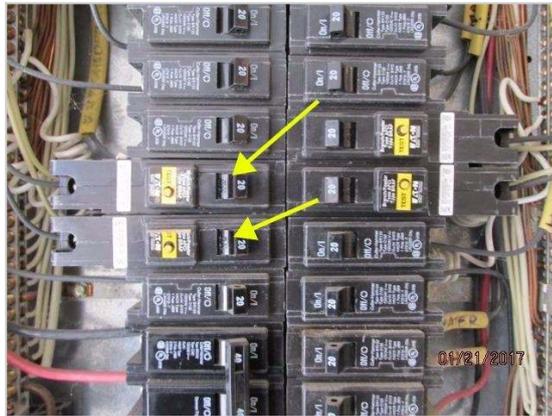
- **Two of the AFCI (Arc Fault Circuit Interrupters) breakers would not trip when tested and should be replaced. They were the two in the left. \$200**

defective AFCI breakers

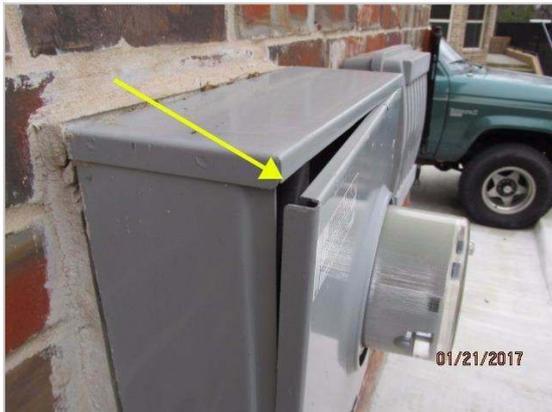
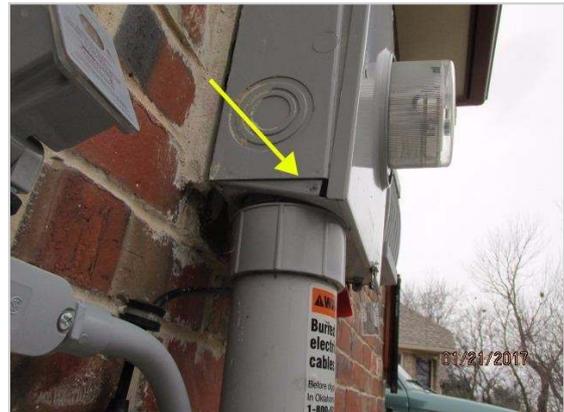
- **The electrical meter box has been damaged by the conduit pulling down on the box from settlement of the concrete walkway. This may or may not be covered by the electric company. It may not be since the sidewalk was added. It is open to weather as it is now and should be repaired as soon as feasible. Cannot estimate due to unknowns**

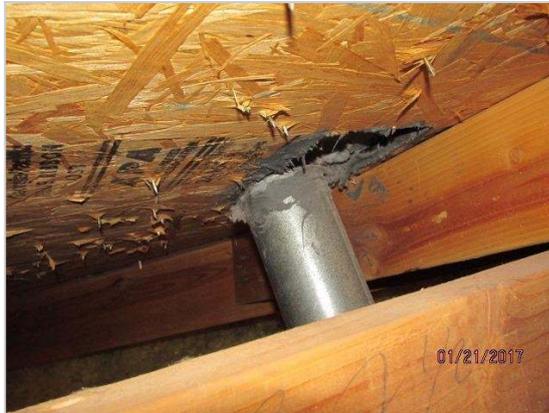
- **The dryer vent was not connected to the roof vent in the attic. This is allowing moisture and lint to vent into the attic. We recommend it is cleaned and re-connected. \$100 [dryer vent](#)**

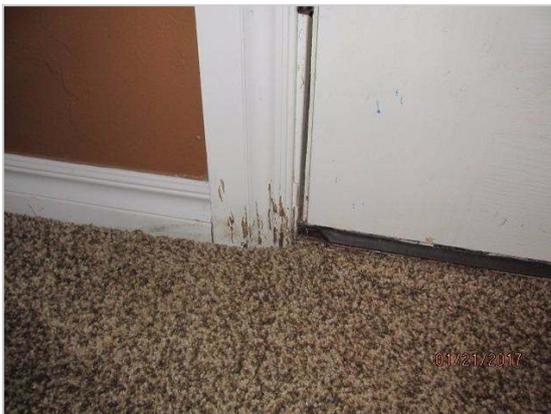
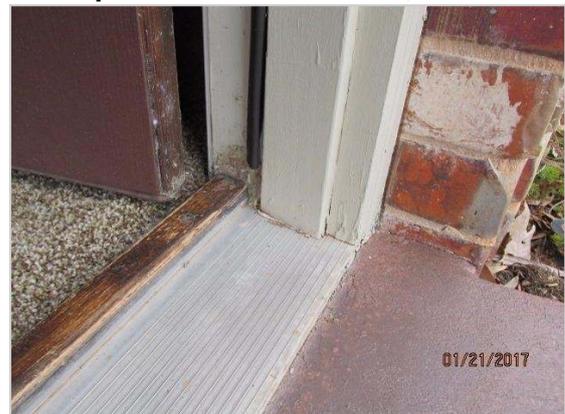
- **Water gets in around the French doors to the left front bedroom due to a poorly installed gasket. We recommend the door is better sealed to keep wind blown rain out. \$100**

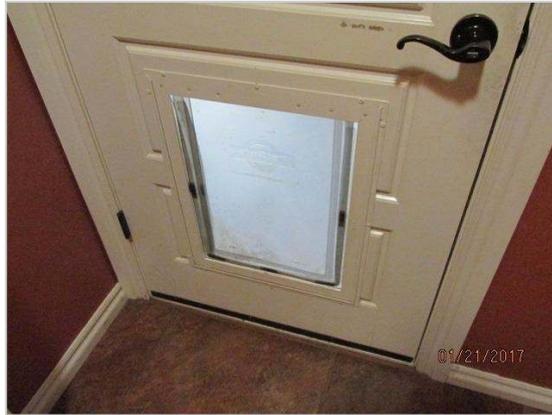
- **There was a pet door through the door going from the inside of the home into the garage. Openings through a wall or door from the home to the garage are not allowed due to possible carbon monoxide issues as well as firewall issues. \$350**

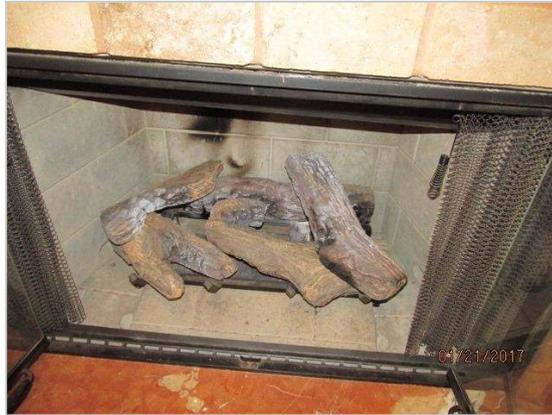
- **The gas log set was not properly installed. This gas log set's proper and safe operation depends on the gas logs fitting together in a specific pattern set by the manufacturer. That is why there are grooves and pins to piece the logs together so that the flames do not impinge on the logs. Flames impinging on the logs can cause the unit to put carbon monoxide into the house which is dangerous. The unit also looked like it may not be compatible with the firebox. We recommend this system is checked out by a qualified fireplace installer to be sure it is safe. \$150**

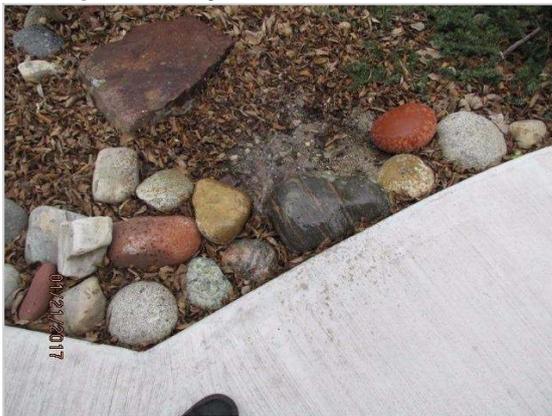
- **There were several sprinkler heads that need to be adjusted and some that were not functional. I recommend the entire system is gone through and repaired as needed by a qualified sprinkler system contractor. \$200**

head not fully popping up here

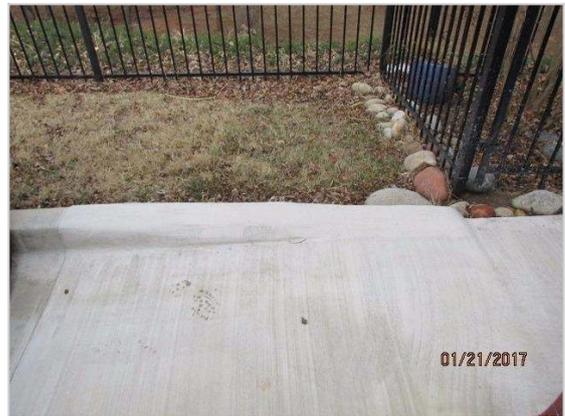
head not popping up here

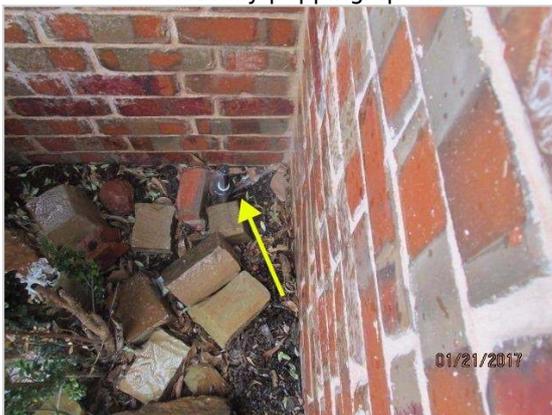
water shooting out the hole in the bottom of head

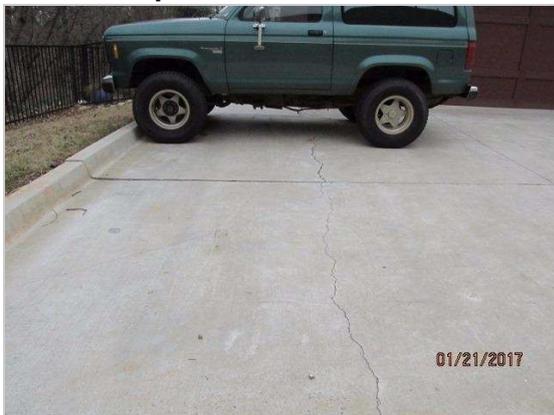
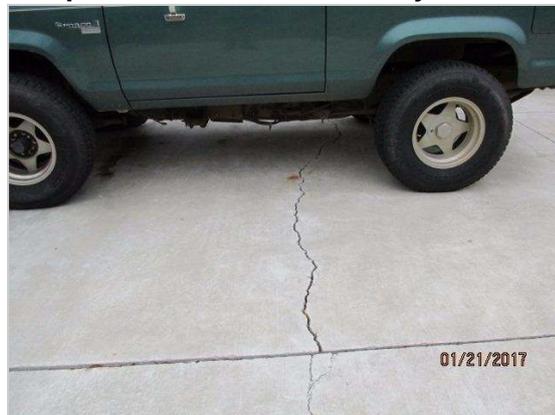
1. **The driveway appears to be settling significantly at the north end where the retaining wall is. Without repair it may continue to sink. We recommend it is repaired as needed by a qualified concrete repair contractor. Get estimates from qualified contractors. Likely around \$750**

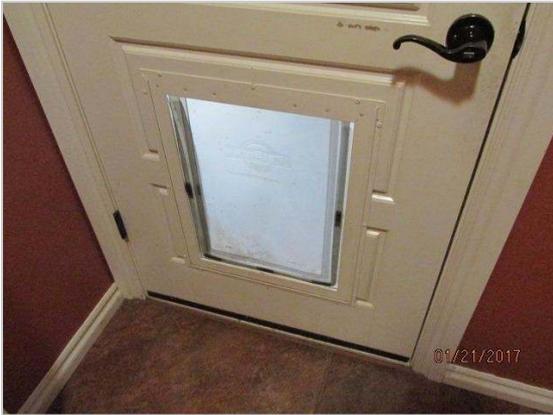
1. **There was a pet door through the door going from the inside of the home into the garage. Openings through a wall or door from the home to the garage are not allowed due to possible carbon monoxide issues as well as firewall issues. \$350**

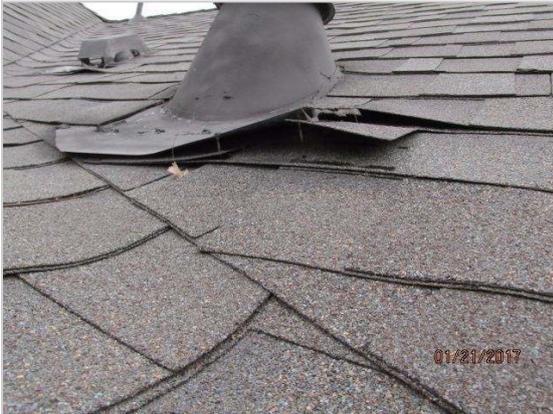
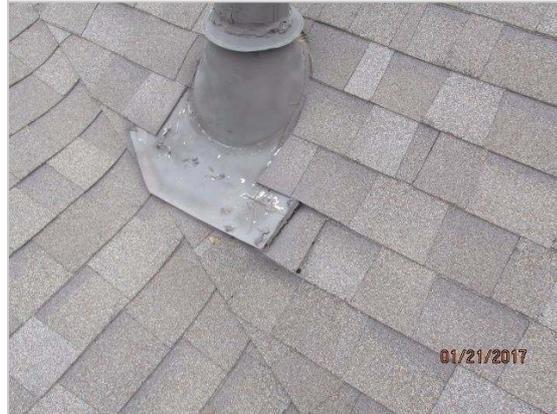
1. The flashing around the vent on the rear side of the roof was lifting and should be sealed back down to prevent leakage. \$150

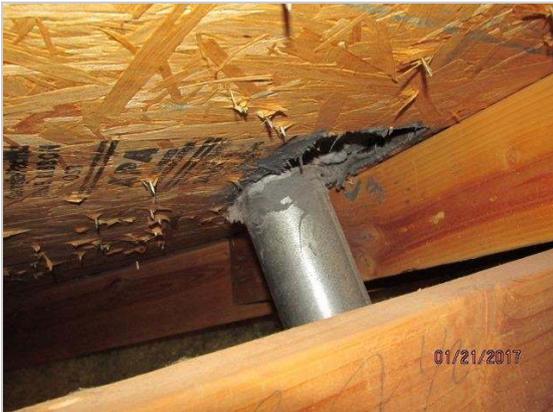
1. The dryer vent was not connected to the roof vent in the attic. This is allowing moisture and lint to vent into the attic. We recommend it is cleaned and re-connected. \$100 [dryer vent](#)

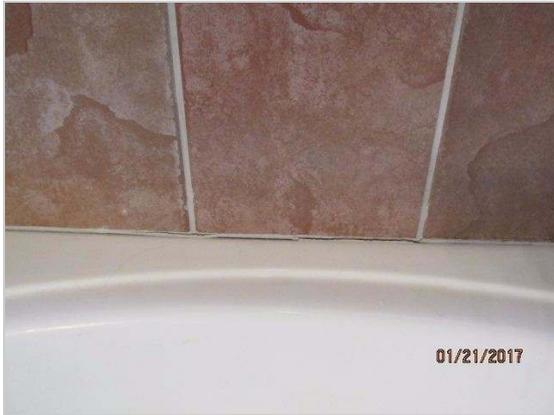
1. There was a crack in the grout around the jetted tub that we recommend sealing. It was caused by minor settlement of the tub and not from foundation movement. \$25

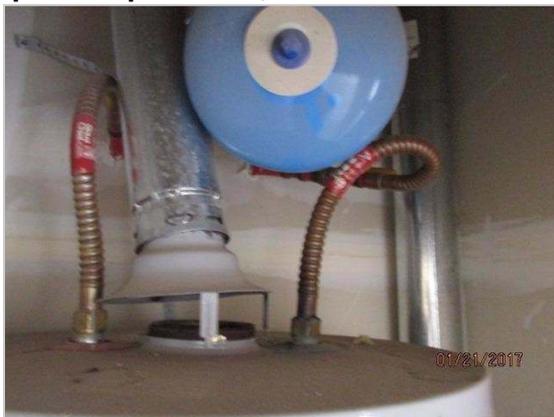
2. **The expansion tank for the water heater appeared to be defective as it was full of water and it was also lying on the water heater vent. We recommend this is repaired as needed by a qualified plumber. \$200**

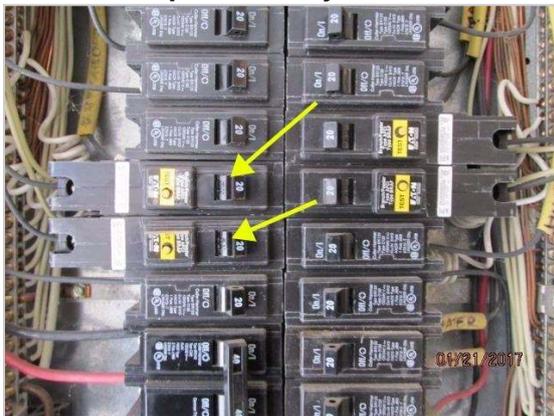
1. **Two of the AFCI (Arc Fault Circuit Interrupters) breakers would not trip when tested and should be replaced. They were the two in the left. \$200**

defective AFCI breakers

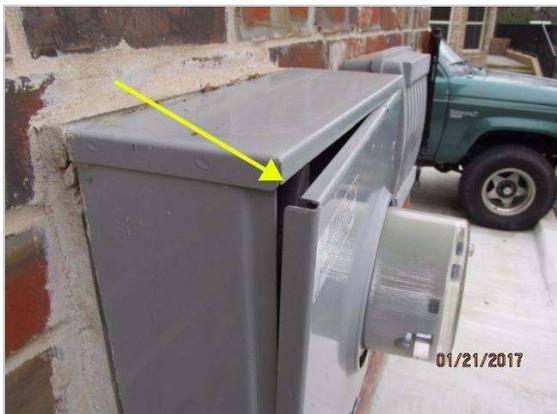
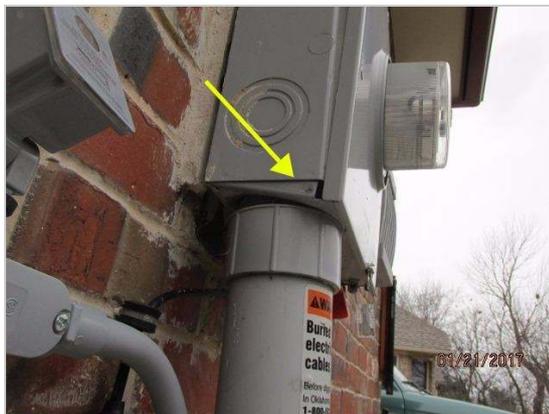
2. **The electrical meter box has been damaged by the conduit pulling down on the box from settlement of the concrete walkway. This may or may not be covered by the electric company. It may not be since the sidewalk was added. It is open to weather as it is now and should be repaired as soon as feasible. Cannot estimate due to unknowns**

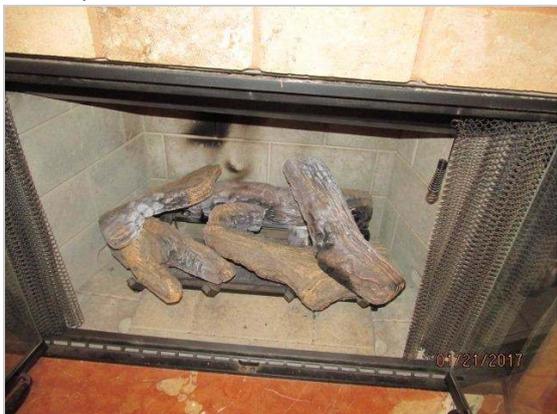
1. **The gas log set was not properly installed. This gas log set's proper and safe operation depends on the gas logs fitting together in a specific pattern set by the manufacturer. That is why there are grooves and pins to piece the logs together so that the flames do not impinge on the logs. Flames impinging on the logs can cause the unit to put carbon monoxide into the house which is dangerous. The unit also looked like it may not be compatible with the firebox. We recommend this system is checked out by a qualified fireplace installer to be sure it is safe. \$150**

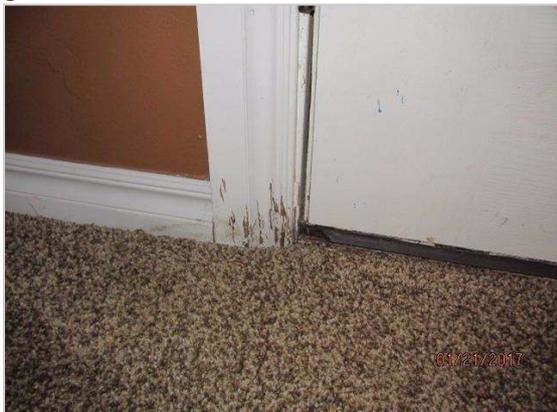
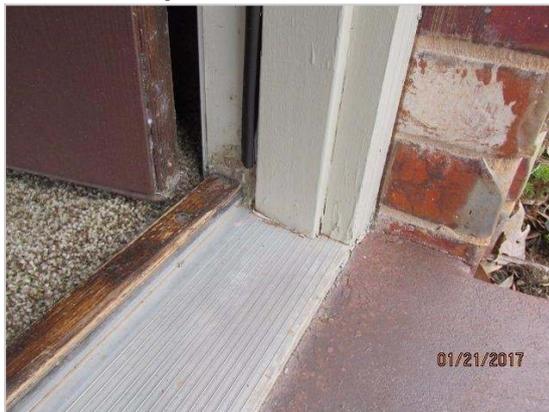
1. **Water gets in around the French doors to the left front bedroom due to a poorly installed gasket. We recommend the door is better sealed to keep wind blown rain out. \$100**

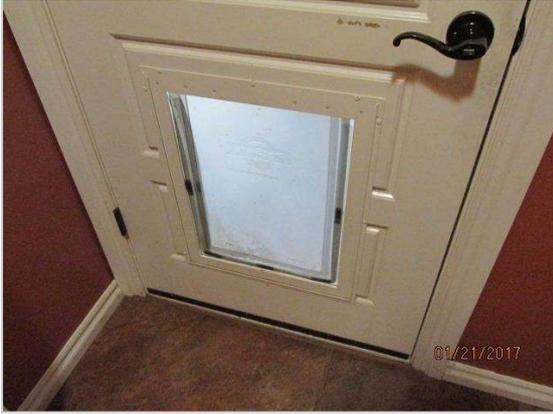
2. **There was a pet door through the door going from the inside of the home into the garage. Openings through a wall or door from the home to the garage are not allowed due to possible carbon monoxide issues as well as firewall issues. \$350**

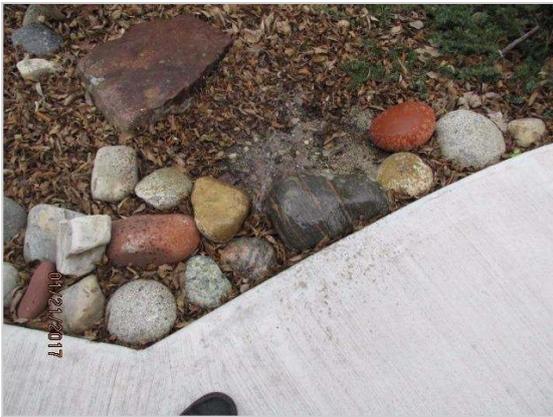
**There were several sprinkler heads that need to be adjusted and some that were not functional. I recommend the entire system is gone through and repaired as needed by a qualified sprinkler system contractor. \$200**

head not fully popping up here

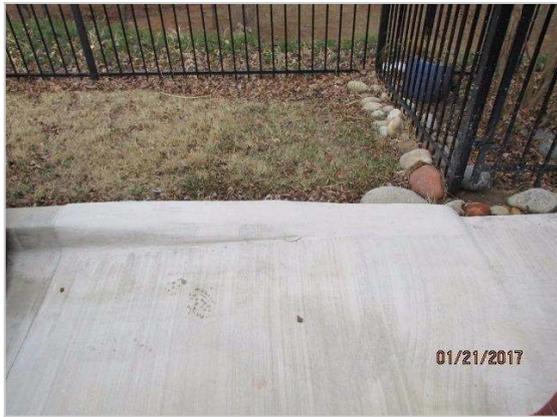
head not popping up here

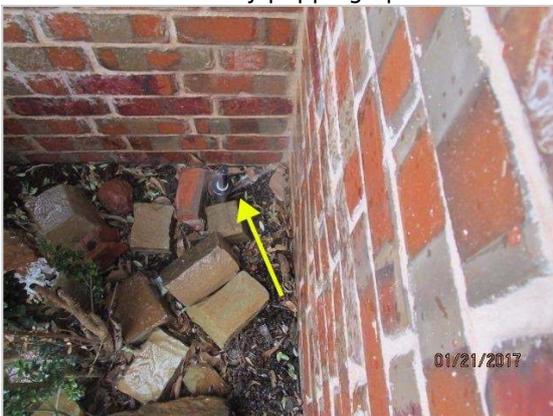
water shooting out the hole in the bottom of head
