On Thursday, June 6, 2019 The HomeTeam Inspection Service made a visual inspection of 123 Sample Drive, Anytown, WI 12345. Enclosed please find a written, narrative report of our findings in accordance with the terms of our Inspection Agreement.

HOME INSPECTION REPORT

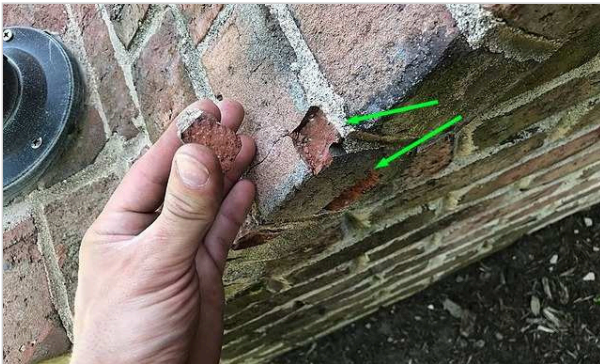
Photo 1

Minor areas of cracked bricks, mortar and/or spalling were present on the brickwork around the home. Small amounts of cracked or missing mortar or spalling is usually inconsequential, large amounts can lead to moisture accumulation behind the brick and worsening conditions. HomeTeam recommends consulting with a qualified contractor for repair of the areas.

near front entrance - right side

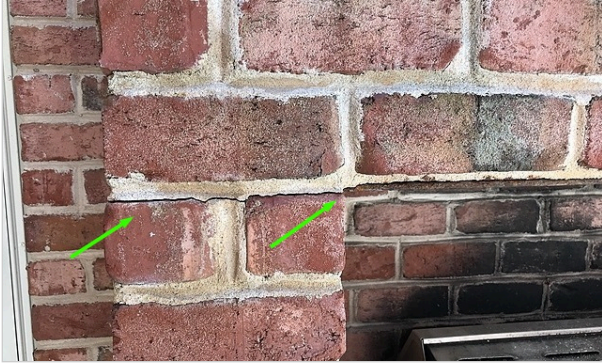
Photo 3

cracked mortar at the lintel line on rear grill chimney

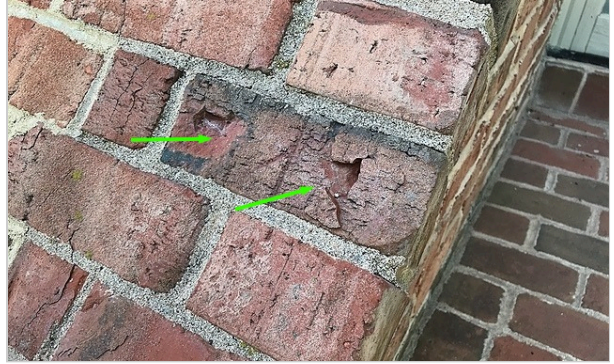
Photo 4

spalling of the brick near front entrance

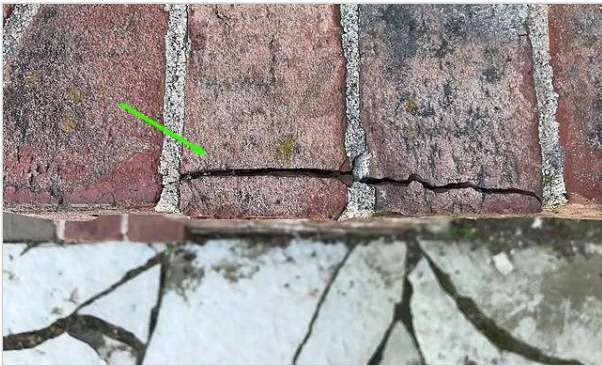
Photo 5

cracked bricks / mortar near the front door

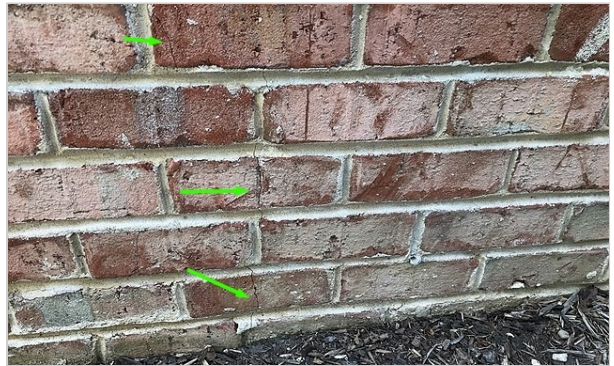
Photo 6

small cracks front right off walkway

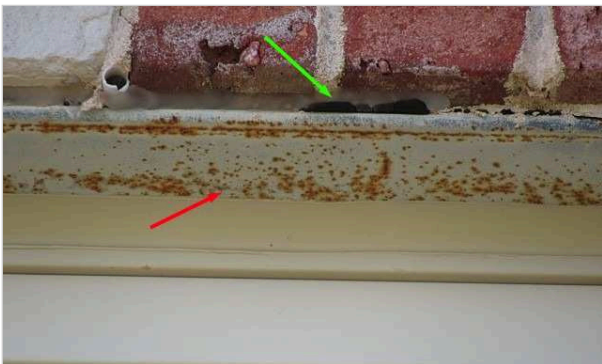
Photo 7

Several of the steel lintels above the windows on the exterior of the structure are showing signs of rusting. Lintels support masonry materials above doors and windows. Keeping the lintels sealed can help prevent rusting and expansion. Expanded lintels can lead to cracks in the masonry on the outside of the home. The affected lintels should be properly sealed to help prevent worsening conditions and expansion.

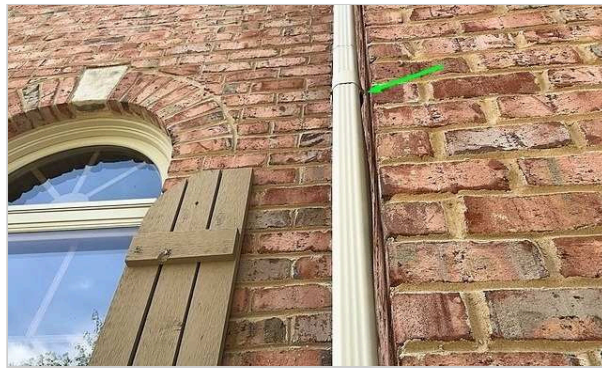
Photo 23

The front left downspout is not properly secured to the structure. To help prevent worsening conditions or gutter and/or downspout damage, the downspout should be secured.

mount is no longer connected

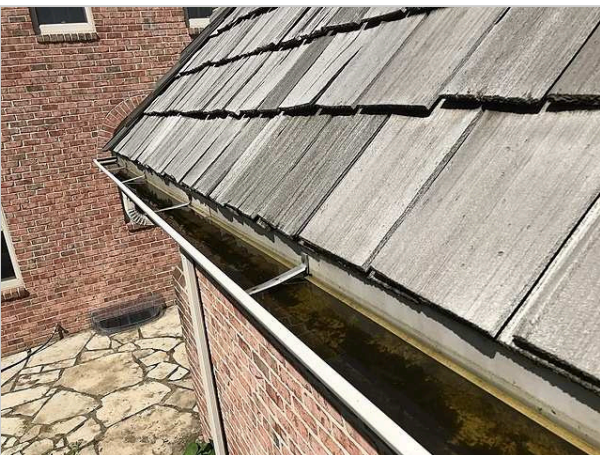
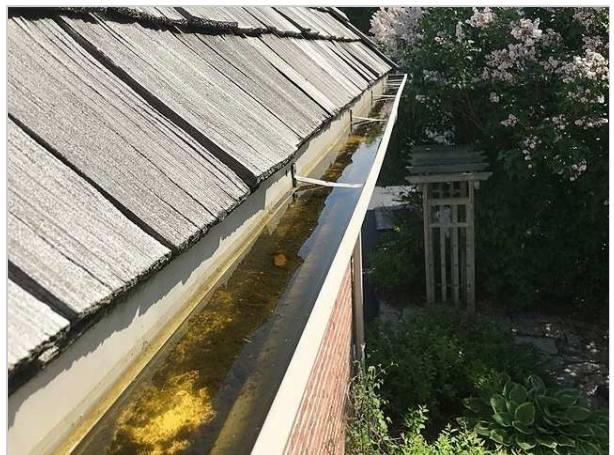
Standing water was present in the rear gutters. This condition could cause the gutter to overflow in the affected areas during periods of heavy or extended rain and can lead to the gutters gradually pulling away from the fascia and possible water damage to fascia that may not be apparent. The gutters should be cleaned and adjusted for proper flow as appropriate, and the underlying fascia assessed and repaired as necessary.

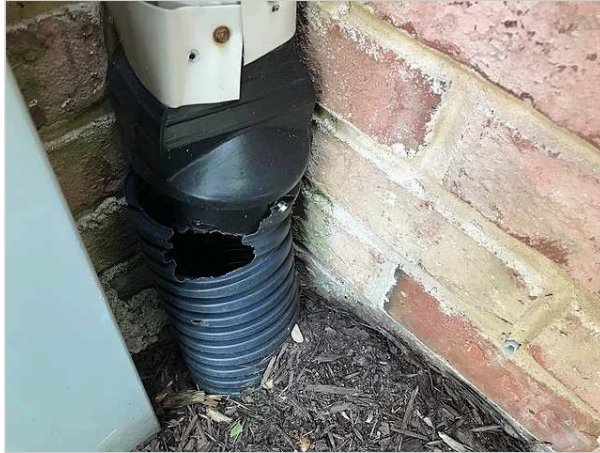
Photo 26

The right side downspout extension is damaged allowing for water to drain too close to the base of the

foundation. To reduce the likelihood of water problems at the base of the structure, the extension should be repaired or replaced.

Torn downspout extension allowing water to drain too close to foundation

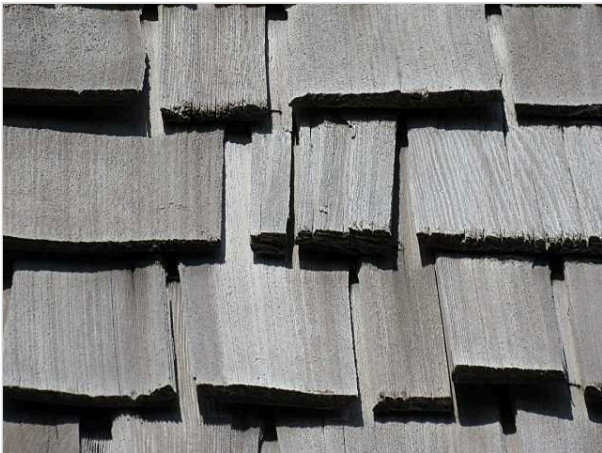
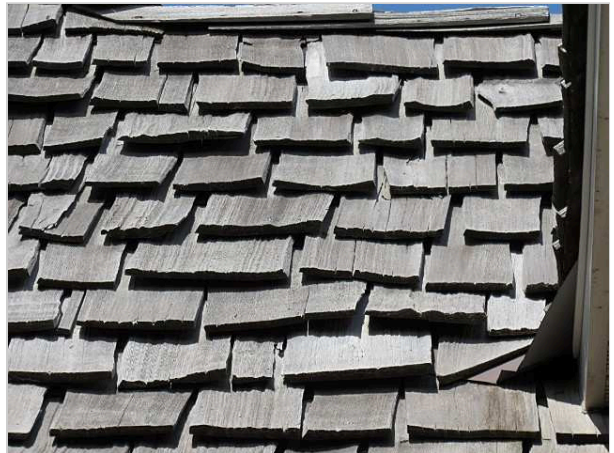
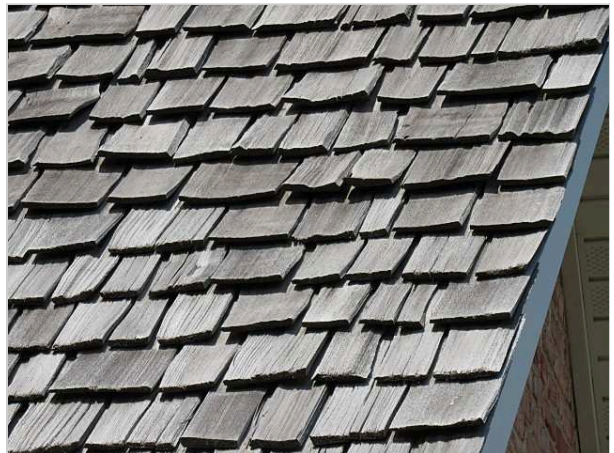
The roof shingles exhibited moderate to substantial curling and cupping and moderate to substantial surface wear. Splits and checking were observed. Evidence of a hail event was not observed.

These conditions indicate the roof shingles were in the latter part of their useful life.

Several areas of the roofing shingles showed significant signs of cupping, curling, checking and/or splitting. In some cases, cleaning and preservation applications can extend the life of shake roofs. In others, areas of the roof may need to be repaired or replaced. HomeTeam recommends the roof be further evaluated by a qualified roofing contractor for estimates on repair or replacement. Depending upon further assessment, this may become a material defect.

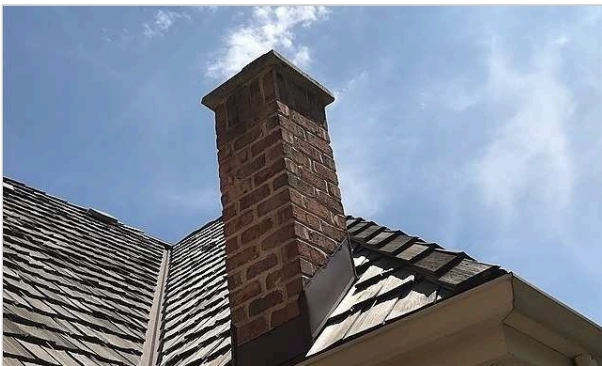
Photo 49

The chimney for the patio grill area is missing a rain cap. A rain cap should be installed to prevent excessive water intrusion and deterioration of the chimney and its components.

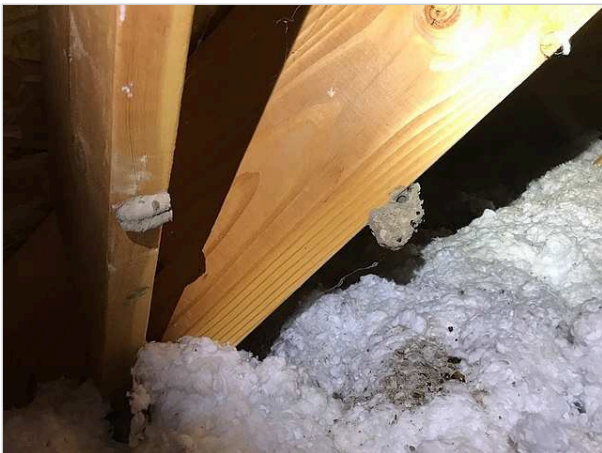
Photo 72

The attic has active mud dauber wasp nests. While not a usually aggressive species, they can sting and anyone with an allergy to wasp venom may have a severe reaction to their sting. Additionally signs of mouse intrusion were noted in the insulation. No live animals were noted. HomeTeam recommends consulting with a qualified pest control contractor for removal of the wasp nests and sealing of the openings to the area once it is determined the area is completely free of the wasps and animals.

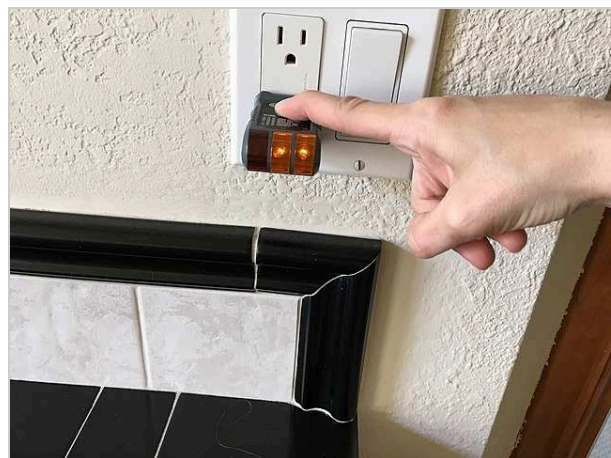
Photo 84

Master bath outlet right side not gfci.

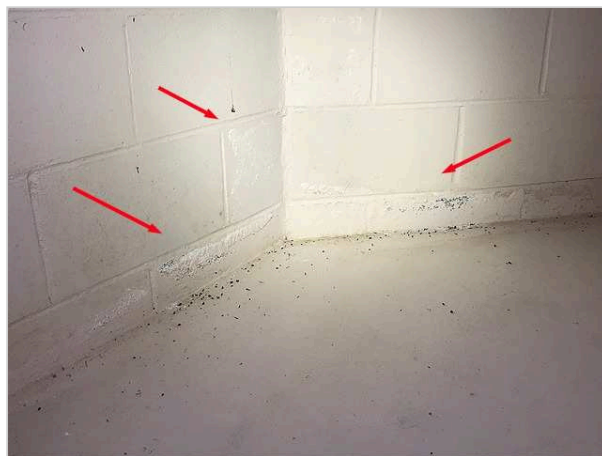
Photo 88

The basement was dry but shows signs of prior water intrusion on the right side near the gutter with the torn extension. The extension above should be repaired and the area monitored closely to observe any recurrence. If future water intrusion is observed, the buyer should consult with a waterproofing company to assess and to reduce or eliminate the problem.

efflorescence - prior water noted right side basement

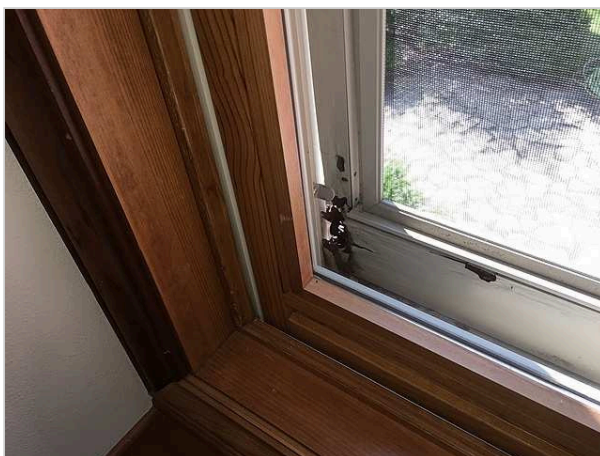
Photo 97

Wood rot in rear window.

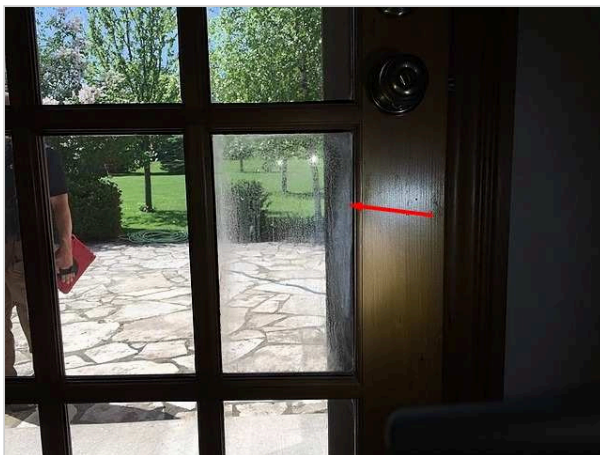
Photo 98

One window pane in the rear patio door had a broken thermal seal. A window with a defective thermal seal will show a slow but gradual "fogging" effect, and the insulation value of the window is marginally reduced. HomeTeam recommends having the affected window(s) repaired or replaced and further assessed.

bad seal on rear patio door window pane

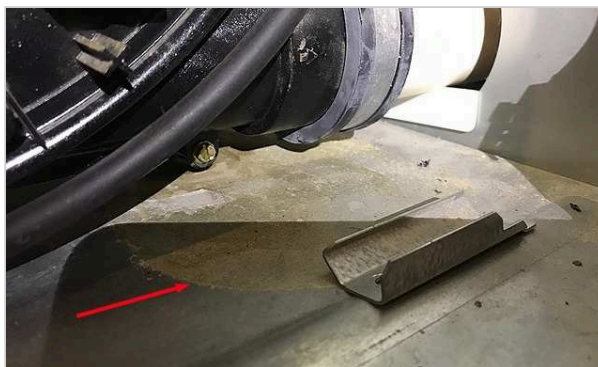
Photo 108

Evidence of prior water was present inside the furnace compartment. The condition may have been caused by a condensate leak in the furnace and/or air conditioning condensate drain lines. Water inside the furnace compartment can damage the furnace cabinet or other operational components and should be repaired. Consult with a qualified HVAC contractor to determine the source of the water and the best course of action should the issue reoccur.

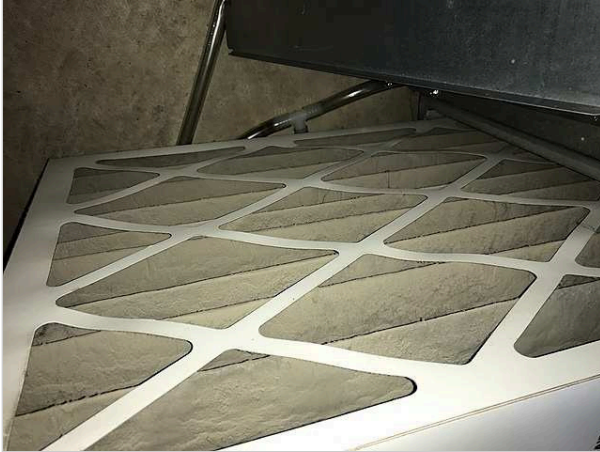
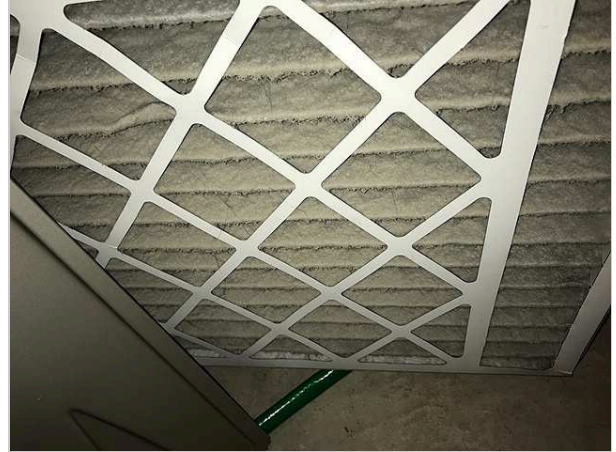
The air filters are extremely dirty on both furnaces and should be replaced. Prolonged operation of an HVAC system with a dirty filter can cause internal damage to the compressor valves that may not be observable during the home inspection; operating with a dirty filter may also damage the air handler.

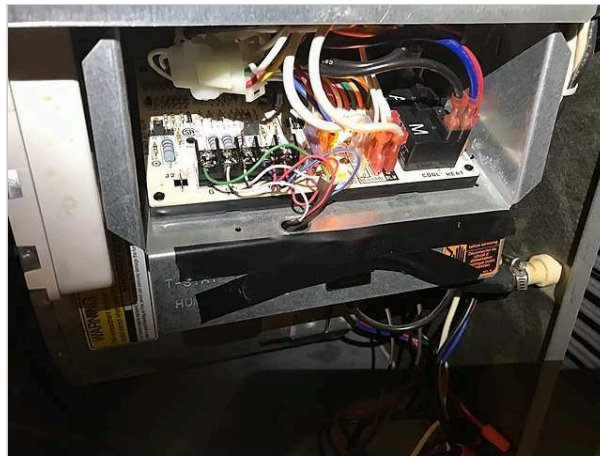
Photo 111

NOTE: The blower door safety switch is taped down on the lower level furnace and while this practice is often seen, it is not recommended. The blower door safety switch is a simple plunger like switch that when the door is opened, the switch cuts power to the furnace. Often times while HVAC technicians are working on furnaces and need the furnace door open, they will temporarily tape the switch shut while operating on the furnace and it is often overlooked when putting the cover back on. HomeTeam recommends the tape be removed and the switch restored to full functionality.
